## Substation – Drone Inspection Executive Brief

Inspection Date: September 12, 2025

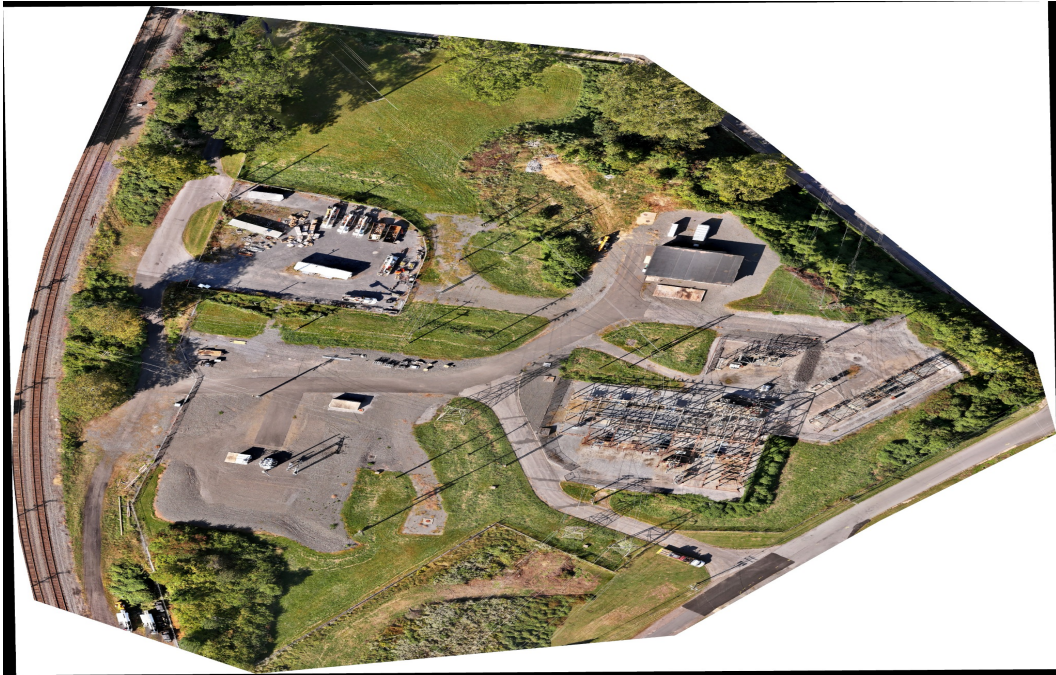
- Site access and layout generally good.
- Vegetation encroachment along some boundaries.
- Equipment and structures appear in stable condition.
- Drainage and surface grading to be monitored.
- No critical defects identified during aerial inspection.

1. Trim vegetation and maintain clear perimeter zones.
2. Inspect drainage near access roads.
3. Protect stored components from exposure.
4. Schedule follow-up drone or thermal survey in 12 months.
