## Substation – Drone Inspection Technical Summary

Inspection Date: September 12, 2025

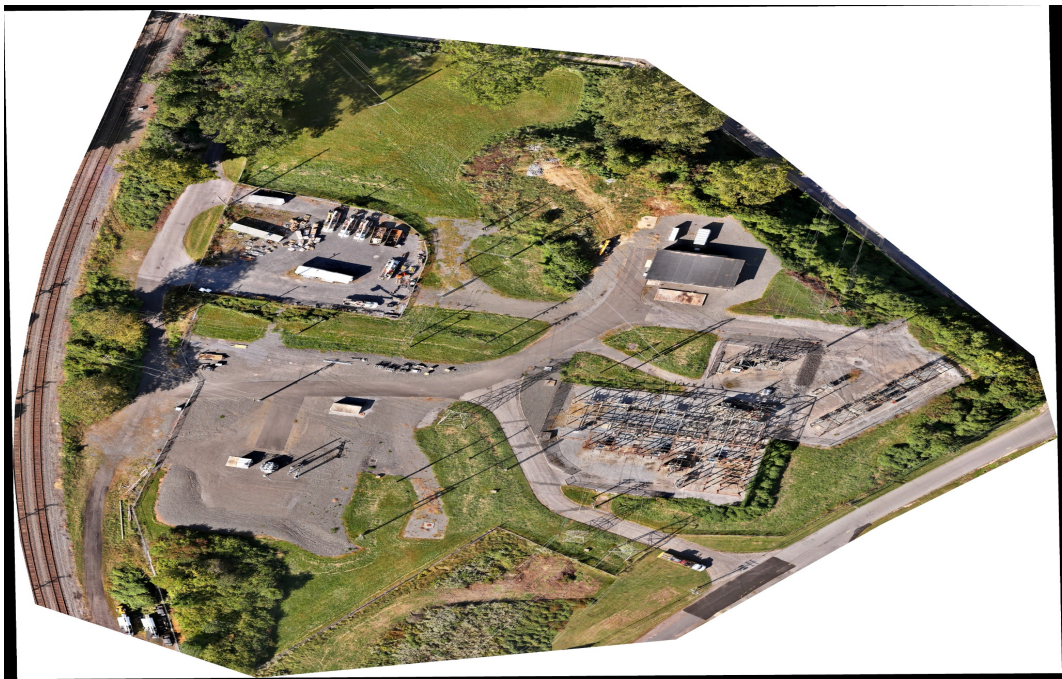
| Area | Condition Summary | Severity | Action |
|---|---|---|---|
| Site Layout | Clear access; minimal erosion. | Low | Maintain and inspect drainage. |
| Vegetation | Encroachment near fence lines. | Medium | Trim and control regrowth. |
| Transformer Bay | No oil or burn marks observed. | Low | Thermal check annually. |
| Control Building | Roof intact, minor staining. | Low | Inspect gutters. |
| Equipment Yard | Some materials uncovered. | Medium | Cover or relocate parts. |

- Prioritize vegetation and drainage improvements.
- Conduct periodic thermal scans for anomalies.
- Continue drone surveys every 6–12 months.
