Master Plan Design Review

Facility Condition Assessment

RE: Nissan Stadium Concept Estimate and Schedule Analysis
(based on Facility Condition Assessment and Gensler Concept Drawings)

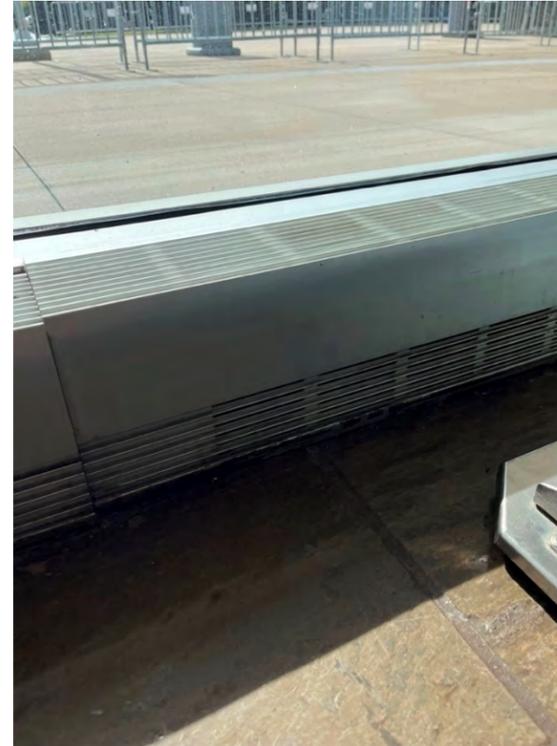
Baseboard heaters in Quad A

Continue with routine maintenance and replace non-operational heaters as needed.

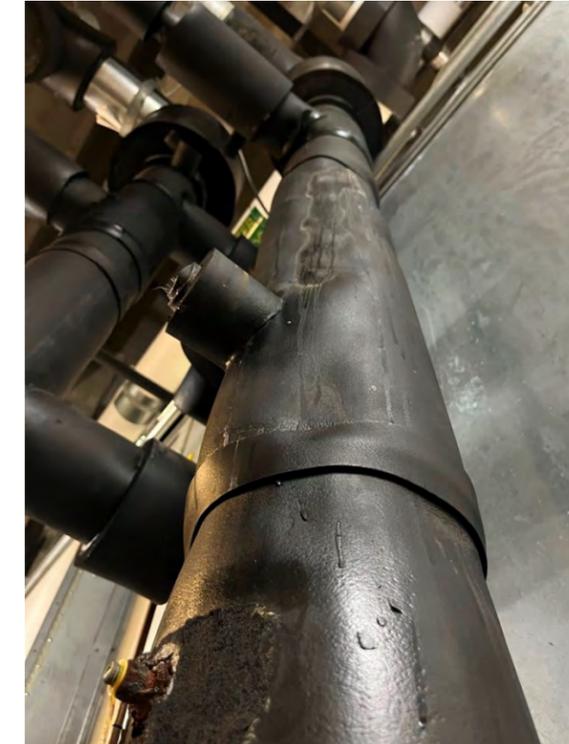
Replace hydronic piping insulation in areas where the original insulation has been compromised. There are several areas where the vapor barrier has not been maintained continuously which allows air/humidity to get behind the insulation and ultimately condense on the chilled water piping behind the insulation. This condensation compromises the integrity of the insulation, allows for biological growth to form, and continues to worsen over time.

Compromised chilled water insulation

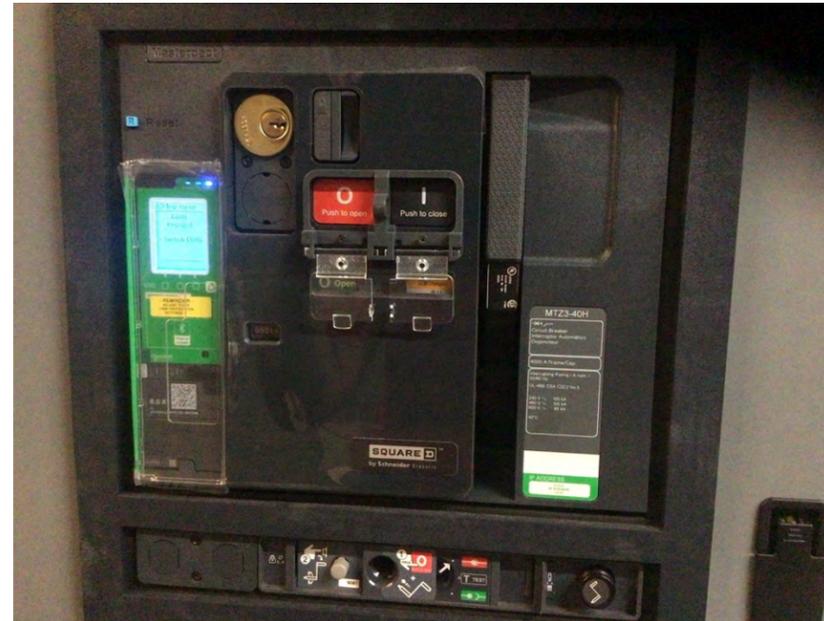
Main switchboards MSA1 and MSA2, located in main electrical room in Quadrant A at the southeast corner of the stadium, has nearly reached its 25-year life expectancy. Facilities management reported that the 4,000A main circuit breaker for each switchboard and the tie breaker between the two boards have all been replaced within the last three years. Each replacement required a custom-built replacement switchboard section with a new bus bar configuration in order to accept new equivalent replacement circuit breakers due the original breakers being obsolete and no longer available. According to facilities staff, the lead time for the custom-built bus configurations exceeded six months.

New main circuit breaker

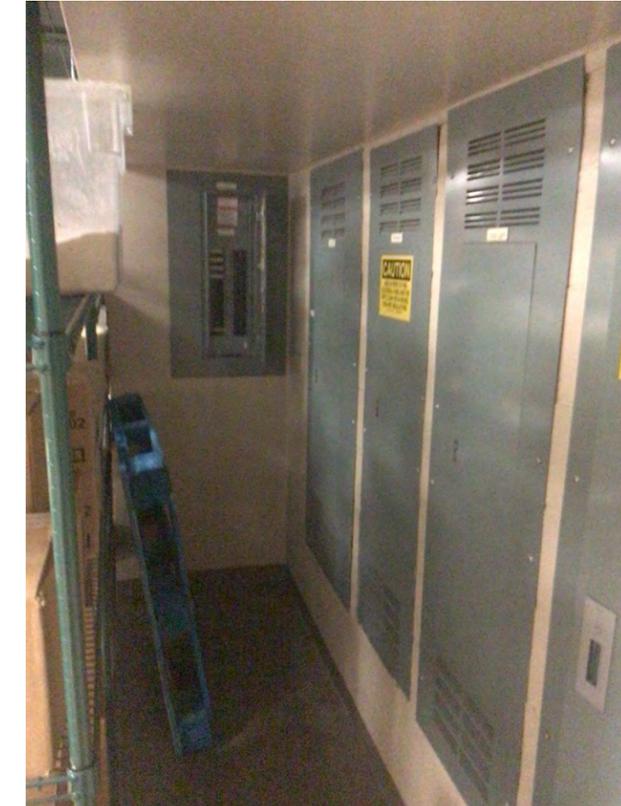
Items were addressed when previous report was issued but keeping the required clearance in front of panelboards and other electrical equipment persists as a reoccurring issue.

Example of clearance at a concession panel

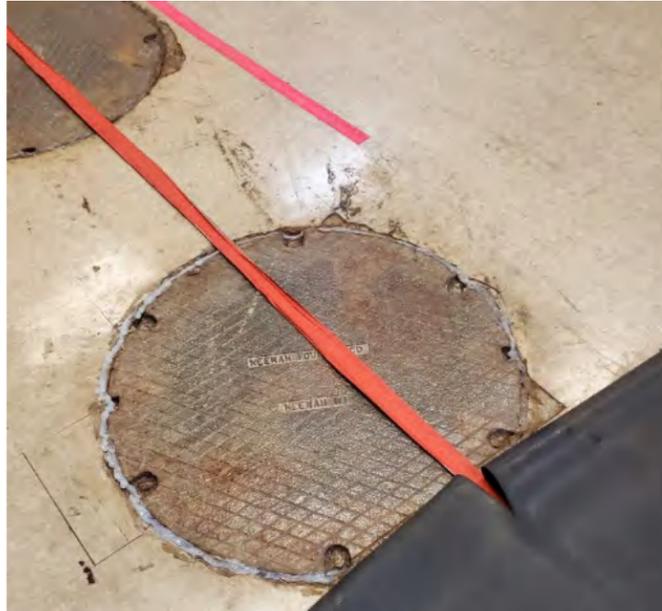
Grease interceptor manhole covers with caulking to prevent gas permeation

- Replace the two existing manhole covers with new gas-tight covers.

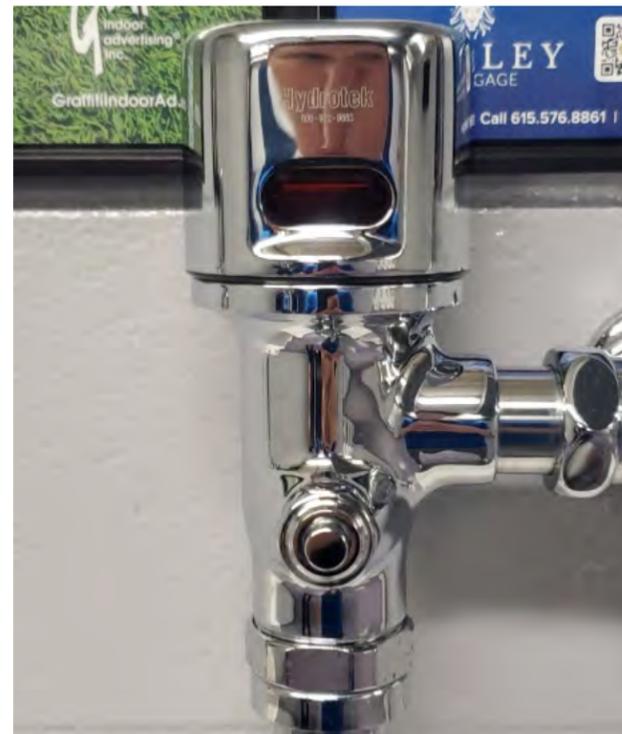
Hydrotek sensor flush valves serving water closets and urinals

- Shut down and drain the domestic cold water system in the zone where the flush valve(s) need to be replaced.
- Replace the failed flush valve with a new unit and test to ensure it's operable.

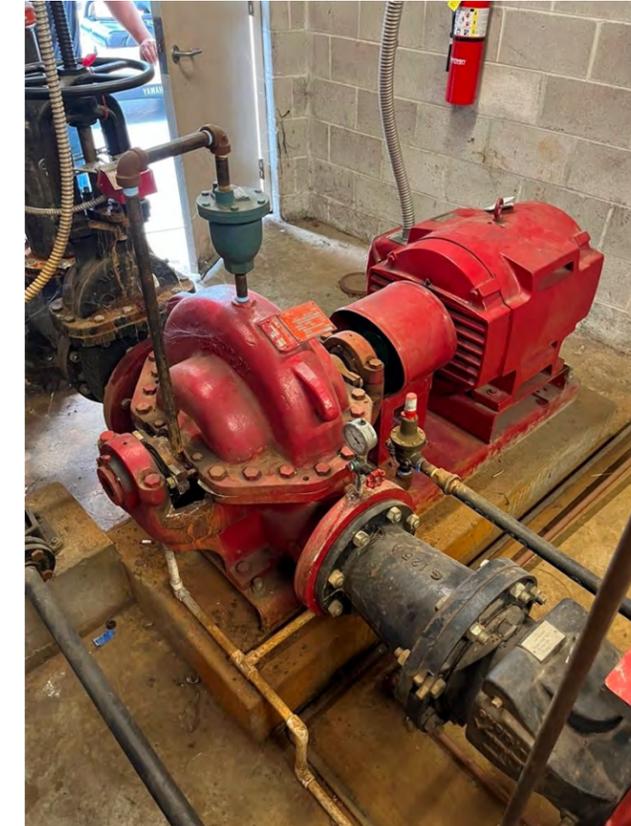
The fire pump and casing does not show significant signs of corrosion or deterioration. Continue routine testing, maintenance, and cleaning of the system.

Fire pump

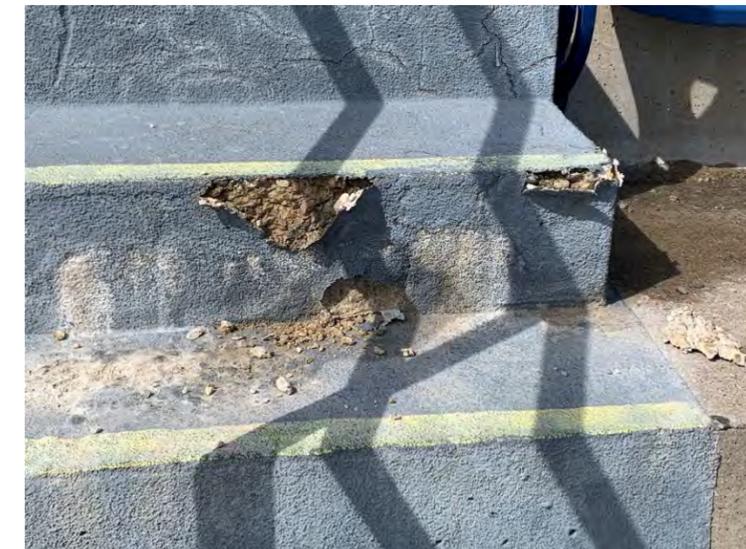
Cast-in-place concrete infill steps throughout the seating bowl were observed to have extensive cracking and occasional spalling of the stair nosing edge. The worst cases observed were at the upper seating bowl. The prevalent nature of the cracking and observation of the spalled regions appears to indicate that this concrete is undergoing an alkali-silica reaction. This is a chemical reaction that occurs within the concrete that has the result of producing a swelling behavior when combined with water. The presence of water is not a surprise given the exterior location. The chemical reaction is made possible due to the presence of reactive forms of silica within the concrete aggregate.

Seating bowl infill step deterioration

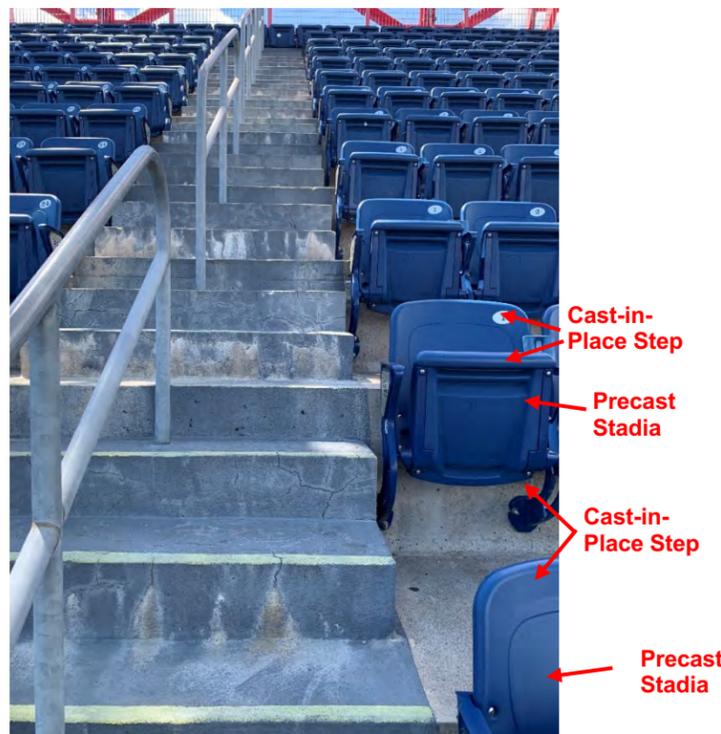
It is our understanding that infill steps throughout the stadium have been replaced in recent years on a case-by-case basis as needed. Additionally, we understand that the bottom approximate eight rows of steps at the upper bowl were recently replaced. We approximate that 1/2 to 2/3 of the remaining upper bowl steps are in a poor enough condition to merit replacement. The lower bowl had fewer occurrences or poor condition steps and these should be replaced on a case-by-case basis.

Upper bowl infill step deterioration prevalence

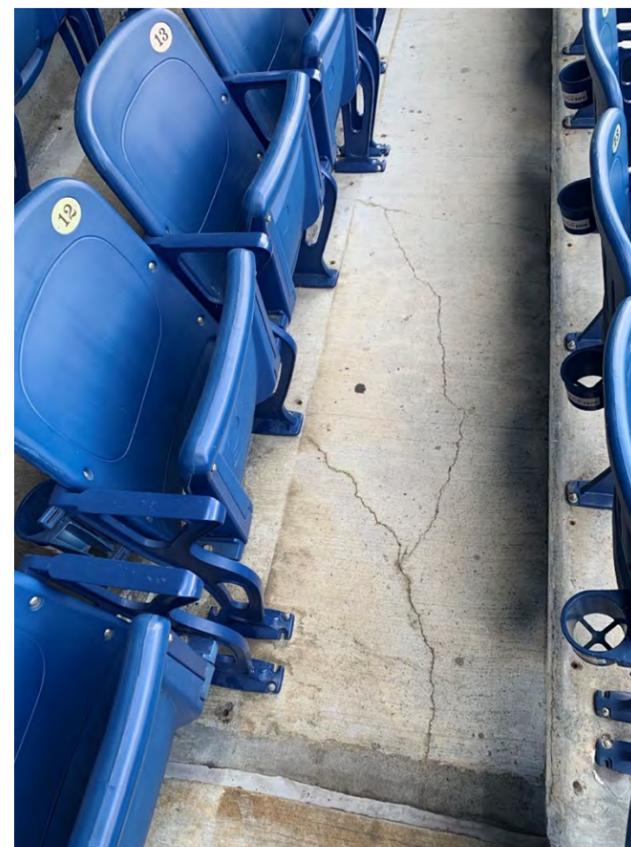
The condition of precast concrete stadia units (seating bowl) and double tee units (upper concourse slab support) was generally good. The majority of these units did not show any signs of degradation aside from general surface wear which is more aesthetic than of a structural concern. Several precast concrete stadia units were observed to have propagating cracks in the top surface of their tread portions, as viewed from above. These cracks are likely the result of environmental temperature fluctuations and shrinkage occurring naturally in concrete units. These cracks do not elicit concern about the current structural integrity of the stadia units. However, it would be prudent to seal the cracks as they are encountered to prevent against water intrusion and increased cracking due to freeze thaw cycles.

Cracking in lower bowl stadia unit tread

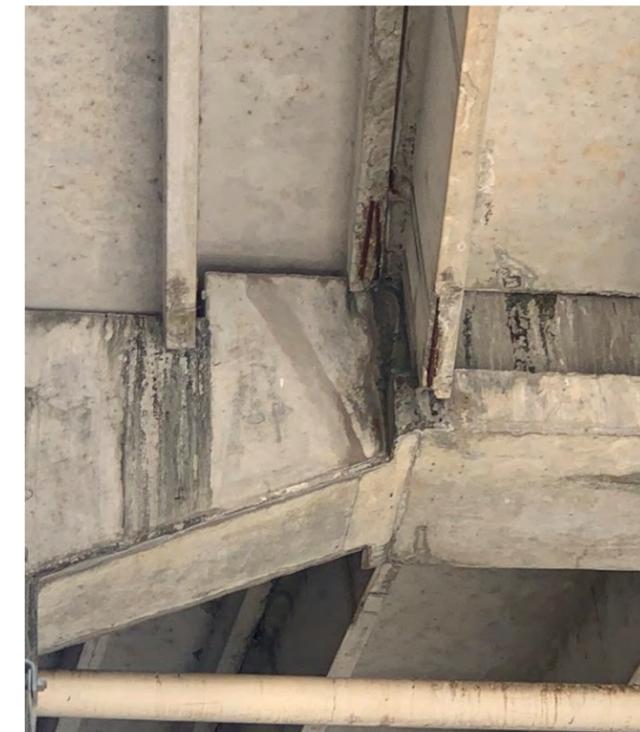
Several stadia and double-tee units were observed to have spalled concrete and exposed and corroding reinforcing steel (rebar) along the bottom of their vertical stem components. These occurrences were observed from the event level team tunnels, the main concourse and the upper concourse looking up at the visible extents of seating bowl and concourse structure above. Some instances of falling spalled concrete were reported by stadium personnel which is an obvious safety issue. A common cause for this kind of deterioration is insufficient concrete cover over rebar, enabling water intrusion which can trigger concrete corrosion. The expansive nature of corroding rebar can spall the surrounding concrete which further exposes the rebar. The rebar running along the bottom of these stems is an important structural component which enables the spanning capability of the precast unit. As such, it is important that instances of exposed and corroding rebar be remediated.

Exposed corroding rebar at precast concrete stems

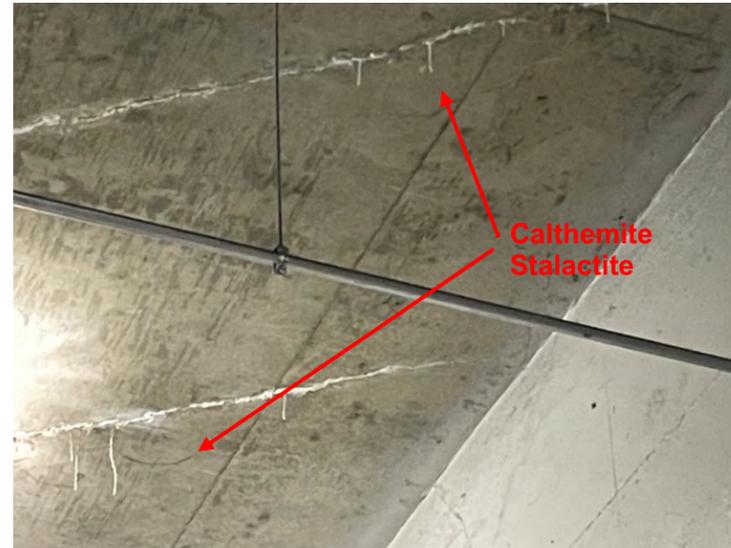
Under-slab calthemite stalactite

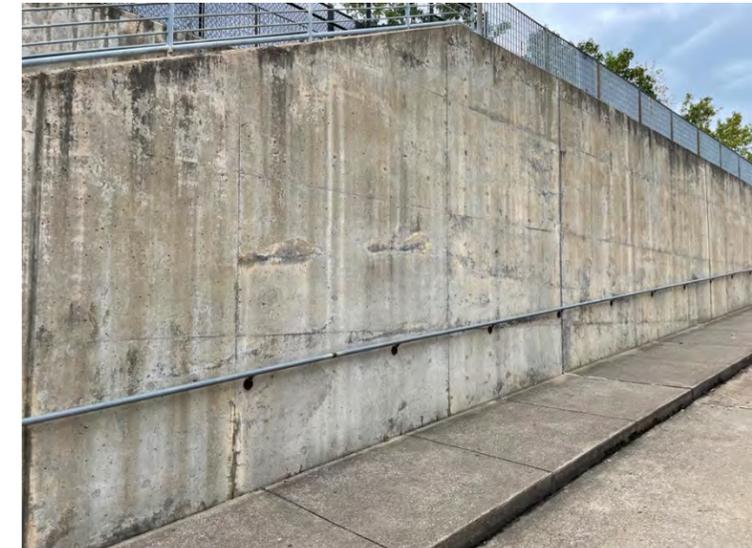
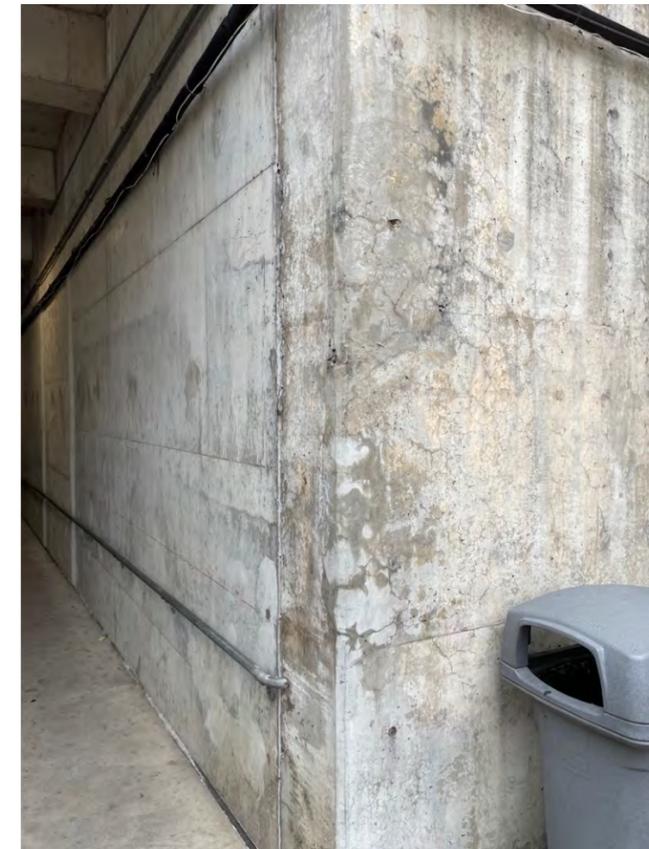
The access ramp to the loading dock was observed to have a variety of cracks and deteriorating regions along its length. This is likely a result of moisture building up behind the wall and leaching through the wall. Once moisture is present within the wall it is subject to expansive freeze and thaw cycles which can create internal stresses in the concrete, further exacerbating the issue.

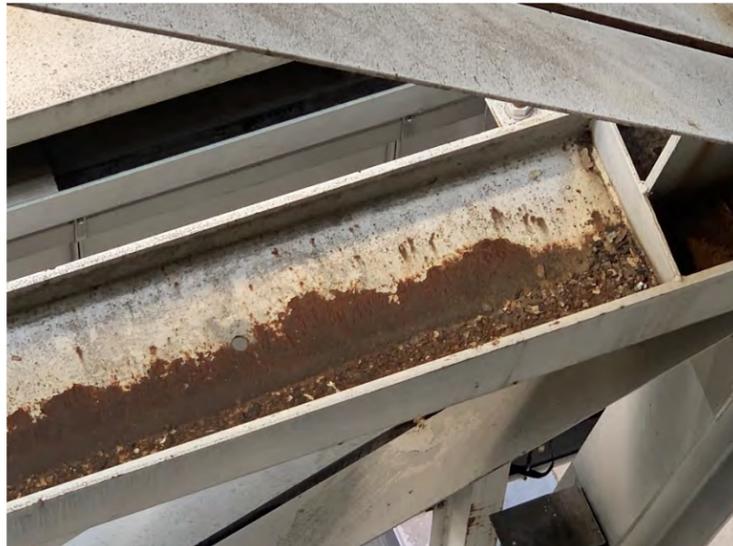
Corrosion was observed in numerous structural steel members comprising the framing for scoreboards and exterior facing signage. The most prevalent corrosion was observed in the web-horizontal wide flange sections acting as girts for exterior signage. It appears that the corrosion is the result of ponding water during rain events exacerbated by incorrect placement of weep holes in the beam web. While the corrosion is extensive in these members, it does not appear to have substantially increased since the documented photos from the 2017 report.

Corrosion at scoreboard signage girt

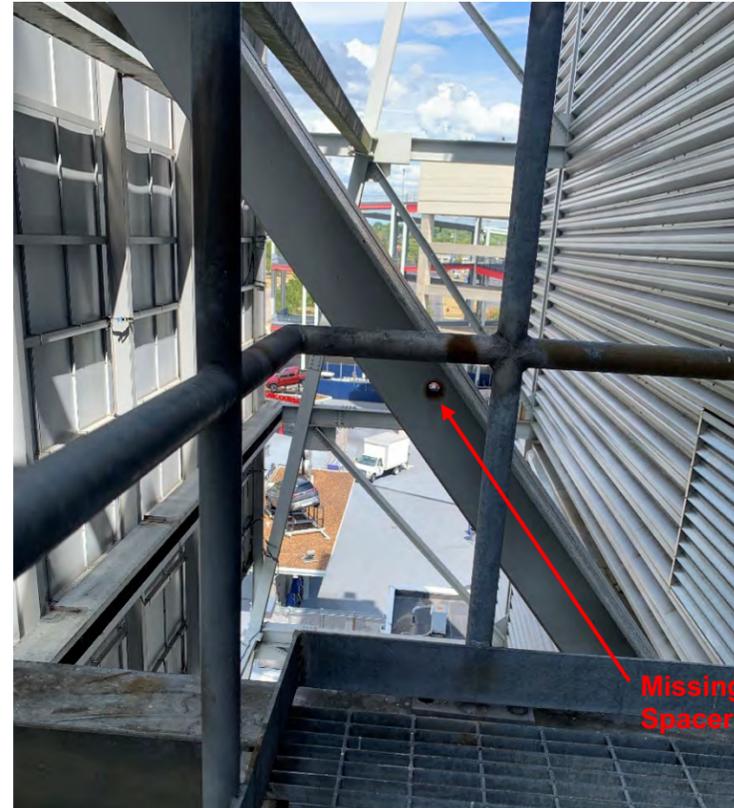
Numerous double-angle braces were observed to be missing the spacer bolt intended to connect braces at their mid-point. It is not clear if the noted bolts were never installed or were removed at some point subsequent to construction. Nevertheless, a spacer bolt serves the function of reducing the unbraced length of individual angle elements which is often a consideration in the design of the overall bracing system. It is noted that a spacer plate between and welded to the individual angles would serve the same function as a spacer bolt. However, TT did not have sufficient access to visually confirm the presence of a welded plate in lieu of the apparent intended bolt.

Missing spacer bolt at angle bracing

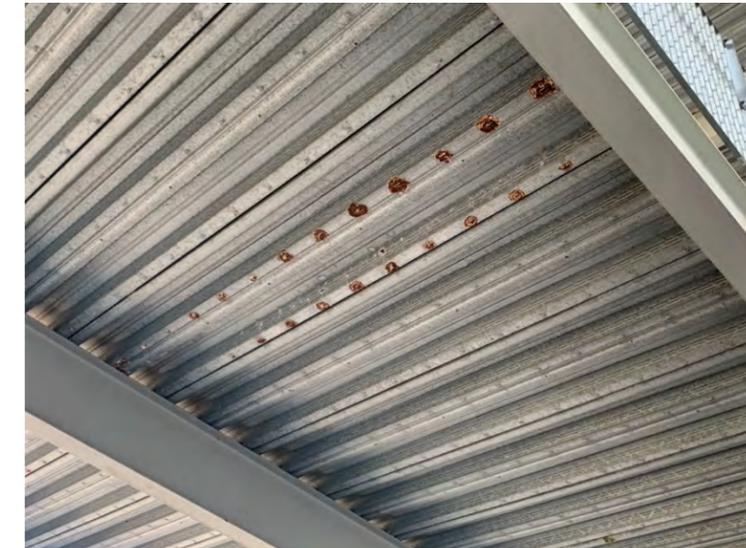
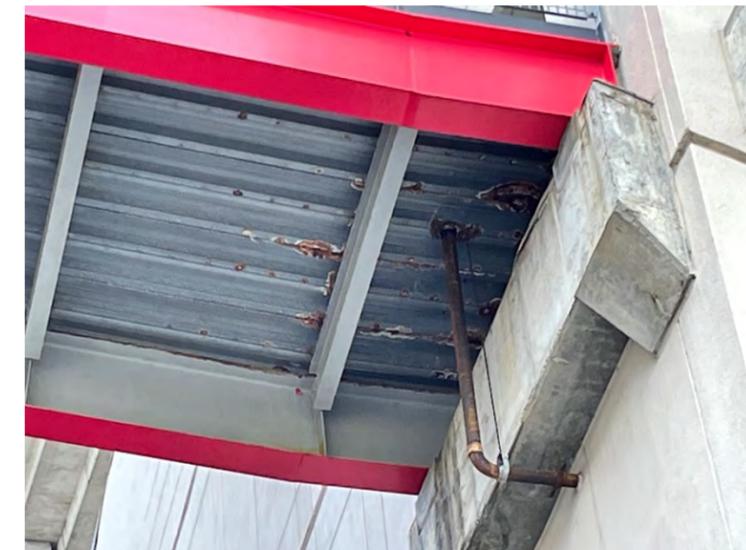
Corrosion was observed at numerous locations at the underside of the metal deck supporting the exterior upper concourse access ramps. In many cases corrosion, appears to be originating at locations of deck attachments and sidelap screws. This is an indication that water is migrating through the slab and reaching the top side of the metal deck. It was noted that some portions of the metal deck and supported slab at end east side ramp had recently been replaced as a result of excessive corrosion in those areas.

Corrosion of metal deck at access ramps

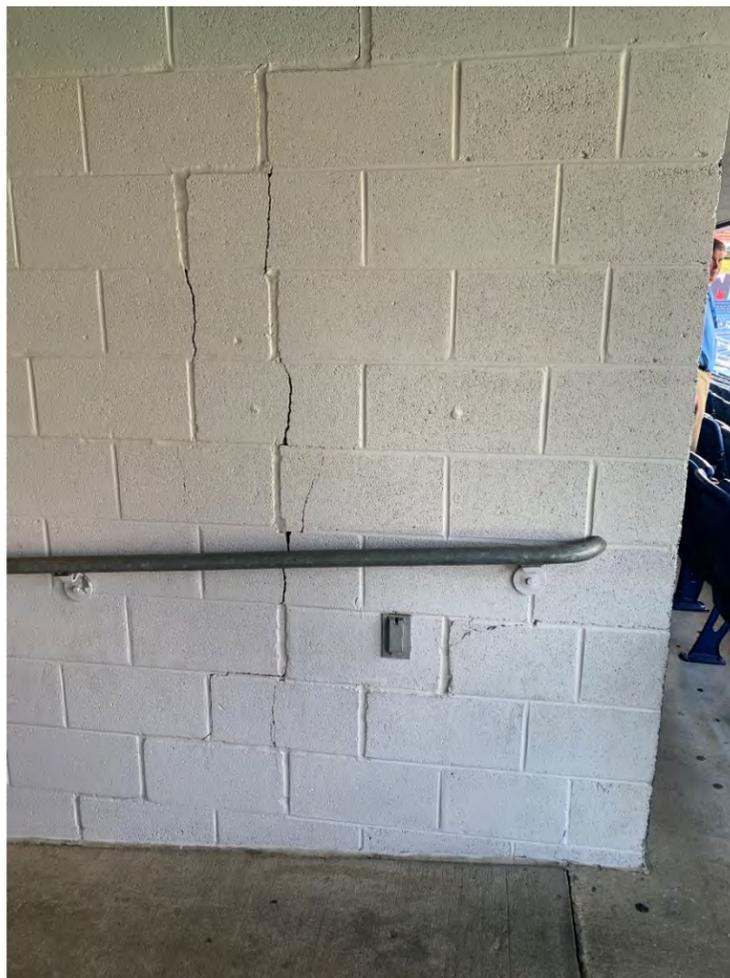
Extensive cracking was observed at many of the CMU vomitory walls at the west side of the main concourse level where the main concourse slab is an elevated slab over the field level. The cracks were typically observed near the vomitory outlet to the seating bowl. These walls also separate the vomitories from numerous concession and pantry spaces. The cracks are an indication of potential excessive deflection of the supporting slab. Additionally, cracks may be an indication that CMU walls are attracting lateral load due to unintended positive connection to the structure above the wall.

Cracking in CMU vomitory wall at main concourse

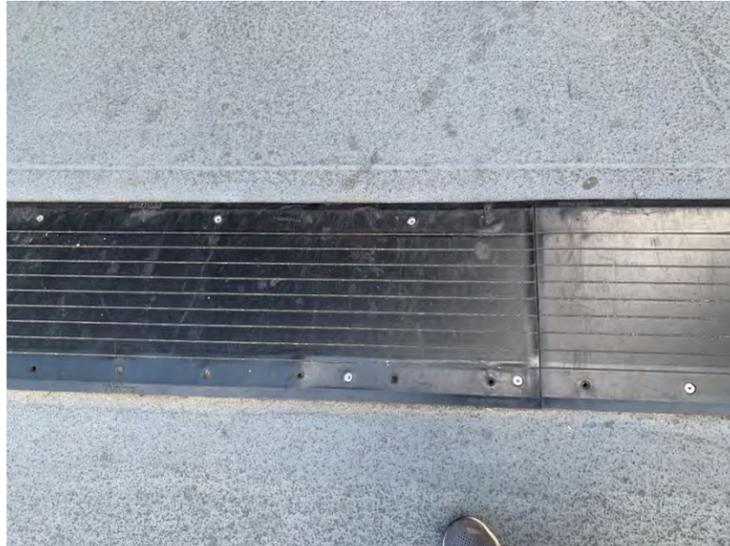
At some of the structured floor joint covers, it was observed that the joint covers were anchored to the structure on both sides of the joint. Properly installed joint covers should only be secured to one side of a joint to prevent lateral load transfer across the joint

Expansion joint cover anchored at both sides of joint

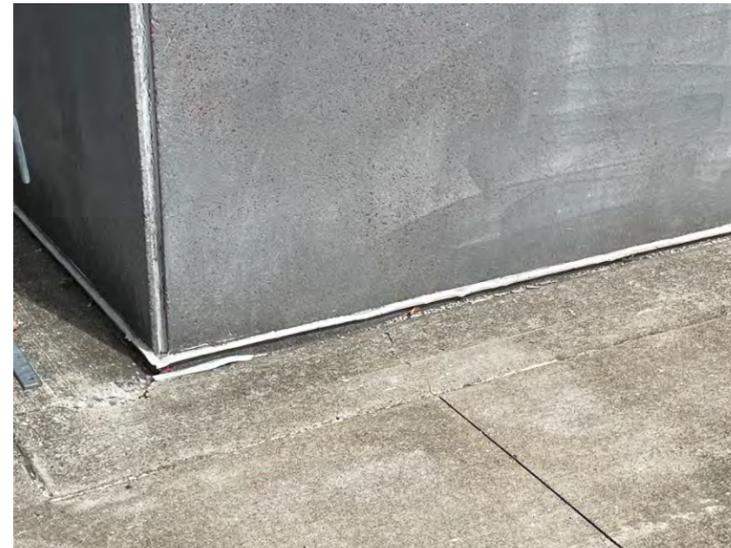
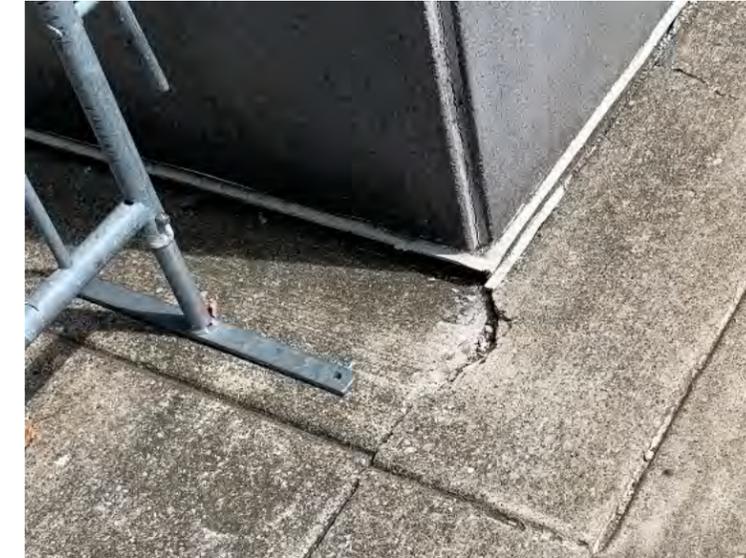
The slab-on-grade on the west side plaza outside the stadium appeared to have settled and cracked in areas such that a gap had formed between the slab and the base of precast wall panels. It appears that the wall panels are attached to other structural elements in that they have not settled with the slab. This has resulted in the bottom caulk joint remaining attached to the precast panel and elevated about the slab on grade. While this is not a structural concern, the current condition will allow for water intrusion into the base of the precast wall panel and under the slab which may cause damage to the base of wall grout and further cracking of the slab on grade.

Plaza slab settlement at exterior wall

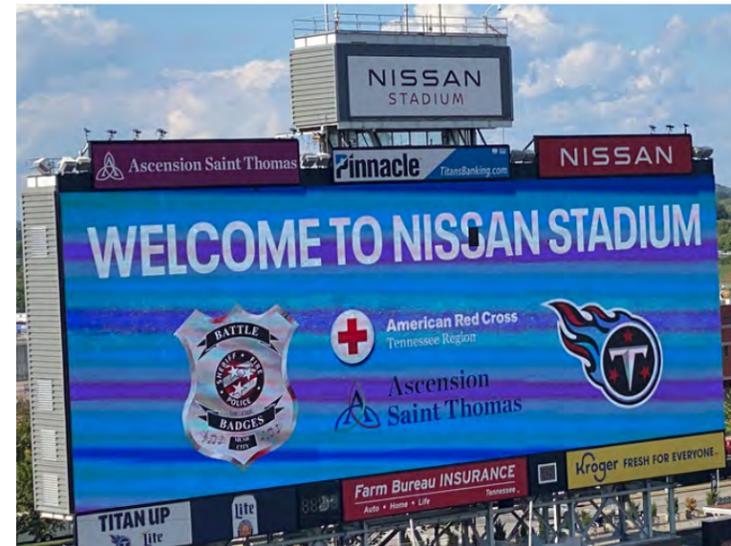
failure of hardware processing at the headend would affect both displays. We would advise testing by the manufacturer on the backup processors to help reduce the risk of failures in a game.

North videoboard with module failures

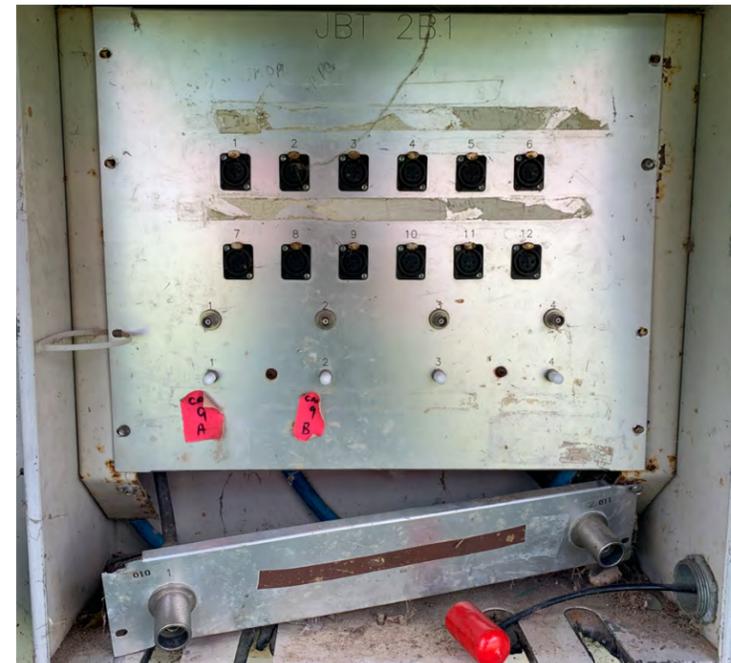
Individual JBT boxes are in poor condition. Each box should be clean, and terminations tested to ensure full functionality.

JBT

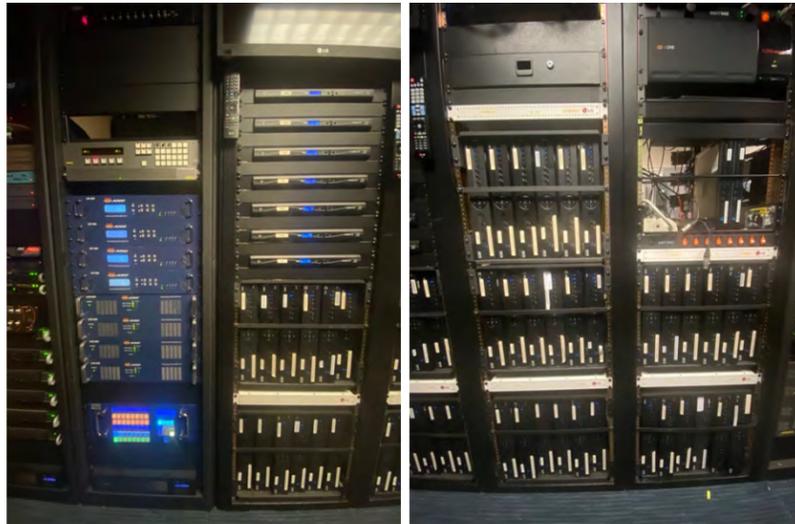
Modulated cable TV systems are becoming uncommon across stadiums and have limited support as product availability is less abundant.

MATV headend components and cable set top boxes

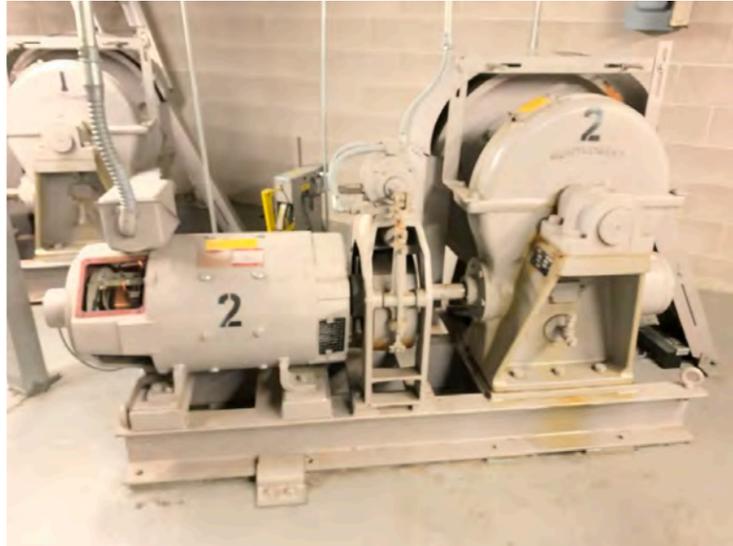
The DC drive hoist motor commutators need to have the carbon dust removed to help prolong motor life. The gear oil levels were found to be adequate during our review. The hoist ropes show signs of crown wear, but with appropriate preventative maintenance and proper tensioning of the ropes, the venue should see several more years of use. If the maintenance is performed to industry standards, the elevators should provide three to five more years of reliable service except for the availability of Montgomery/KONE controller parts, and SCR drives.

Original Montgomery/KONE 1996 Hollister Whitney 63-OH geared machines

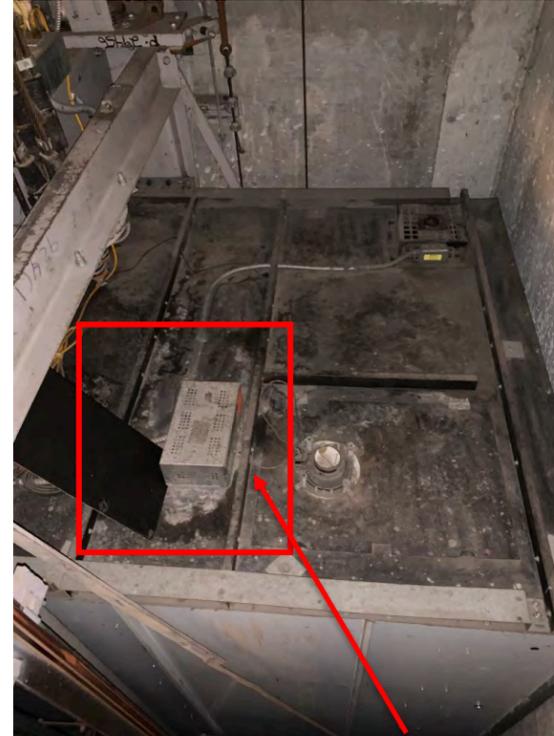
Both unit cartops were dusty and do not appear to have had preventative maintenance performed recently. The cartop surfaces are showing signs of weather-related deterioration and it is recommended that the car top equipment be painted to help prevent rust and extend equipment life. Note, there is an extension cord laying on the cartop that is not code compliant. The cord appears to be supplying power to the added monitor inside the cab. The MAC door operator appears to be in fair overall condition. All door operator belts appeared to be in good condition and operate smoothly. The door closing torque on elevators 1 and 2 exceed the code requirements and need adjustment to 30 pound of force (lbf) or less. The hoistway door track has surface rust due to the high moisture condition in the hoistways. The door equipment requires preventative maintenance, and the surface rust should be removed, and inhibitor applied to the track surfaces.

Passenger elevator #1 has signs of water damage and dust cover is being stored on the cartop and should be reinstalled

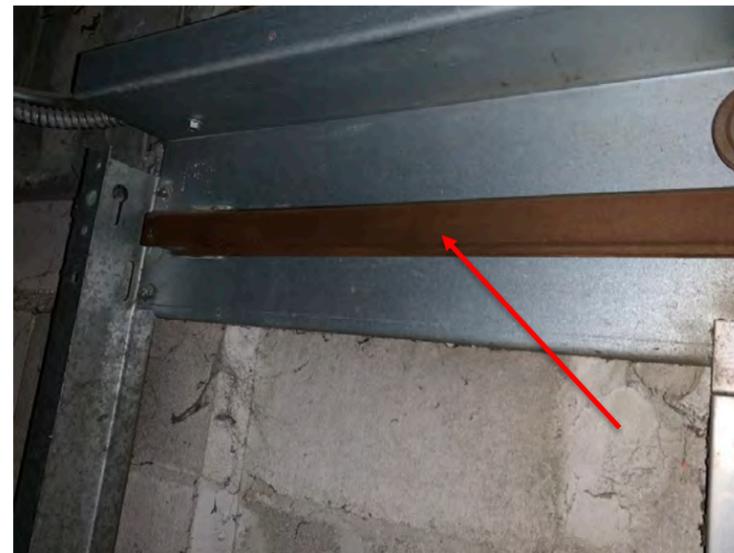
Hoistway door tracks are showing signs of rust

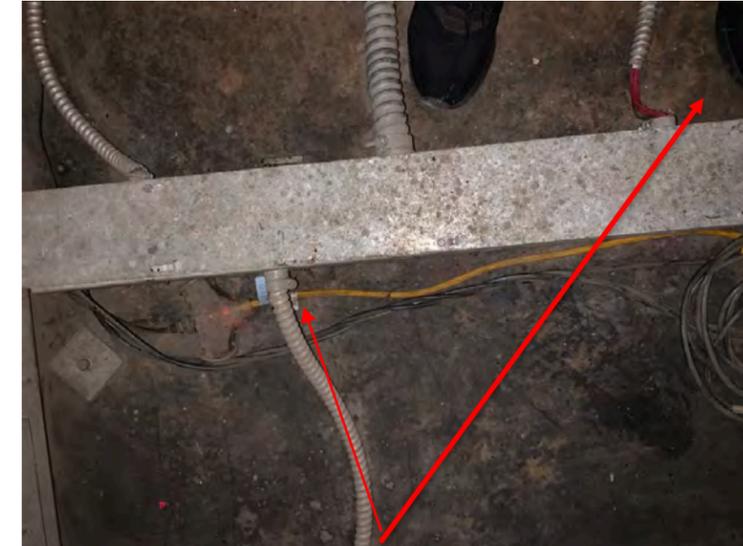
Extension cord is laying on cartop and greenfield is pulled loose from the duct fitting

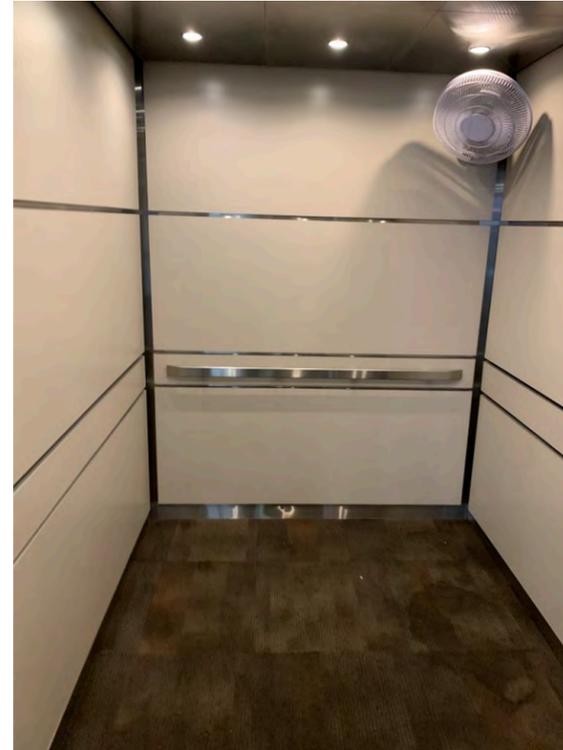
Temporary fans have been installed in the elevator cabs and are used during warm conditions

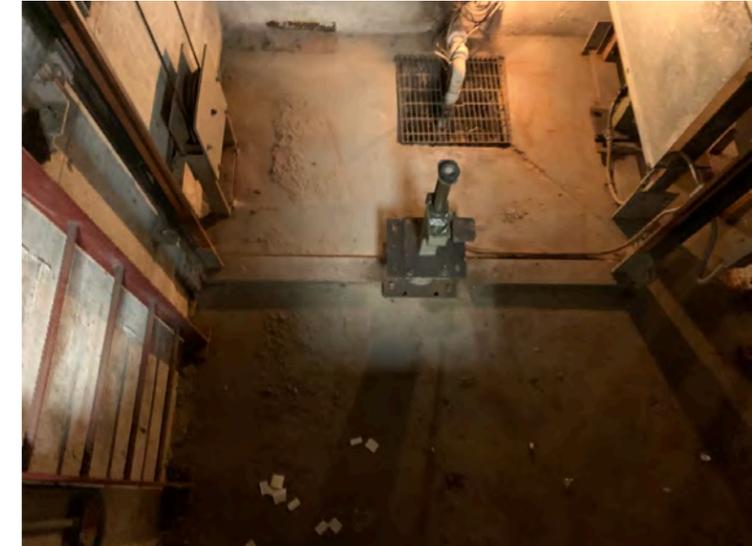
The pits are in fair condition with no water present. Sump pump and sprinklers are present, and debris was found on the pit floors. The underside of the elevators shows signs of surface rust. It is recommended to remove the rust and paint surfaces.

No counterweight run by data tags in place and trash was found on pit floor

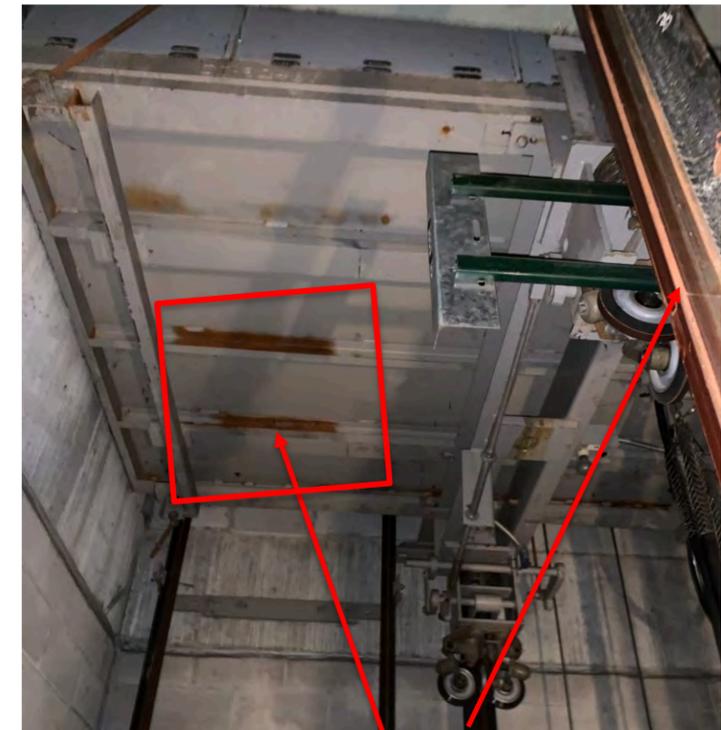
Underside of elevators are showing signs of surface rust in addition to the rust found on the guide rail blades

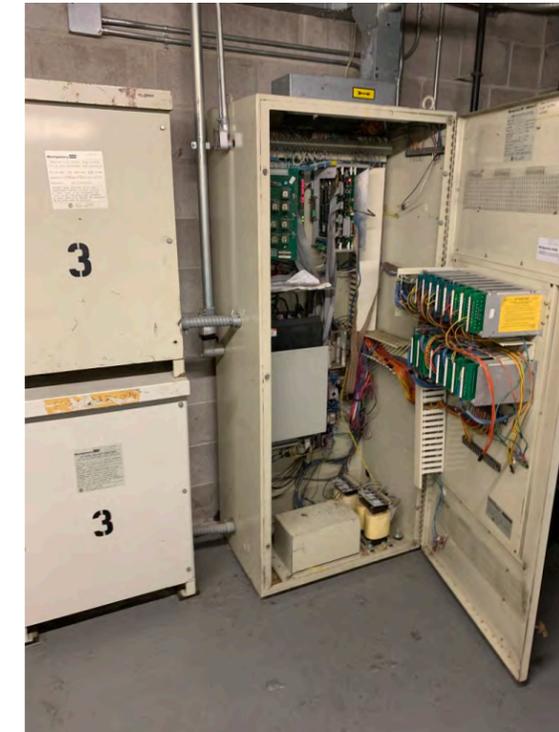
The DC drive hoist motor commutators need to have the carbon dust removed to extend equipment life. The gear oil levels were adequate at the time of our review. The hoist ropes show signs of crown wear but with recommended preventative maintenance and proper tensioning of the ropes, should provide several years of use. If the maintenance is continued to industry standards the elevators should give three to five years of reliable service except for the availability of Montgomery/KONE controller parts, and SCR drives.

Original Montgomery/KONE 1996 controller and drive

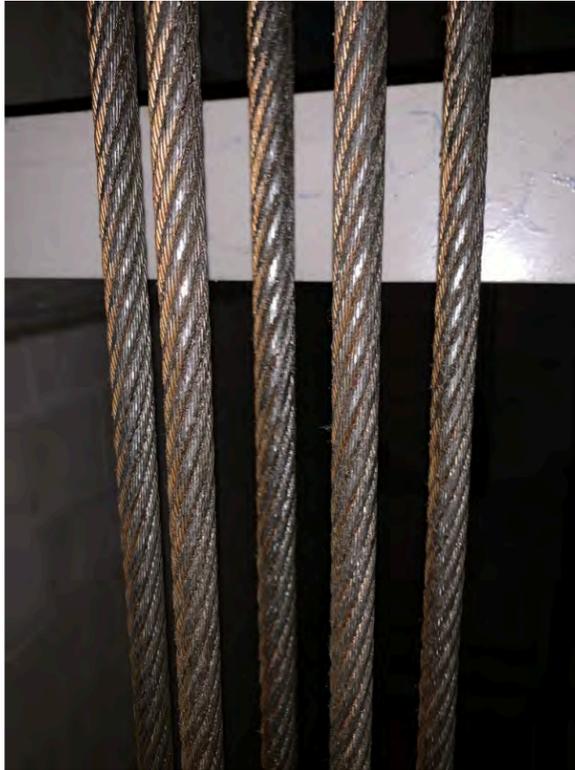
The cartop was dusty and does not appear to have had preventative maintenance performed recently. The cartop surface is showing signs of weather-related deterioration and it is recommended that the car top equipment be painted to help prevent rust and extend equipment life. There is an extension cord laying on the cartop that is not code compliant. The cord appears to be supplying power to the added monitor inside the cab. The MAC door operator appears to be in fair overall condition. All door operator belts appeared to be in good condition and operate smoothly. The hoistway door track has surface rust due to the high moisture condition in the hoistway. The door equipment requires preventative maintenance, and the surface rust should be removed, and inhibitor applied to exposed metal surfaces.

Hoist ropes show signs of slight crown wear and need tensioning, cleaning, and lubrication

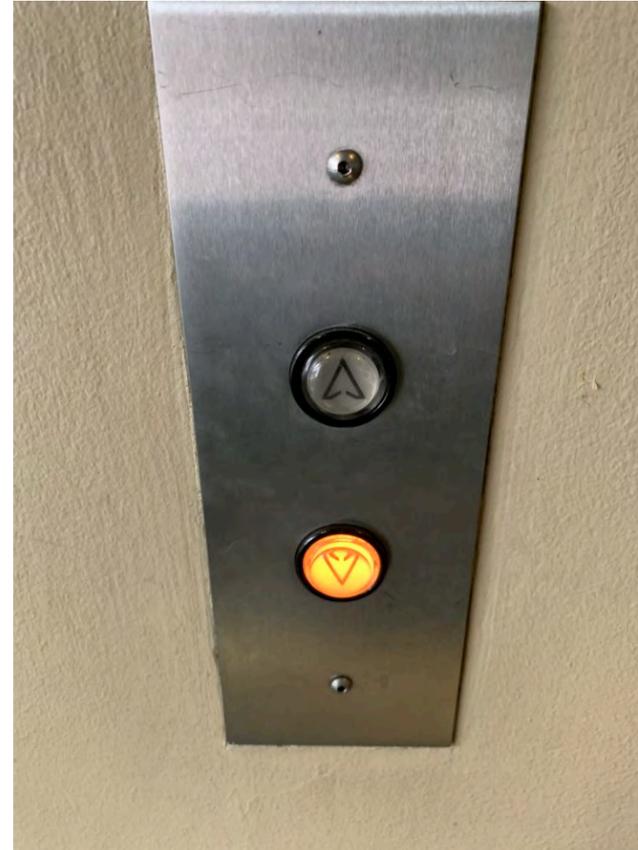
All push button fixtures appear to be original and are 24 years old. It is recommended that they be replaced with vandal resistant fixtures. The push button lighting levels do not match on several floors which is an aesthetic issue, and should all be replaced when the next one burns out so they match.

Fixture buttons are original plastic design

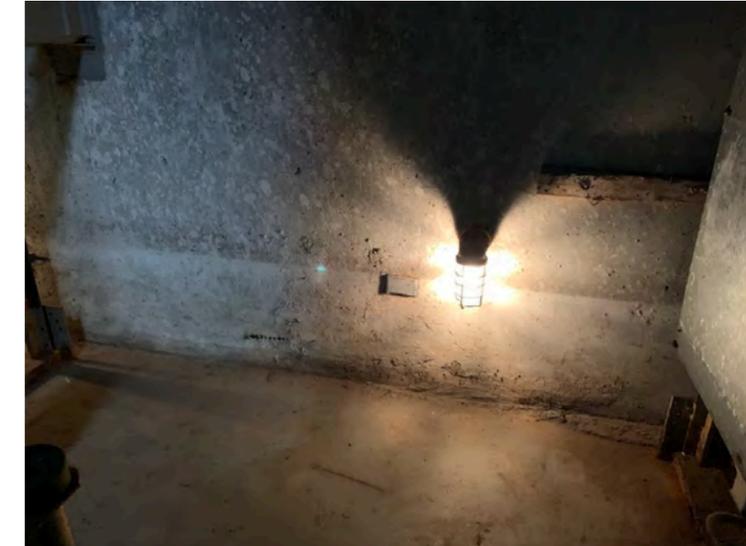
The pit area is in fair condition with some debris on the pit floor and there was no water present on the day of inspection. The metal pit equipment is showing signs of rust and needs to be cleaned and should be painted.

The pit equipment is showing signs of rust

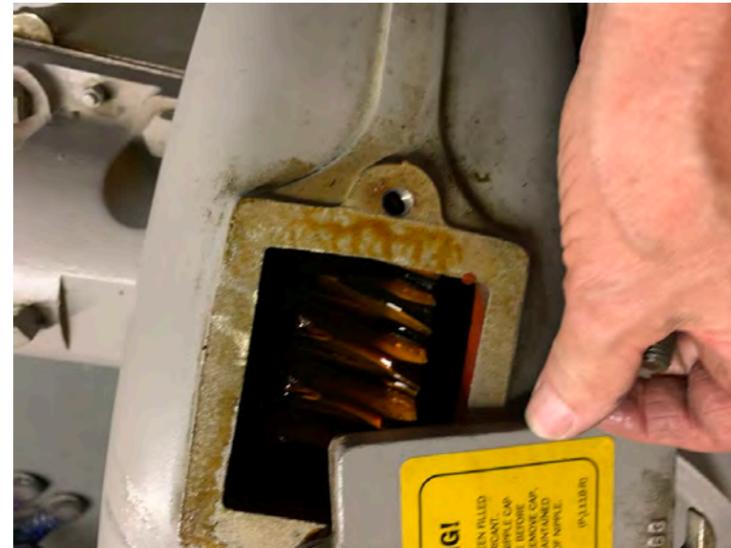
Geared machine carrying oil on to ring gear

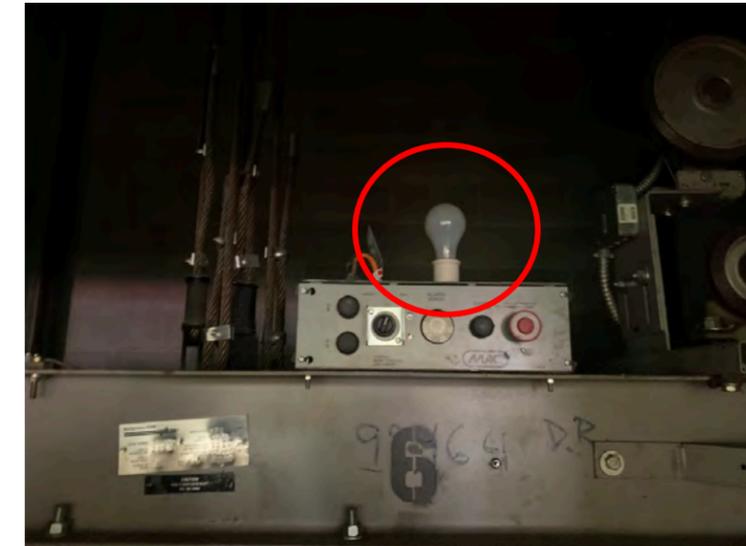
The cartop was dusty and does not appear to have had preventative maintenance performed recently. The cartop surface is showing signs of weather-related deterioration and it is recommended that the car top equipment be painted to help prevent rust and extend equipment life. There is an extension cord laying on the cartop that is not code compliant. The cord appears to be supplying power to the added monitor inside the cab. The MAC door operator appears to be in fair overall condition. All door operator belts appeared to be in good condition and operate smoothly. The hoistway door track has surface rust due to the high moisture condition in the hoistway. The door equipment requires preventative maintenance, and the surface rust should be removed, and inhibitor applied to exposed metal surfaces.

Light bulb guard missing from inspection station

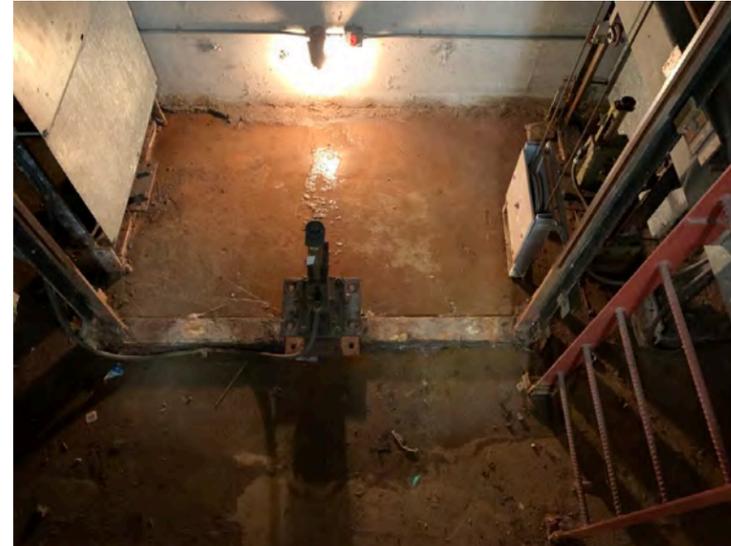
Elevator #6 pit has standing water and the equipment is rusting

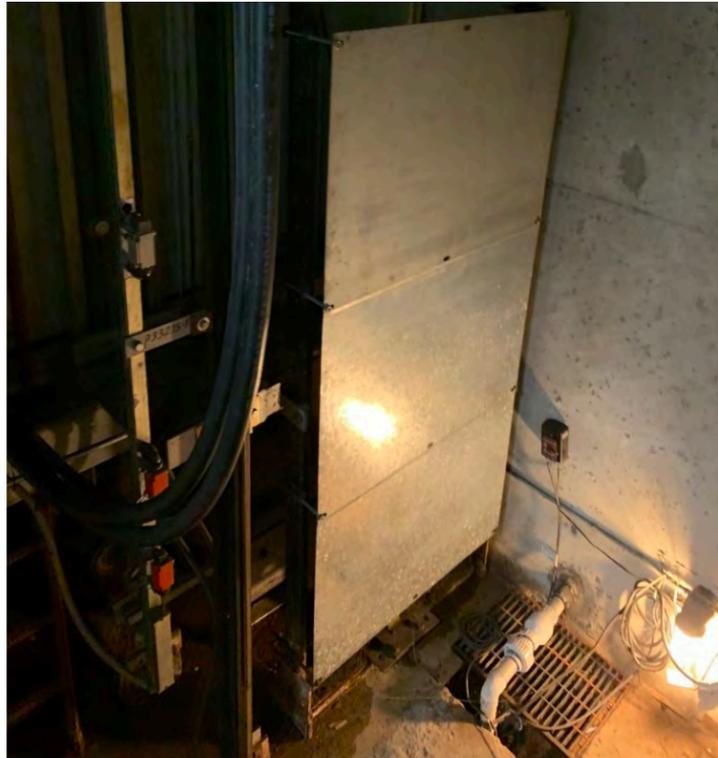
Elevator #8 has water entering the pit

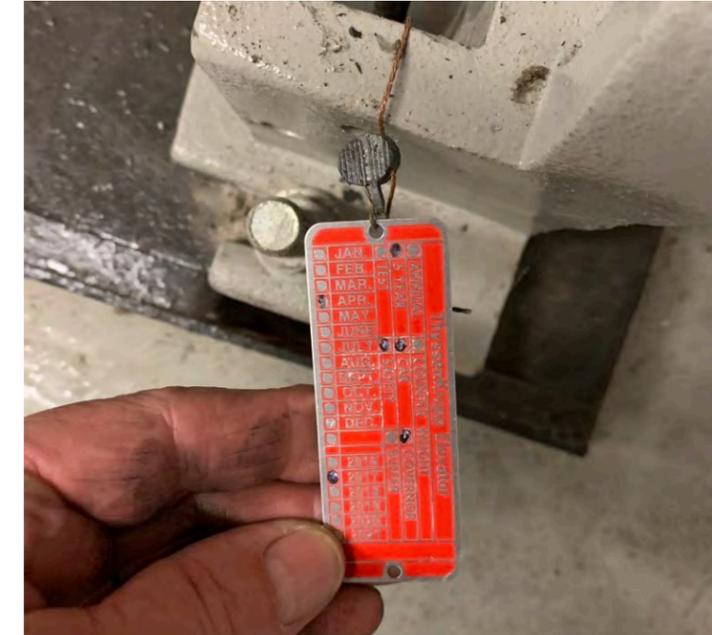
CAT 5 test was performed April 2017 and in overdue for testing
