Master Plan Design Review

Facility Condition Assessment

RE: Nissan Stadium Concept Estimate and Schedule Analysis
(based on Facility Condition Assessment and Gensler Concept Drawings)

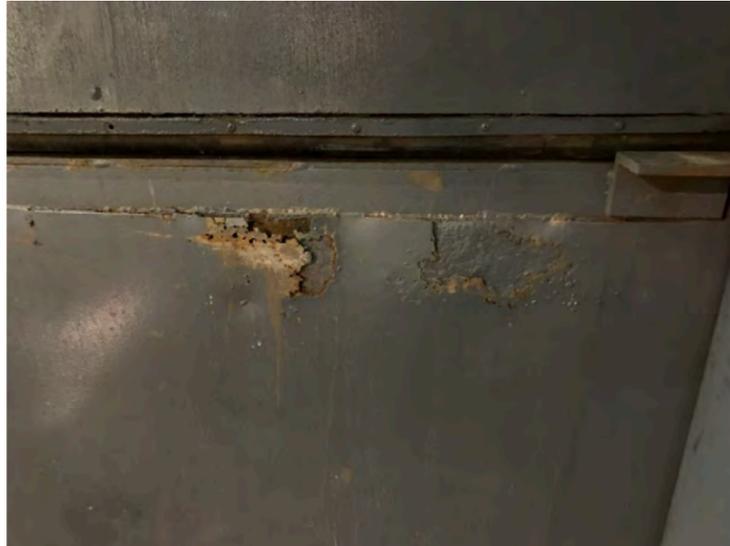
Freight elevator #4 bottom landing door is rusted, and the metal is separating

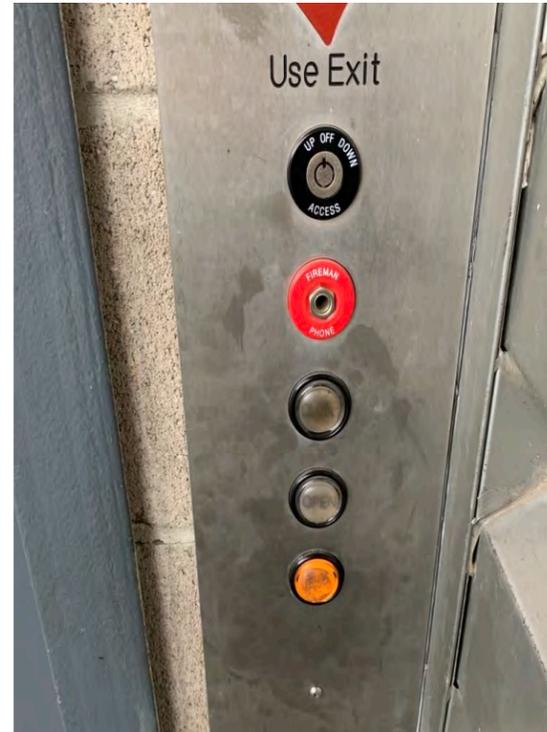
The top floor hall door station plastic button covers are discolored making it hard to read the door open and close buttons

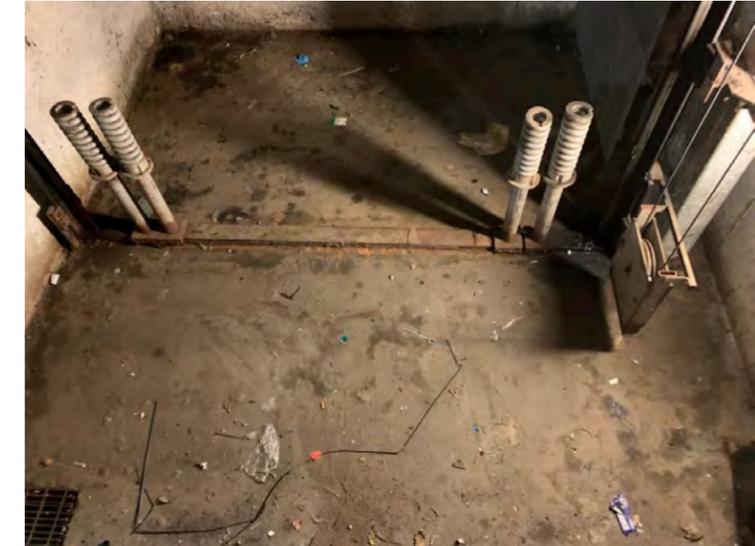
Elevator #4 pit area has signs of water related issues and equipment is rusting

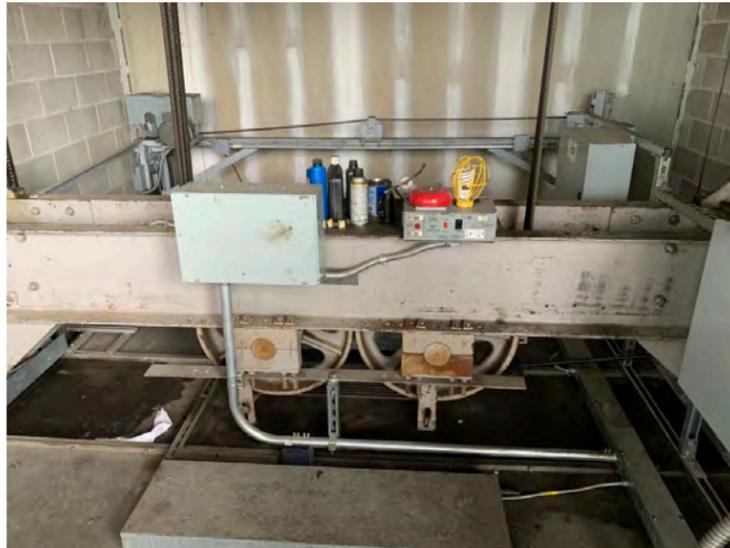
Freight elevator #5 cartop has material and parts stored on top

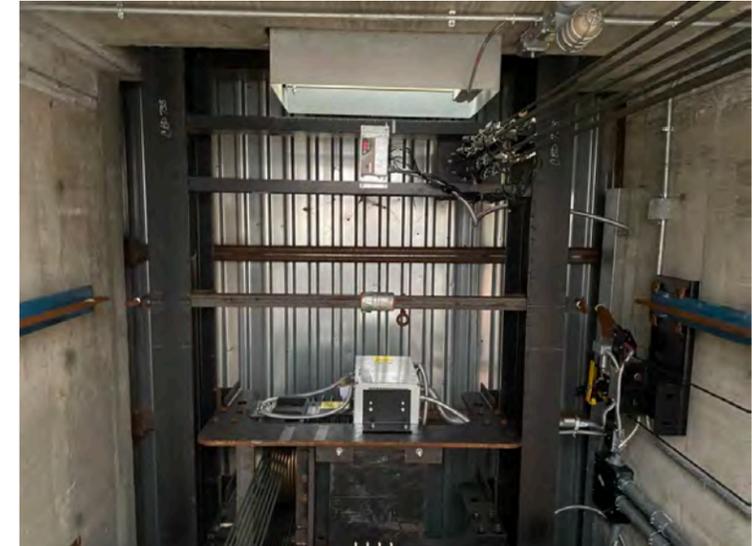
Typical rust on equipment in overhead on express cars

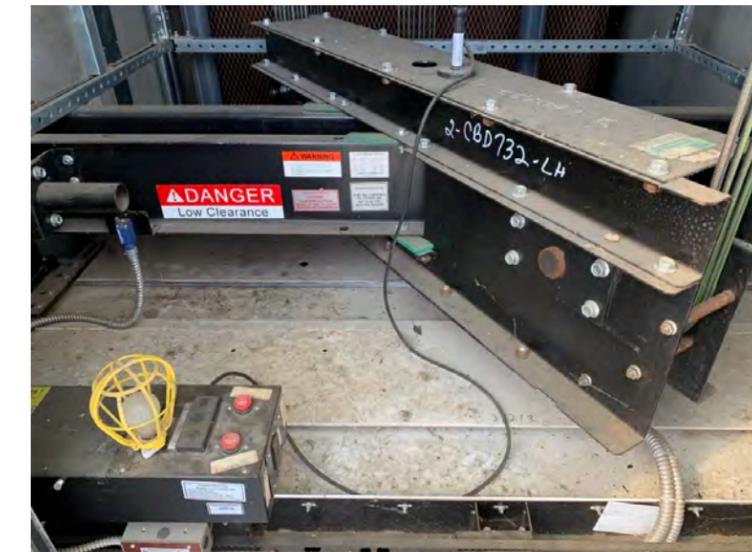
Car tops are dirty and in need of cleaning and rusted surfaces should be painted

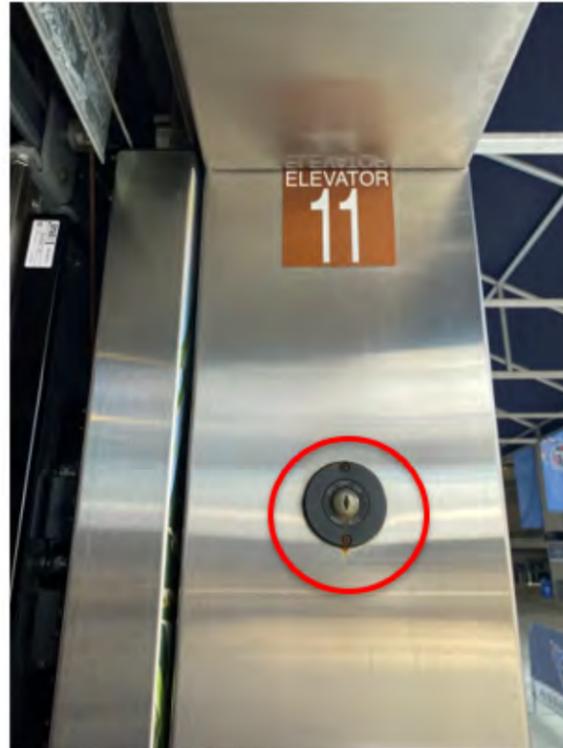
Access key switches are showing signs of rusting

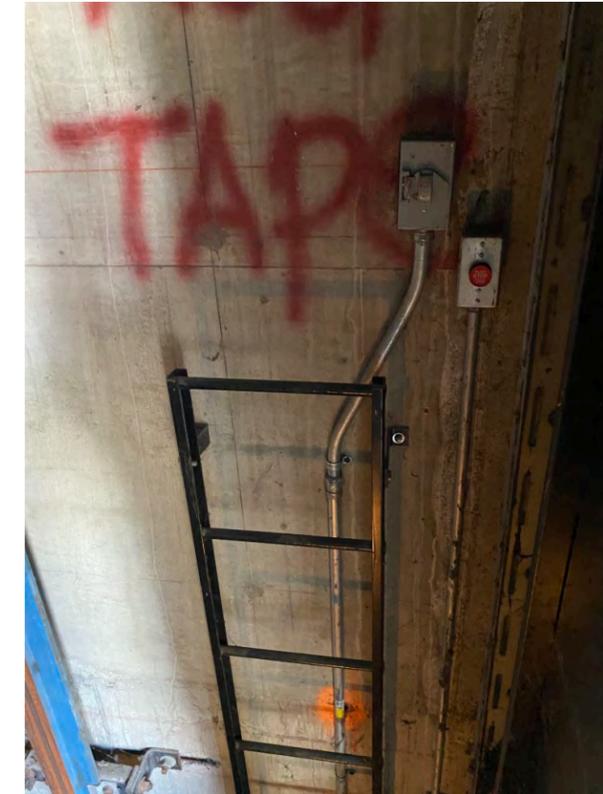
Express elevator pits are missing identification numbers

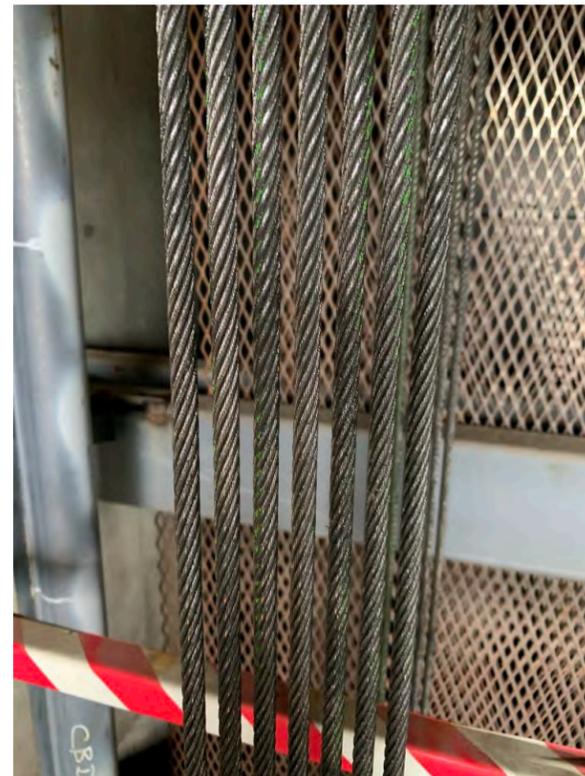
Hoist ropes have slight crown wear and tensioning, and lubrication is needed

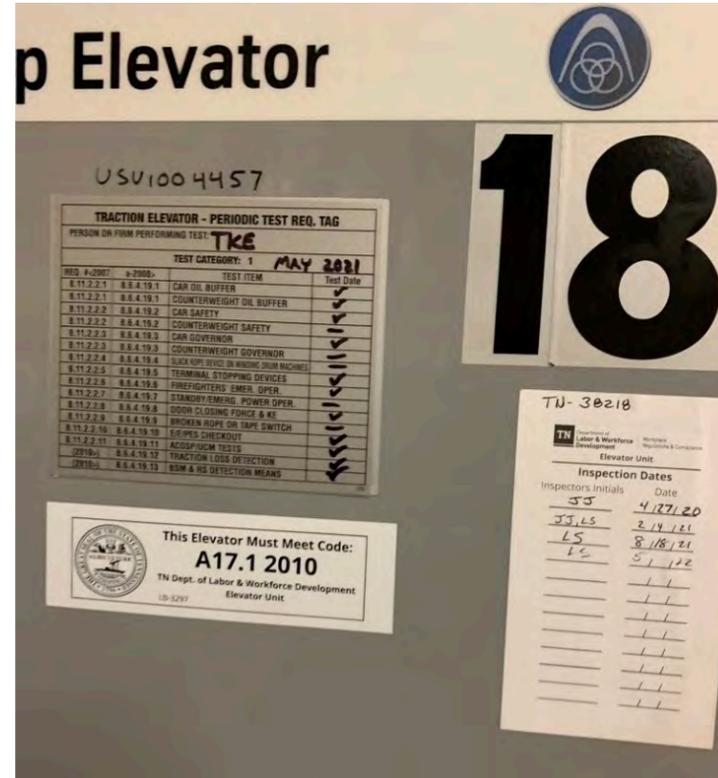
CAT5 test tag missing from group, CAT1 tests are overdue

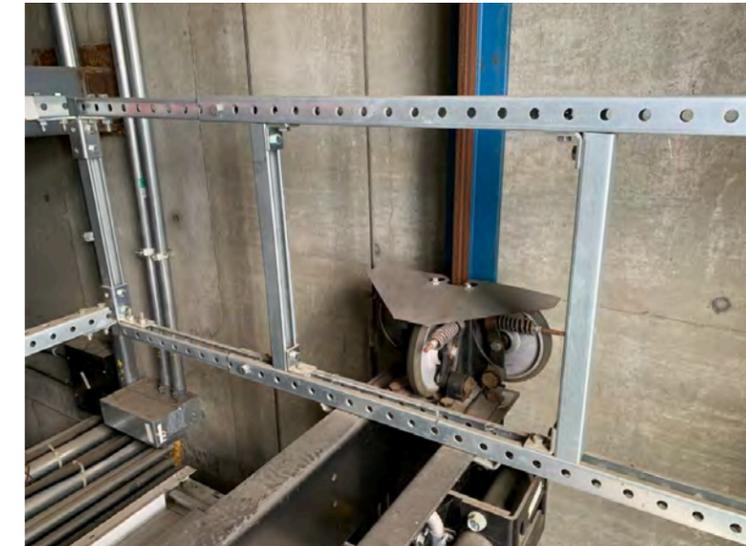
Car tops are equipped with handrails and roller guides roughly operating

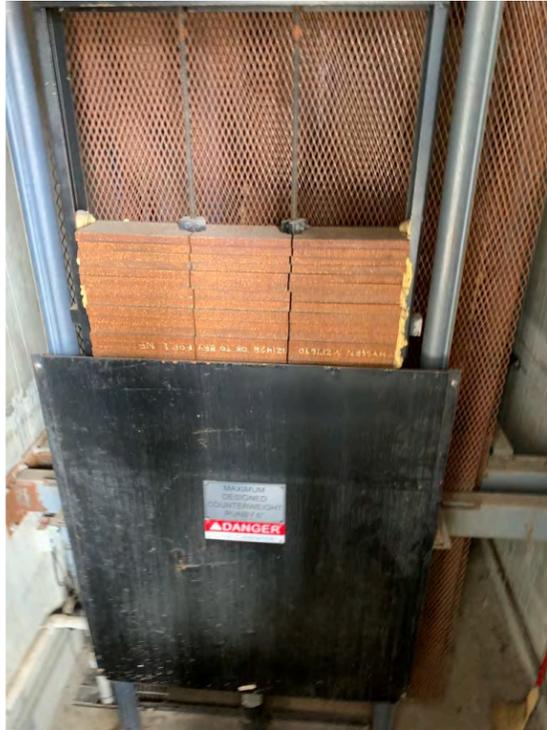
Counterweights and equipment are rusting due to high moisture levels in the hoistway

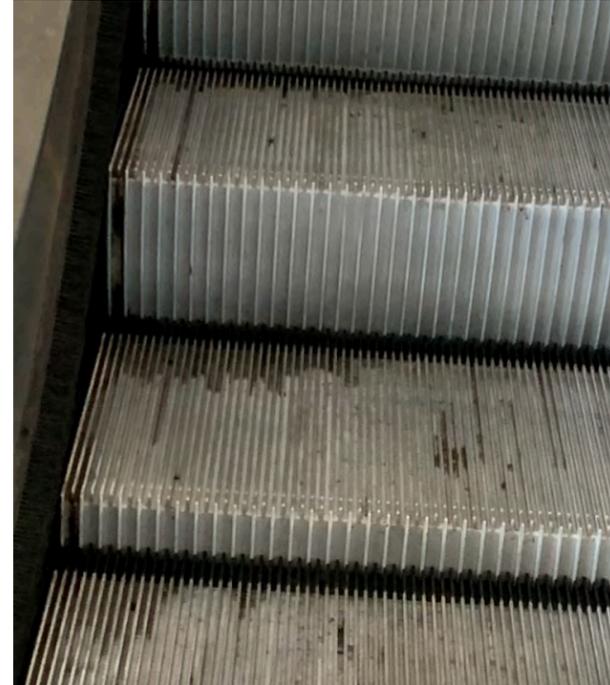
Escalator steps have residual oil leaking from step chain lubrication

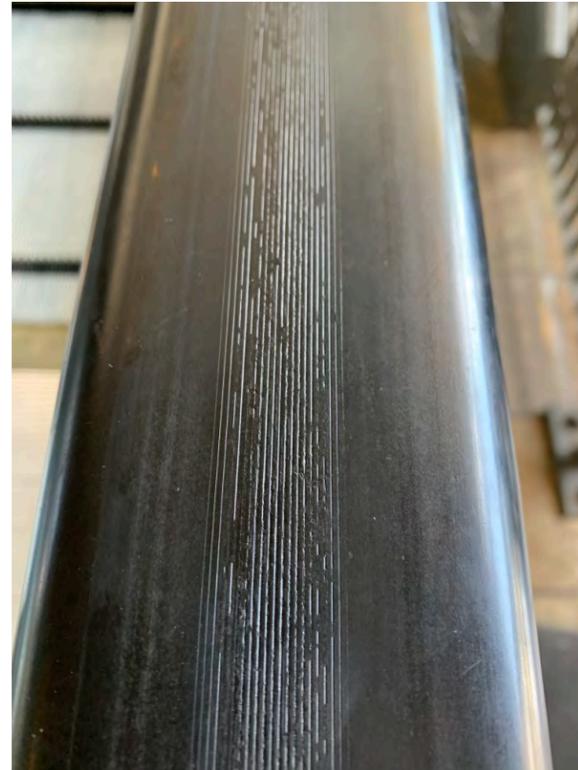
Right side handrail is damaged from rubbing on drive wheel

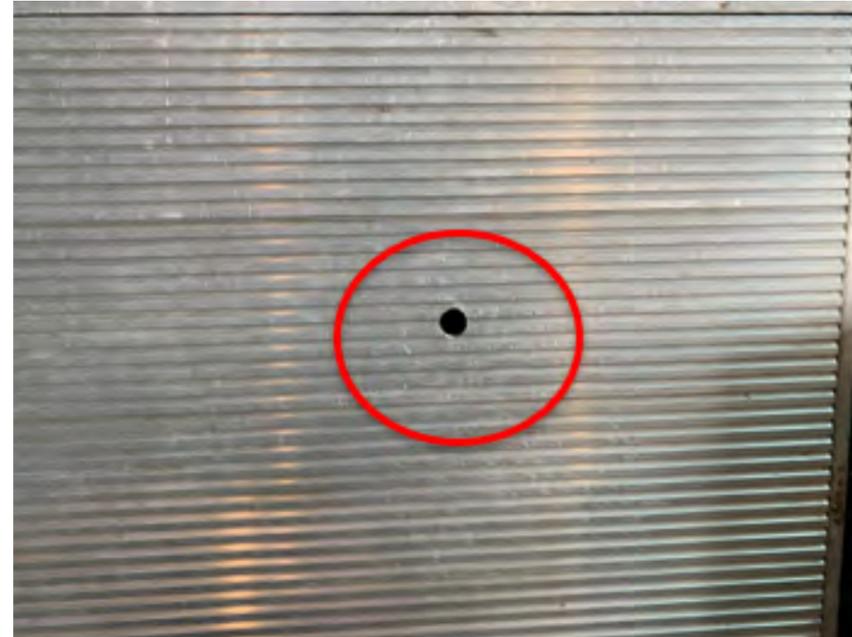
Upper landing floor plate was not secured with a hole in the plate which TKE has since repaired

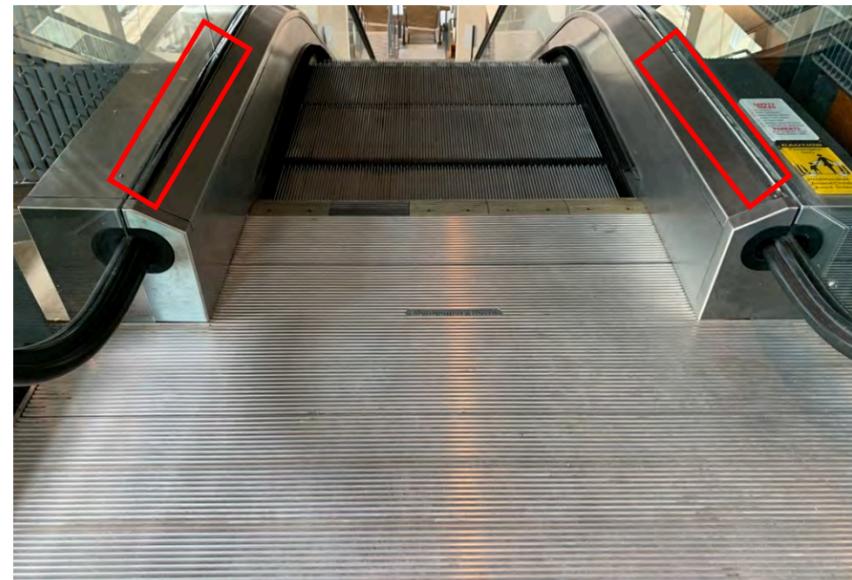
Upper landing plastic skirting cover on the right side is missing and damaged on the left side

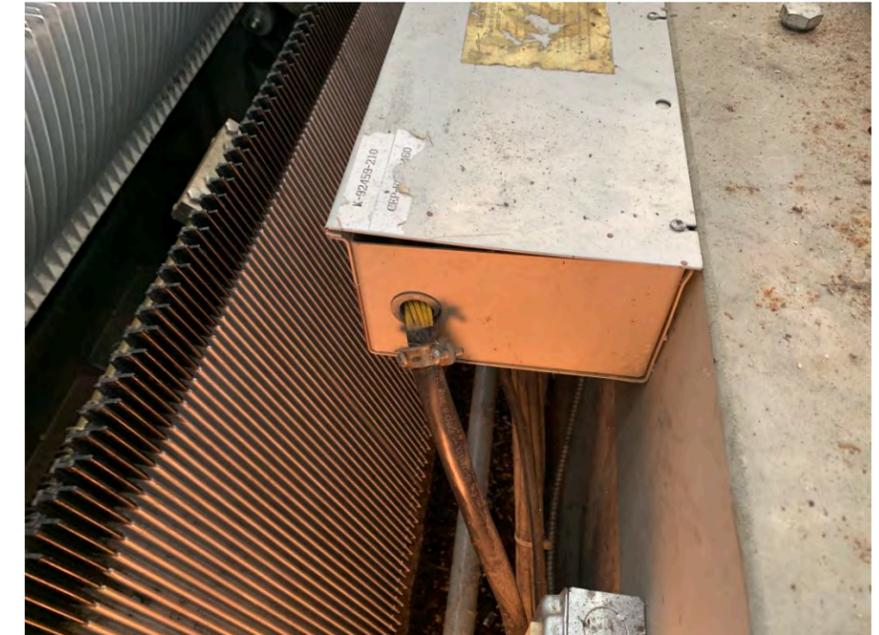
Wiring pulled loose from junction box at the lower end pit
