CAPITAL RESERVE STUDY

CATEGORY 2: UPDATE WITH ON-SITE REVIEW

LEISURE KNOLL AT MANCHESTER HOMEOWNERS ASSOCIATION

Prepared: November 2016

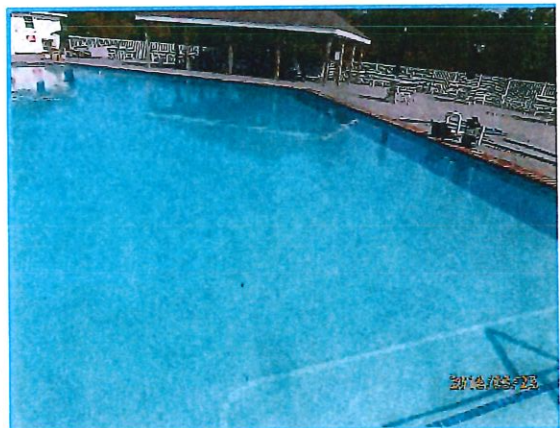
Swimming Pool

The pool area is enclosed by both a four (4') foot aluminum fence and a three (3') foot vinyl picket fence along the lakeside. These types of fencing have a twenty-five (25) year typical useful life. The four (4') foot fence was observed to be in average condition. The three (3') foot fence was observed to be in below average condition with many missing picket caps and some staining observed.

The interior marcite plaster surface of the pool requires resurfacing every seven (7) years to ensure a smooth watertight surface for swimmers. The pool is bordered with a decorative concrete pool coping and ceramic waterline tile, both of which have a typical useful life of twenty (20) years. The pool surface and border were observed to be in average condition with minor scraping observed on the brick coping.

The deck surrounding the swimming pool is constructed of concrete pavers, which have a thirty (30) year typical useful life. The deck was observed to be in average condition with minor staining observed. Trip hazards and areas presenting safety hazards should be replaced immediately through the operating budget.

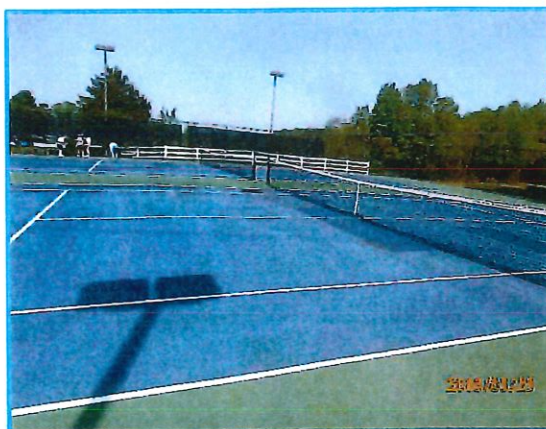
Tennis Courts

Two (2) tennis courts are located within the community and are constructed of bituminous concrete. Funding for the resurfacing of the courts followed by replacement has been included in the schedule. It is recommended that the courts are recoated with a minimum of two coats of latex-acrylic paint every seven (7) years to seal minor cracks and deficiencies in the surface and also to rejuvenate surface. Tennis courts have a typical useful life of twenty (20) years, after which time they will require an overlay of new asphalt or full reconstruction, depending on their condition. The unit costs for tennis court recoating includes reconstruction of all significant cracks, crack sealing, application of a new color coat, etc. The replacement cost includes a complete removal and replacement of the asphalt courts. The tennis courts were observed to be in average condition with minor cracking, wear at edges, and minor water ponding noted.

The ten (10') foot vinyl-coated chain link fence surrounding the courts has a typical useful life of twenty-five (25) years, and was observed to be in below average condition with peeling paint on the framework and rusted fasteners observed.

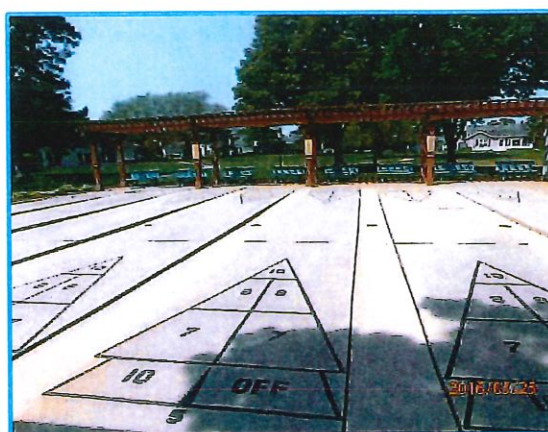
Located behind the Clubhouse are eight (8) concrete shuffleboard courts. Shuffleboard courts have a typical useful life of thirty (30) years. The courts are original to the community and were observed to be in below average condition containing surface cracks and spalling.

The shuffleboard courts are provided with two (2) wood frame trellis structures set on concrete footings. The structures are constructed of 8"x8" posts supporting 2"x10" girders and 2"x10" joists. The components are in below average condition with surface splitting, loose nails, and minor rot observed. It is recommended that exterior wood products are weatherproofed every three (3) to five (5) years to ensure that premature replacement will not be required.

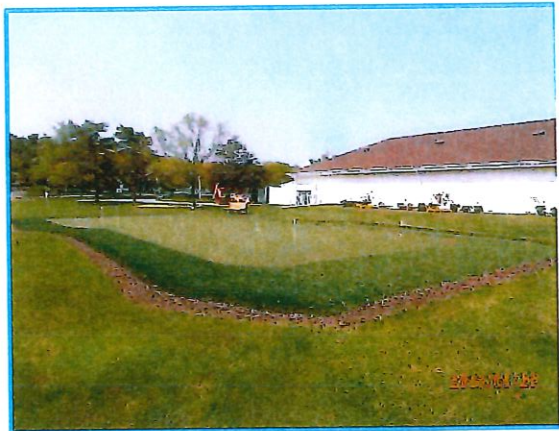
Putting Green

The community is provided with two (2) putting greens. Putting greens have a typical useful life of fifteen (15) years. One putting green is located near the shuffleboard courts and was observed to be in below average condition. The second putting green is located near the Performing Arts Center and was observed to be in above average condition as it was recently replaced in 2015.

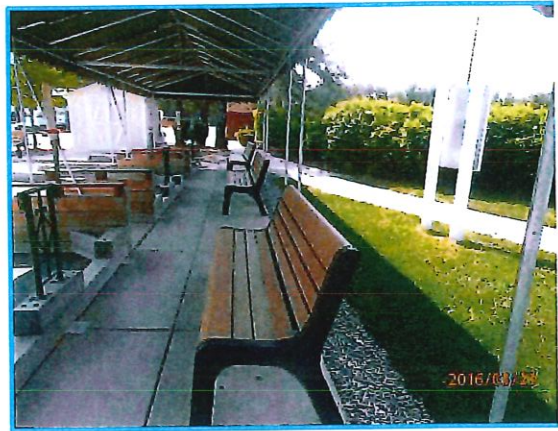
Benches

Composite benches are located throughout the community and were observed to be in varying condition. Composite benches have a typical useful life of twenty (20) years.

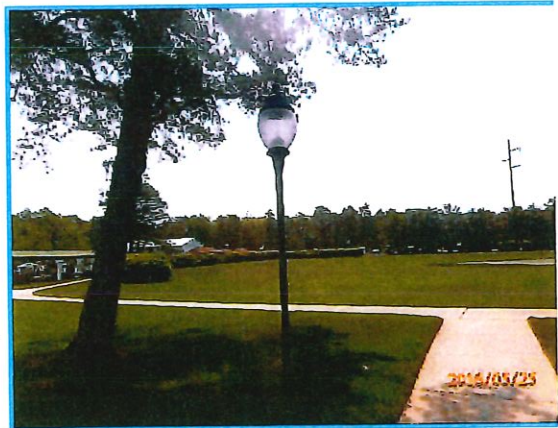
Walkway Lighting

Six (6') foot lantern fixtures on fiberglass posts are located along the walkway near the bocce courts. Exterior lighting has a typical useful life of twenty-five (25) years. The six (6') foot lantern fixtures were observed to be in average condition.

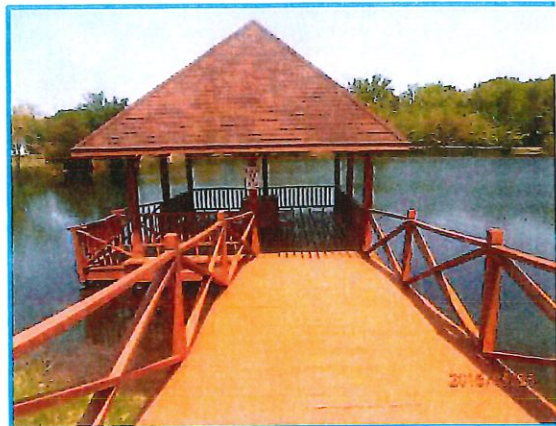
Boathouse and Dock

A boathouse and boat ramp are located on the northern side of the lake. The structure provides seating and shelter for residents from the elements. It is constructed of 2"x6" deck boards, 2"x8" joists, and 2"x10" girders supported by wood piers. The gazebo, deck, and ramp were observed to be in below average condition. Surface splitting of boards, cupping, and general weathering were observed. The boathouse is provided with a three (3)-tab shingle roof that was observed to be in below average condition. Three (3)-tab shingles have a typical useful life of twenty (20) years. It is recommended that exterior wood products are weatherproofed every three (3) to five (5) years to ensure that premature replacement will not be required. The replacement cost includes funding for the deck components as well as the roofing. There are also aluminum boats which have a typical useful life of twenty-five (25) years and were observed to be in average condition.

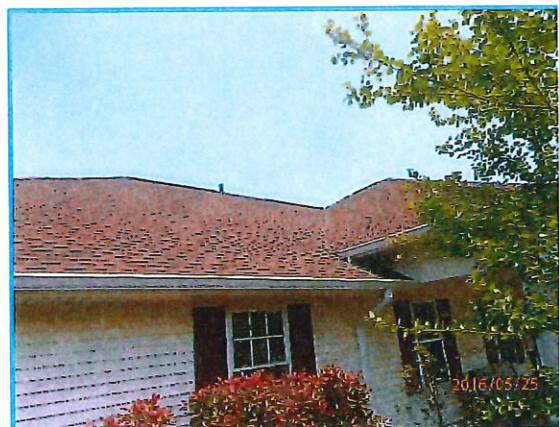
Roofing Shingles

The Lakeside Lodge building, Timber Hall building, Performing Arts Center, and gatehouses are roofed with architectural asphalt shingles. Shingles of this type have a thirty (30) year typical useful life. The roofing was observed to be in average condition.

The association offices and commercial building have corrugated fiberglass roofs that are scheduled to be replaced with architectural asphalt shingles. The roof was observed to be in below average condition.

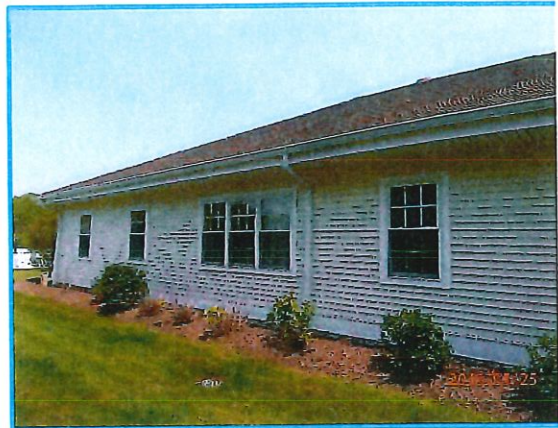
Vinyl Siding

The Lakeside Lodge building, Timber Hall building, and Performing Arts Center are clad with vinyl siding. Vinyl siding has a typical useful life of forty-five (45) years. The siding was observed to be in average condition.

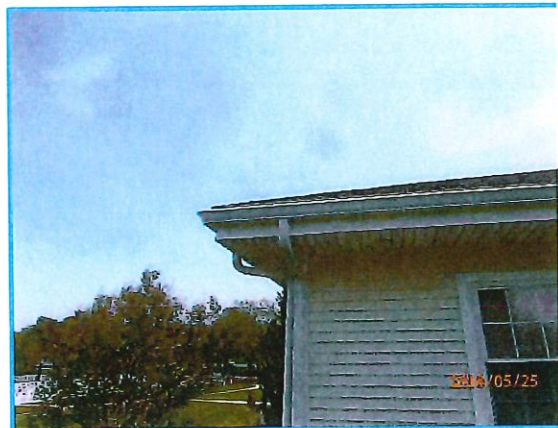
Gutters and Leaders

Aluminum gutters and leaders located on the community buildings were observed to be in average condition. Gutters and leaders have a typical useful life of twenty-five (25) years.

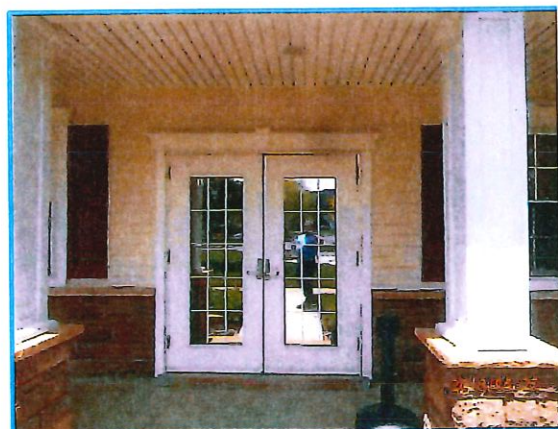
Exterior Doors

The exterior windows and doors of the Lakeside Lodge, Timberland Hall, and Performing Arts Center were observed to be in average condition for their age. Windows and doors have a typical useful life of forty (40) years.

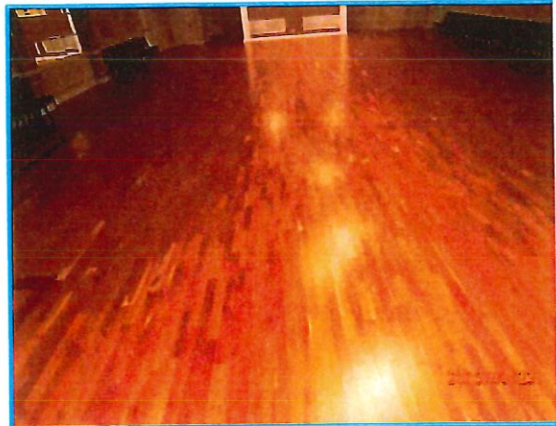
Hardwood Floor

- b) **Wood Flooring** – Hardwood flooring located in the Performing Arts Center and wood parquet flooring located in the sewing and painting rooms in Timberland Hall appeared to be in average condition with usual wear observed. The unit cost within the schedule funds for replacement of the parquet floors and resurfacing of the hardwood.

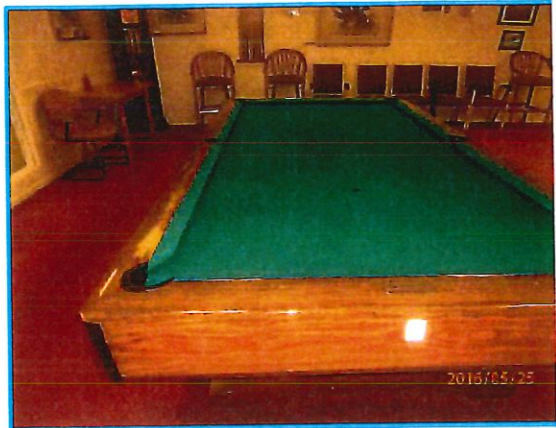
Billiards Table

- a) **Billiard Equipment** – The Clubhouse at Leisure Knoll at Manchester is provided with a billiard room. Funding for the three (3) billiard tables and equipment has been included in the study. Billiards equipment has a typical useful life of ten (10) years and was observed to be in below average condition.
