# AMERISPEC<sup>®</sup> INSPECTION SERVICES

Doc #:	41619	Inspector:	Todd Newman
Date:	4/15/2019		
Dwelling Address:	3010 Gateway Ct Louisville KY 40219		
Client Name:	Norm Woods		
Client's Agent:	Martha McGough	Real Estate Company:	United Real Estate

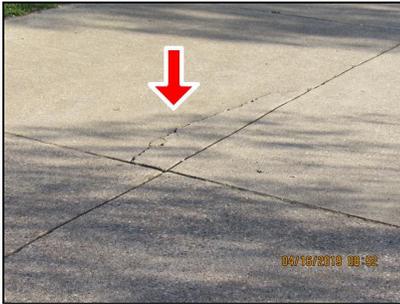
1.0 Item 1(Picture)

Common cracks observed, primarily a cosmetic concern. We suggest sealing all cracks in concrete/asphalt/brick surfaces to prevent water penetration as a routine maintenance effort.

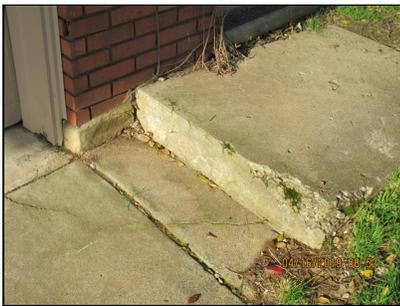
1.1 Item 1(Picture)

Common cracks observed, primarily a cosmetic concern. We suggest sealing all cracks in concrete/asphalt/brick surfaces to prevent water penetration as a routine maintenance effort.

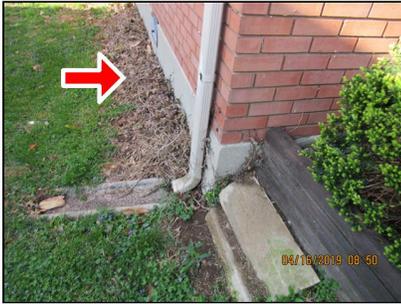
1.2 Item 1(Picture)

(1) Extensive vegetation and overgrowth observed at various locations. This can promote moisture damage and wood deterioration to the siding and structure which is not always visible to the inspector. Suggest trimming/removal of vegetation to prevent damage to the home. This was a limited review of this area. Damage/deterioration can only be viewed after removal of vegetation/overgrowth.

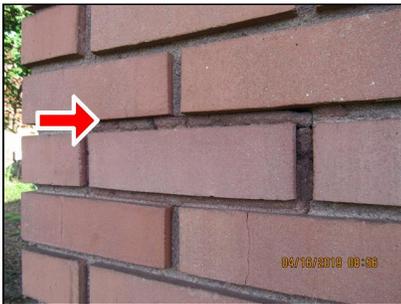
1.2 Item 3(Picture)

(2) Damaged/deteriorated mortar observed at various locations; suggest tuck pointing as necessary to prevent further damage.

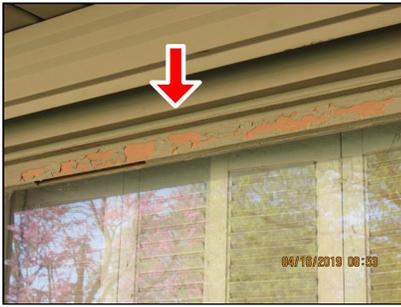
1.4 Item 1(Picture)

Peeling paint observed at right side; suggest scraping and painting as necessary as part of normal maintenance.

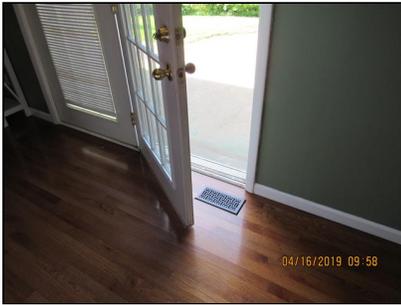
1.5 Item 1(Picture)

Rear entry door doesn't lock well without adjusting door. Recommend adjustments as needed.

- **This door is reliant on a key for opening instead of a dead bolt handle. This could be a potential safety hazard in the event of a fire and the key is missing. This room has no other means of egress by windows except for this doorway.**

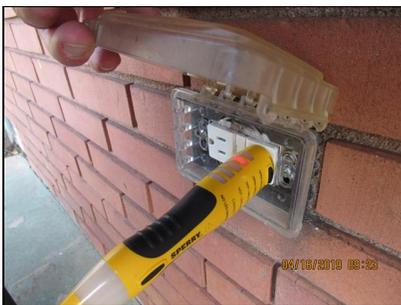
1.7 Item 1(Picture)

(1) Ungrounded three prong receptacles observed at rear of home. It is recommended that these types of receptacles be grounded, replaced with two prong receptacles, or protected on a GFCI circuits as applicable. Suggest review by licensed electrical contractor for repairs/replacements as needed to ensure safety.

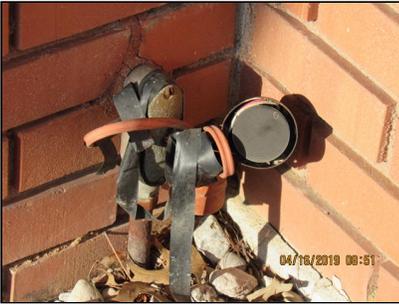
1.7 Item 2(Picture)

(2) Exposed electrical wiring observed at front of home. This is a safety concern if used where it could be subject to "Physical Damage". Exposed electrical wires are normally encased in conduit to ensure safety. Client should consult with a licensed electrician prior to closing for repairs/replacement as needed to ensure safety.

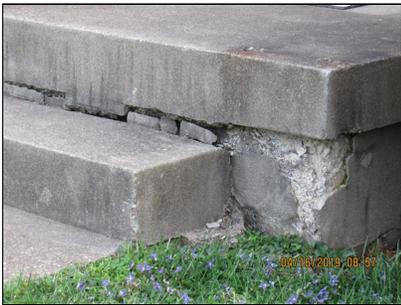
1.12 Item 1(Picture)

Cement deterioration and chipping present at back steps. Recommend review by a qualified professional for repair or replacement as necessary.

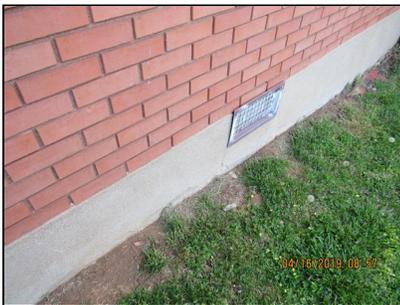
2.1 Item 1(Picture)

Cement parking is flaking/deteriorated at various locations. Recommend review for repair as necessary.

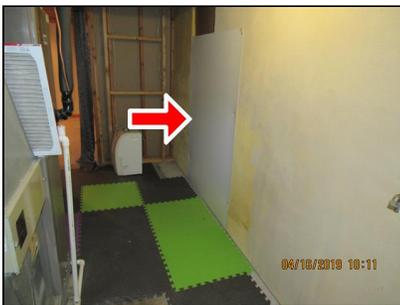
2.3 Item 1(Picture)

Structural wall re-enforcements or patching work observed in the basement, unable to determine effectiveness of repairs, suggest consult sellers or a structural engineer for additional information, prior to close.

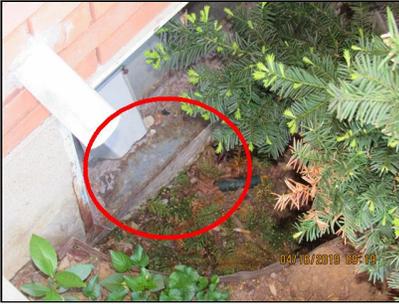
2.9 Item 1(Picture)

Peeling paint observed; suggest scraping and painting as necessary as part of normal maintenance to avoid more rust decay.

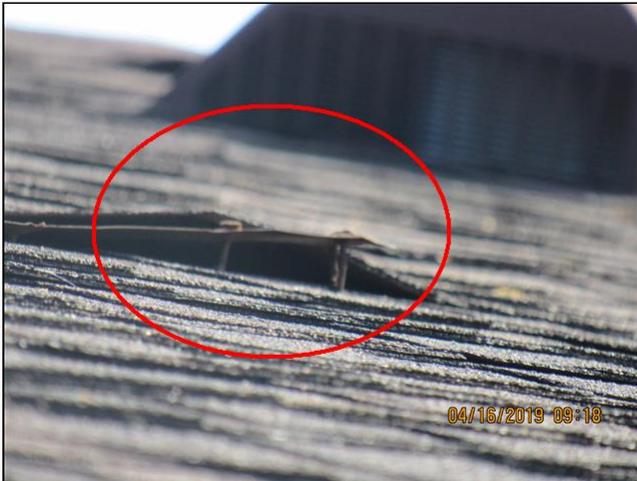
3.0 Item 1(Picture)

(1) Popping nails observed near furnace vent. Nails should be secured as part of a routine maintenance effort to prevent roof damage.

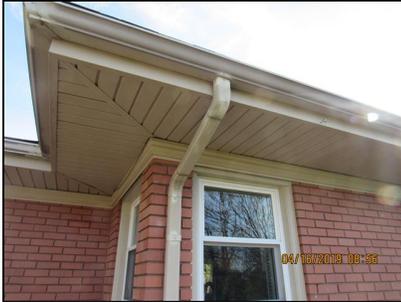
3.2 Item 1(Picture)

(3) The downspouts are loose and need securing to the wall at most areas of the home. Recommend securing to avoid movement and potential damage.

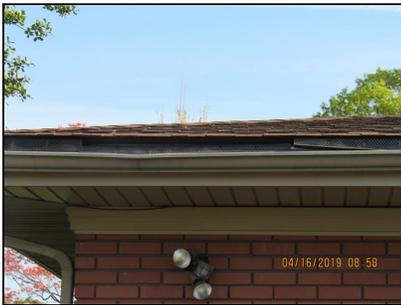
3.2 Item 3(Picture)

(4) Gutters are improperly pitched at rear of home, gutters should be re-aligned to slope towards downspouts for proper drainage.

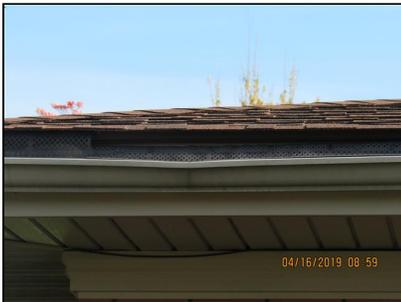
3.2 Item 4(Picture)

(5) Damage observed at left corner (facing rear). Recommend review for repair or replacement as necessary.

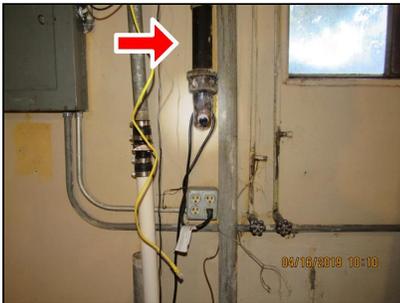
4.0 Item 1(Picture)

(1) Poorly supported piping observed in the basement. This line may rattle when the sump pump is used. Recommend installing additional supports as necessary, review by a licensed plumber for repair or replacement, as necessary.

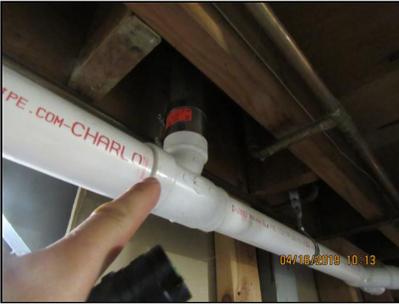
4.1 Item 2(Picture)

(3) Fernco/Rubber piping installed as a connector. These may leak over time due to collapsing or sagging. No leaks were detected at the time of inspection, although it is advised to monitor and replace as needed with correct fittings.

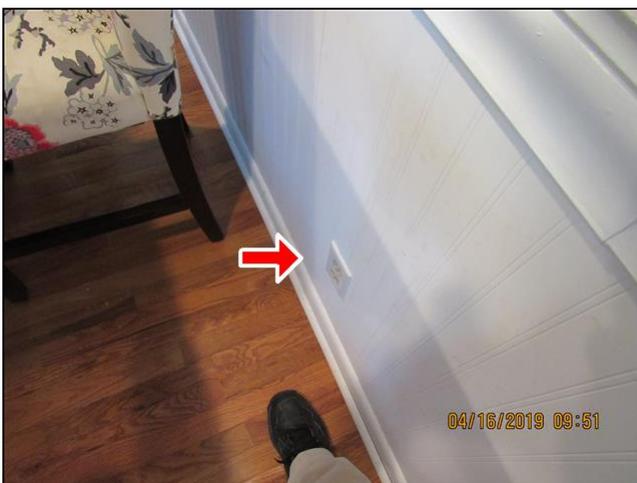
5.6 Item 1(Picture)

The top outlet plug is loose from use where an appliance will not stay plugged in possibly. Suggest replacing.

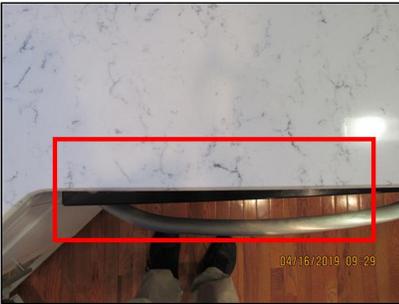
5.11 Item 1(Picture)

The dishwasher needs adjustment as it isn't properly aligned with the countertop. Recommend repair or adjusting as necessary.

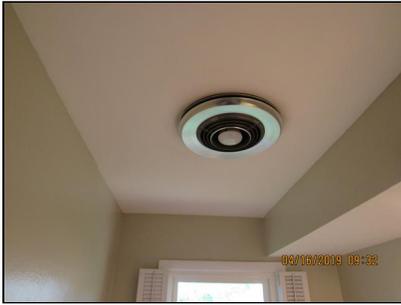
6.8 Item 1(Picture)

Fans located in the hall bathroom may be improperly venting into attic. Due to spray foam in attic, this unable to completely verify. Recommend extending the fans' exhaust to the exterior of attic to prevent damage/deterioration in the attic from moisture/condensation.

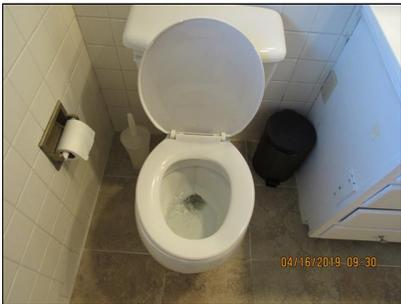
6.12 Item 1(Picture)

The toilet does not flush properly in the hall bathroom. Recommend review by a licensed plumber for repair or replacement, as necessary.

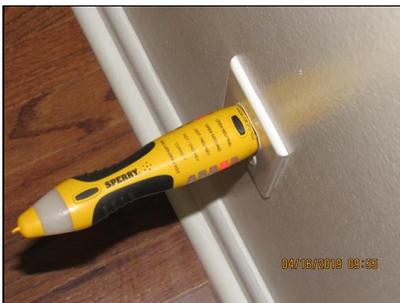
7.7 Item 1(Picture)

Ungrounded three prong receptacles observed in the living room. It is recommended that these type receptacles be grounded, replaced with two prong receptacles, or protected on a GFCI receptacle as applicable. Suggest review by licensed electrical contractor for repairs/replacements as needed to ensure safety.

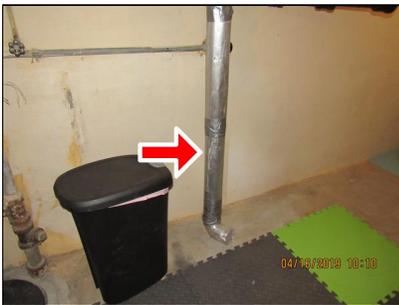
8.10 Item 1(Picture)

The dryer vent piping is duct taped and may not be properly functional. Recommend review for repair as needed.

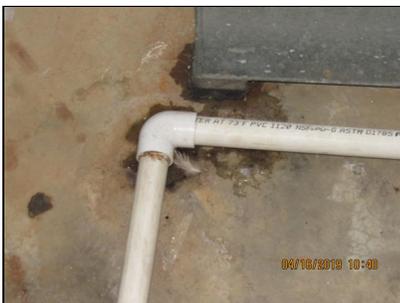
9.0 Item 1(Picture)

(2) Condensate line is leaking and should be replaced or repaired as needed.

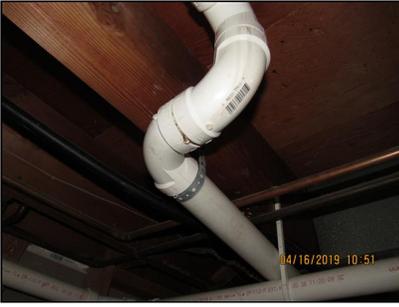
9.2 Item 1(Picture)

Exhaust vent pipe for furnace is leaking condensate. Suggest maintenance/ repairs to ensure leak free conditions.

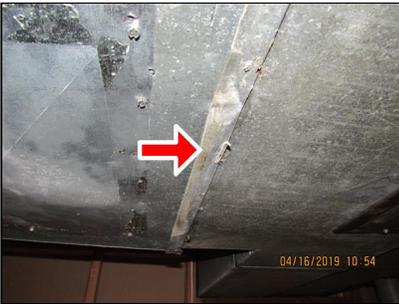
9.5 Item 1(Picture)

(1) The ductwork is not insulated. This may not have been required when home was built. Recommend review by a licensed heating contractor for corrections as necessary.

(2) Possible asbestos materials observed. The materials were torn, ripped, or damaged at the time of inspection. This is a possible safety hazard. Suggest further review by a licensed asbestos testing lab be performed prior to closing for repairs/replacement needed to ensure safety.

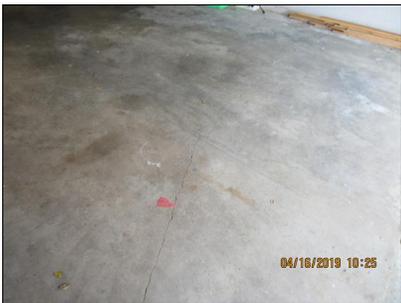
13.2 Item 1(Picture)

**Common cracks observed, primarily a cosmetic concern. We suggest sealing all cracks in concrete/asphalt/brick surfaces to prevent water penetration as a routine maintenance effort.**

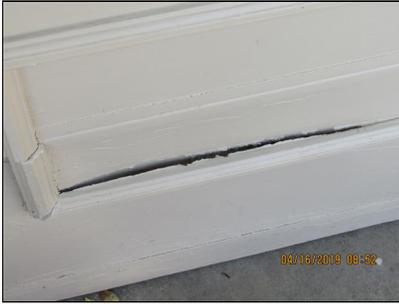
13.3 Item 1(Picture)

The door panel of the garage door is warping. We recommend repair as necessary to help assure long term serviceability.

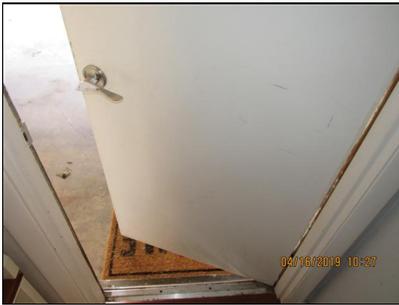
13.5 Item 1(Picture)

The occupant door from inside garage to inside the home is not a fire rated door. This means that should a fire occur in garage, the occupant door does not afford protection until fireman arrive. This door should be replaced with a fire rated door.

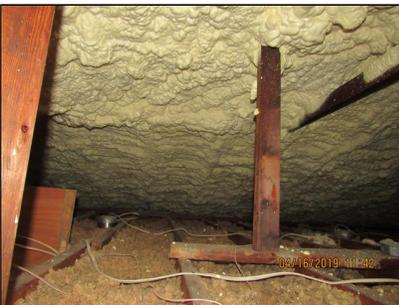
15.1 Item 1(Picture)

**Limited inspection due to spray foam insulation added to framing members. We are unable to verify stability, condition or integrity of this system.**

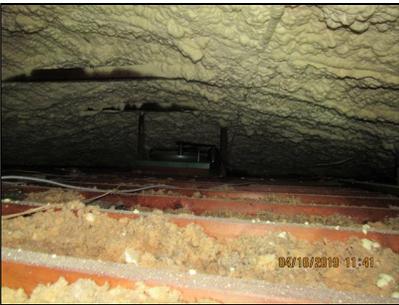
15.4 Item 1(Picture)

- **Unable to verify proper attic ventilation by spray foam or if the seller intended to seal the attic space with it. There is a draft in the attic that can not be detected to its location. If vents were to be added, generally, vents should be installed at a minimum ratio of 1 square foot of ventilation per 300 square feet of attic space balanced between the lower and upper thirds of the attic space. This can help to reduce interior temperatures and preserve the life of the roofing materials.**

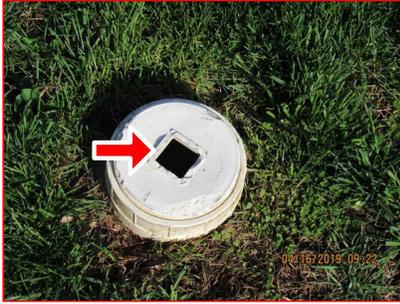
1.14 Item 1(Picture)

Possible septic clean out area for local utility observed. This cover is broken in the center and will need replacement as possible sewer gases can release odors or hazardous gases into the air. We are unable to confirm if this system is an actual live line at the time of inspection as septic lines are outside the scope of a home inspection due to being a utility company issue and underground.

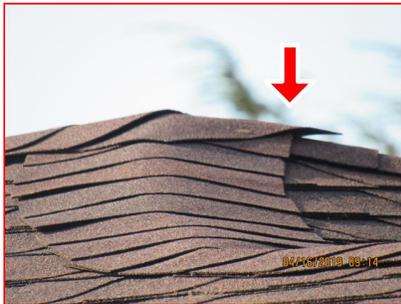
3.0 Item 3(Picture)

(2) Ridge cap shingle has lifted. This may be torn in high winds. Repair/replace as needed to prevent water entry into the attic space.

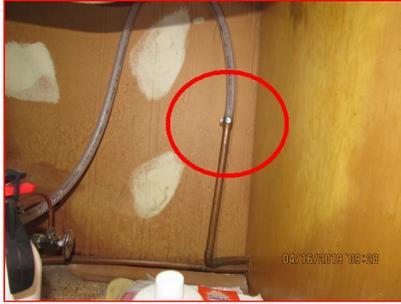
5.9 Item 1(Picture)

Drainage was serviceable at the time of inspection although this connection may be prone to leaking. Recommend monitoring over time or review by a licensed plumber for replacement as needed..

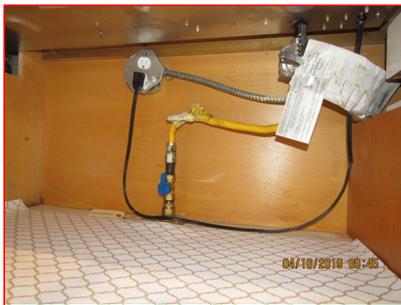
5.12 Item 1(Picture)

Odors of natural gas were observed under the cook top while testing the burners. It is possible gas may be leaking under the cook top area into the cabinet. A qualified appliance contractor is needed for further review and to perform necessary repairs/corrections to ensure safety.
