AMERISPEC[®] INSPECTION SERVICES

Doc #:	20519B	Inspector:	Todd Newman
Date:	2/4/2019		
Dwelling Address:	102 Smith Bardstown KY 40004		
Client Name:	D Stuart		
Client's Agent:	Tammy Gowin	Real Estate Company:	Goldmark Realtors

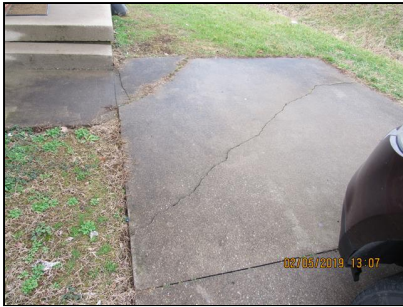
1.0 Item 1(Picture)

Common cracks observed, primarily a cosmetic concern. We suggest sealing all cracks in concrete/asphalt/brick surfaces to prevent water penetration as a routine maintenance effort.

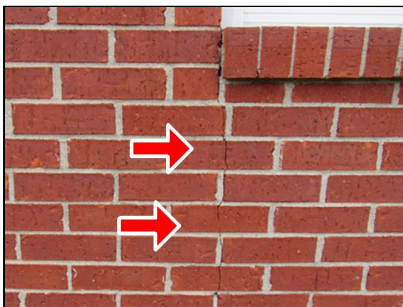
1.2 Item 1(Picture)

(1) Cracked brick and mortar joints observed at front of home rear of home. We recommend professionally repairing the affected area to reduce the potential for water infiltration into the home and further displacement.

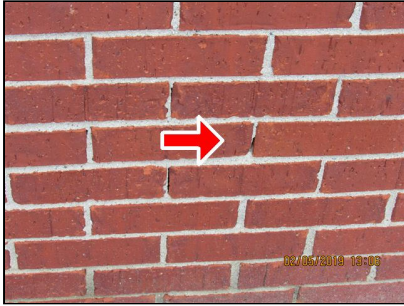
1.2 Item 2(Picture)

(2) Damaged/deteriorated mortar observed at front of home; suggest tuck pointing as necessary to prevent further damage.

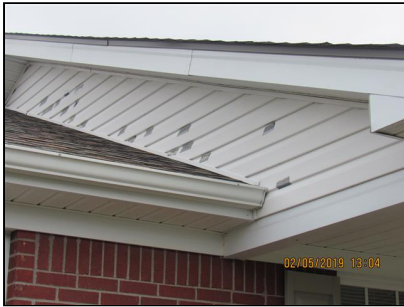
1.3 Item 1(Picture)

(2) Damaged trim observed at left side. Recommend repairs to prevent further damage.

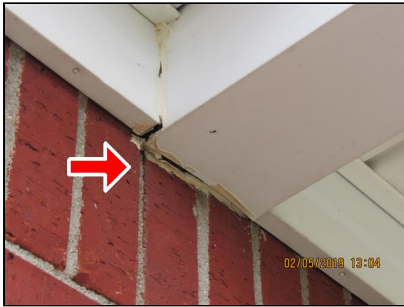
1.3 Item 2(Picture)

(3) Caulking should be applied around all windows, doors, and any voids where necessary.

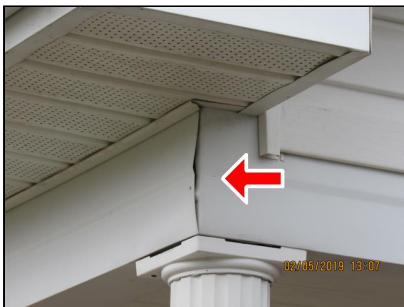
1.3 Item 3(Picture)

(4) Loose trim piece observed at right side of front entry, suggest repairs/replacements.

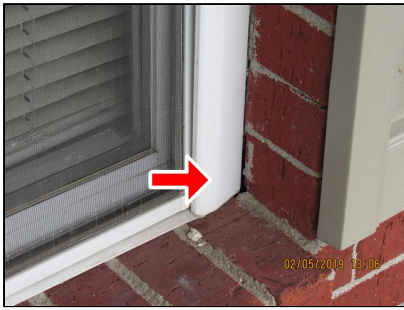
1.4 Item 1(Picture)

(1) Caulking should be applied around all windows, doors, and any voids where necessary.

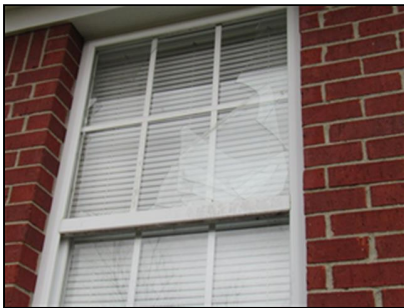
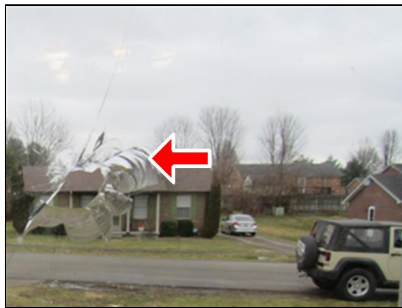
(2) Damaged/deteriorated glazing observed at several areas; suggest re-glazing as necessary.

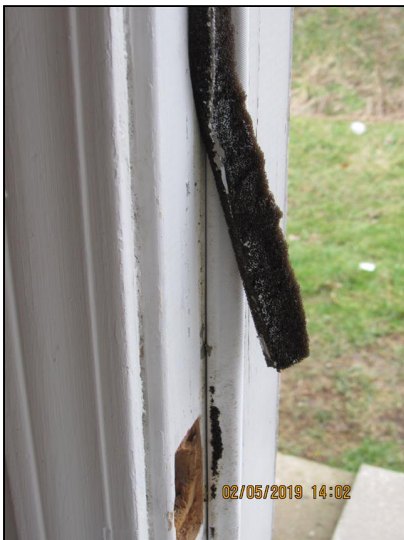
1.5 Item 1(Picture)

(1) The threshold at the entry right side of home is damaged/loose; recommend corrections as needed.

(2) Damaged/missing weather stripping & missing striker plate observed at the entry right side of home, repair/replace as needed.

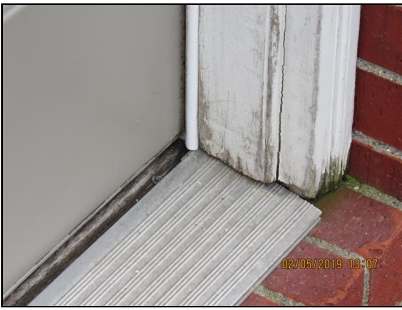
1.5 Item 2(Picture)

(3) Wood deterioration observed at the entry right side of home. Suggest repairs/replacement as needed.

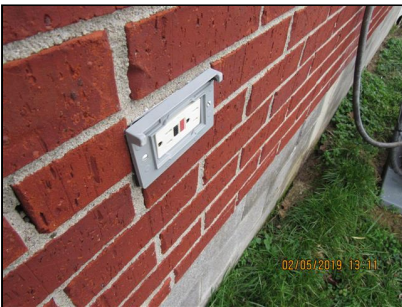
1.7 Item 1(Picture)

Damaged receptacle cover was observed at rear of home. Recommend review for repair or replacement as necessary.

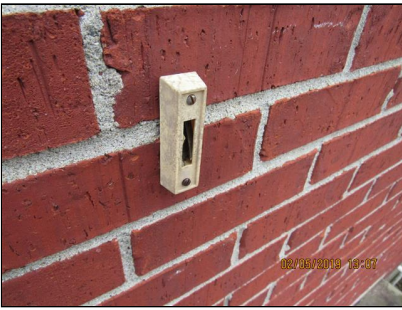
1.10 Item 1(Picture)

The doorbell is damaged. Recommend corrections.

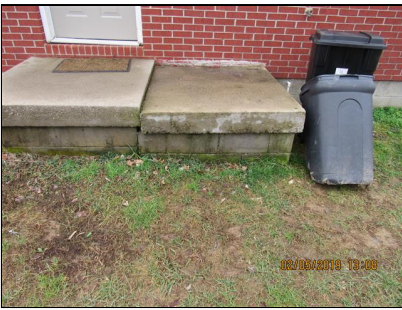
1.13 Item 1(Picture)

(1) Missing guardrails observed. This is a "Safety Concern". Although guardrails may not have been required when the home was built, we recommend client consider installing guardrails as a safety enhancement.

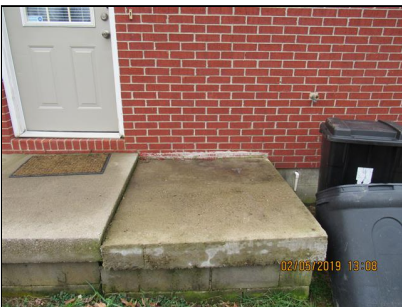
1.13 Item 2(Picture)

(2) Patio is not level, or has settled over time. Recommend review by a qualified professional for repair or corrections as needed.

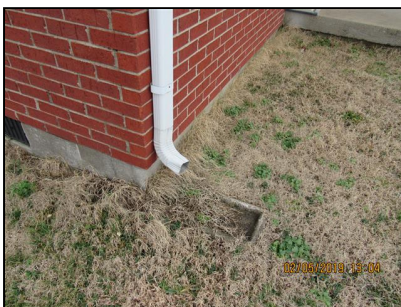
2.2 Item 1(Picture)

(2) Suggest installing extensions to gutter system to ensure proper drainage away from foundation.

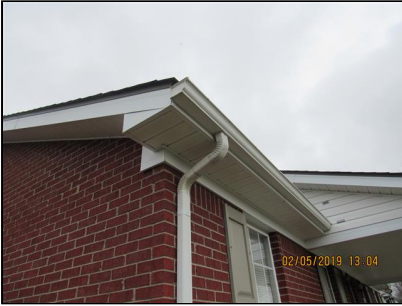
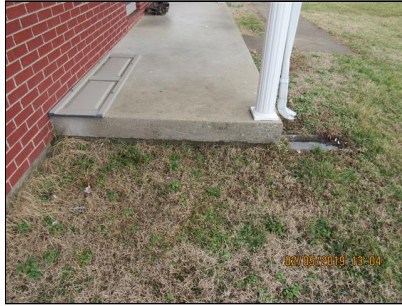
(3) Downspouts are loose and or damage and need securing to the wall at the virtually all areas where gutters are installed or replacement.

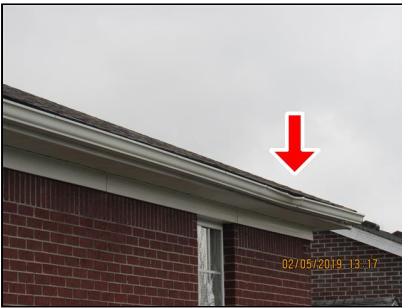
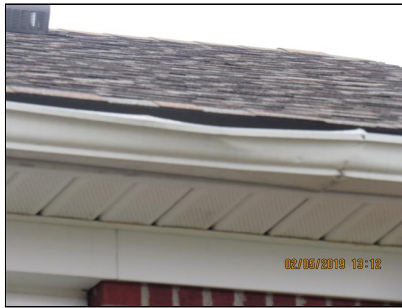
(4) Damage observed at right corner (facing rear). Recommend review for repair or replacement as necessary.

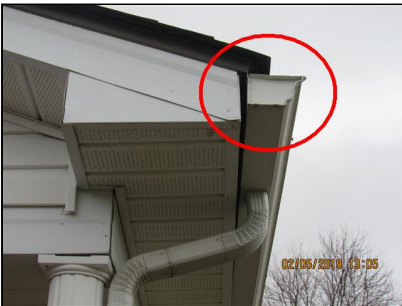
2.2 Item 6(Picture)

(6) Loose gutter at front (left of main entry). Recommend review for repair or securing as necessary.

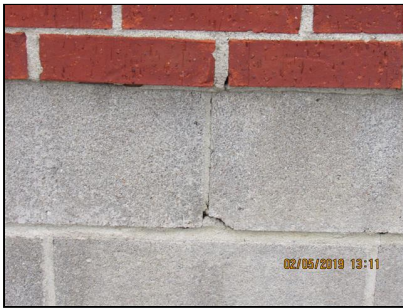
5.1 Item 1(Picture)

Hairline settlement crack observed at various locations. Recommend review by licensed contractor for corrections as needed.

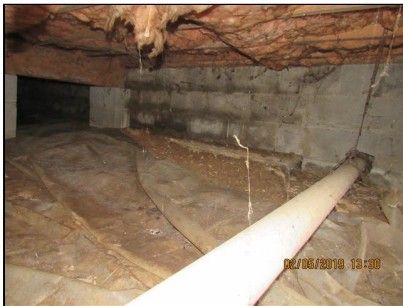
5.3 Item 1(Picture)

Efflorescence is present on the foundation on the crawlspace. Efflorescence is the salts left behind from moisture soaking into or passing through a masonry product. This moisture could adversely affect the foundation and/or the crawl space environment. A licensed structural engineer or a licensed general contractor specializing in crawl space moisture will need to determine the source of moisture and recommend or make necessary repairs.

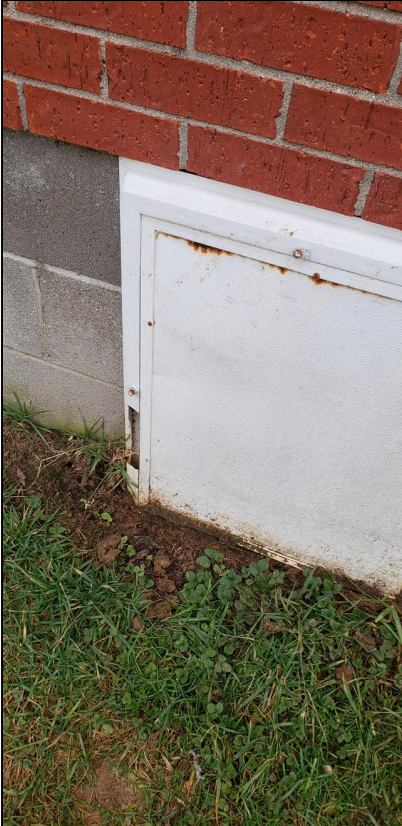
5.8 Item 1(Picture)

Cover/door to crawlspace is damaged. Recommend repair or replacement.

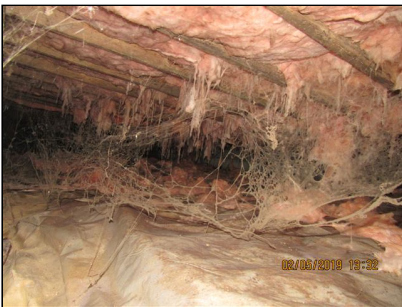
5.11 Item 1(Picture)

Loose insulation observed in the crawlspace, suggest securing as necessary.

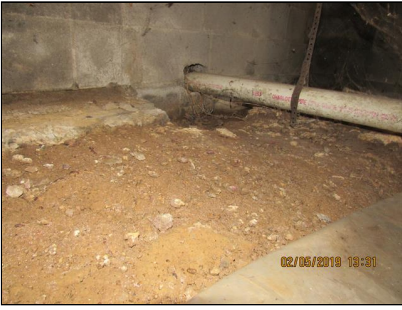
5.12 Item 1(Picture)

Gaps observed. Recommend review for repairs/replacement as needed.

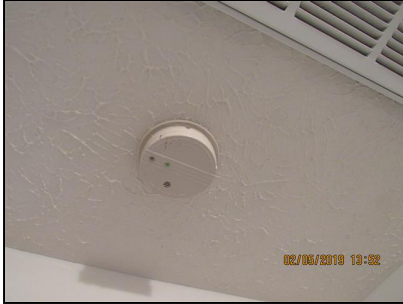
7.6 Item 1(Picture)

The smoke alarm did not work when tested at the hallway. Without a working smoke detector in your home you have no first alert to a possible fire. A qualified person should repair or replace as needed.

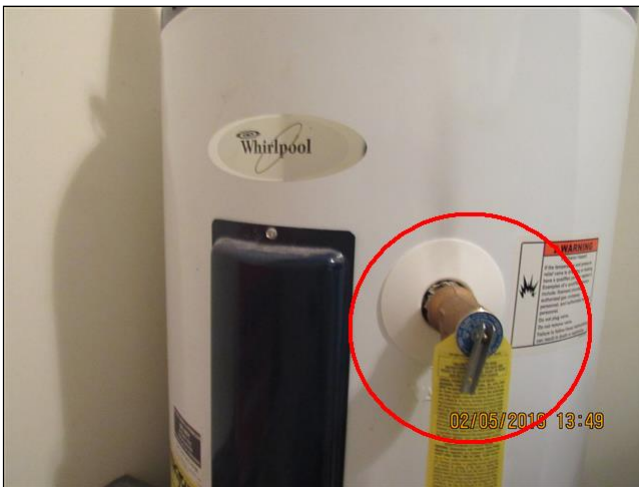
10.4 Item 1(Picture)

Discharge pipe is missing on the temperature pressure relief valve. Suggest installing the required 3/4 inch discharge pipe on the temperature pressure relief valve to within 6 inches of floor or to exterior of the building to ensure safety.

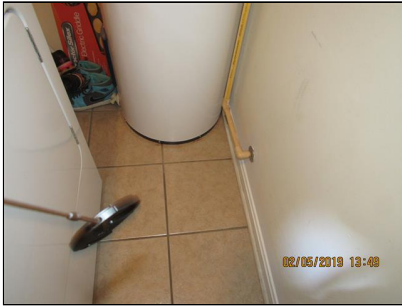
10.5 Item 1(Picture)

Water heater is located indoors without an overflow pan/drain line. This may not have been required when the home was built. Client is aware that the seller is not required to upgrade to current building standards. Suggest installation of overflow pan to prevent water damage from possible leakage or emergency discharge from the temperature pressure relief valve. Client is advised that overflow pan will be required when a new water heater is installed.

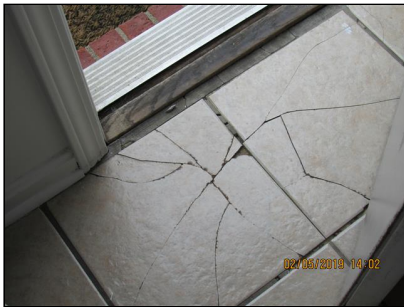
11.0 Item 1(Picture)

Damaged tiles observed; recommend corrections a needed.

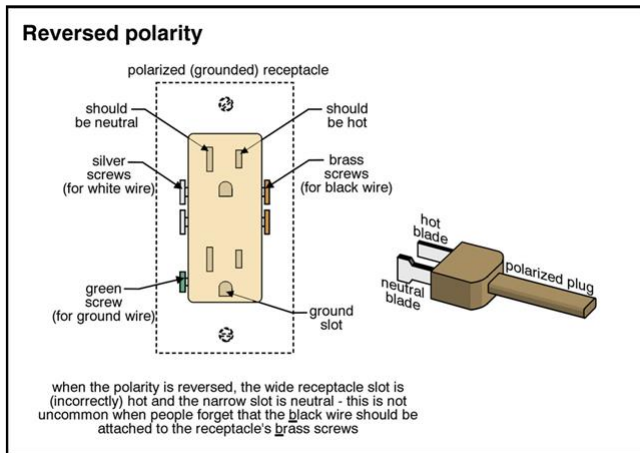
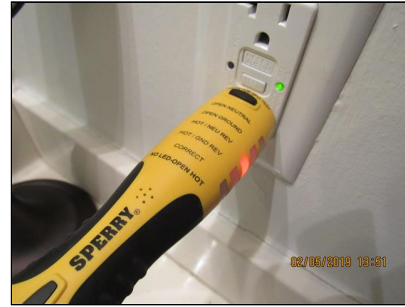
(1) Reversed polarity receptacle detected in the master bathroom. Reversed polarity, hot and neutral wires reversed, is usually easily corrected by minor wiring adjustments at the affected outlet(s). When this condition is observed, a qualified electrical contractor is needed for repairs/corrections.

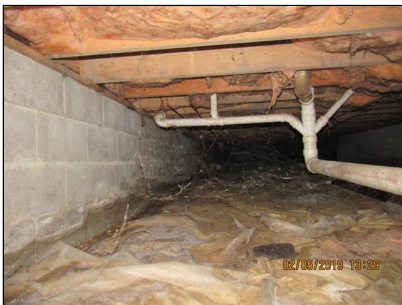
13.10 Item 1(Picture)

The dryer vent line terminates in the crawlspace. Lint build-up at crawlspace is a potential fire hazard. The line should be extended to exterior with weather cover installed at exterior foundation wall.

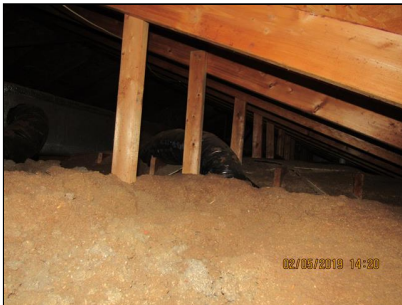
15.0 Item 1(Picture)

- **Unable to enter attic due to insulation and low clearance. Recommend review of the Sellers Disclosure Statement regarding the condition of the attic prior to close. Entering attics that are heavily insulated can cause damage to the insulation and attic framing. Attics with deep insulation cannot be safely inspected due to limited visibility of the framing members upon which the inspector must walk. In such cases, the attic is only partially accessed, thereby limiting the review of the attic area from the hatch area only. Inspectors will not crawl the attic area when they believe it is a danger to them or that they might damage the attic insulation or framing. This is a limited review of the attic area viewed from the hatch only; recommend consulting sellers for any additional information.**

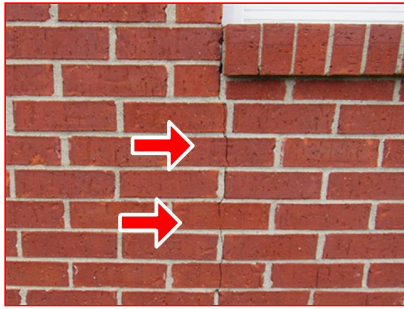
1.2 Item 1(Picture)

(1) Cracked brick and mortar joints observed at front of home rear of home. We recommend professionally repairing the affected area to reduce the potential for water infiltration into the home and further displacement.

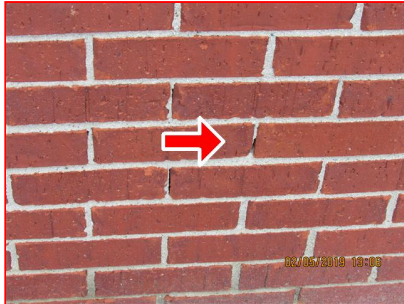
1.2 Item 2(Picture)

(2) Damaged/deteriorated mortar observed at front of home; suggest tuck pointing as necessary to prevent further damage.

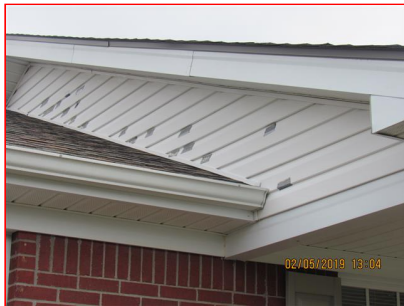
1.3 Item 1(Picture)

(2) Damaged trim observed at left side. Recommend repairs to prevent further damage.

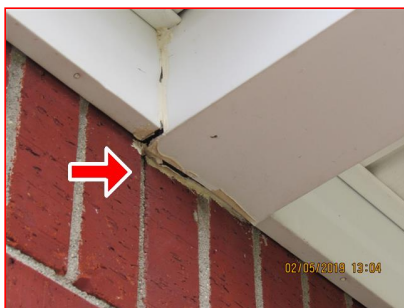
1.3 Item 2(Picture)

(3) Caulking should be applied around all windows, doors, and any voids where necessary.

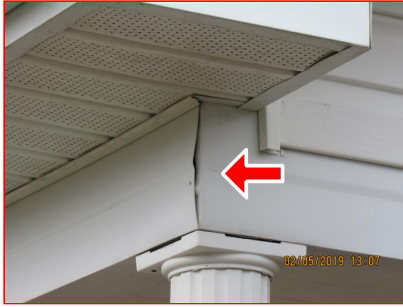
1.3 Item 3(Picture)

(4) Loose trim piece observed at right side of front entry, suggest repairs/replacements.

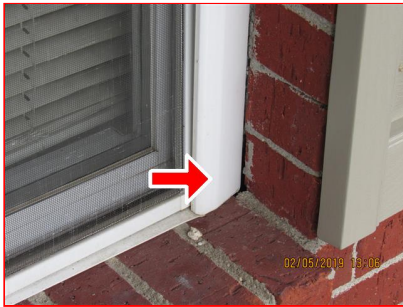
1.4 Item 1(Picture)

(1) Caulking should be applied around all windows, doors, and any voids where necessary.

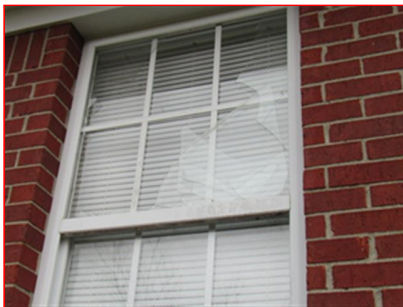
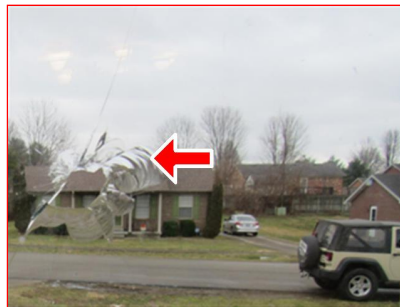
(2) Damaged/deteriorated glazing observed at several areas; suggest re-glazing as necessary.

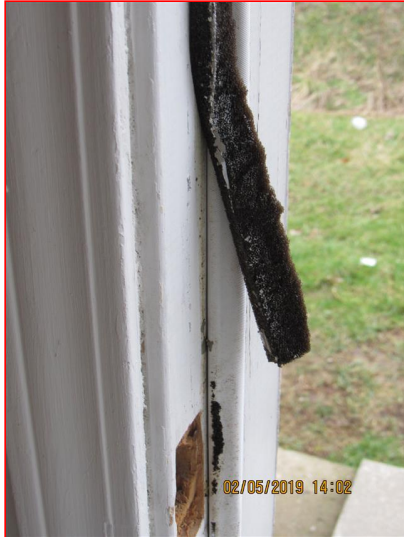
1.5 Item 1(Picture)

(1) The threshold at the entry right side of home is damaged/loose; recommend corrections as needed.

(2) Damaged/missing weather stripping & missing striker plate observed at the entry right side of home, repair/replace as needed.

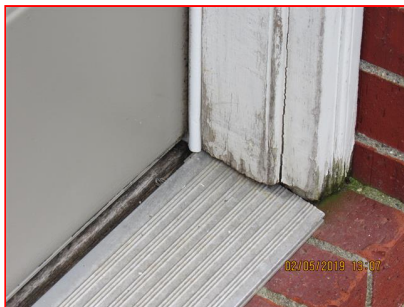
1.5 Item 2(Picture)

(3) Wood deterioration observed at the entry right side of home. Suggest repairs/replacement as needed.

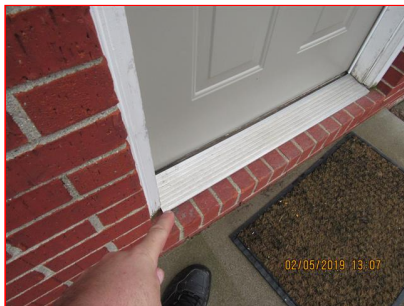
1.5 Item 3(Picture)

(4) The threshold at the entry right side of home is loose; recommend corrections as needed.

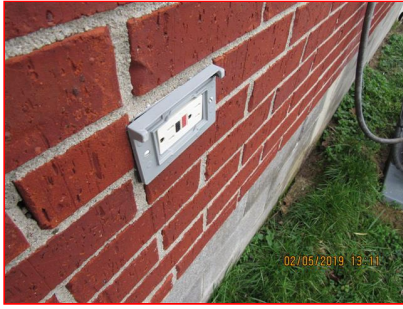
1.7 Item 1(Picture)

Damaged receptacle cover was observed at rear of home. Recommend review for repair or replacement as necessary.

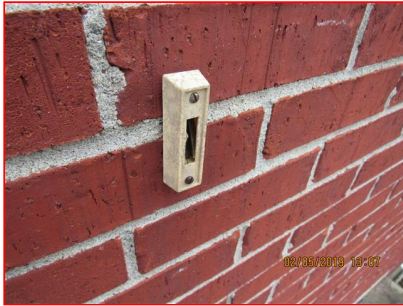
1.10 Item 1(Picture)

The doorbell is damaged. Recommend corrections.

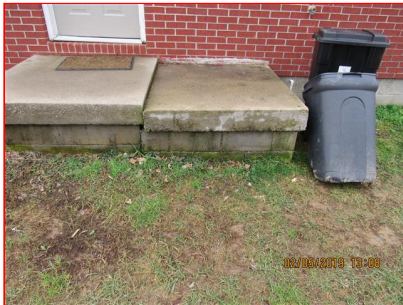
1.13 Item 1(Picture)

(1) Missing guardrails observed. This is a "Safety Concern". Although guardrails may not have been required when the home was built, we recommend client consider installing guardrails as a safety enhancement.

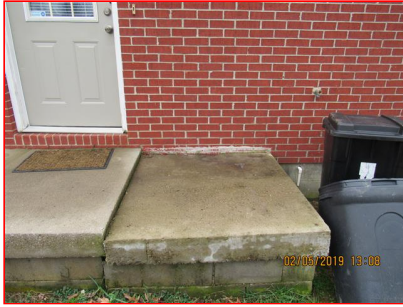
1.13 Item 2(Picture)

(2) Patio is not level, or has settled over time. Recommend review by a qualified professional for repair or corrections as needed.

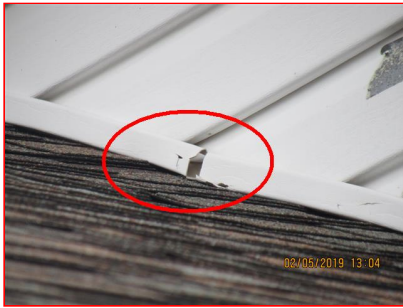
2.1 Item 1(Picture)

Flashings are damaged/deteriorated at left side. Suggest review by a licensed roofer prior to closing for repairs/ replacement as needed.

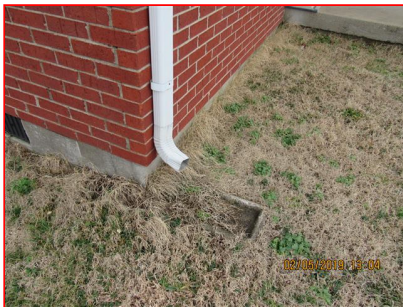
2.2 Item 1(Picture)

(2) Suggest installing extensions to gutter system to ensure proper drainage away from foundation.

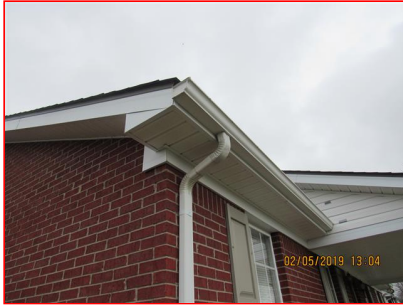
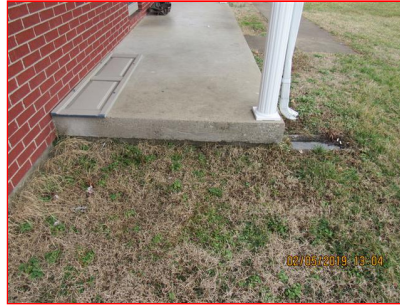
(3) Downspouts are loose and or damage and need securing to the wall at the virtually all areas where gutters are installed or replacement.

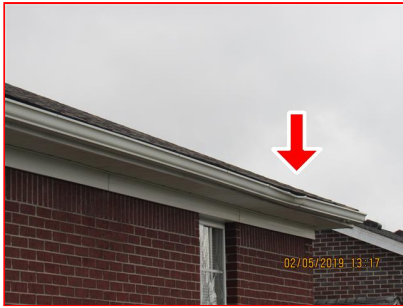
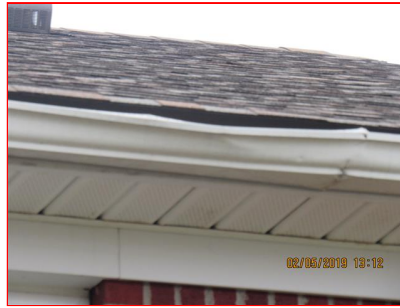
(4) Damage observed at right corner (facing rear). Recommend review for repair or replacement as necessary.

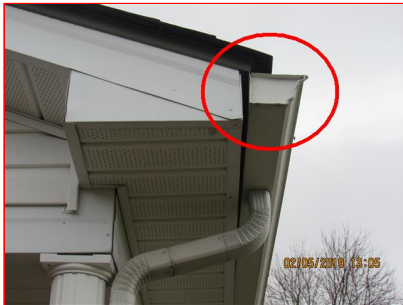
2.2 Item 6(Picture)

(6) Loose gutter at front (left of main entry). Recommend review for repair or securing as necessary.

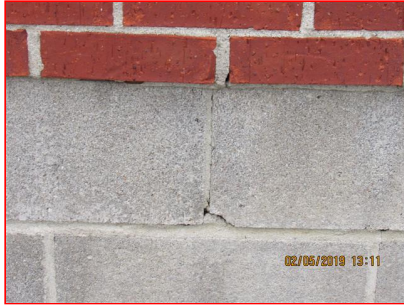
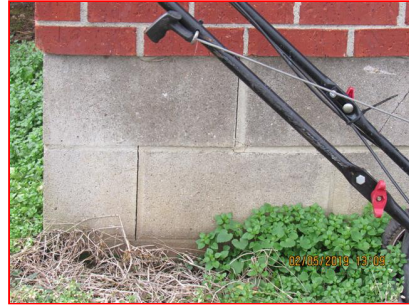
Hairline settlement crack observed at various locations. Recommend review by licensed contractor for corrections as needed.

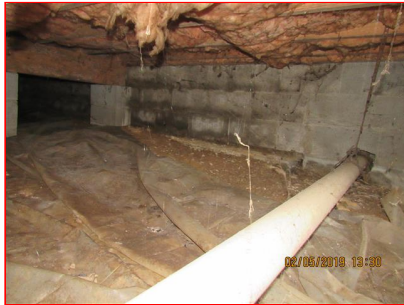
5.3 Item 1(Picture)

Efflorescence is present on the foundation on the crawlspace. Efflorescence is the salts left behind from moisture soaking into or passing through a masonry product. This moisture could adversely affect the foundation and/or the crawl space environment. A licensed structural engineer or a licensed general contractor specializing in crawl space moisture will need to determine the source of moisture and recommend or make necessary repairs.

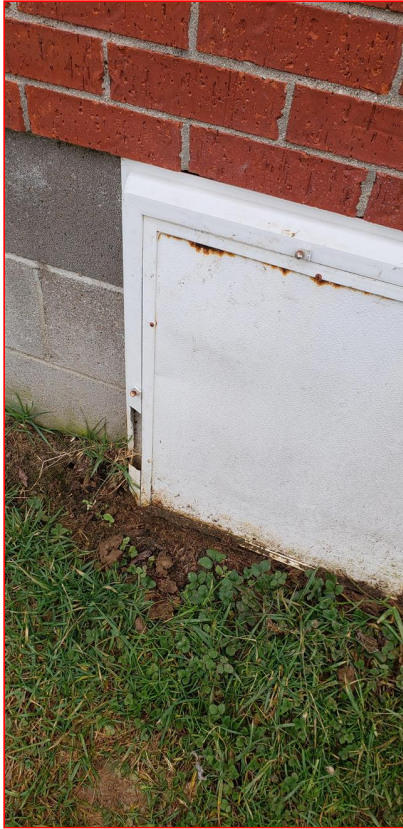
5.8 Item 1(Picture)

Cover/door to crawlspace is damaged. Recommend repair or replacement.

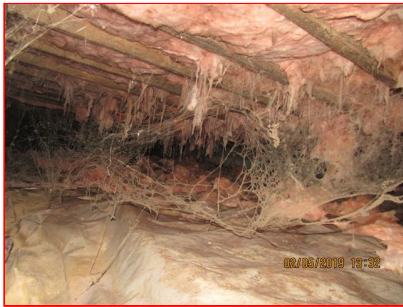
5.11 Item 1(Picture)

Loose insulation observed in the crawlspace, suggest securing as necessary.

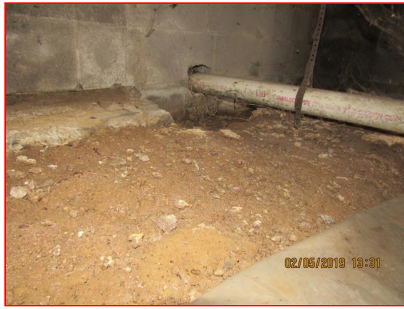
5.12 Item 1(Picture)

Gaps observed. Recommend review for repairs/replacement as needed.

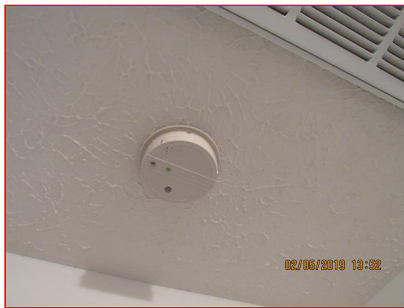
7.6 Item 1(Picture)

The smoke alarm did not work when tested at the hallway. Without a working smoke detector in your home you have no first alert to a possible fire. A qualified person should repair or replace as needed.

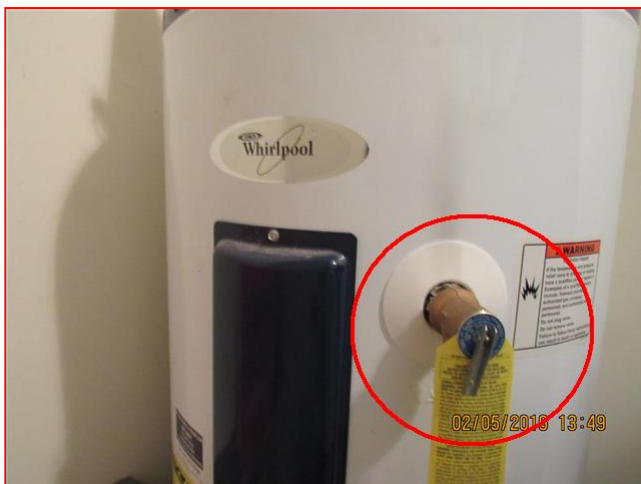
10.4 Item 1(Picture)

Discharge pipe is missing on the temperature pressure relief valve. Suggest installing the required 3/4 inch discharge pipe on the temperature pressure relief valve to within 6 inches of floor or to exterior of the building to ensure safety.

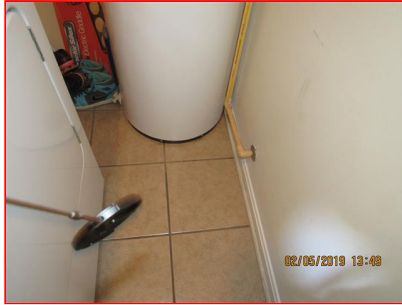
10.5 Item 1(Picture)

Water heater is located indoors without an overflow pan/drain line. This may not have been required when the home was built. Client is aware that the seller is not required to upgrade to current building standards. Suggest installation of overflow pan to prevent water damage from possible leakage or emergency discharge from the temperature pressure relief valve. Client is advised that overflow pan will be required when a new water heater is installed.

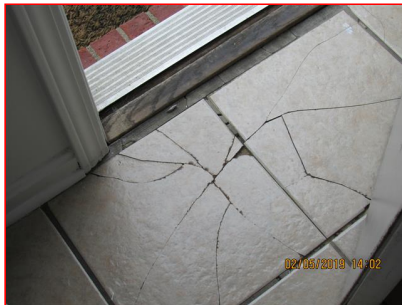
11.0 Item 1(Picture)

Damaged tiles observed; recommend corrections a needed.

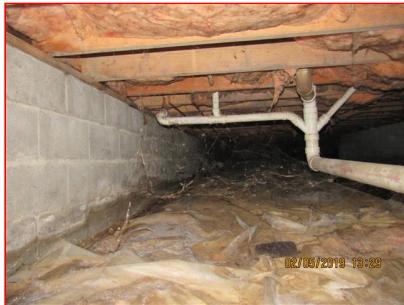
13.10 Item 1(Picture)

The dryer vent line terminates in the crawlspace. Lint build-up at crawlspace is a potential fire hazard. The line should be extended to exterior with weather cover installed at exterior foundation wall.

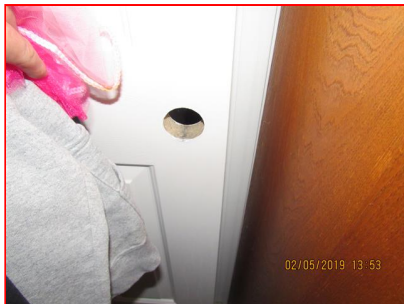
14.3 Item 1(Picture)

The doorknob is missing on the door in the left bedroom. Recommend replacement for proper operation.
