## Home Inspection Report

Prepared exclusively for  
**Grace Lutheran Church C/O Chad DuLac**

PROPERTY INSPECTED:  
**1408 Washington Street  
Wenatchee, WA 98801**

**Date of Inspection: 05/04/2022**

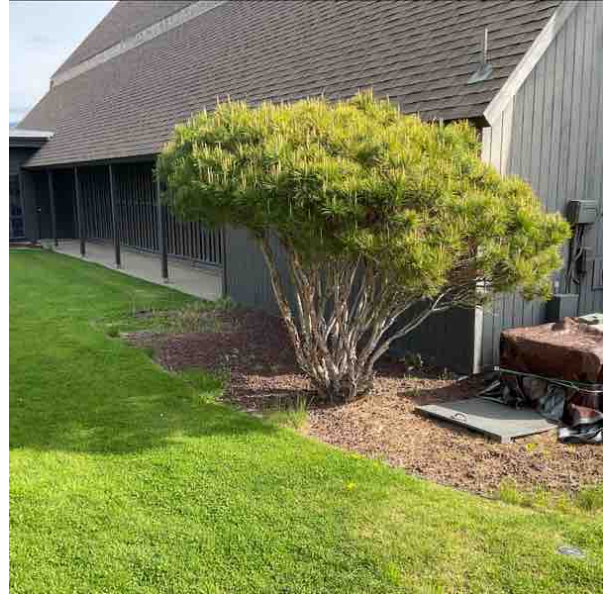
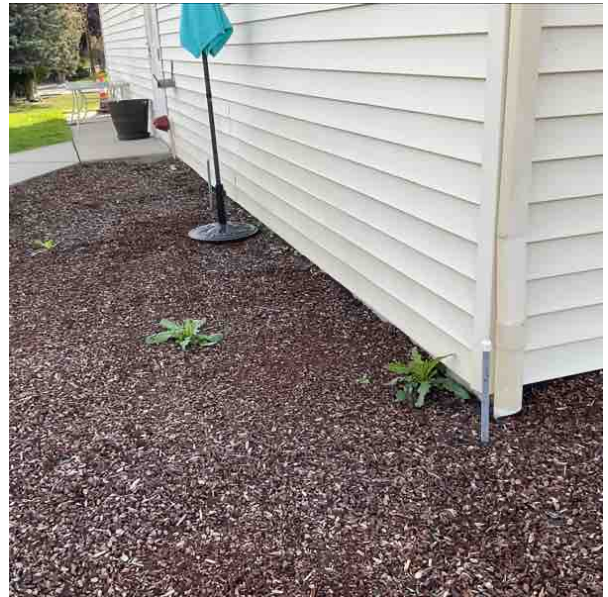
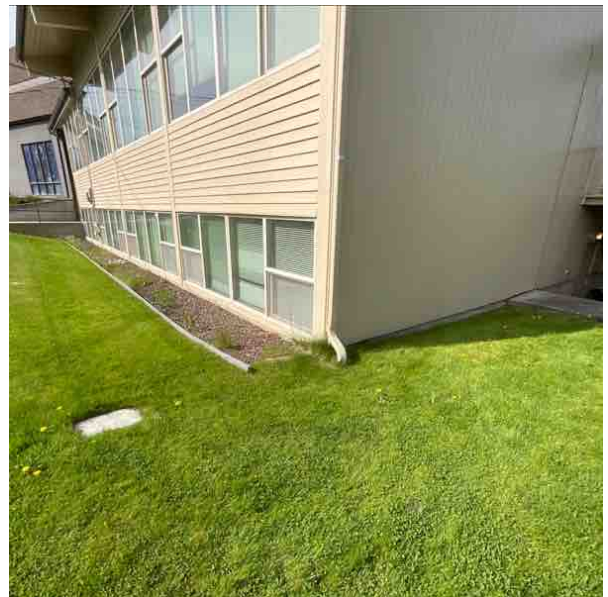
- Exterior East
- Exterior North
- Exterior South
- Exterior West

2.3.2 The ground surface is flat or sloped toward the structure in places. Grade landscaping to slope away from the foundation/structure, to help prevent water entry and/or deterioration to the foundation. Grading should always divert water away from the home. We recommend sloping away from the structure 6 inches in the first 10 feet, or a slope of 5%, to direct water away from the structure.

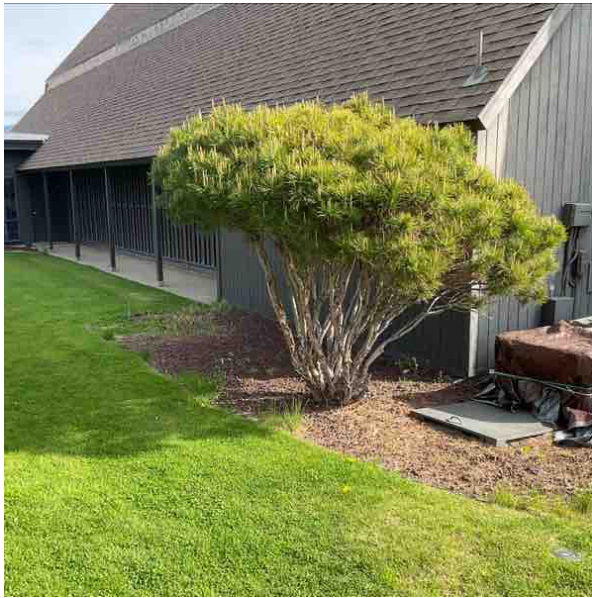
2.3.3 Regularly trim and maintain vegetation away from the structure to minimize damage/wear to the structure and to discourage animal/pest activity. Creating a 12" to 16" gap is recommended. We recommend trimming back any overhanging branches. Consult a landscaping contractor or arborist as needed. **(Exterior West)**

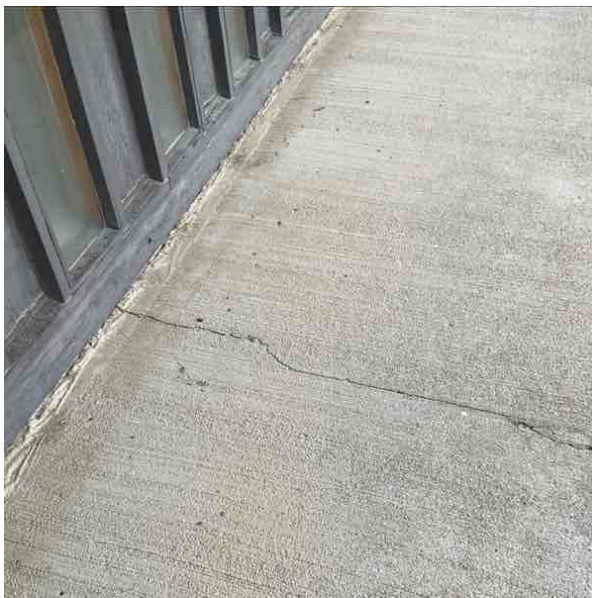
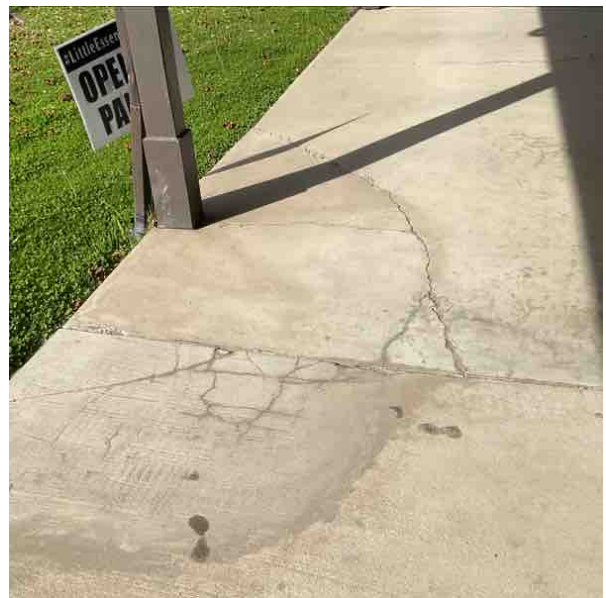
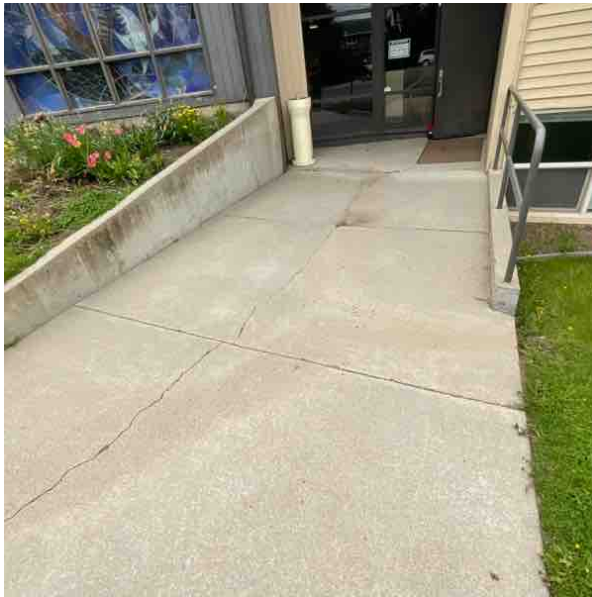
- Exterior East
- Exterior West

2.4.1 Seal cracks to reduce water penetration and separation/damage.

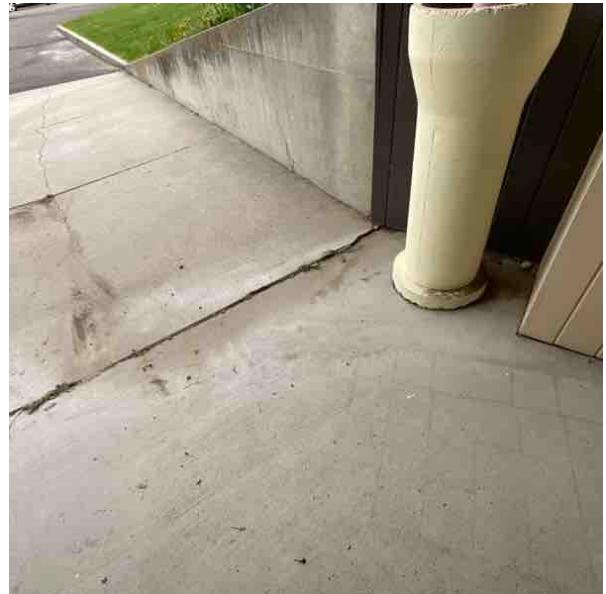
- Exterior East
- Exterior North

2.4.2 **Consult a concrete contractor to repair damaged walkway/trip hazards for safety.**

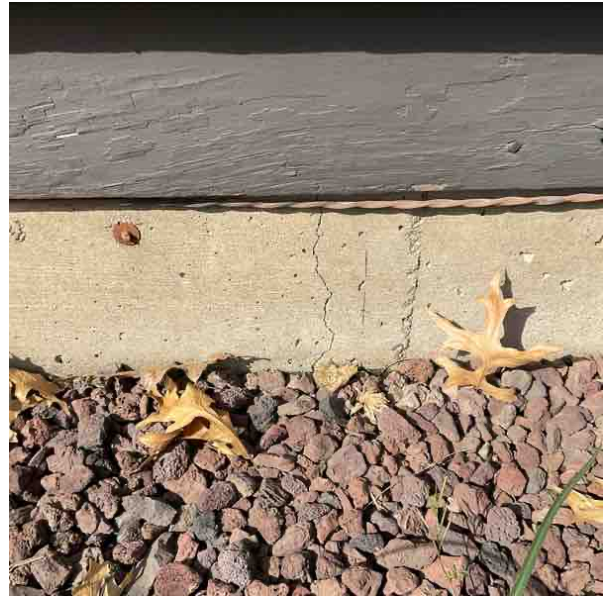
- Exterior East
- Exterior North

3.3.1 Seal minor crack(s) to reduce possible water entry into the foundation and subsequent damage. Small vertical cracks are not considered a structural defect.

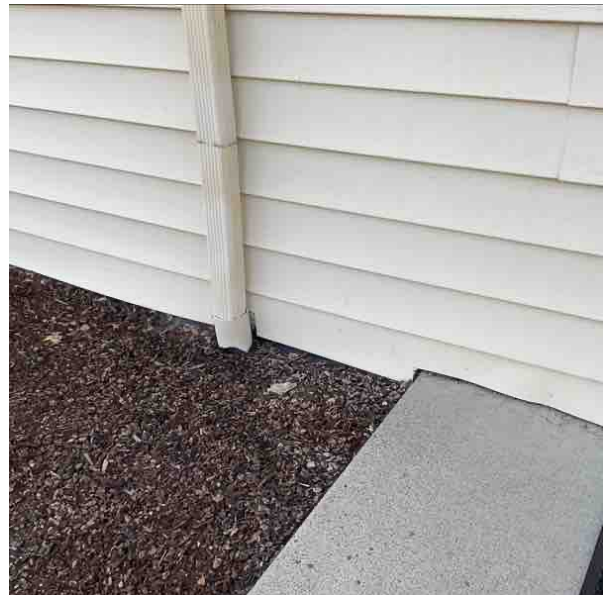
- Exterior North
- Exterior West

**3.4.1 Vinyl siding becomes brittle over time, can be affected by sun or heat exposure and is prone to damage. Monitor siding materials and repair all damaged areas for performance and to reduce pest or water access.**

**It is recommended to create a 6" inch gap between the ground and siding/trim. This is to limit potential damage/deterioration, reduce pest access, and for observation of the foundation. Most siding and trim manufacturers recommend a minimum 6" gap between the siding and the landscaping and at least a 1"-2" gap between a concrete slab or asphalt surface. At a minimum, all edges should be monitored and maintained/caulked and painted for water protection.**

**Repair missing or damaged vinyl siding and trim for water protection/continued function.**

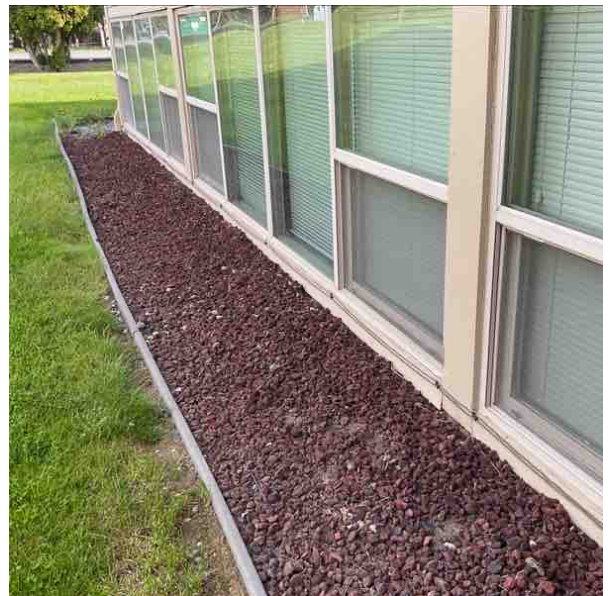
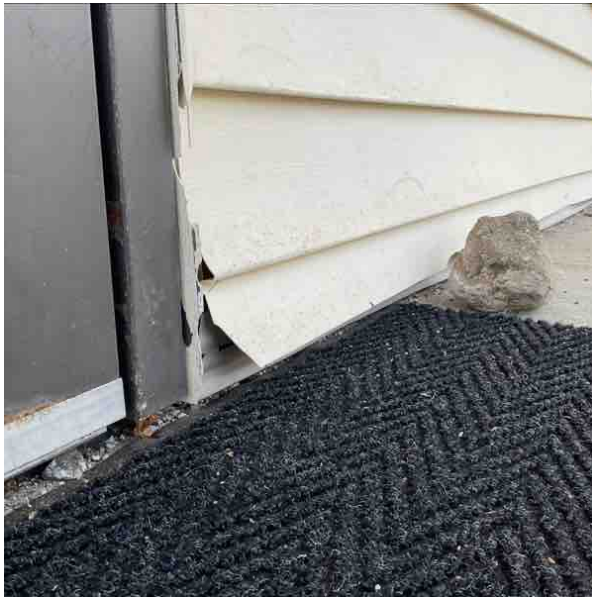
- Exterior North
- Exterior West

3.4.2 Seal gaps at lower edges of siding to reduce rodent/pest access points.

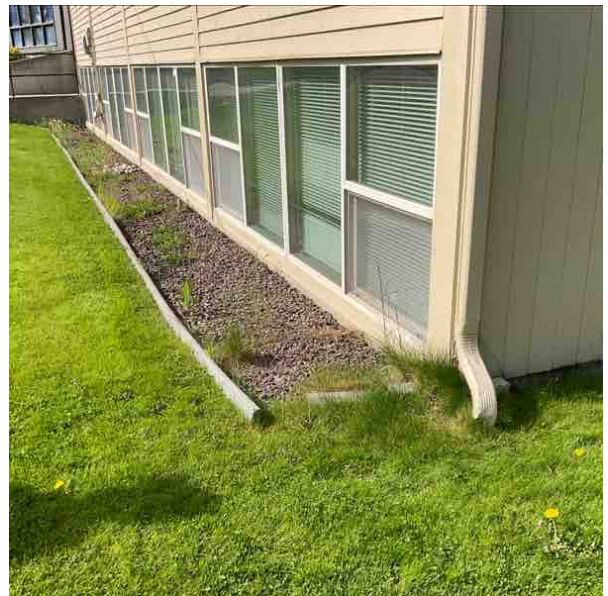
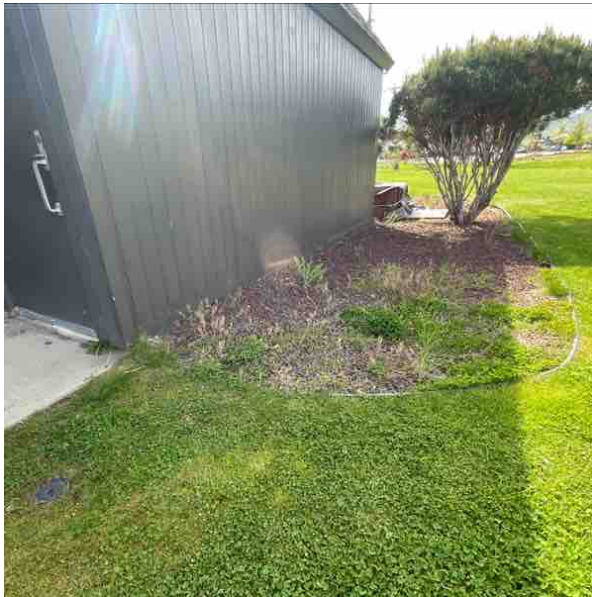
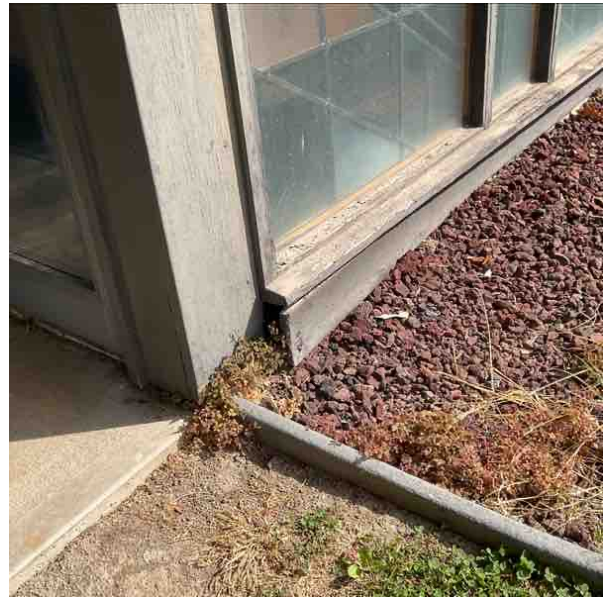
- Exterior East
- Exterior North
- Exterior West

3.4.3 Siding or trim is in contact/close contact with the ground/landscaping. This is a conducive condition for water absorption, wood rot, rodent access. It is recommended to create a 6 inch gap between the siding and the ground to limit deterioration of the siding and possible rodent access. When removing dirt/landscaping, further investigate and repair as needed.

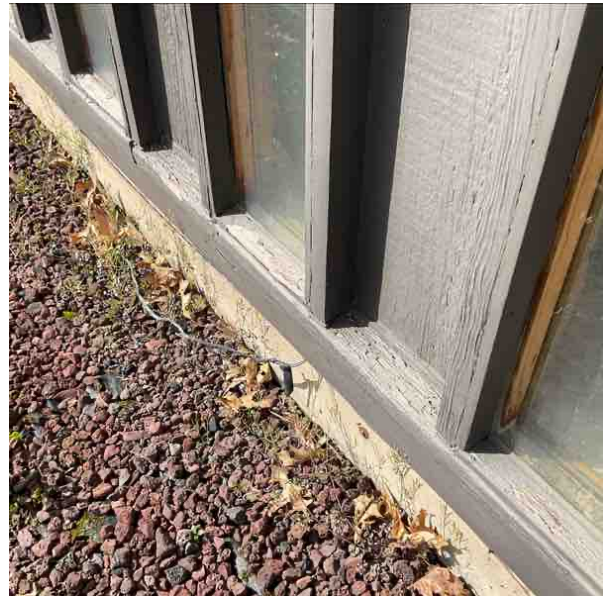
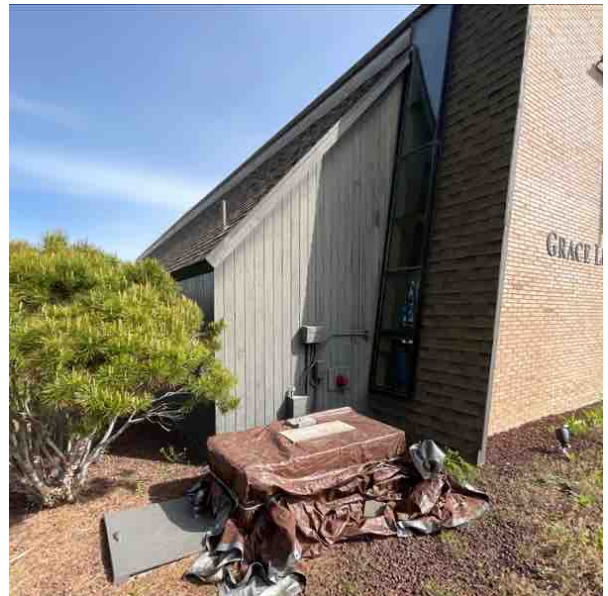
- Exterior East
- Exterior South

3.4.4 Peeling / fading paint noted. Caulk gaps and paint all exposed siding, for water protection.

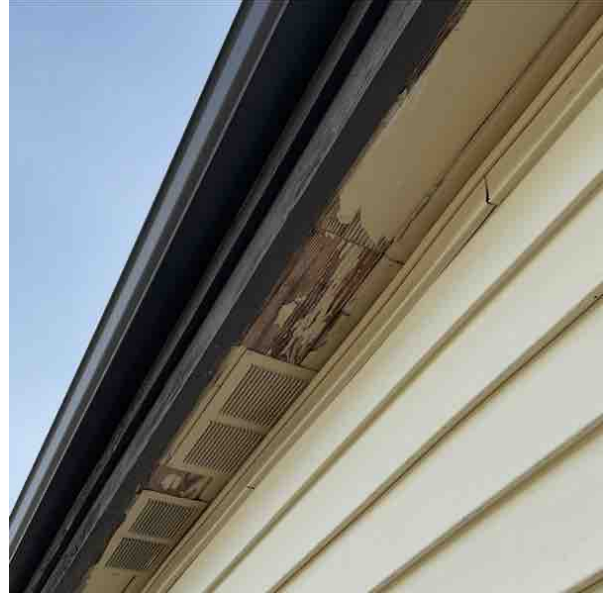
- Exterior East
- Exterior North
- Exterior South
- Exterior West

3.5.1 Fascia and soffit boards show signs of water absorption/deterioration. Peeling paint observed. We recommend caulking and painting for water protection. Repair damage for continued function.

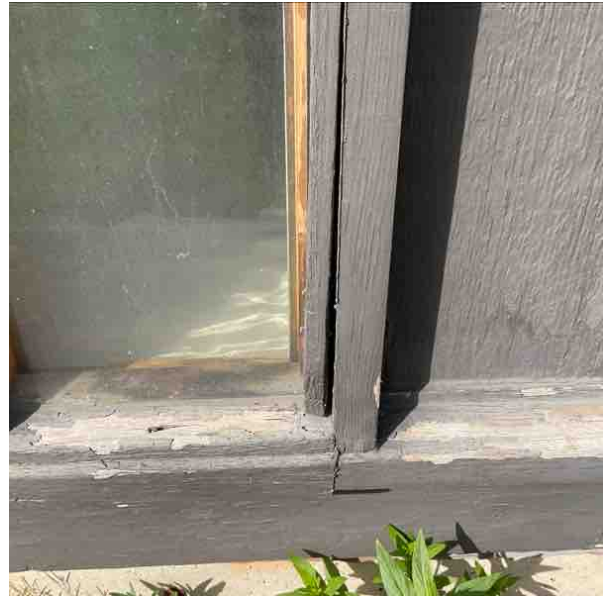
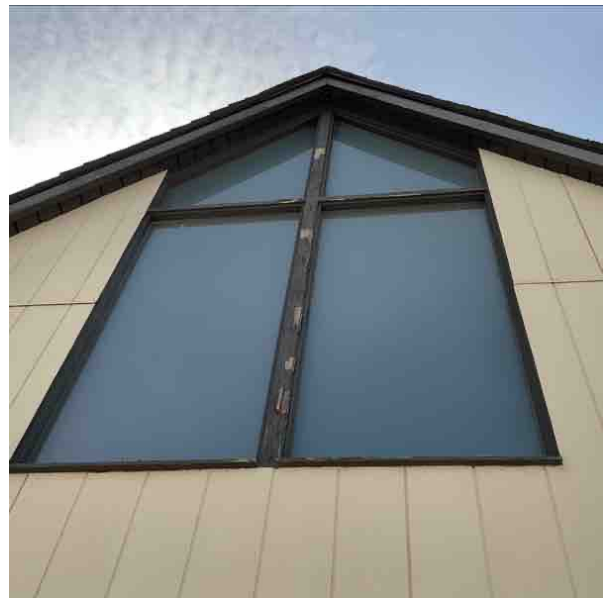
- Exterior East
- Exterior North
- Exterior South
- Exterior West

3.6.1 Touch up caulk and painting recommended for water protection.

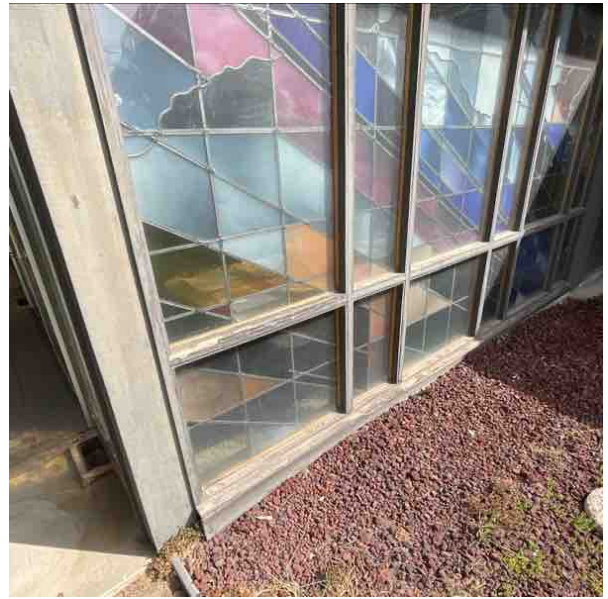
- Exterior East
- Exterior West

3.6.2 It is recommended to install flashing over top edges of trim, to reduce the chance of moisture getting trapped between surfaces and potential water related damage.

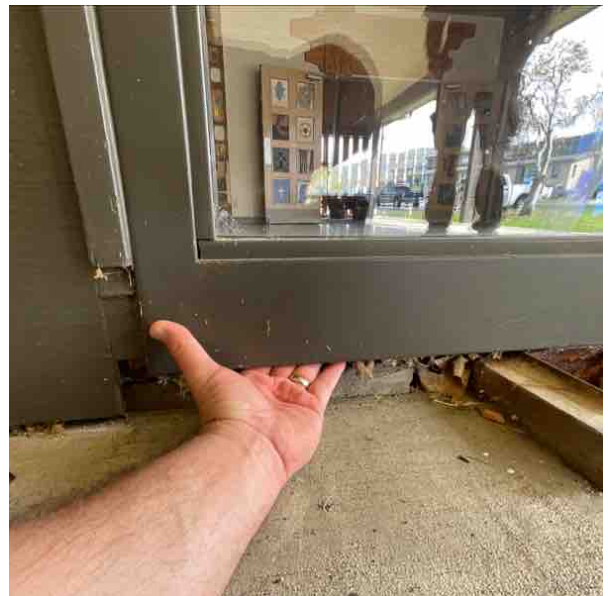
3.6.3 Repair loose trim to reduce potential pest access near the west main entrance.

Gaps below the metal trim can allow for pest access/activity. **(Exterior West)**

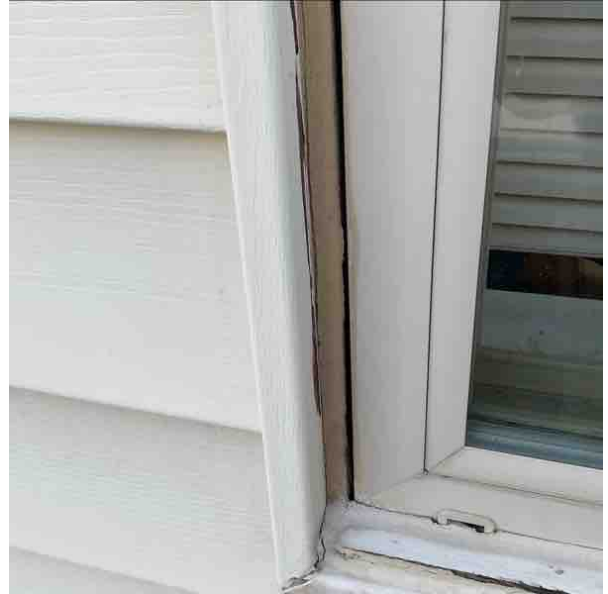
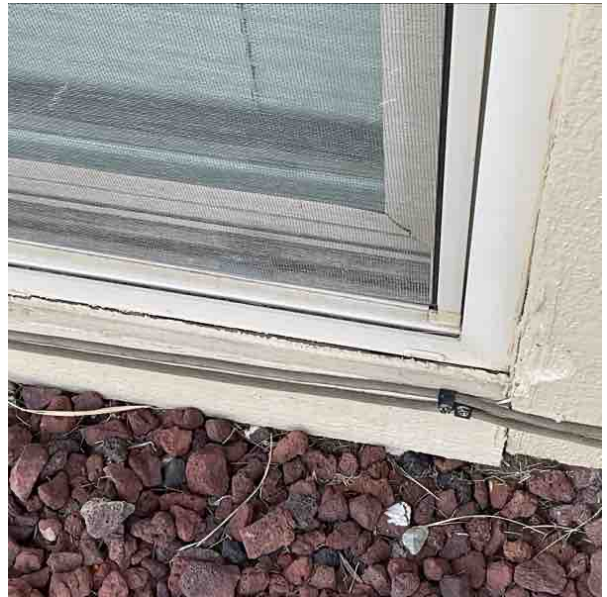
- Exterior East
- Exterior North
- Exterior South
- Exterior West

3.7.1 Caulking improvements recommended in several areas to keep water out of the building envelope.

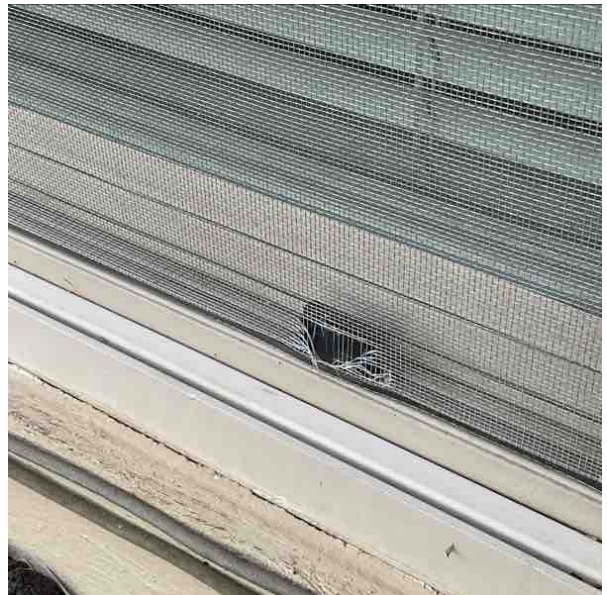
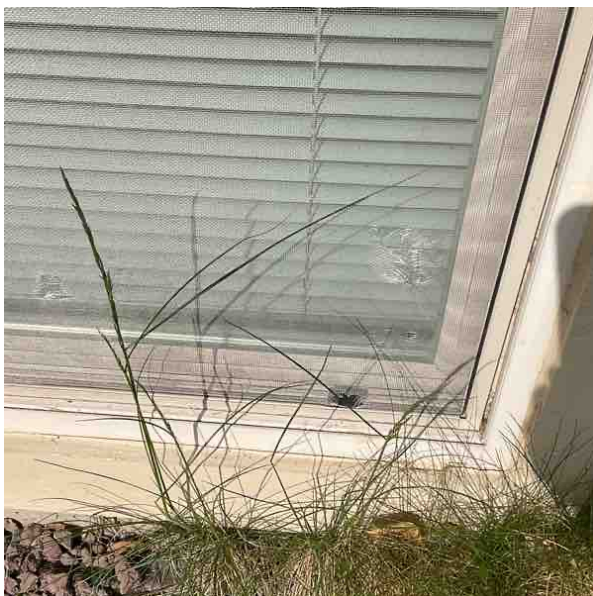
3.7.2 Provide window screens, where missing or damaged, as desired for function. **(Exterior North)**

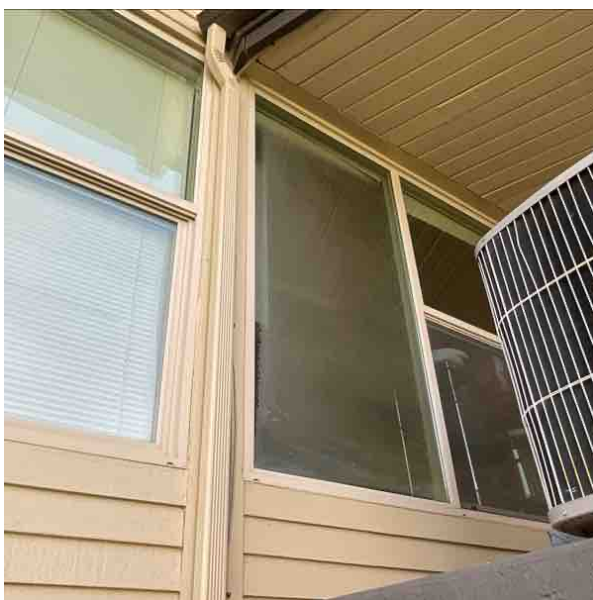
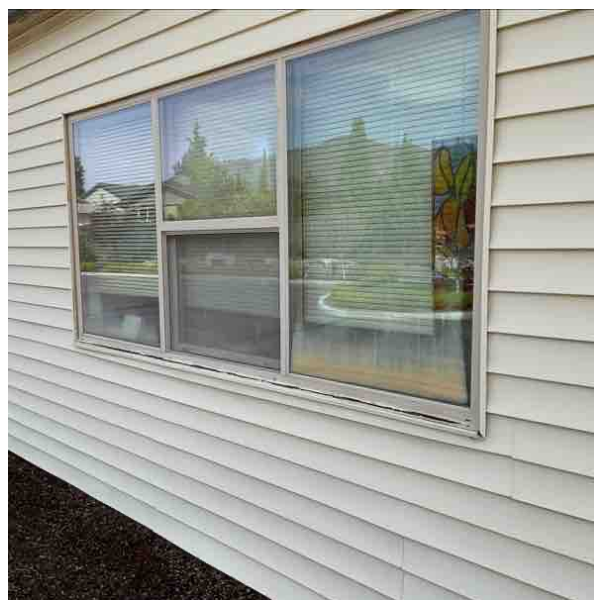
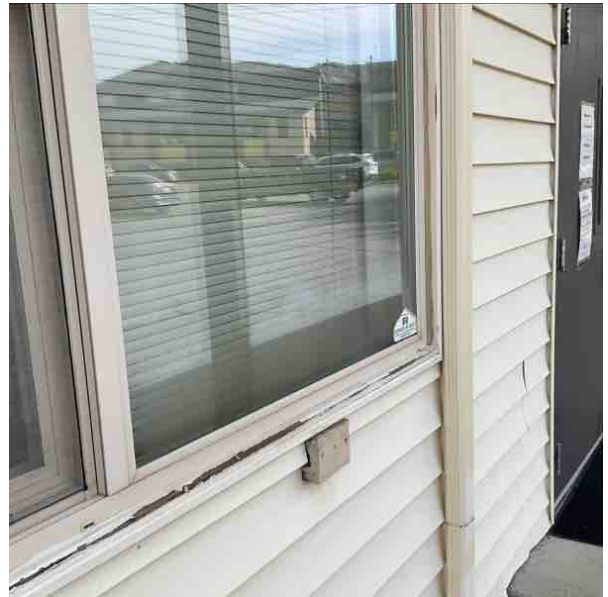
- Exterior North
- Exterior South
- Exterior West

3.7.3 Although determining the condition of thermal window seals is outside the scope of a the inspection, it appears that some windows have moisture between the panes of glass. This is generally considered a cosmetic condition. To repair, windows have to be replaced . Consult a window contractor for further evaluation and repair.

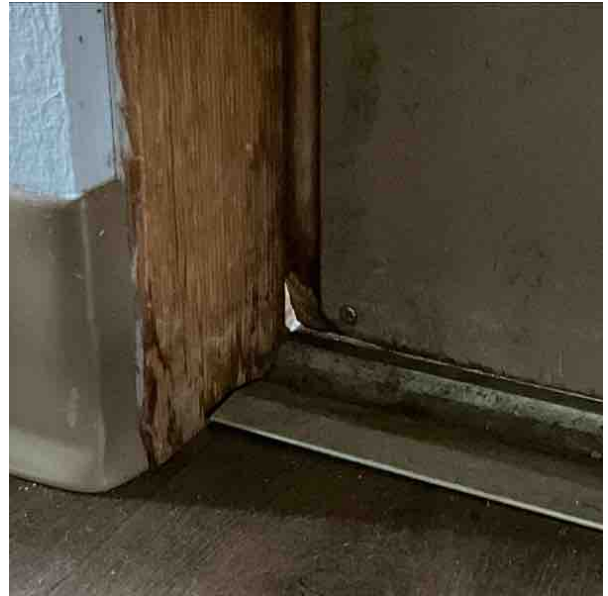
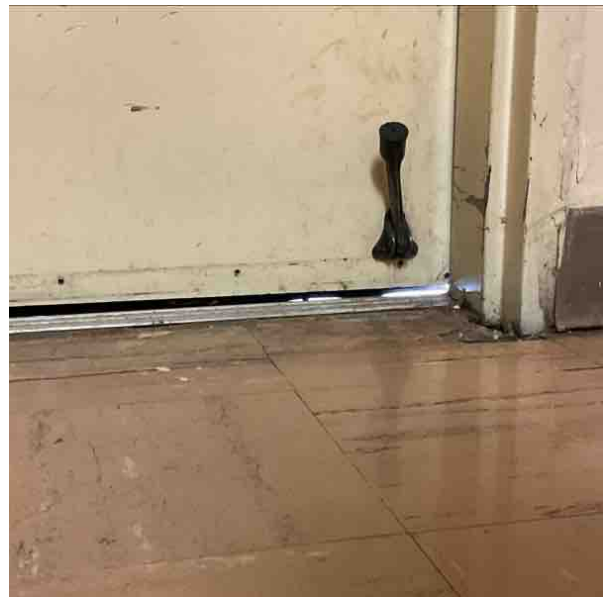
- Exterior North
- Exterior West

3.8.2 Install new weatherstripping at exterior doors, where gaps can be seen, or where weatherstripping is missing or worn. This will help eliminate an entry way for unwanted pests, limit air exchange, and promote a more comfortable environment.

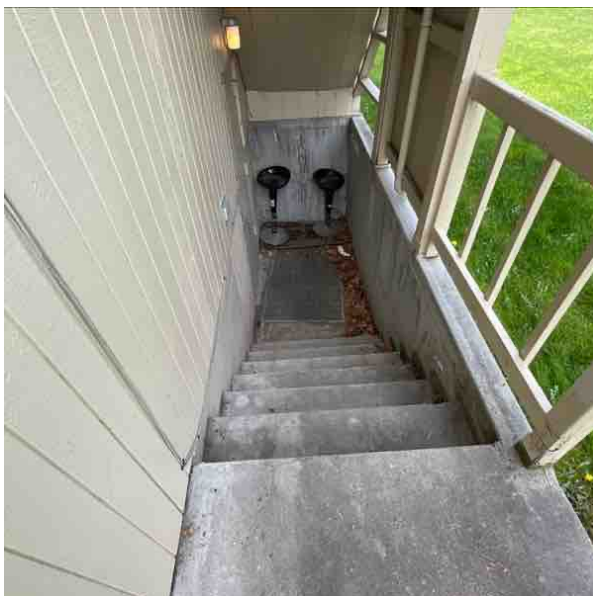
3.9.1 Installation of graspable railing is recommended for trip/fall safety. **(Exterior North)**

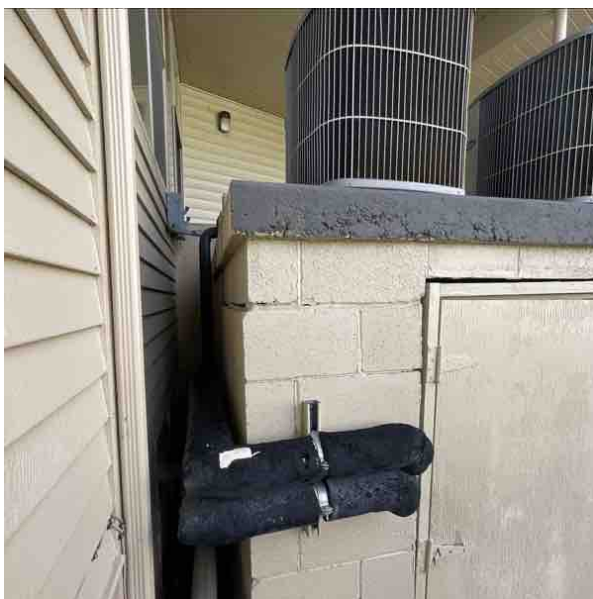
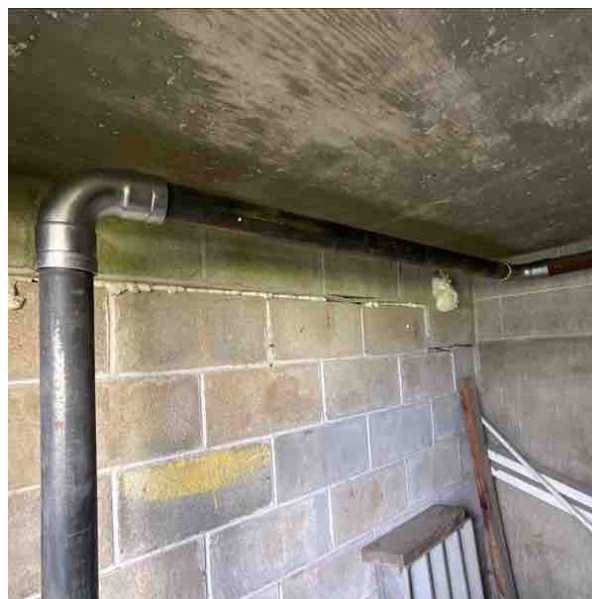
3.10.1 Consult a contractor to further evaluate and repair the slab, walls and door of the exterior storage room.

-All gaps should be sealed to limit pest access. **(Exterior North)**

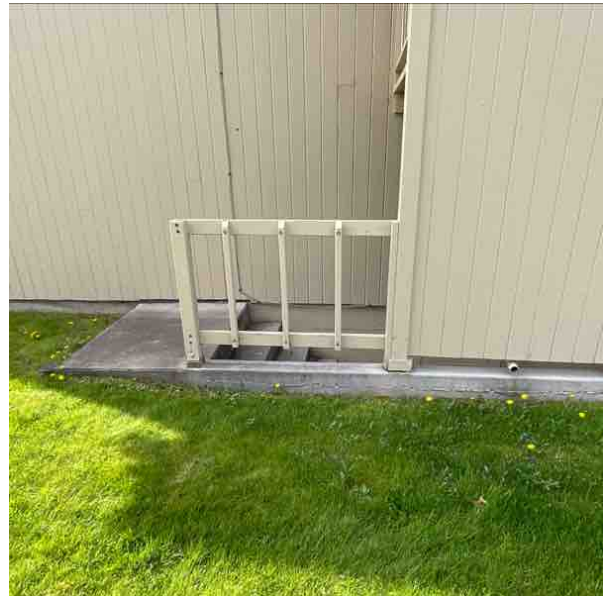
Maintenance at steps recommended. Paint/stain as needed.

Protruding nails should be reset for safety and function. **(Exterior North)**

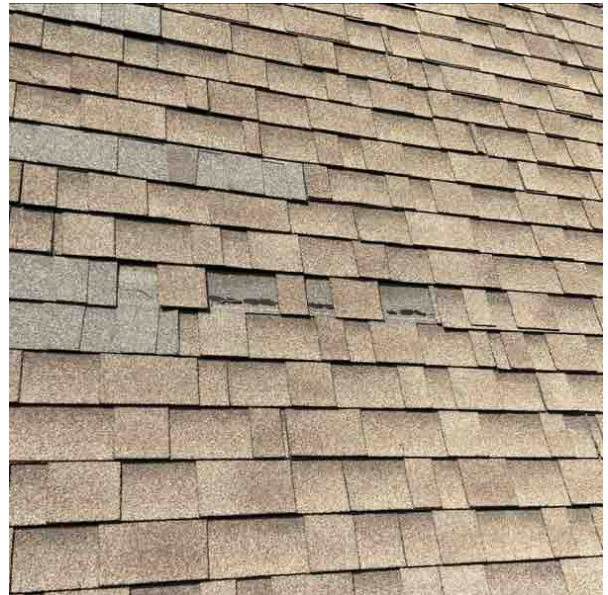
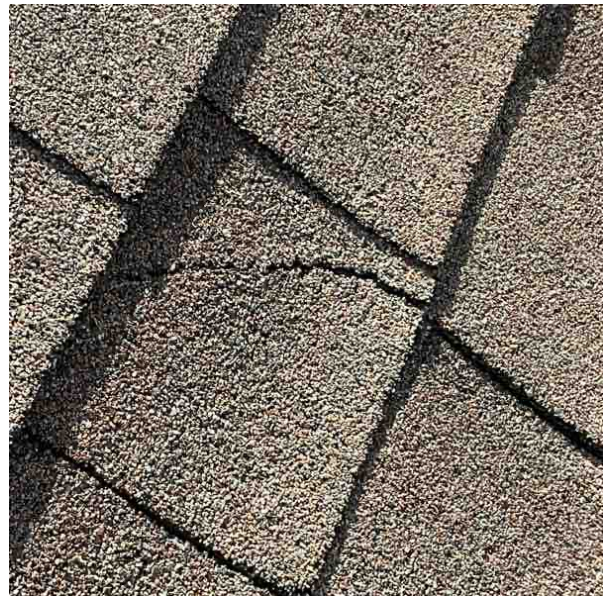
4.4.1 **Repair damaged/missing shingles for water protection and to reduce further damage/deterioration. Consult a roofer for further evaluation and repair.**

**-There are several shingles with small cracks. These should be sealed for continued water protection.  
(Exterior East)**

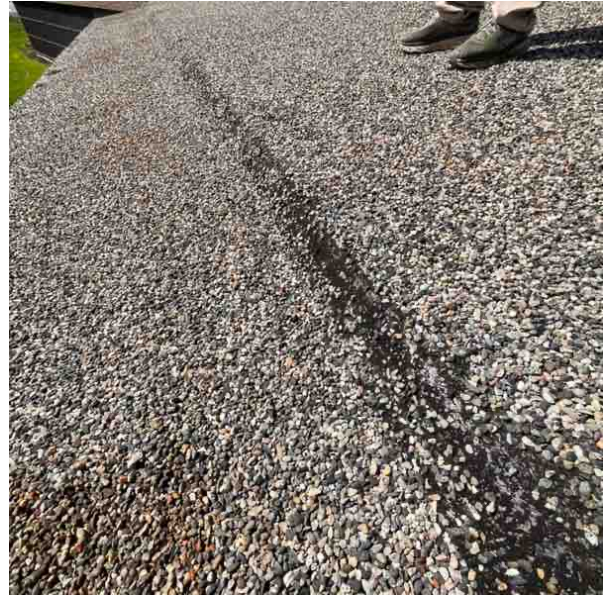
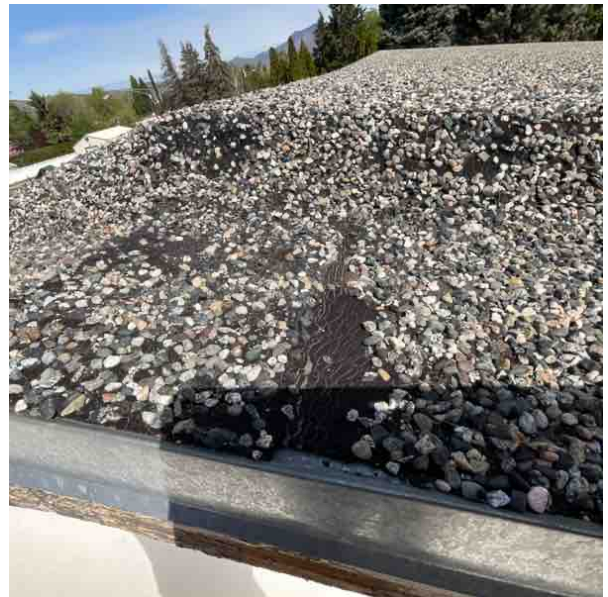
**4.5 Flat Surface(s)****4.5.1 Built up roofing at the north wing of the building.**

There are several areas of the roof where the gravel has worn away, and the roof surface is showing wear/alligator cracking. Further evaluation/patching recommended for intended/continued function.

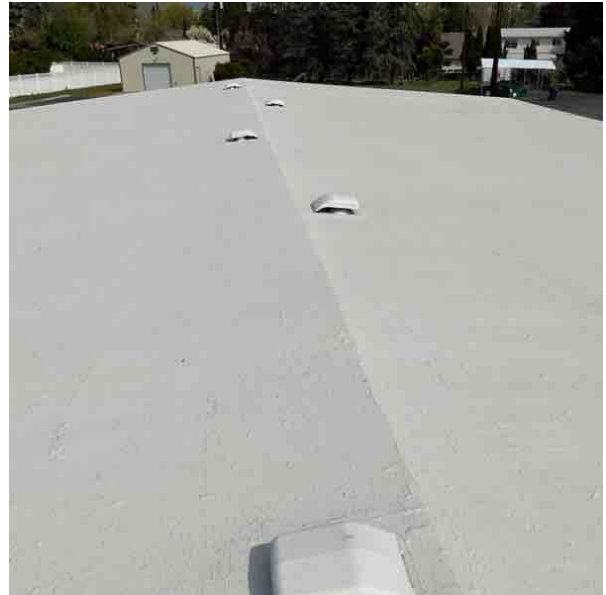
4.5.2 The roof at the northwest wing appears to be constructed of plywood, which is coated with a protective paint/sealant. This roof appears to be in generally good condition. Monitor and maintain for continued function.

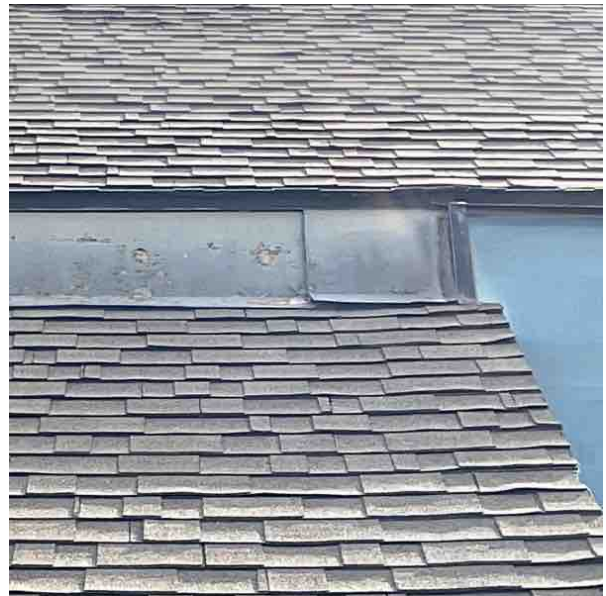
- Exterior East
- Exterior West

4.6.1 Secure flashing for continued function. Some loose nails/fasteners observed.

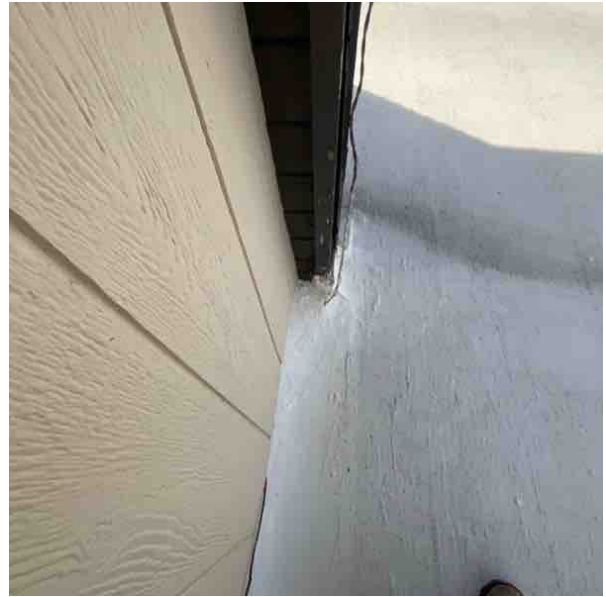
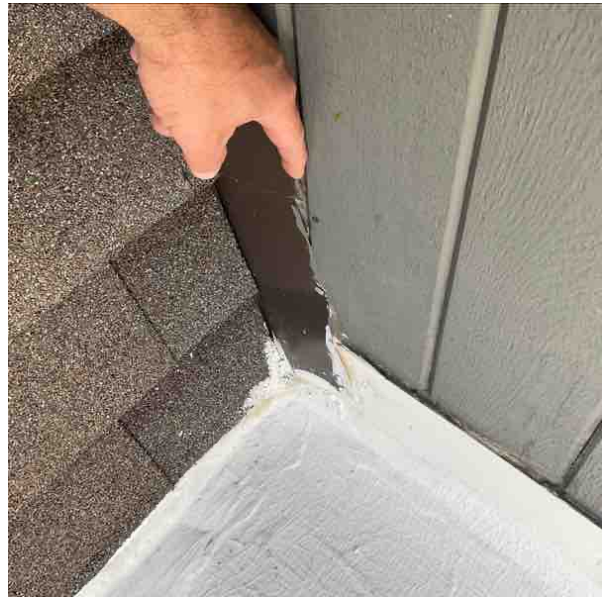
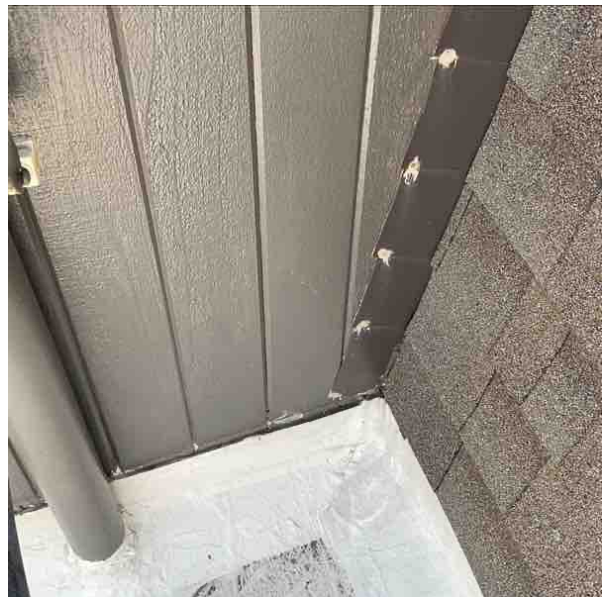
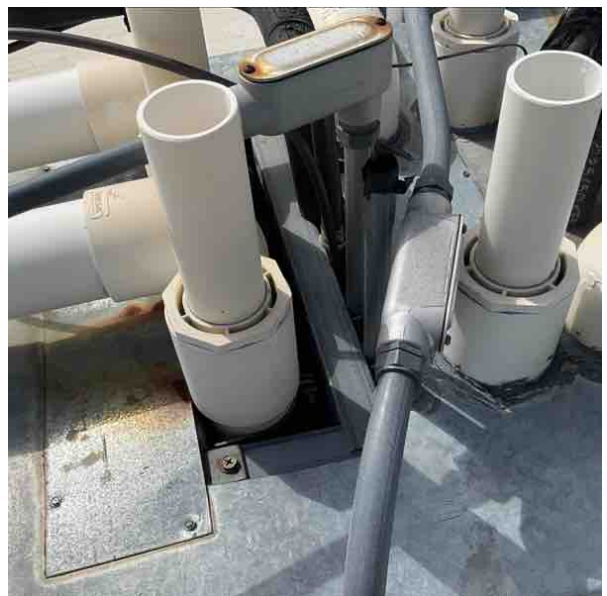
4.6.3 **Small gaps in roof to wall flashing/sealant could allow for water entry into the structure. Repair recommended.**

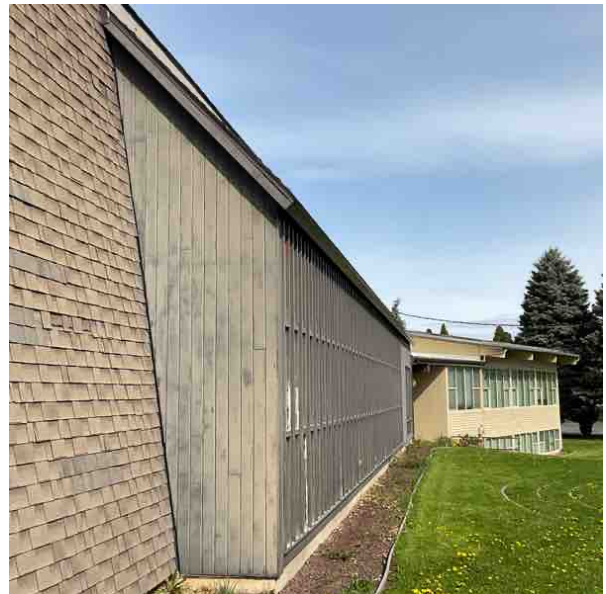
- Exterior East
- Exterior West

4.7.2 Consider having gutters and downspouts with extensions installed to help drain water off of the roof and away from the structure.

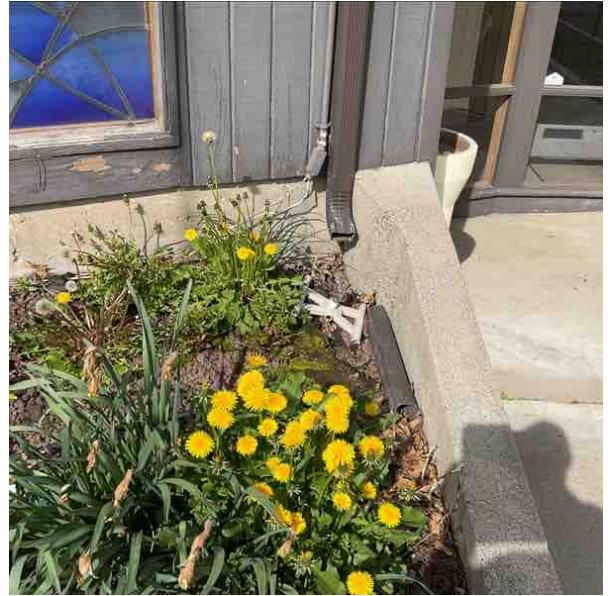
4.7.3 Downspouts is/are discharging water near the foundation or walkways. It is recommended to install downspout extensions to drain water away from the structure, to help prevent water entry into the foundation or concrete and to protect from possible subsequent water related issues or damage. Splash blocks are not recommended, as they tend to slope back toward the house over time. **(Exterior West)**

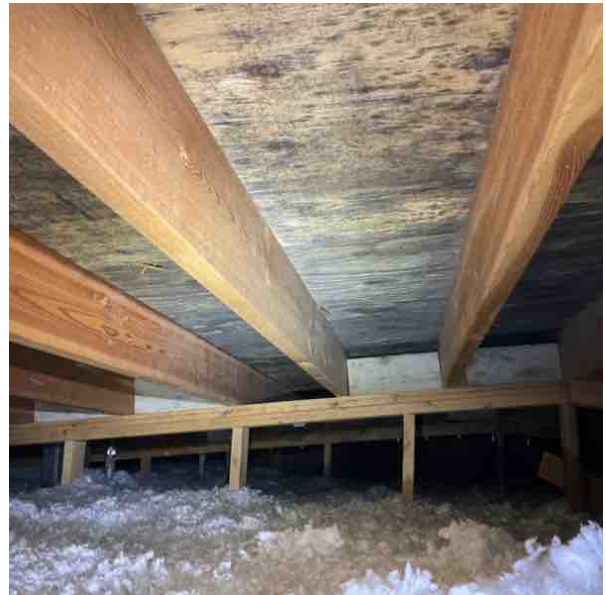
5.7.1 **Mold/mildew noted on the attic sheathing (above the kitchen and foyer areas). This can be caused due to several past or present circumstances, including inadequate ventilation, loose exhaust ducts, inadequate insulation, air leaks from the interior of the house into the attic, can lights, past or present roof leaks, or a combination of several items. The color of mold is due to the type of material the mold is digesting for nutrients and is not a good indicator of the type of mold. Further evaluation/treatment recommended by a mold remediation contractor. It is recommended to have the sheathing treated to kill off any possible living mold/mildew and further evaluation/repairs performed by a licensed contractor to reduce the chance of future growth. Over time, moisture can weaken the attic sheathing. Further investigation and repair is recommended by (a) licensed contractor(s). Mold grows when moisture is present, but will cease to grow in dry conditions.**

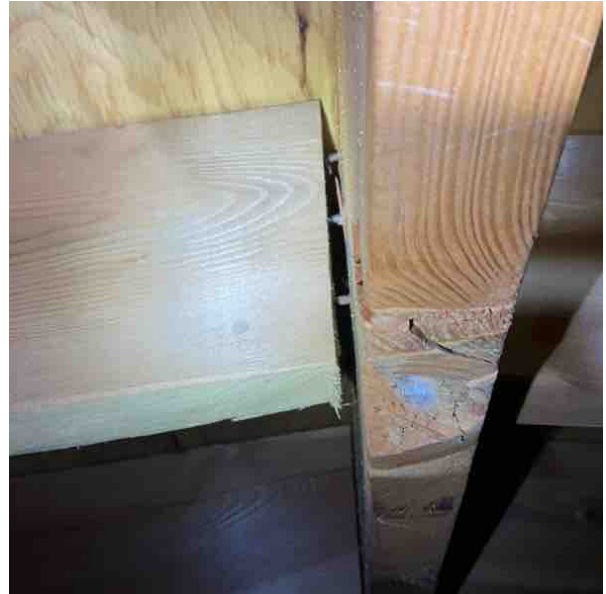
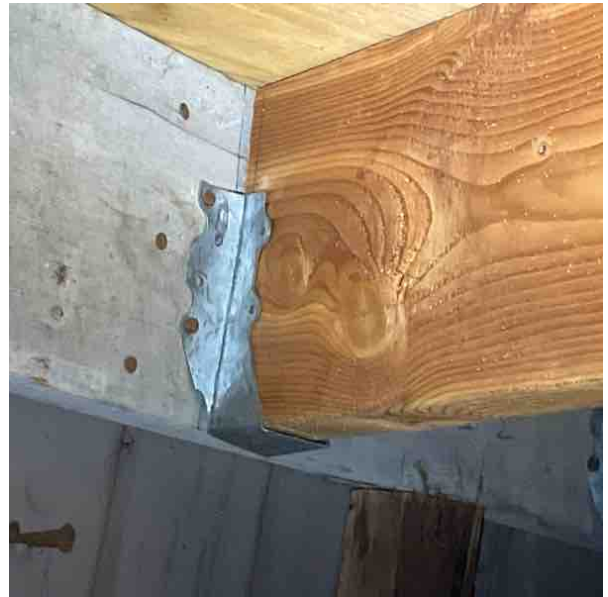
6.7.1 In some locations over the northwest wing there are gaps between the rafters and ridge board. It is possible that rafters were cut short, or that some movement has occurred over time. Further evaluation recommended. Secure rafters as needed. A couple of the rafters were not nailed/secured to the ridge board.

Brackets were used above the foyer to attach the roof rafters to the ledger board at the wall. It is recommended that fasteners fill all holes for intended support.

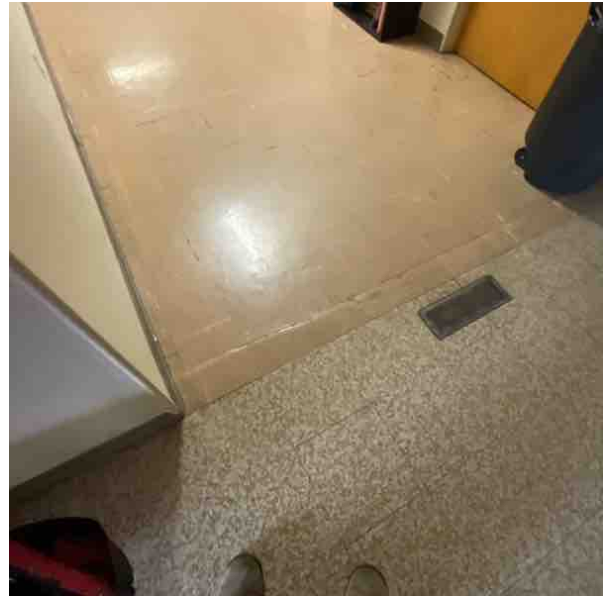
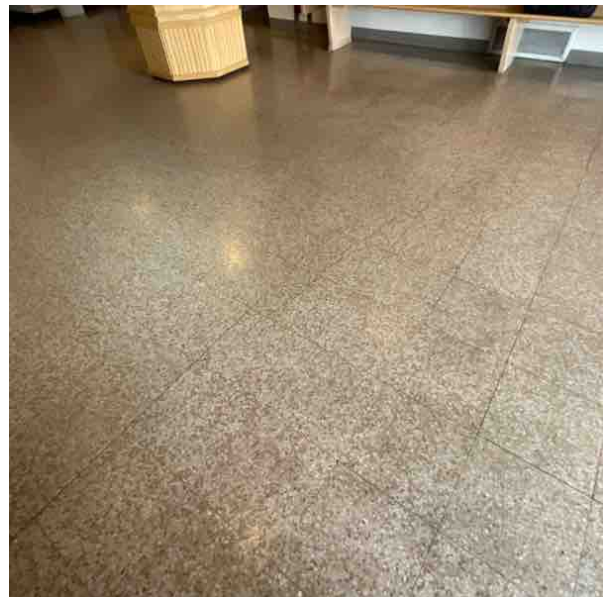
6.10.2 Minor cracks could be a sign of some minor settling. These do not appear to be a structural concern.  
(Various locations)

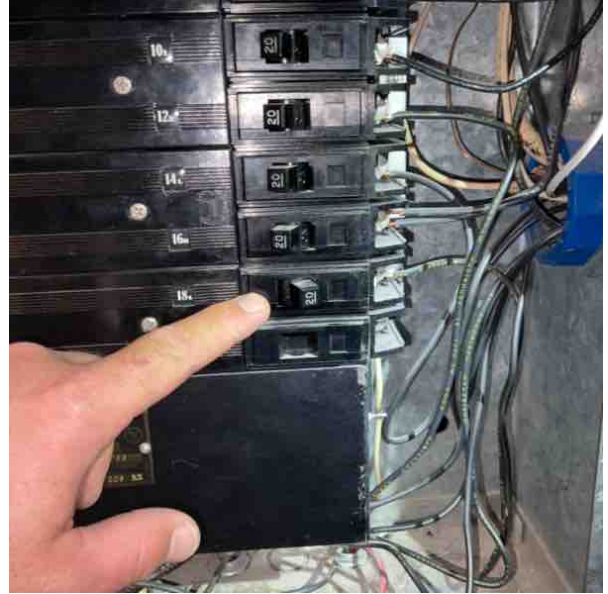
Stranded wire does not appear to have a good connection at breaker #8. (Sanctuary front storage rm.)

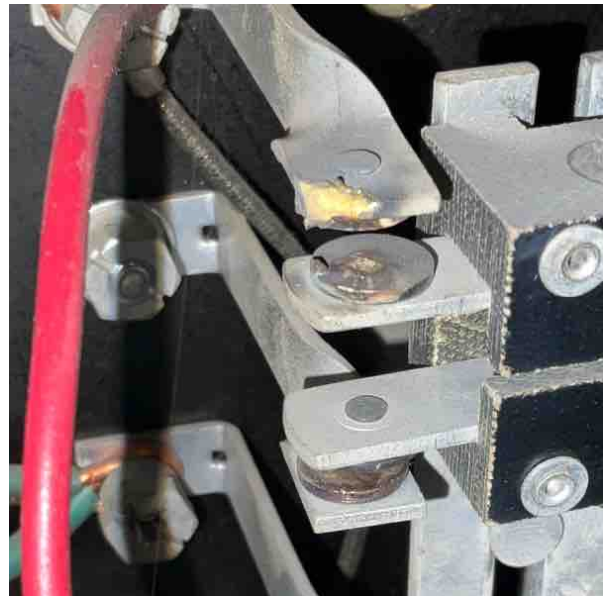
7.6.2 There was an electrical buzzing noise coming from the box marked as transfer-switch. The inspector is uncertain as to what would cause this buzzing sound, or what the box is for. Some of the contacts inside the panel showed some wear/deterioration. Further evaluation recommended. **(Basement Electrical Room)**

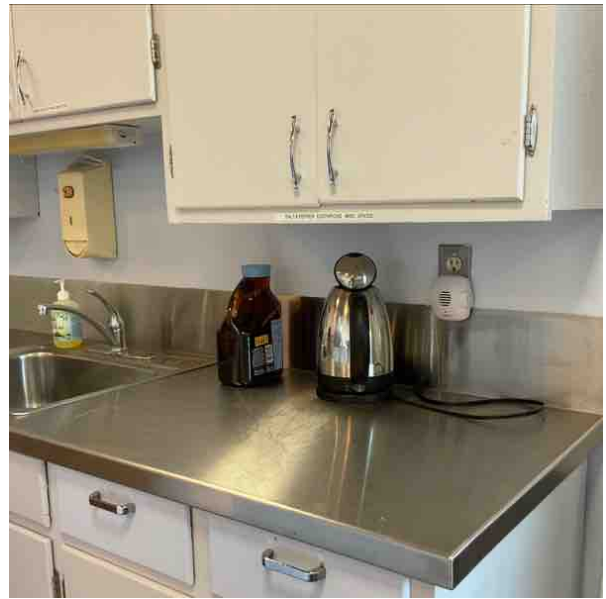
- Basement Electrical Room
- Copy Room
- HVAC room
- Kitchen
- Multi-purpose room
- Sanctuary front storage rm.

**\* GFCI protection should be installed at the copy room, if use of the sink is restored.**

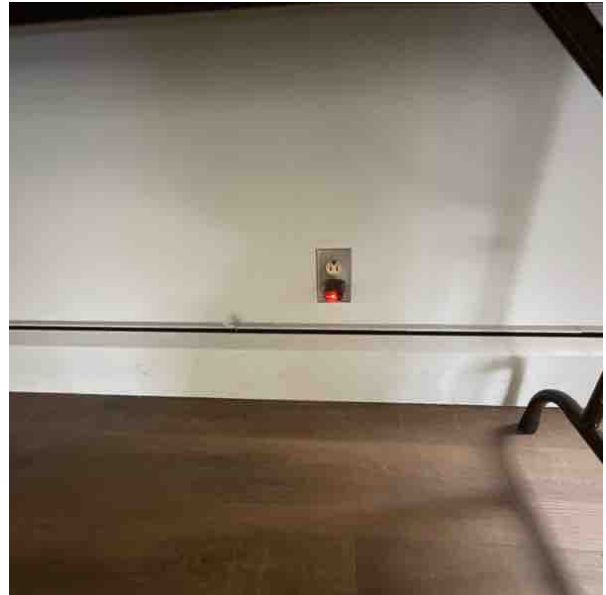
- Basement room 1
- Basement room 5-6
- East hall
- Fellowship Hall

7.8.3 Receptacles with loose contacts noted. We recommend updating with tamper resistant receptacles for intended function and safety.

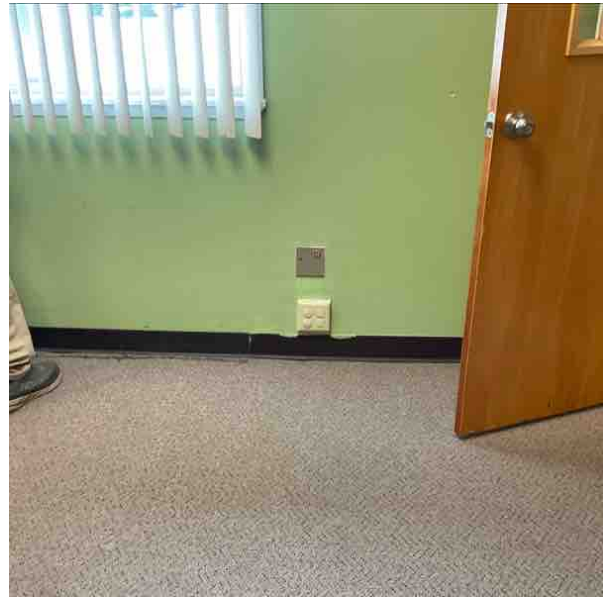
**7.8.5 Non-functioning receptacles noted. Further investigation and repair recommended. (library)**
