## Home Inspection Report

Prepared exclusively for  
**Grace Lutheran Church C/O Chad DuLac**

PROPERTY INSPECTED:  
**1408 Washington Street  
Wenatchee, WA 98801**

**Date of Inspection: 05/04/2022**

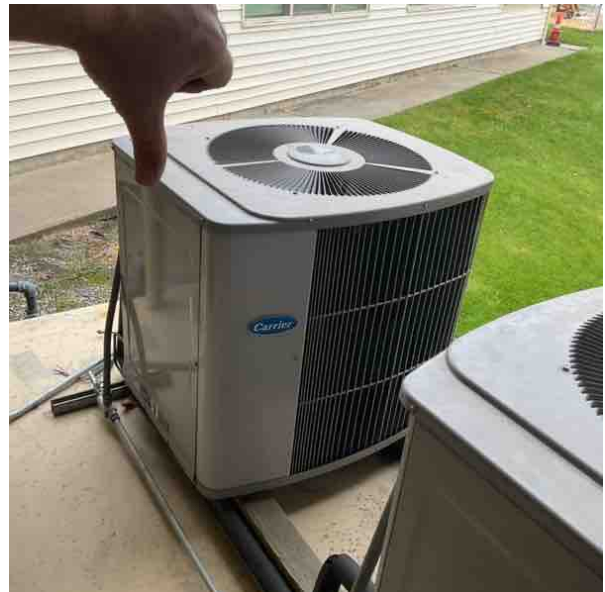
8.5.1 Both air conditioning units at the north side of the building or manufactured in 1991. Further evaluation/repair recommended. Neither one of the air conditioning units would activate at the time of the inspection, although the thermostat indicated that they were on.

**Because the air conditioners use the older R22 refrigerant, if replacing the A/C units, it may also be necessary to replace the furnaces and air handlers. (Exterior North)**

Replace worn/missing insulation on the suction line, to help with system efficiency.

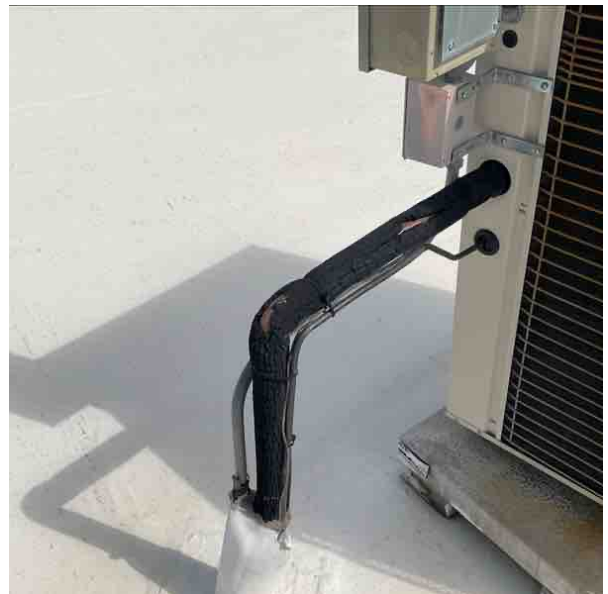
The condensate line has been disconnected and deteriorated. Repair for intended function.

**8.5.2 The large air conditioner on the northwest wing of the roof was manufactured in 2004. Further evaluation/repair recommended.**

**The large air conditioner, over the north west wing was not functional at the time of the inspection. The AC unit kept cycling on and off, and the suction line was beginning to ice up. (Roof)**

Replace worn/missing insulation on the suction line, to help with system efficiency.

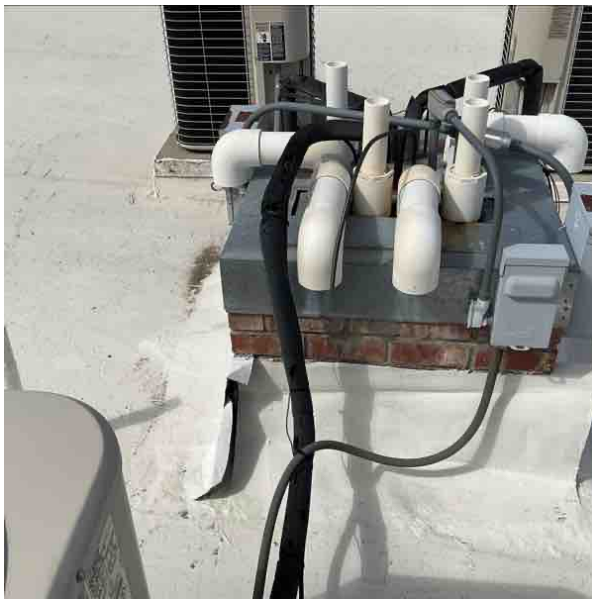
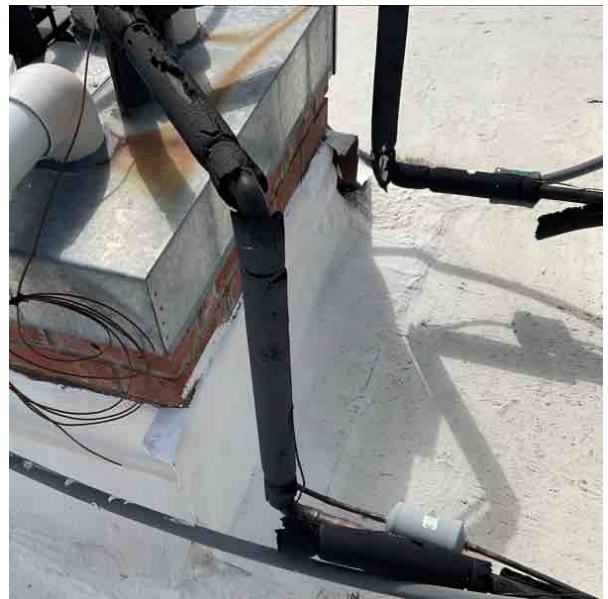
**8.5.3 There are three air-conditioning units, located in the central part of the roof system. Two of the units were manufactured in 1997, and the other in 2003. Further evaluation/Repair recommended. The middle AC was not working as intended at the time of the inspection.**

**Replace worn/missing insulation on the suction line, to help with system efficiency. (Roof)**

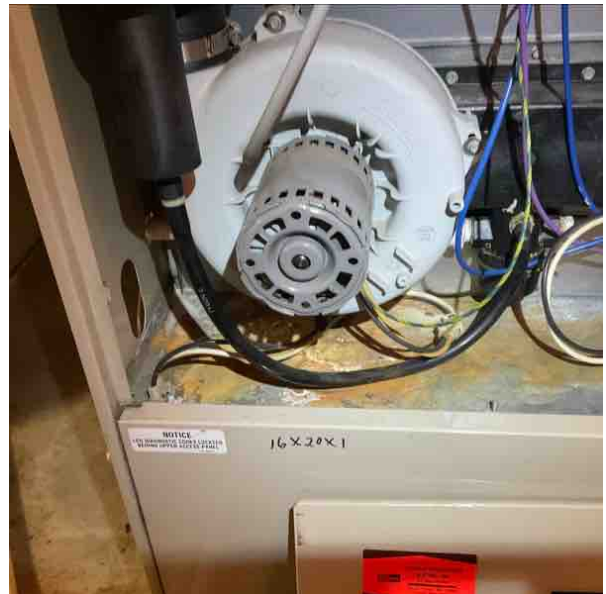
8.6.3 Some of the furnaces show signs of water/condensation near the exhaust fans. Service recommended for intended exhaust/function. **(HVAC room)**

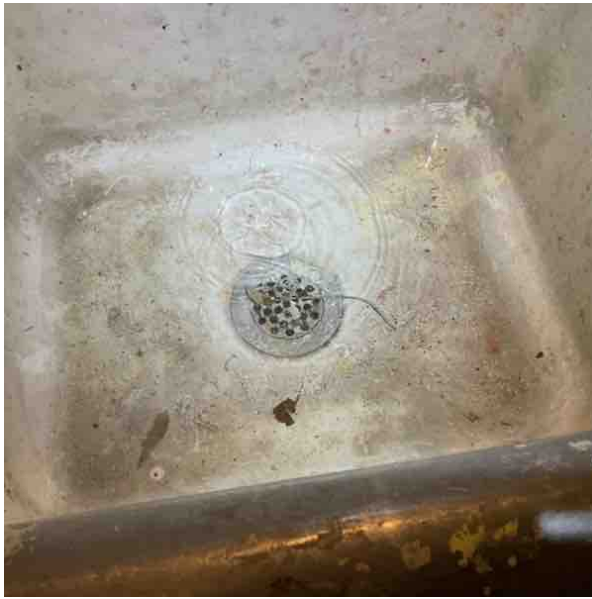
9.8.5 The sink drains slowly. Clean/repair for improved function. **(Basement Electrical Room)**

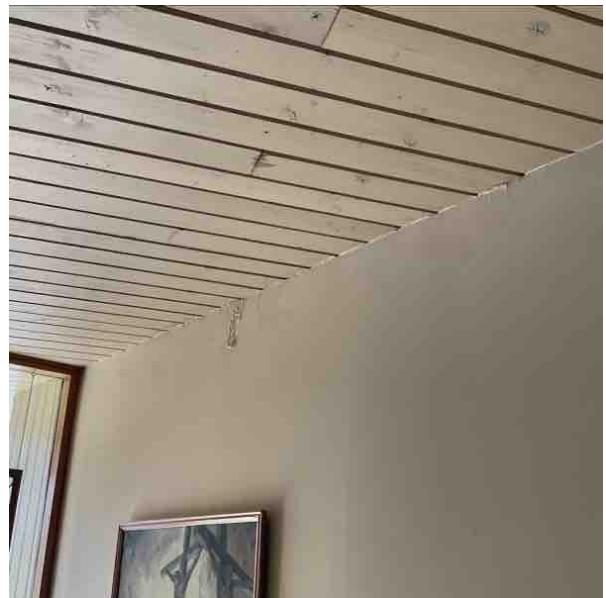
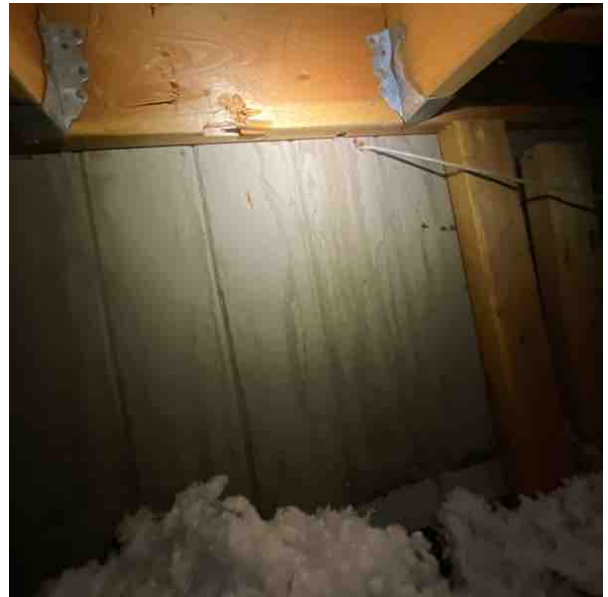
10.4.1 Evidence of past water entry at the east entrance/foyer. At this time there is no sign of current moisture on the wall or in the attic. **(Foyer)**

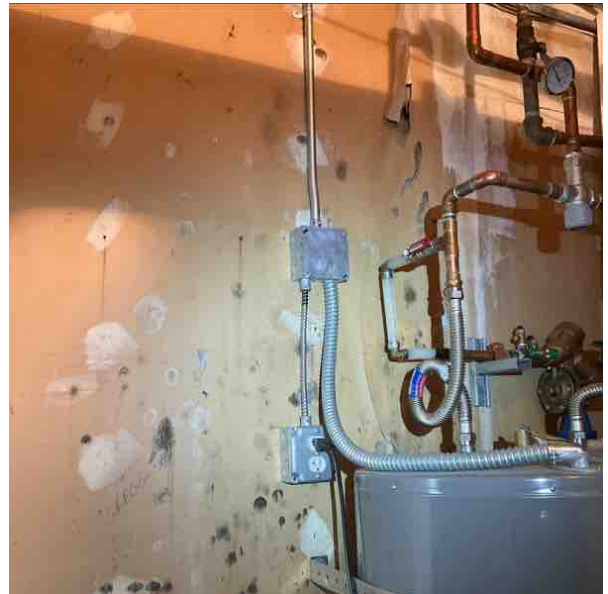
10.4.5 Interior walls show damage and show signs of past water entry/mold and mildew. Repair recommended to promote health. **(HVAC room)**

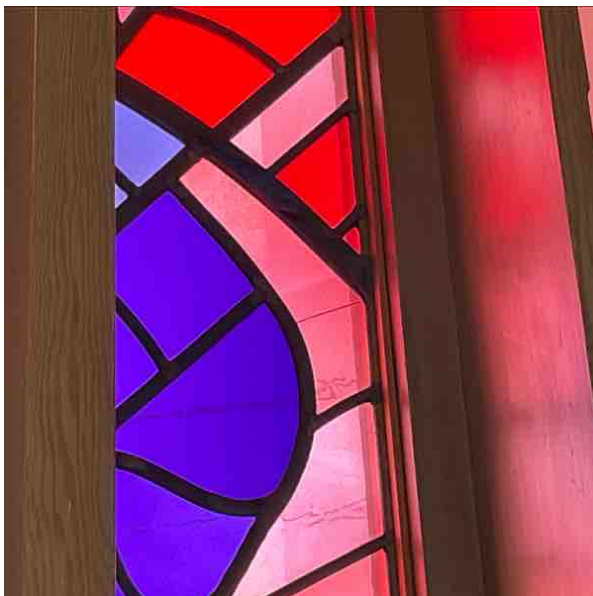
10.5.1 Minor crack/s at stained glass. Monitor/repair as desired. **(Sanctuary)**

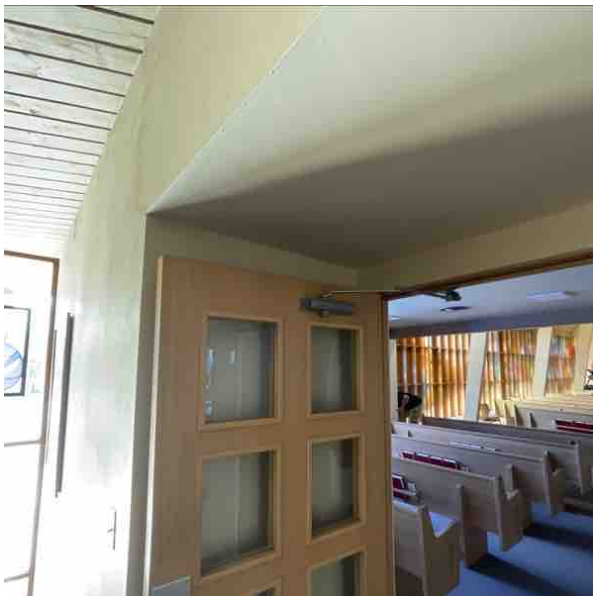
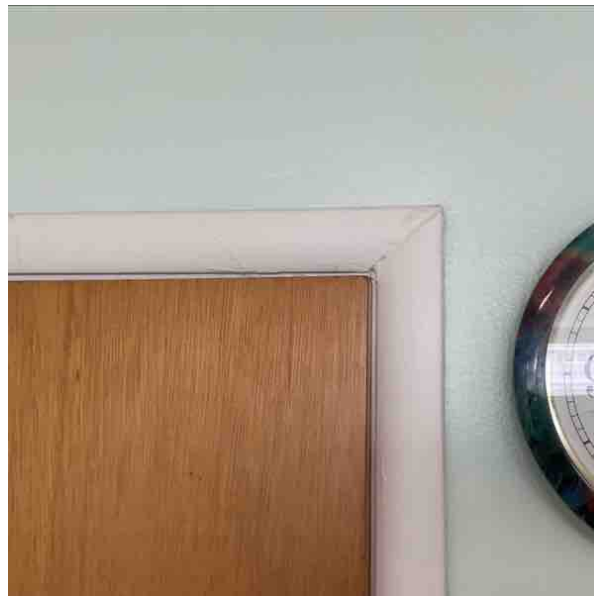
- Basement room 1
- Basement room 5-6
- Copy Room
- Meeting 3
- Sanctuary
- Sanctuary front storage rm.

10.6.1 Repair or adjust door hardware for intended function.
