Inspection reference: 3028

GENERAL INFORMATION

41649 W. Sesame Street.
Maricopa AZ 85138.

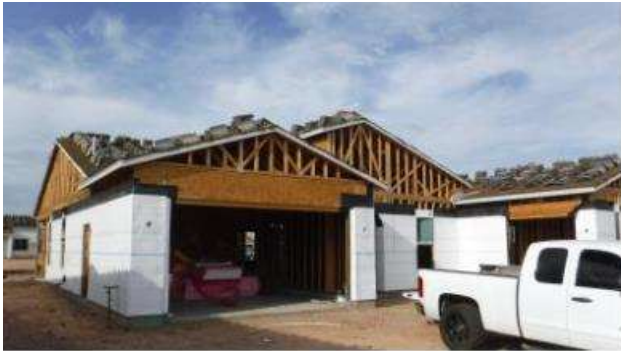
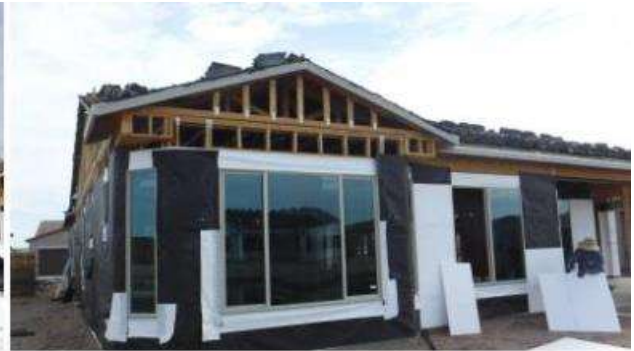
1. Incomplete lath installations noted at multiple locations.
2. Gaps, separations at lath viewed at single garage windows.
3. Incomplete / uneven tape and sealing of lath seams; near north window.

LATH INSTALLATIONS IN PROGRESS.

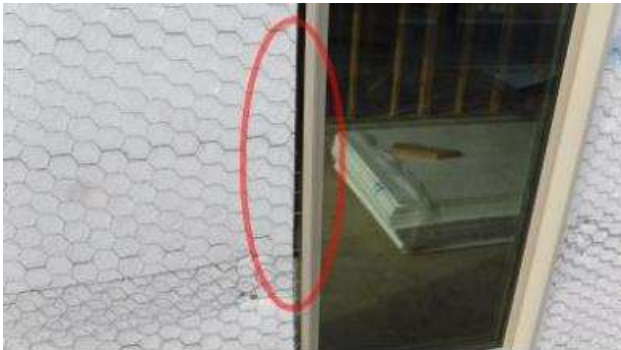
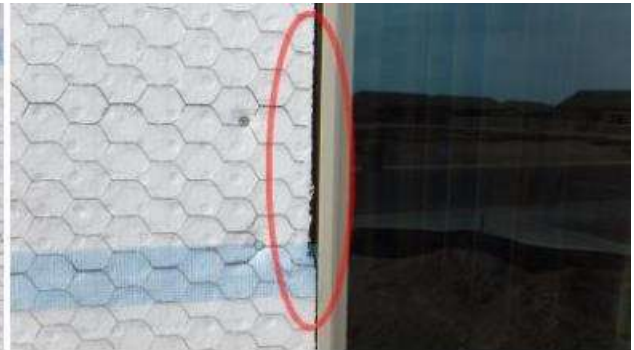
GAPS IN LATH AT WINDOWS.

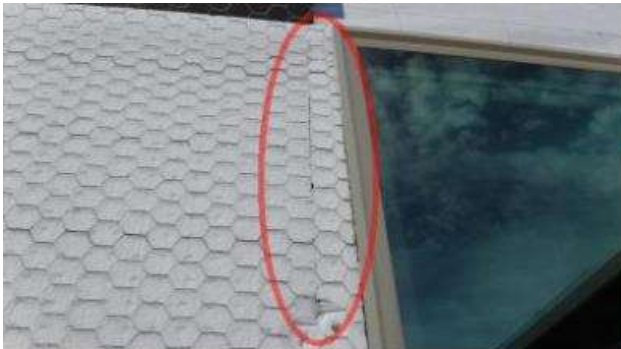
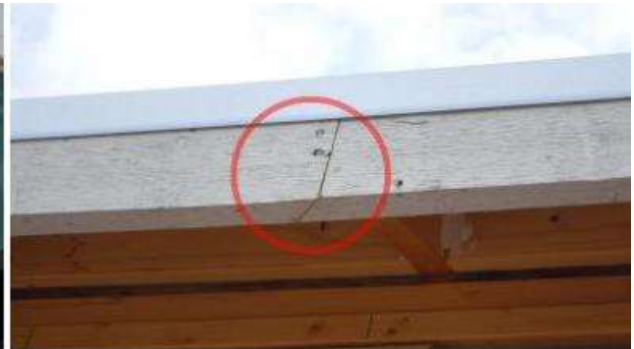
4. Missing fascia clips; south.
5. Form board needs removed at northeast foundation.
6. Chips in foundation, slab surfaces noted at; garage, north, entry, single garage, patio, east, interior.

LATH SEAM NOT TAPED-SEALED / MISSING FASCIA CLIP.

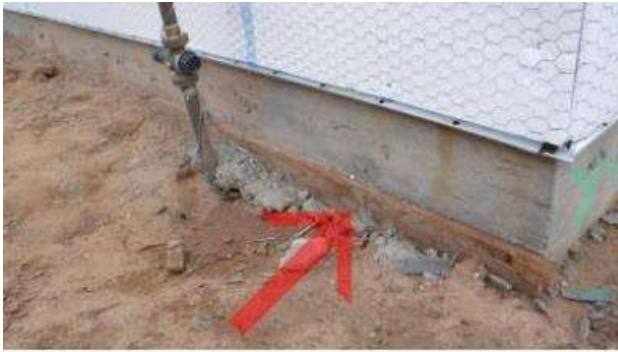
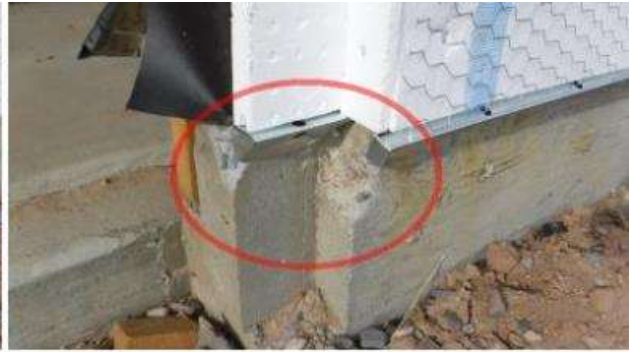
NEED TO REMOVE FORM BOARD / CHIPS IN FOUNDATION.

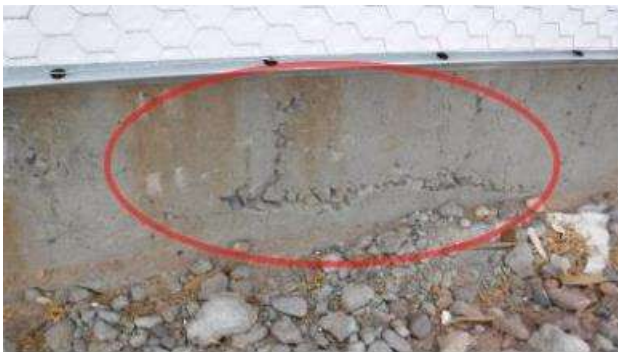
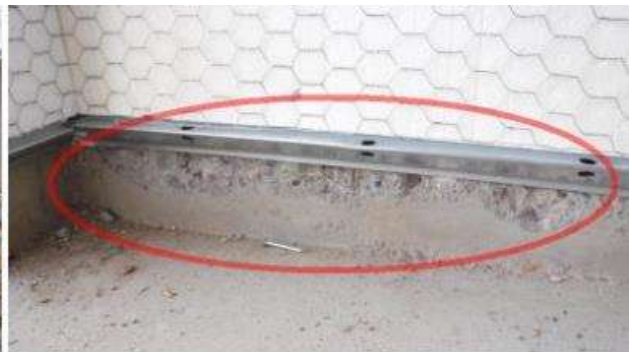
ROUGH SURFACES AND CHIPS AT FOUNDATION.

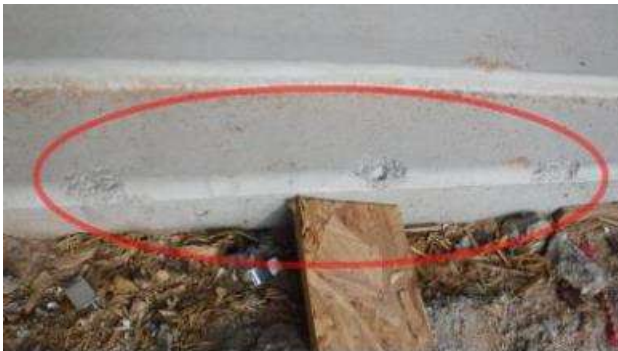
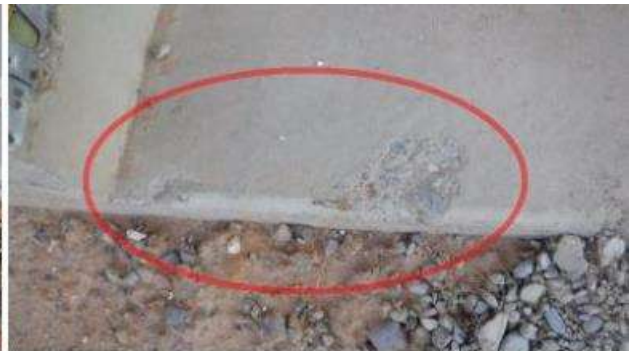
CHIPS IN SLAB.

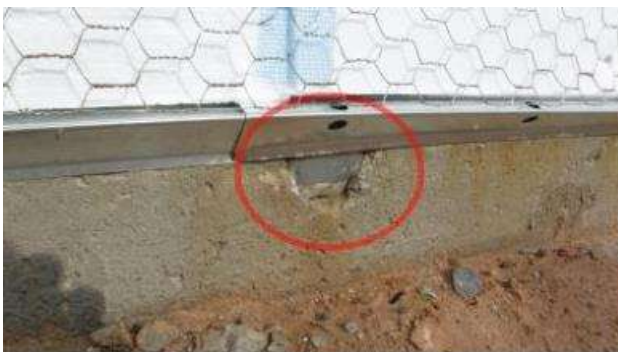
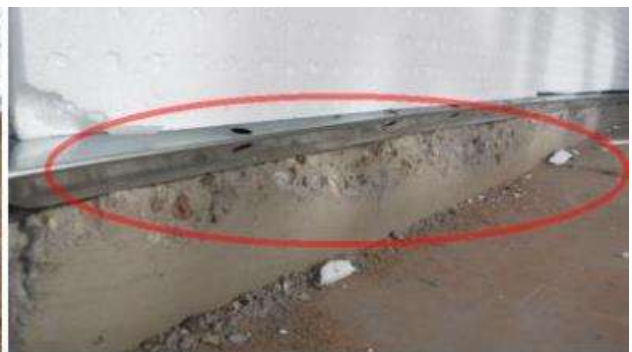
CHIPS IN FOUNDATION.

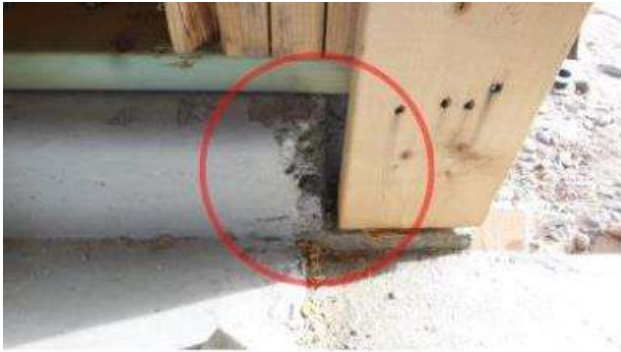
CHIPS IN FOUNDATION AND SLAB.

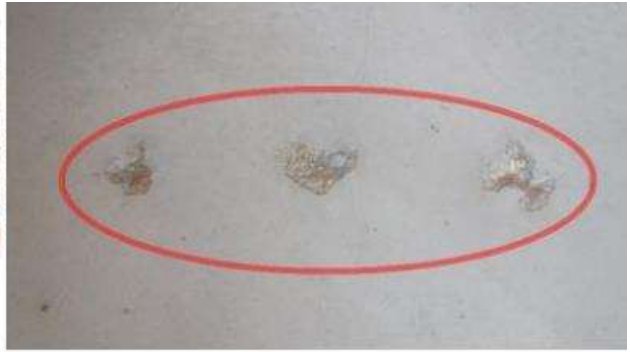
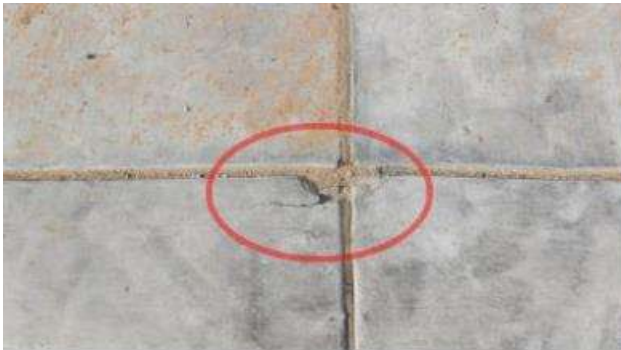
7. Sills / exterior walls not sealed.
8. No upper roof / attic vent provided over single garage; vents should be half upper / half lower.
9. Cracks, damaged concrete viewed at front curb.

CRACKED-CHIPPED CURB / CONSTRUCTION DEBRIS.

12. All trash / debris should be removed from home and site on a routine basis.
13. Recommend gutters and downspouts be installed at time of final to help with site drainage.

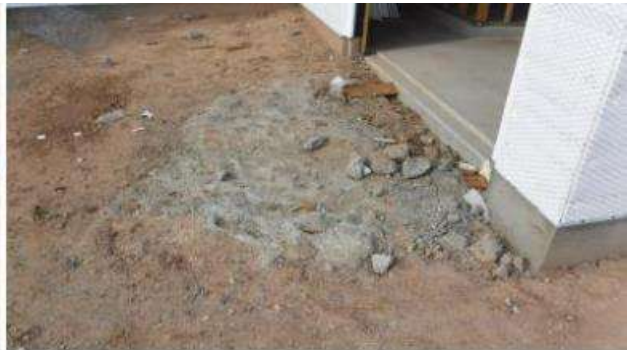
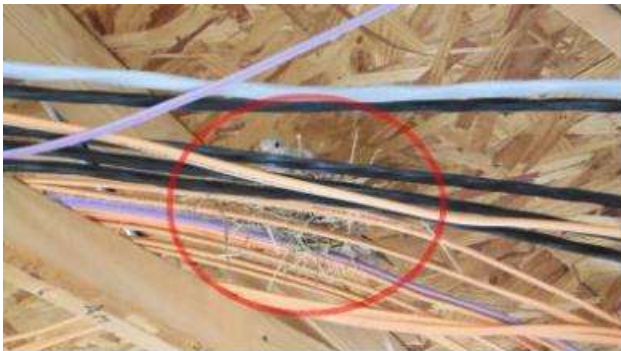
10. Missing / incomplete flashing (storm collar) and caps viewed at water heater B-vent and dryer vent.
11. Bird nest and droppings noted; single garage, north guest.

BIRD NEST AT DROPPINGS IN HOME.

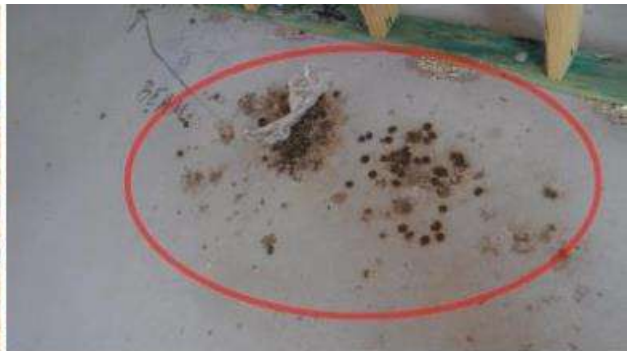
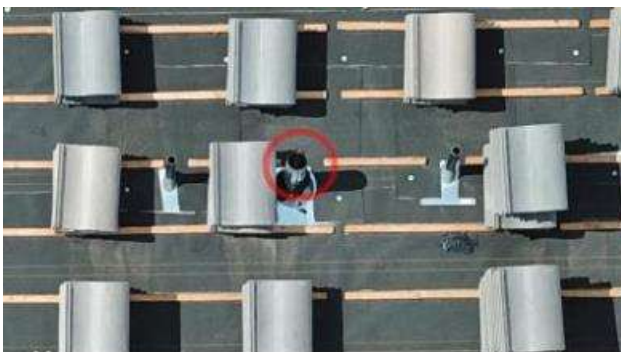
MISSING VENT CAPS AND STORM COLLARS.

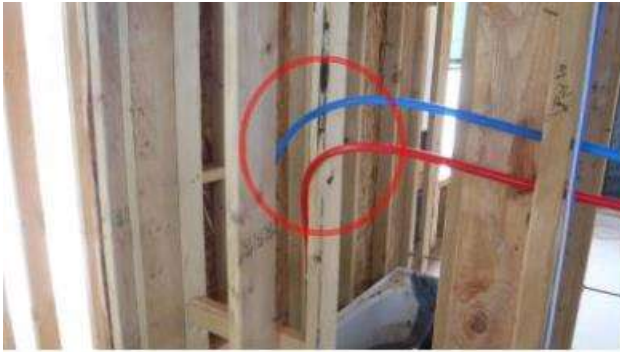
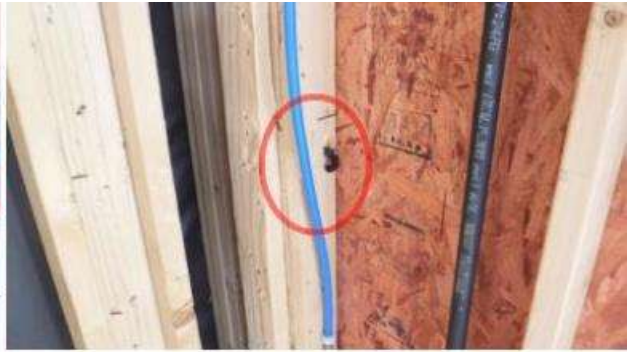
1. Pex type plumbing lines installed. Lines not fully secured; hall bathroom tub, den southeast hose faucet.
2. Incomplete securing of washer box noted in the laundry room.
3. Supply and return air registers may be located too close together in the master bedroom; may allow conditioned air to "short-cycle" back to system.
4. Insufficient rise / improper slope at DWV pipe above shower in the master bathroom; vent pipe should have minimum 1/4" per foot rise.
5. Vertical dryer vent noted; recommend cleaning every 6 to 12 months.

PLUMBING LINES NEED SECURING.

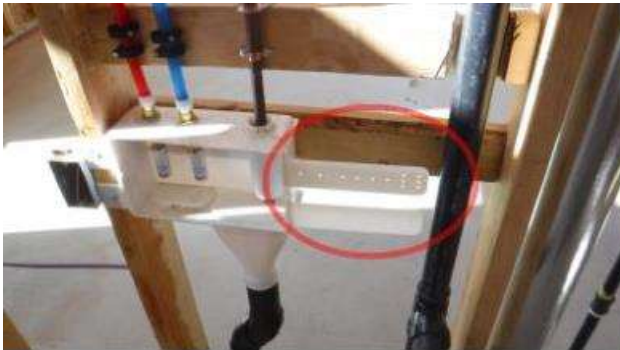
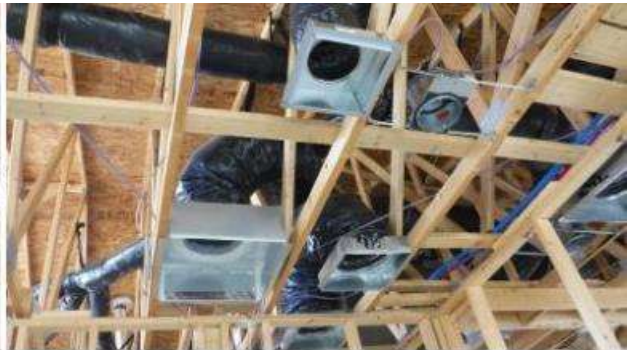
LAUNDRY BOX NOT FULLY SECURED / SUPPLY AND RETURNS CLOSE TOGETHER.

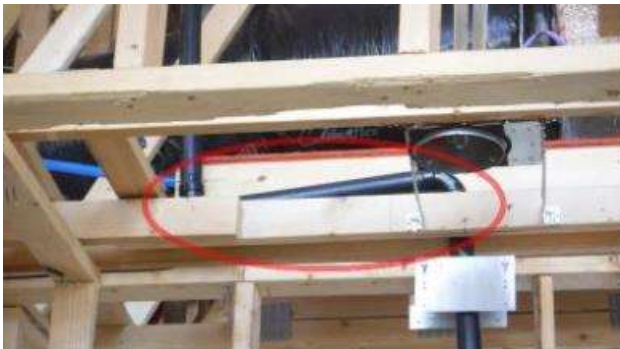
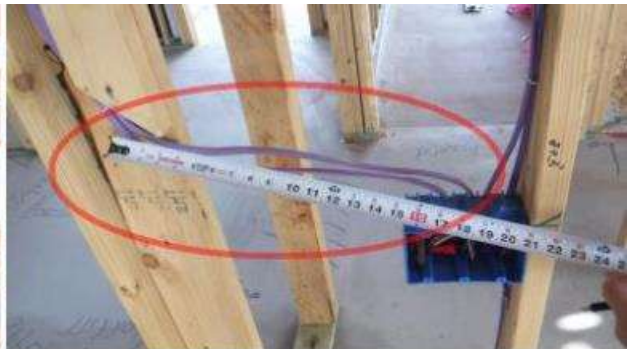
1. Wires not stapled / secured within 12" of boxes / fixtures; family room north, guest bathroom south.
2. No 120 volt outlet provided for gas dryer hook-up in the laundry room.
3. No 120 volt wiring provided to network panel outlet.
4. Uneven can lights noted above wetbar.

IMPROPER RISE AT VENT PIPE / WIRES NOT SECURED WITHIN 12"

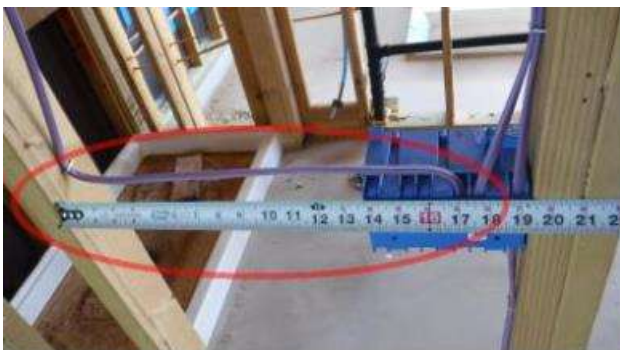
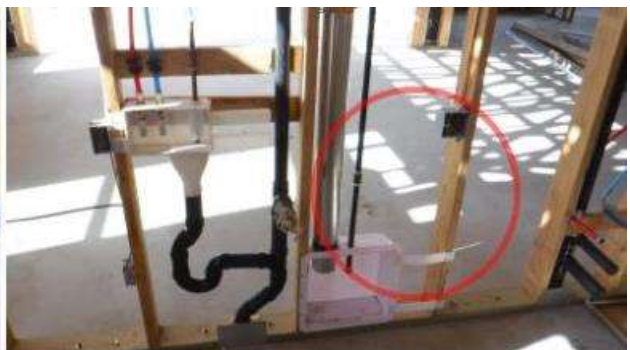
WIRES NOT SECURED WITHIN 12" / NO GAS DRYER 120.

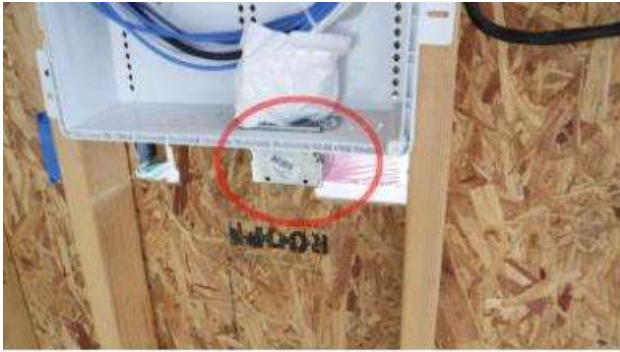
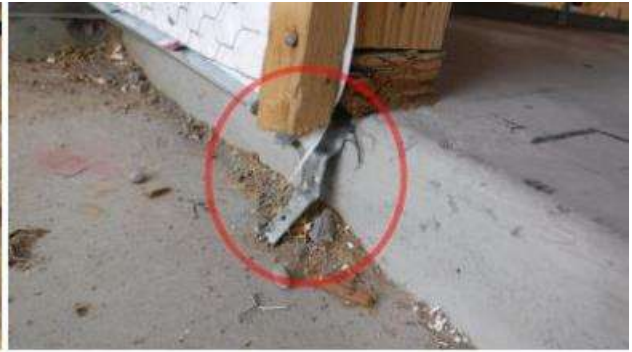
16. Damaged / loose framing strap at slab viewed at entry door.
17. Separations at beam / column framing viewed at patio southeast.
18. Split sole plates noted; north guest west wall, guest bathroom northeast, pantry.

NO WIRING AT NETWORK PANEL OUTLET / LOOSE STRAP AT ENTRY.

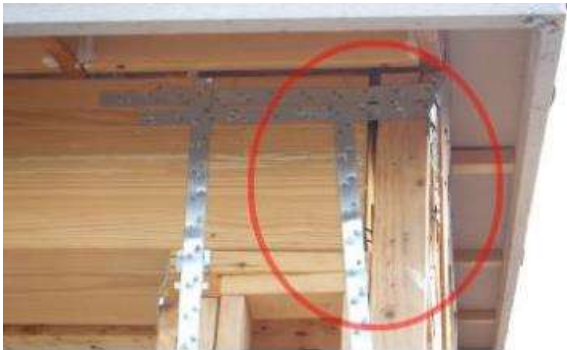
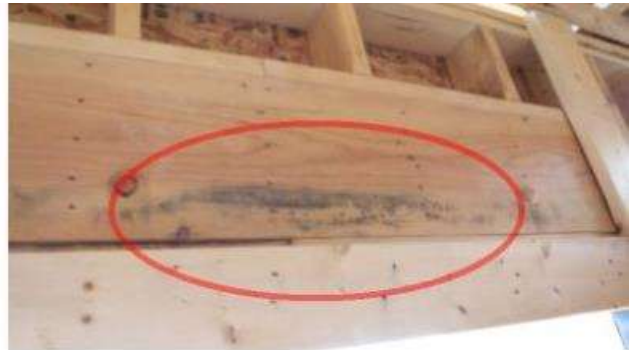
19. Stains / growth / possible mold at framing viewed at multiple locations; garage header, laundry west sill, northwest guest bedroom truss, northwest guest north sill, master bedroom southeast and east sills, master bathroom and master closet sills.

SEPARATIONS AT PATIO BEAM / POSSIBLE MOLD AT GARAGE HEADER.

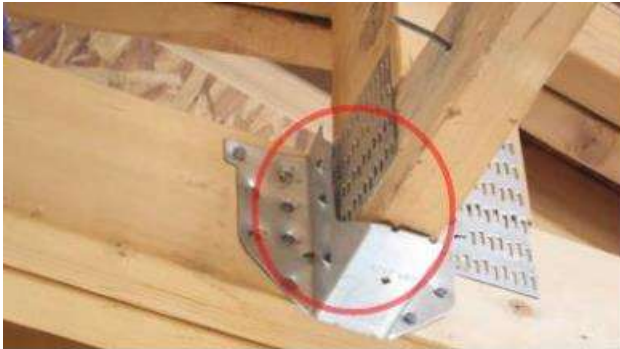
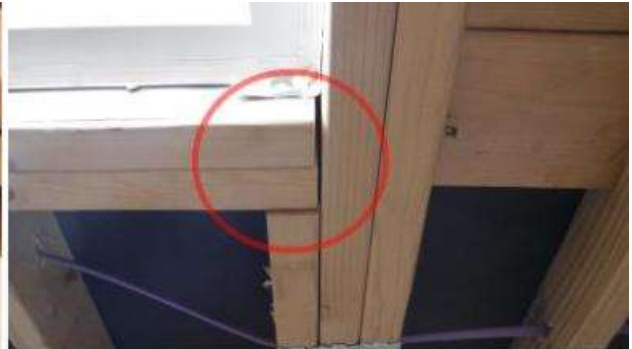
1. Separations, uneven framing connections at headers / studs / sills at window framing noted; north guest, master bedroom, den, dining room, family room.

7. Incomplete securing of truss strap; garage southeast.
8. Framing not square at arches; entry to west hall and to laundry / mudroom.
9. Framing not square at doors; service door, north guest, hall bathroom, guest bathroom, den, patio.

TRUSS NOT SECURED IN STRAP / SEPARATIONS AT WINDOW FRAMING.

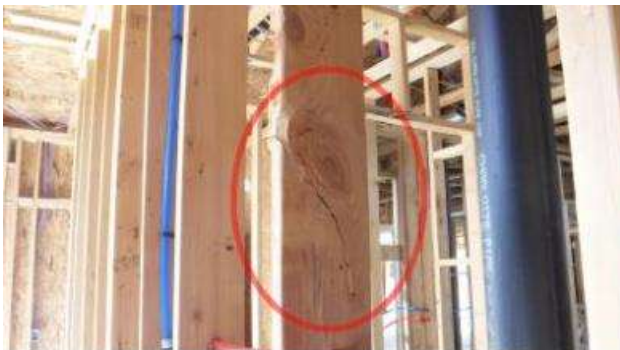
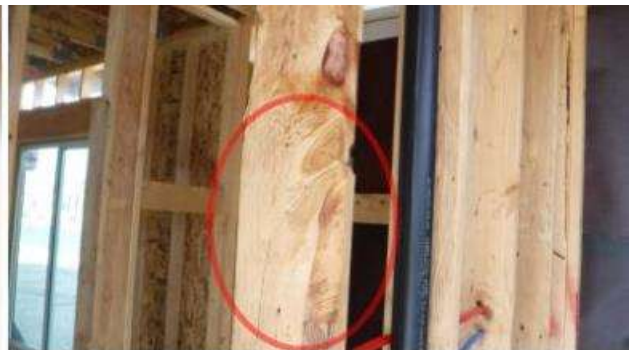
14. Cracked / damaged stud viewed between guest bathroom and single garage (2x6 at bearing wall).
15. No end bearing of trusses, uneven framing will result in uneven ceiling finish; hall bathroom, northwest guest.

CRACKED WALL STUD.

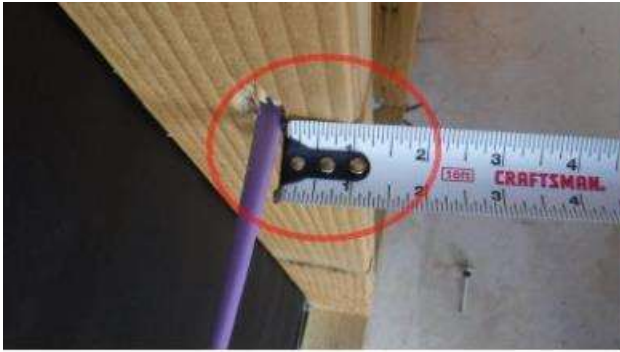
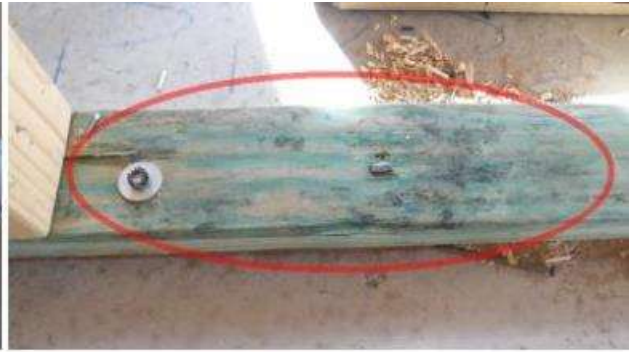
4. Missing nail protection for wiring / plumbing; north guest east wall, master bathroom west at DWV pipe.
5. Uneven reveals, framing not square at windows noted; northwest guest, master bedroom, dining room, family room.

MISSING NAIL PROTECTION / POSSIBLE MOLD AT SILL.

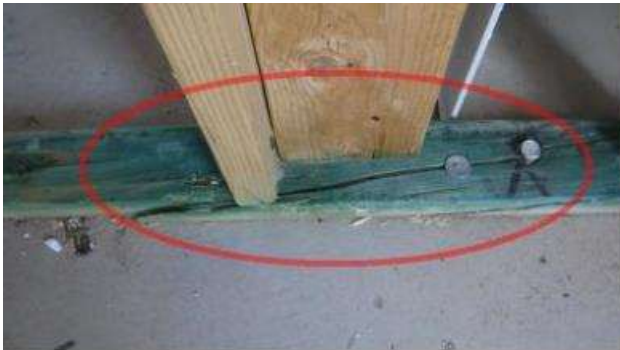
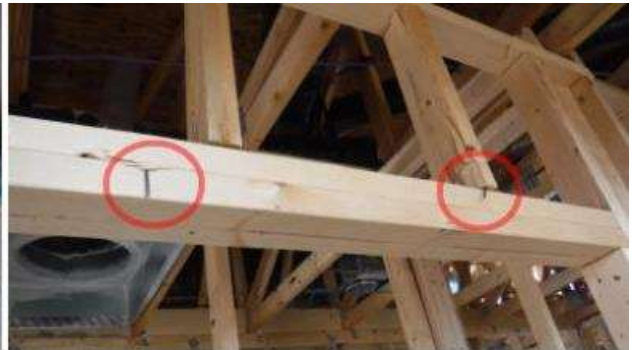
6. Exposed nails / shiners at framing; north guest closet, hall bathroom door, northwest guest door, master bedroom southeast, master bedroom west ceiling, master bathroom arch, master closet south, master bathroom west top plate, family room southeast.

SPLIT SILL PLATE / SHINERS AT CLOSET.

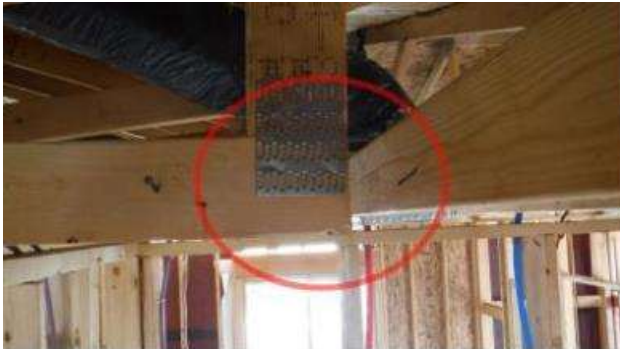
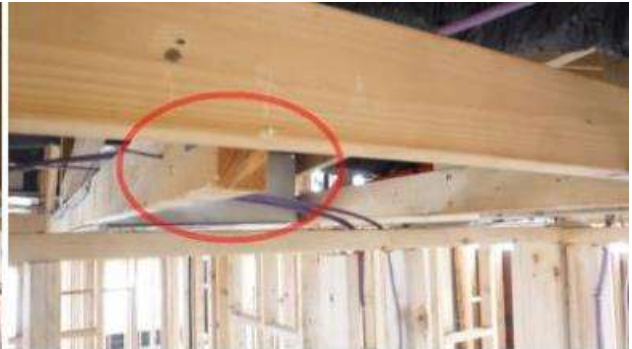
NO END BEARING-UNEVEN CEILING FRAMING.

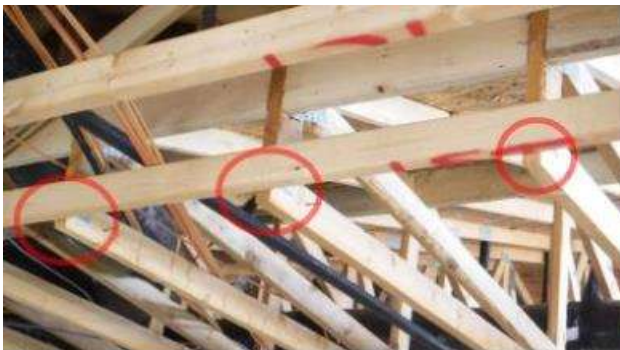
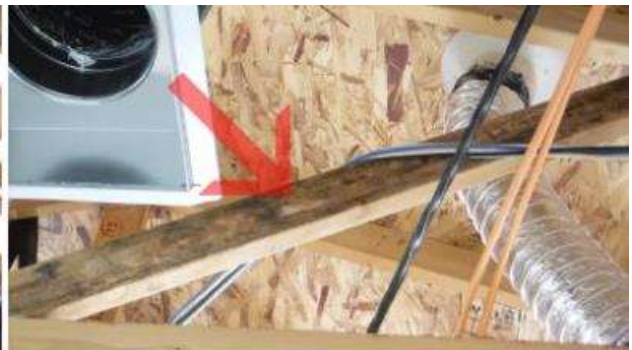
NO END BEARING-UNEVEN CEILING FRAMING / POSSIBLE MOLD AT TRUSS.

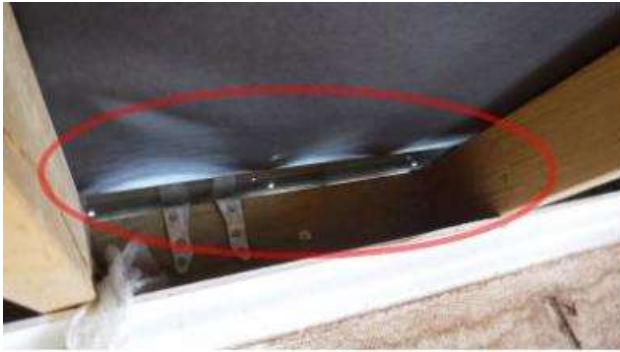
SILLS NOT SEALED / POSSIBLE MOLD AT SILLS.

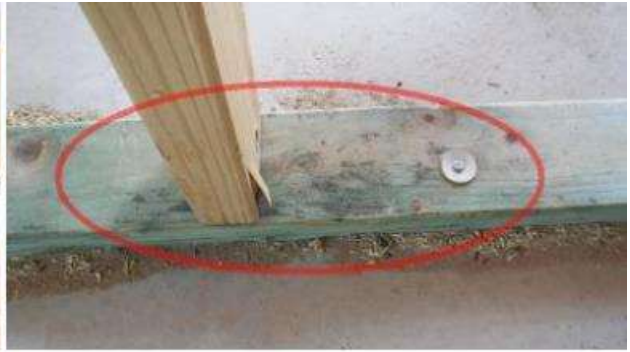
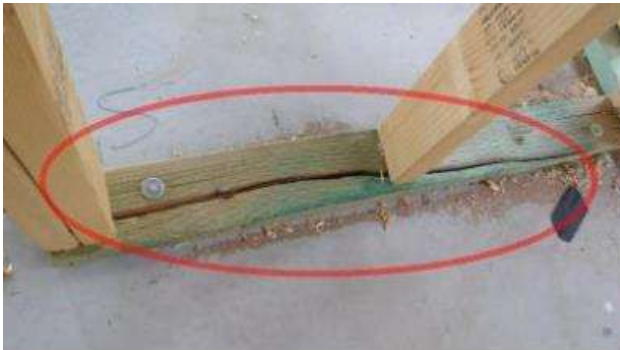
SPLIT SILL PLATE / SEPARATIONS AT WINDOW FRAMING.

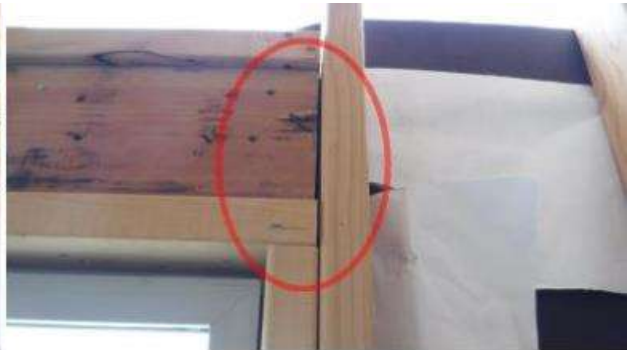
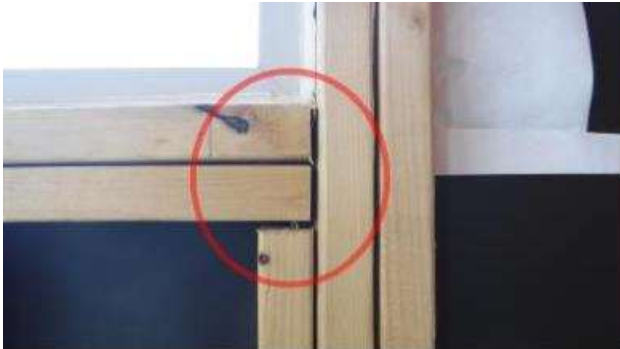
SEPARATIONS AND UNEVEN WINDOW FRAMING.

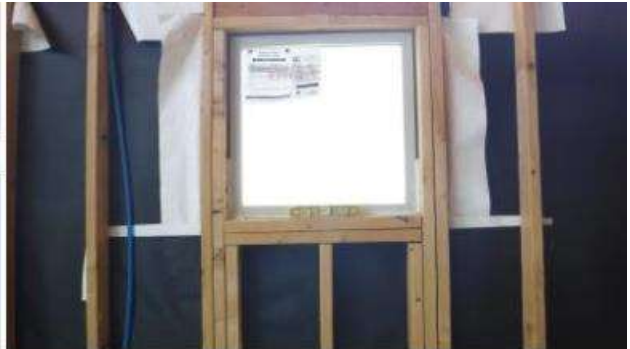
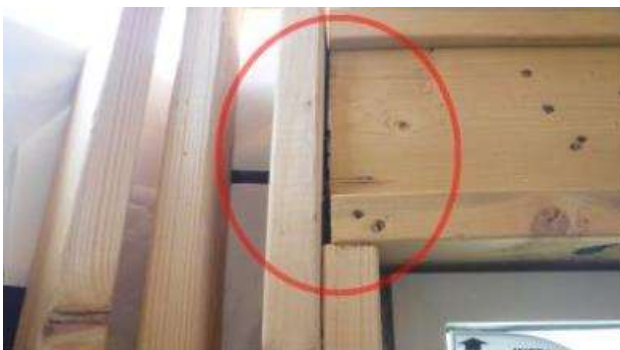
SEPARATIONS AT WINDOW FRAMING.

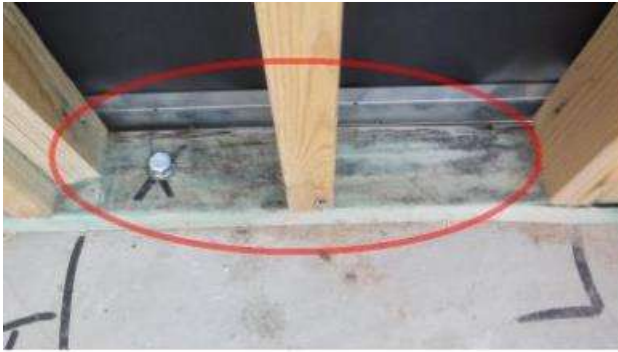
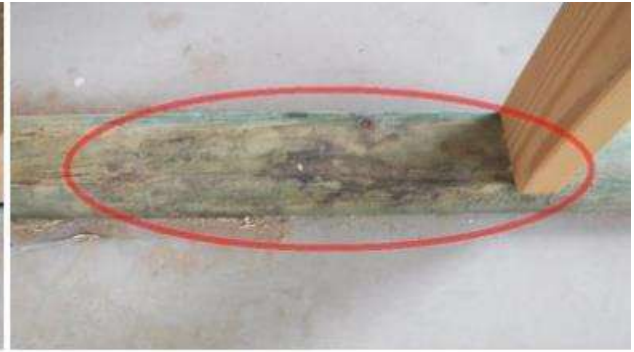
POSSIBLE MOLD AT SILLS.

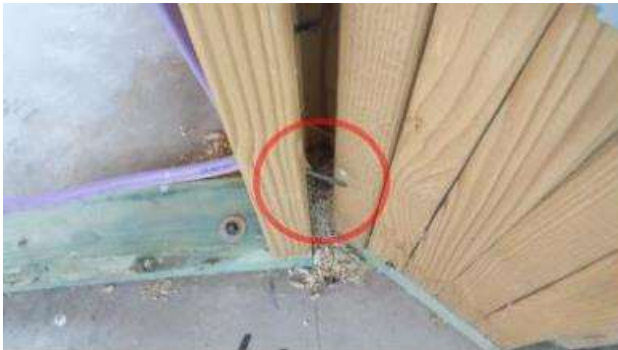
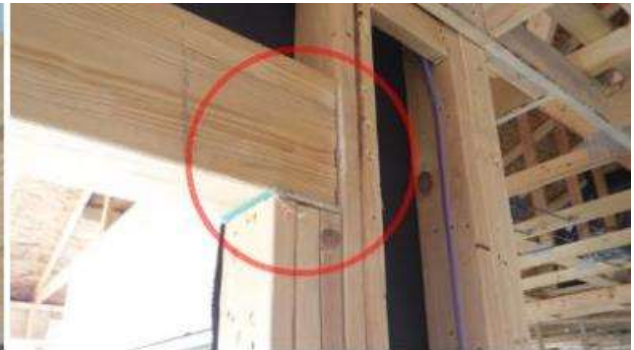
12. Loose spacers between trusses noted at multiple locations; should be removed to prevent falling and damage to materials below.
13. Separations / uneven framing viewed at patio door.

SHINERS AT WALL FRAMING / SEPARATIONS-UNEVEN FRAMING AT PATIO DOOR.

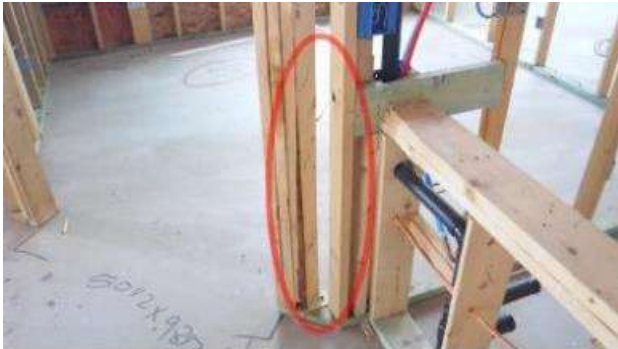
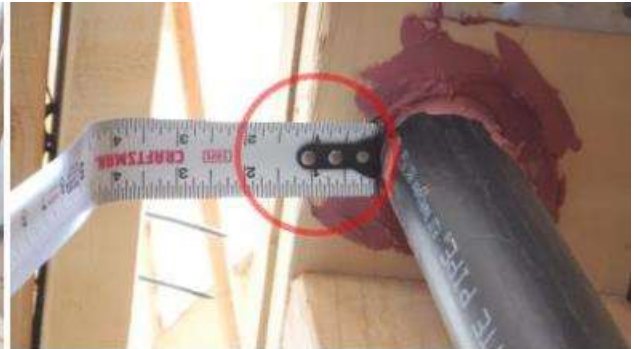
10. Drywall protection blocking recommended at 45 degree corners; sides of den entrance.
11. Separations, framing not square / plumb at tray ceilings; family room, kitchen.

NO BLOCKING AT 45 DEGREE CORNERS / NO NAIL PROTECTION.

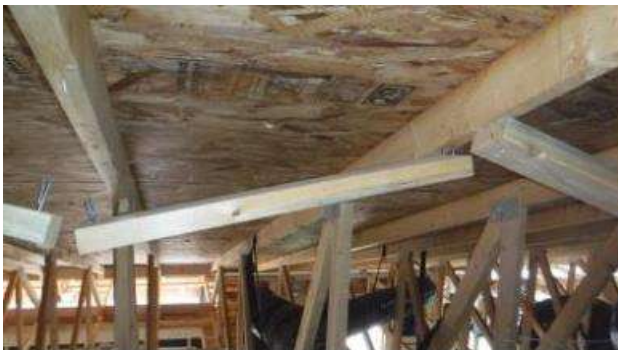
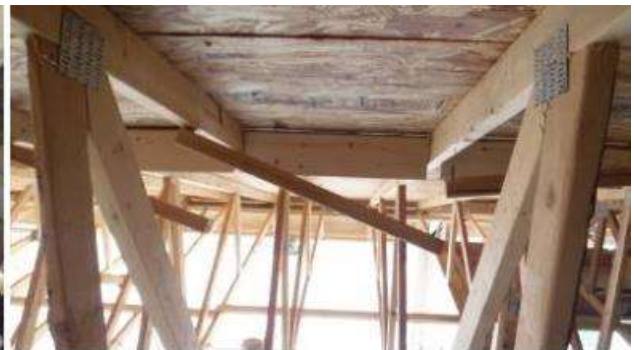
LOOSE TRUSS SPACERS IN ATTIC.

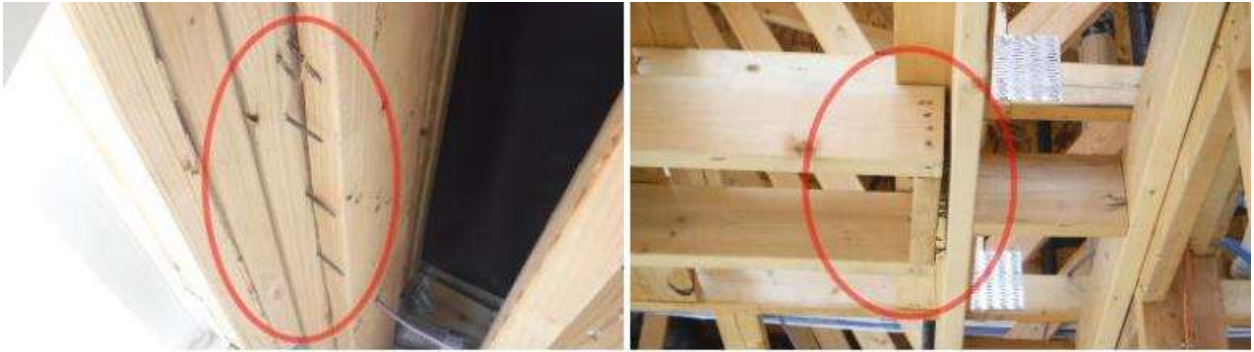
RSHINERS AT WALL FRAMING / SEPARATIONS AT TRAY CEILING.
