Inspection reference: 3187

Confidential Inspection Report

5324 S. Sesame Street

October 14, 2019

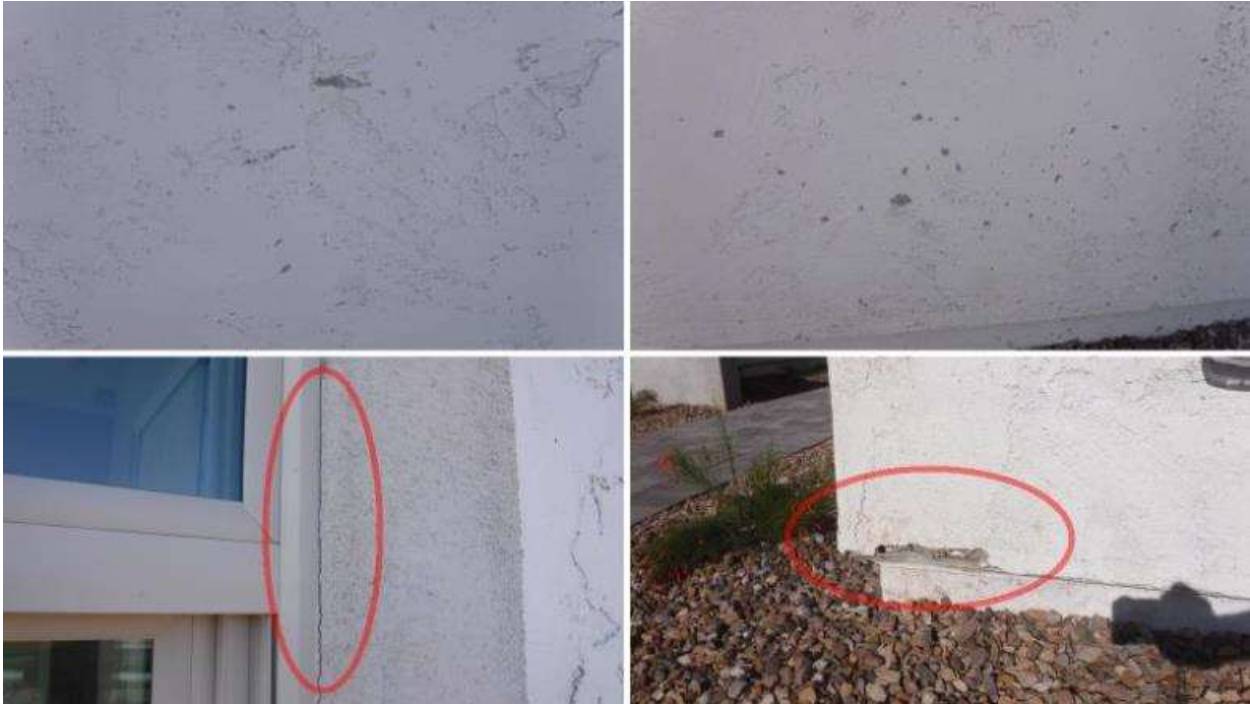
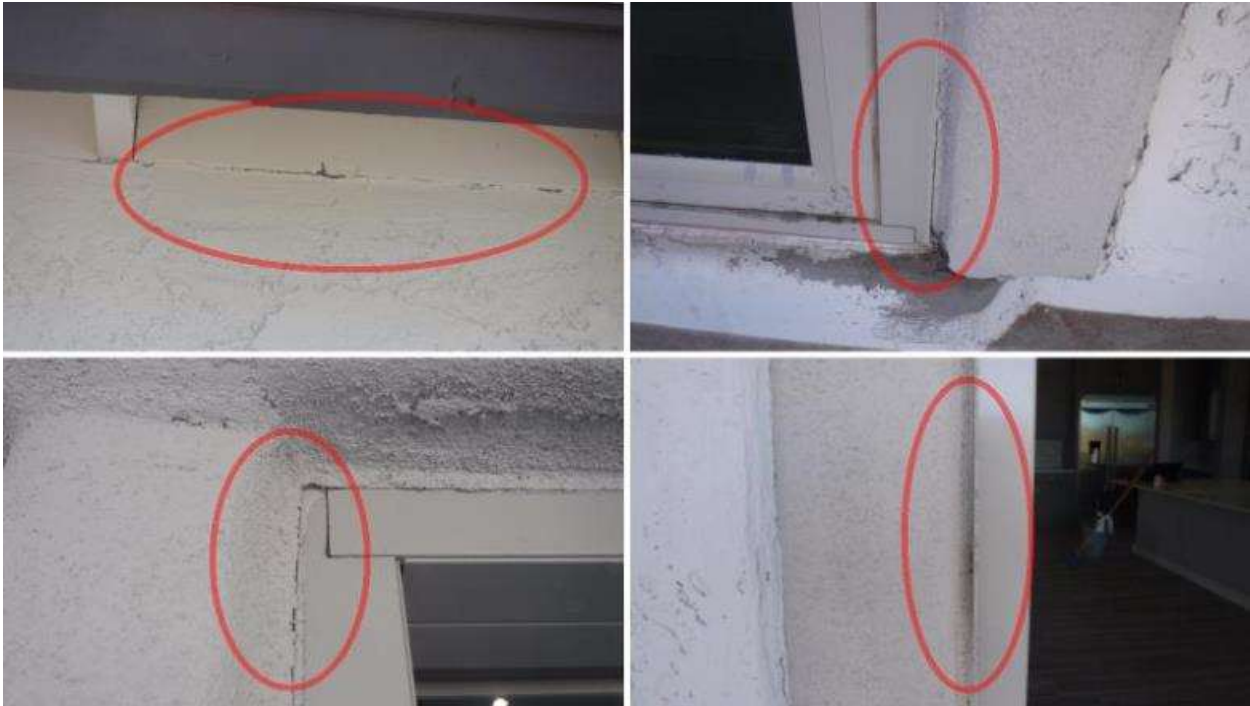
Walls are constructed with Frame construction. Stucco, Cracks noted are typical. Splatter viewed; north. Separations at stucco / wood connections. Separations at stucco / window connections. Flaking stucco and / or paint noted, damaged weep screed; east. Separations / uneven at stucco / sliding glass door connections.

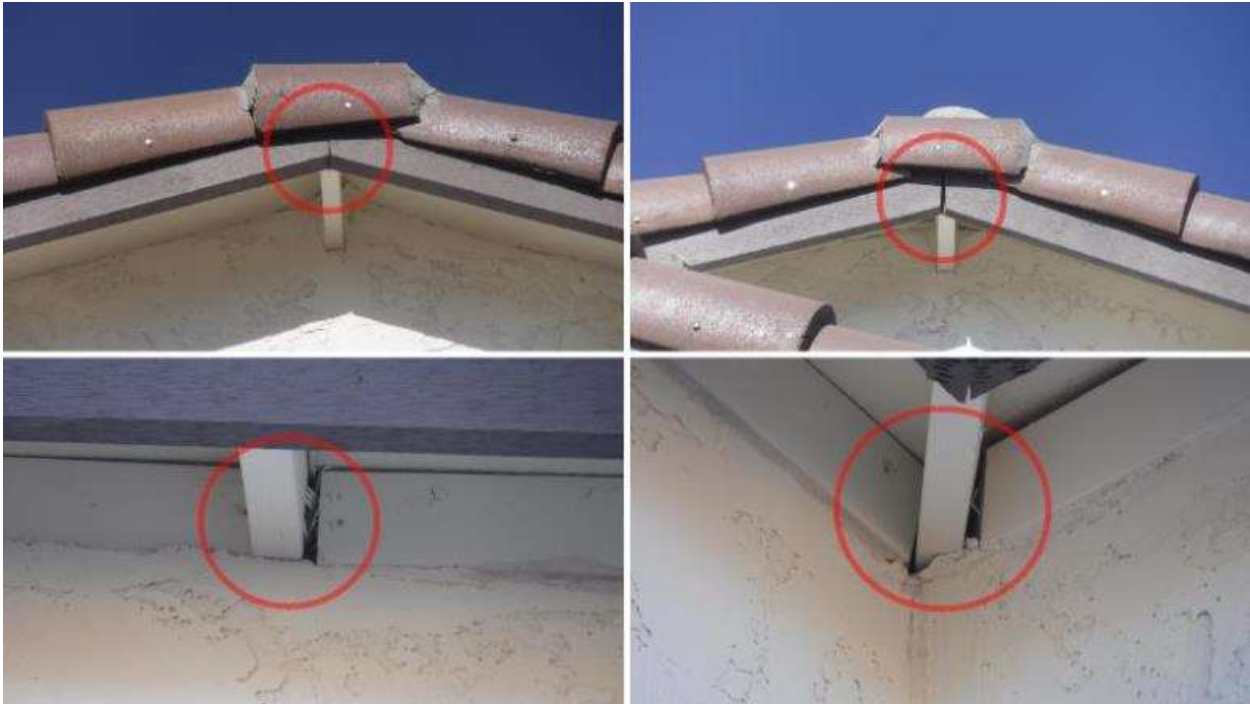
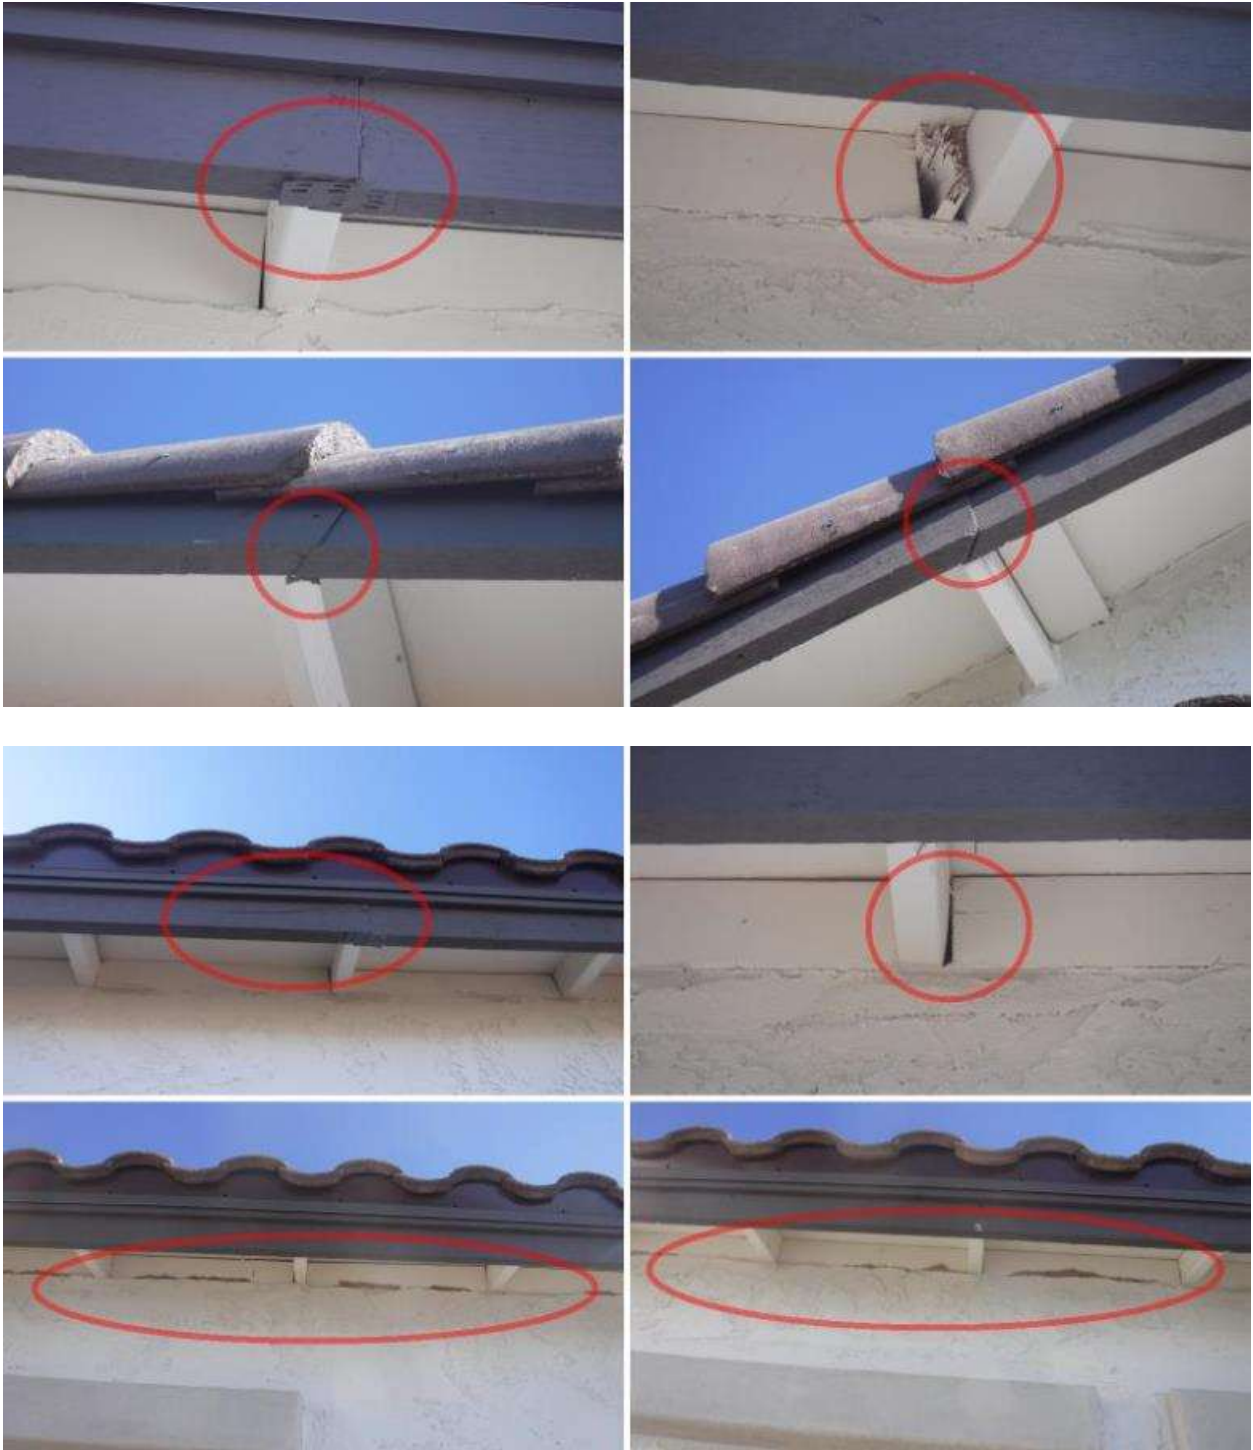
Wood materials. Vinyl materials. Separations at joints / seams / connections noted. Voids / separations at eaves may allow pest access. Missing fascia clip, east, south. Loose fascia clip; north. Damage viewed; south. Split fascia board; north.

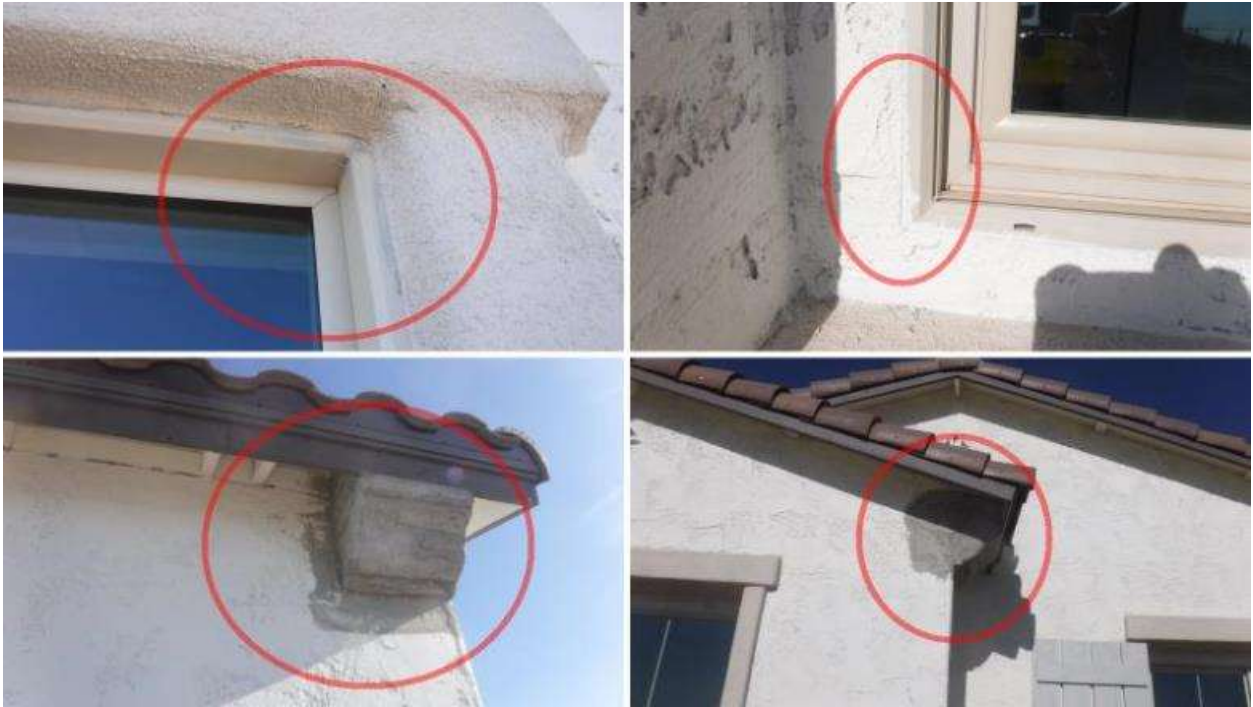
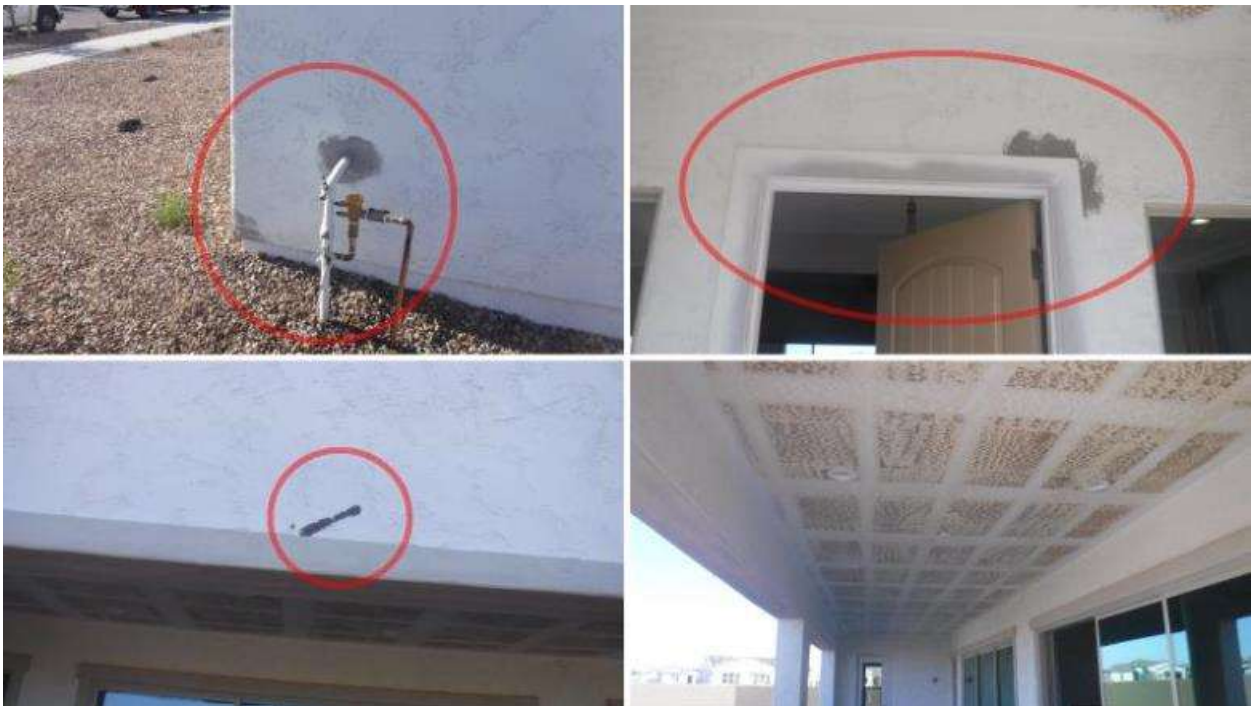
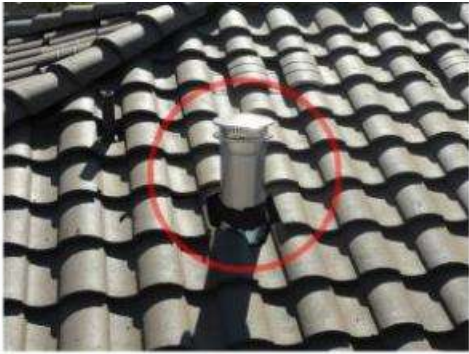
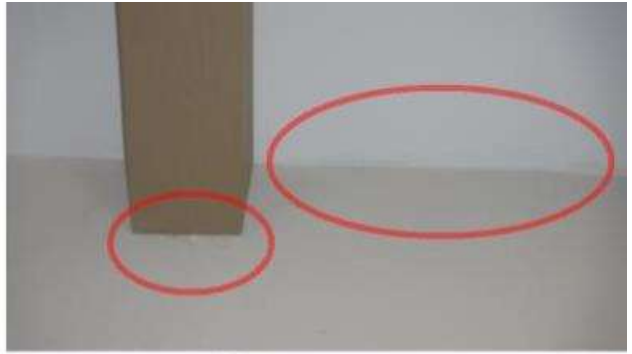
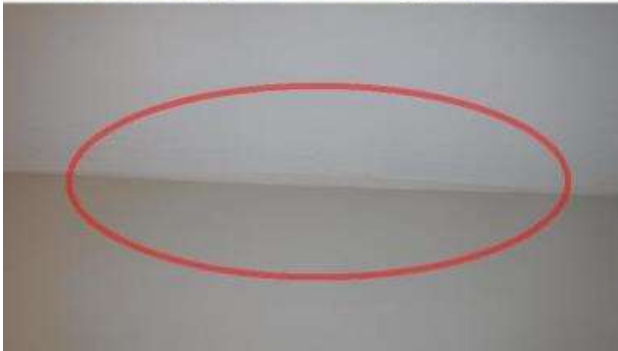
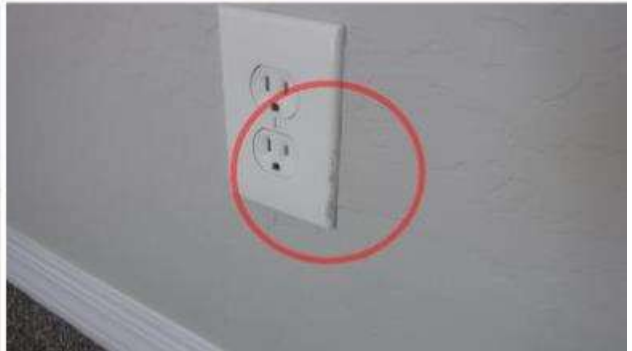
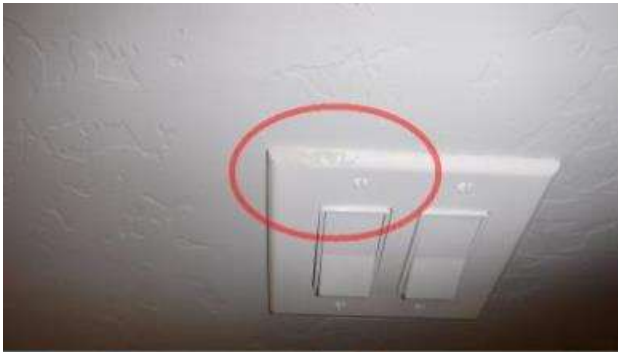
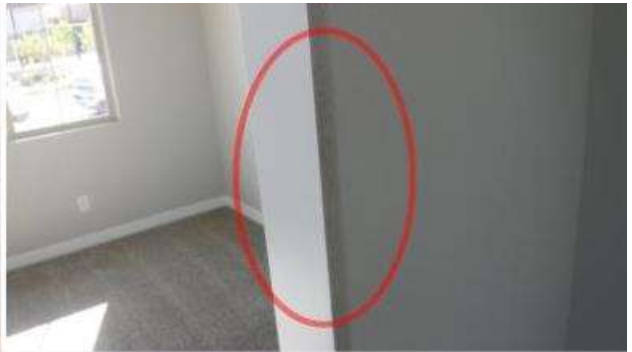
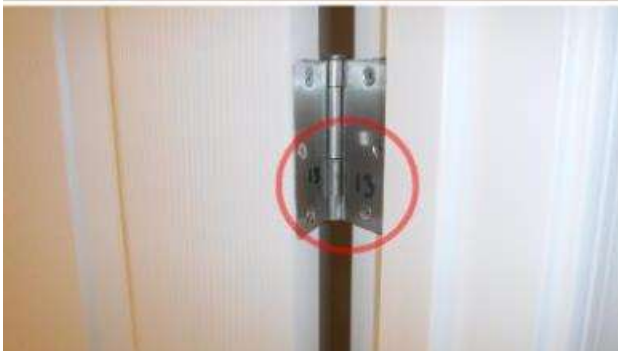
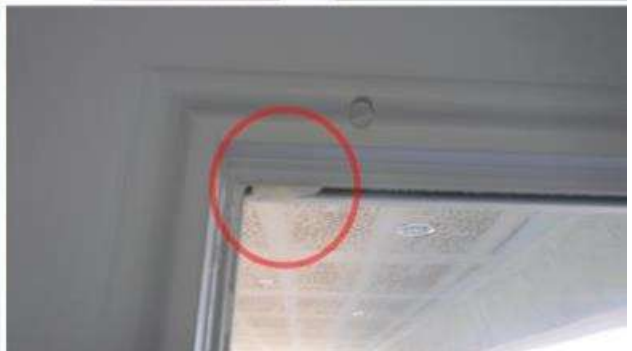
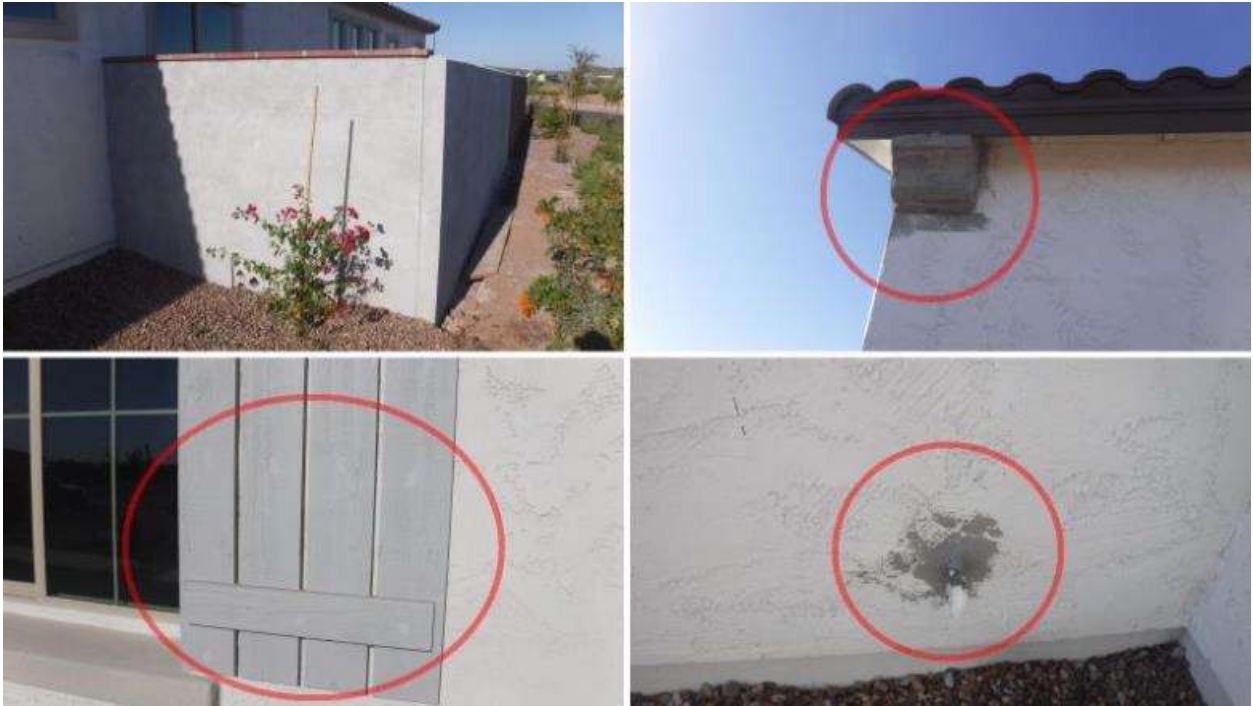
Incomplete / uneven paint noted; window frames, fence, multiple areas at exterior, entry bird blocking north, patio door frames, fire place flue, multiple areas at interior, family room wall east and west near beams, dining room ceiling, outlet / switch cover plates, inside closets at trim, door hinges, 1/2 bath ceiling, standard door glass master bedroom, patio and porch ceilings.

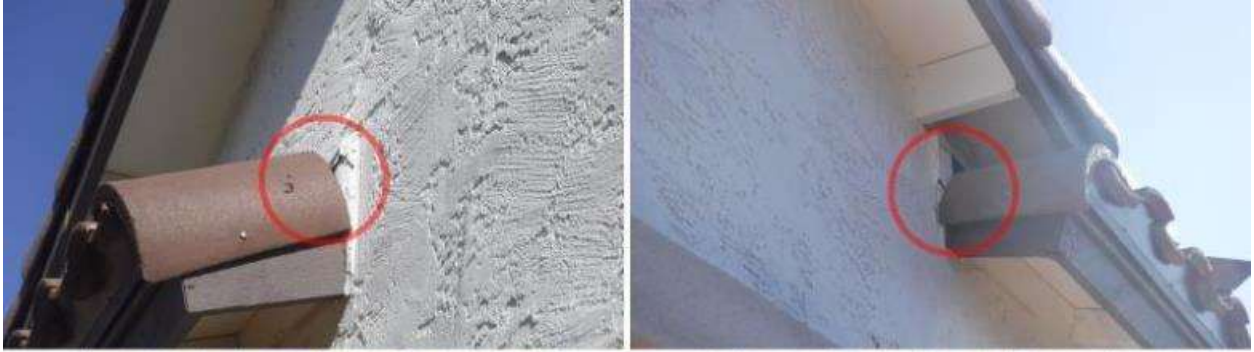
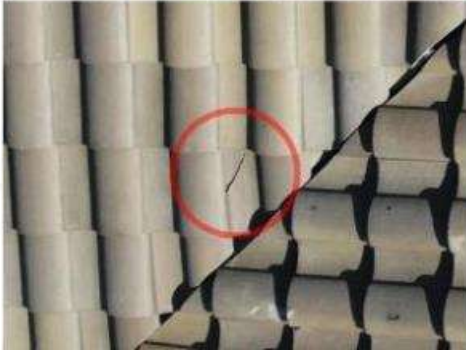
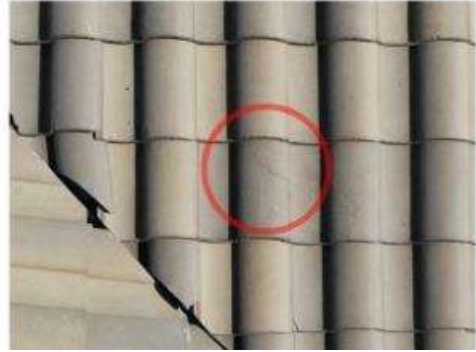
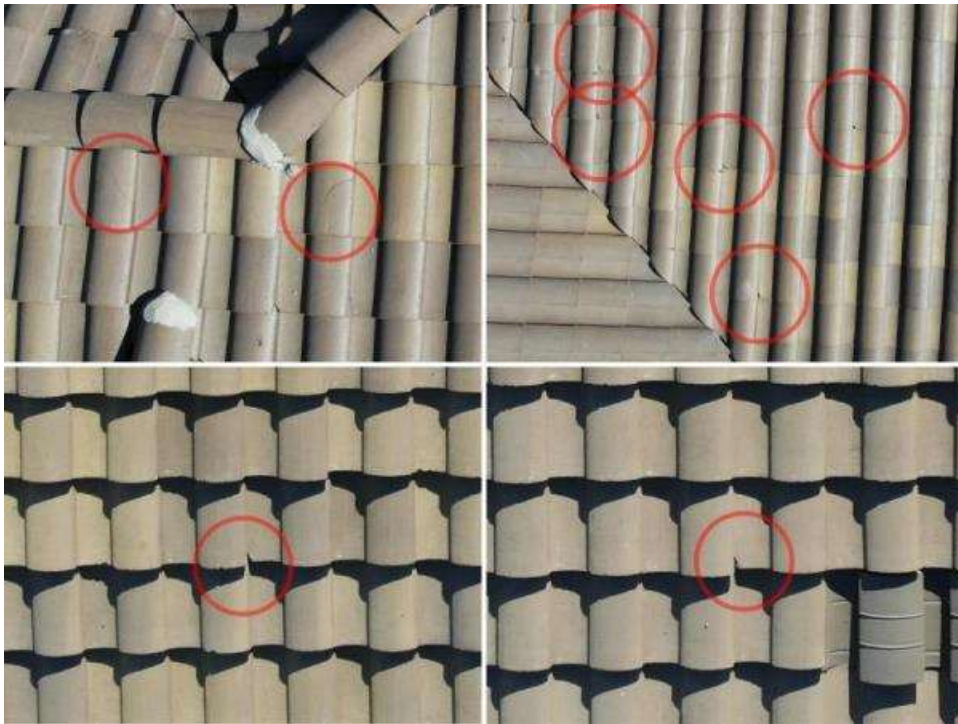
Roofing membrane under tiles is not visible and its condition cannot be determined without removal of roof tiles. Incomplete at mortar joints noted; south at rakes. A few cracked tiles were noted: 1 at south slope above northeast area, 2 at south slope, 1 at south slope near southwest valley. Cracked, chipped roof tiles should be repaired to protect underlying roofing materials. A licensed roofing contractor should be called in to make further evaluation and to repair or replace as needed.

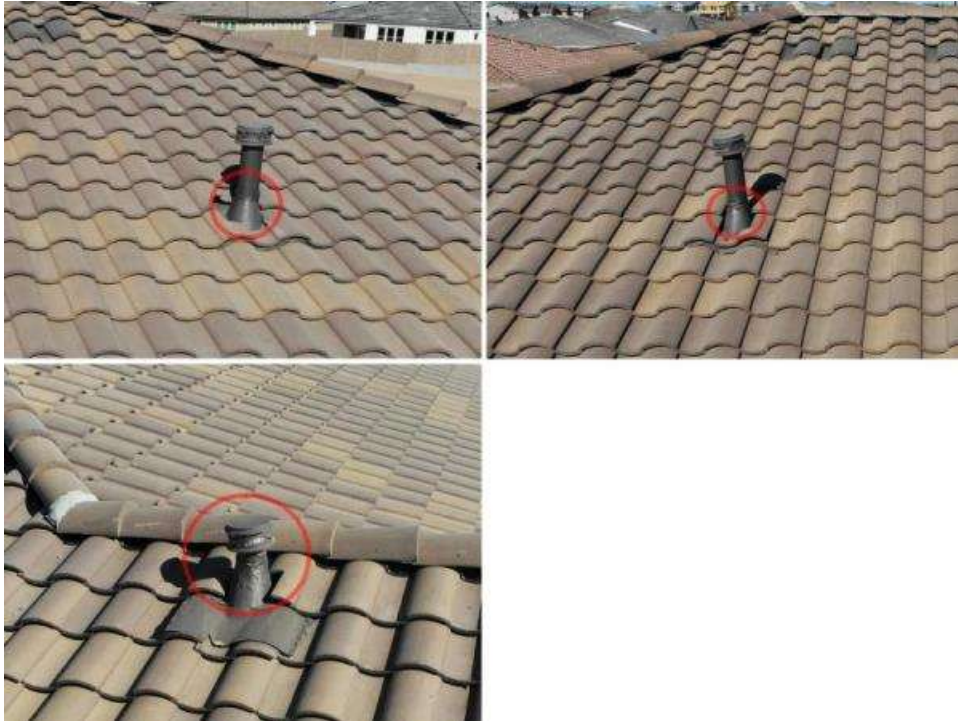
Metal, Storm Collar(s) are missing / none provided at B-vents. A licensed roofing contractor should be called to make further evaluation and repairs as needed.

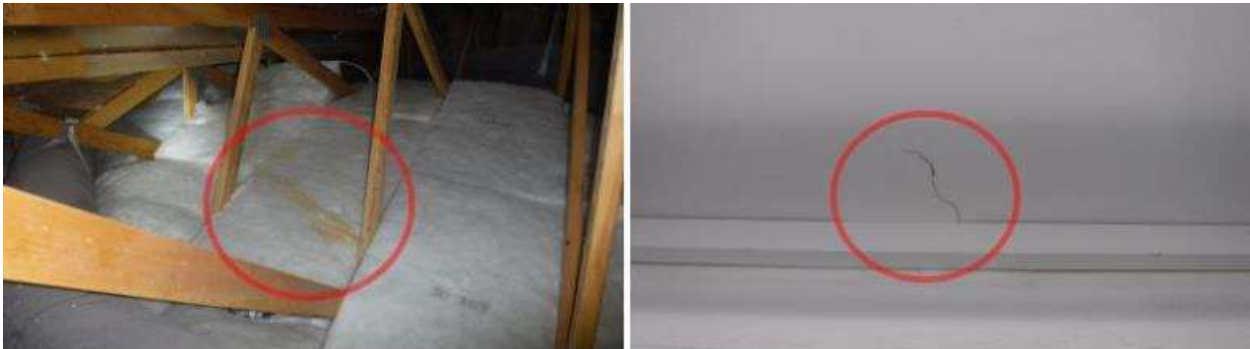
Attic is partial, Viewing was limited, due to space, insulation, ductwork etc. Moisture stains / discoloration is noted. Damaged scuttle lid viewed; garage access.

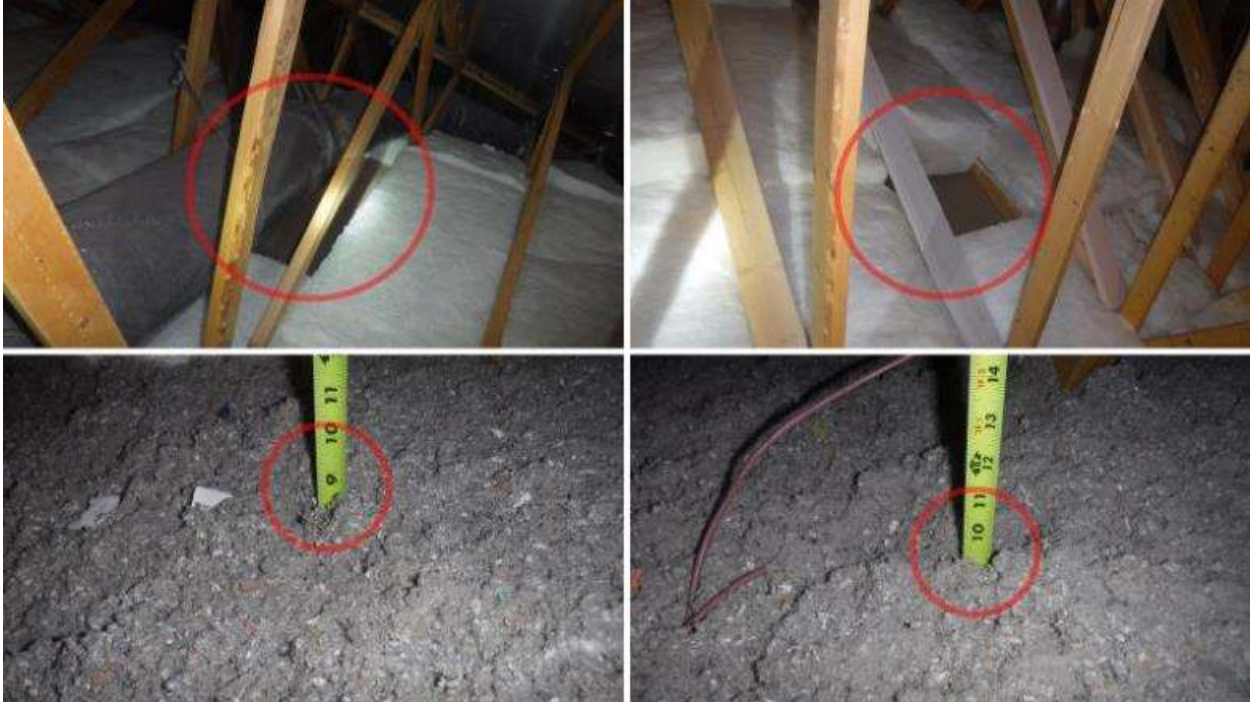
Tag indicating installed insulation depth is missing. Typically, cellulose blown insulation has a minimum settled thickness of 8.37 inches at R-30, 10.59 inches at R-38. Random / undisturbed areas of insulation measuring between 8.5 - 9 inches.

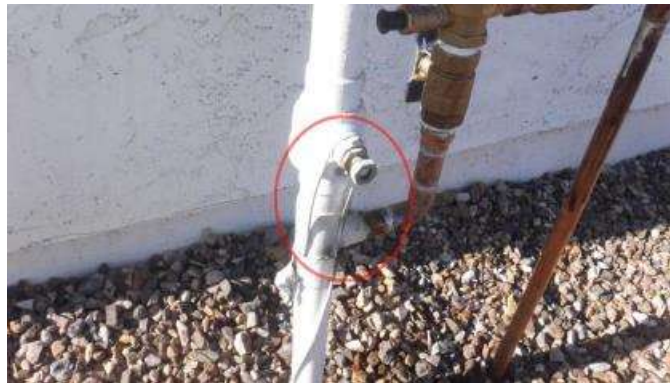
Main shutoff valve is located, at the north side of the house. Main Shutoff Valve, Valve is missing its handle. This could be a big problem in the event of a supply line leak.

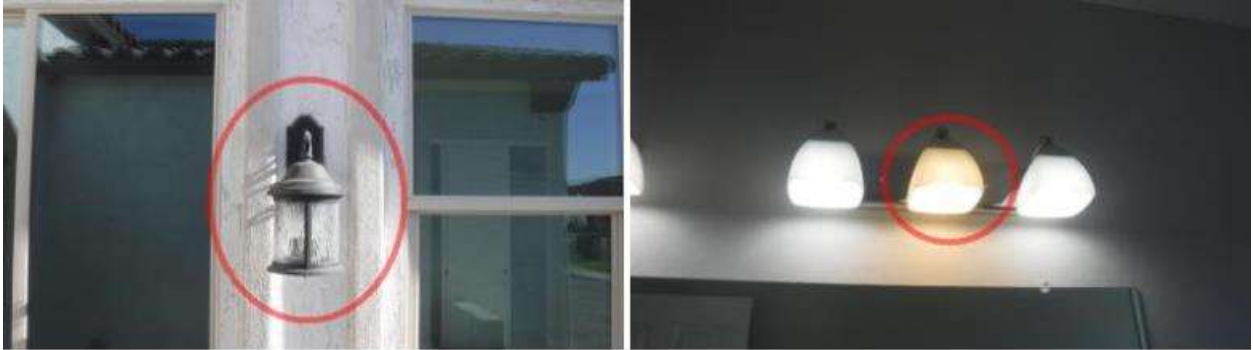
Uneven fixture; entry north between windows. Different bulbs noted; bathroom vanities.

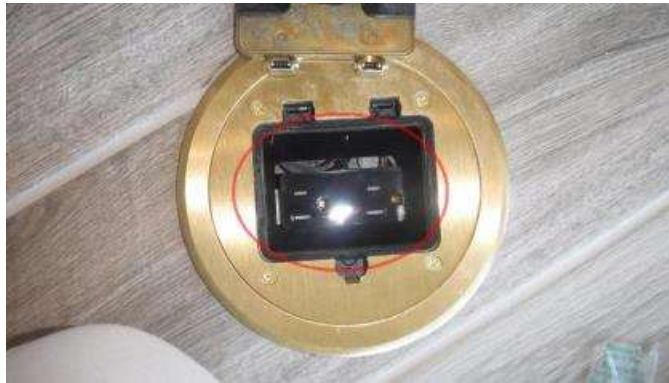
GFCI outlets are operational. Uneven floor outlet: family room northwest.

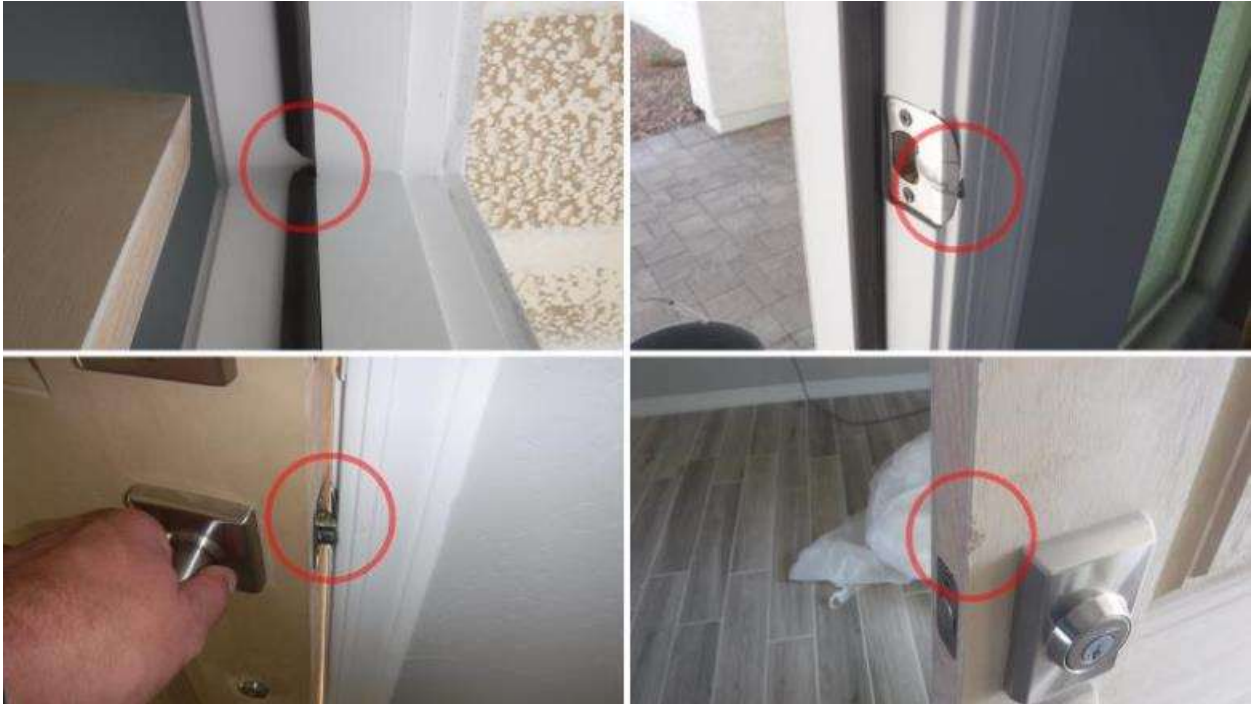
Damaged / incomplete seal noted. Door latch hits / rubs trim causing wear; recommend extended striker plate installations to prevent wear and damage. Chip viewed at door edge.

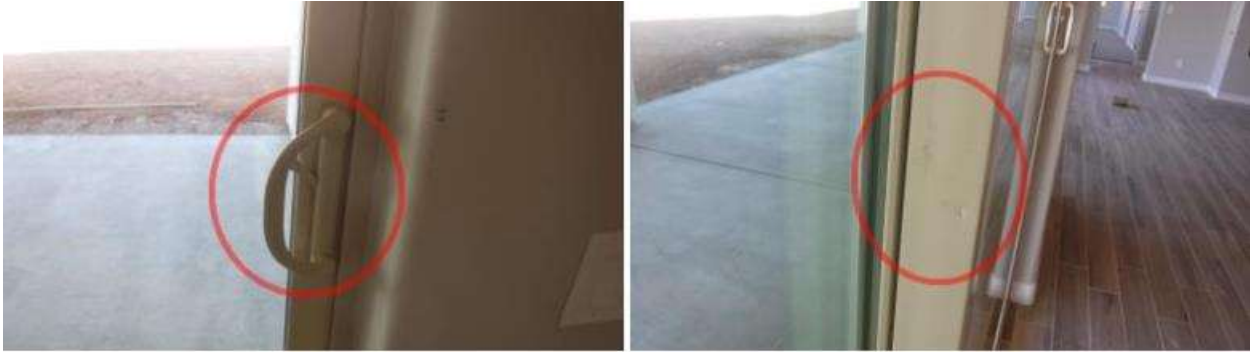
Sliding glass doors. Typical wear noted. Door does not lock properly, adjustments needed; southwest. Damage viewed at door; southwest. Standard rear / side door(s). Appears satisfactory.

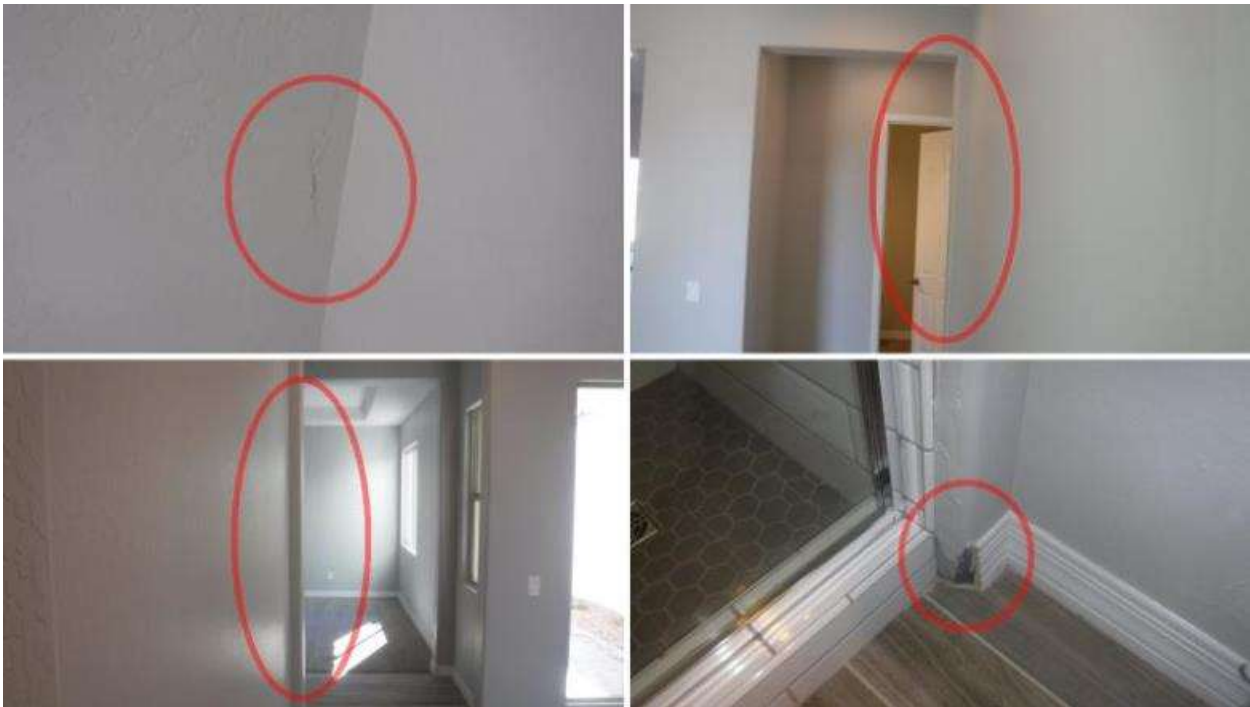
Drywall, Typical cracks noted. Marks viewed near outlet; butler's pantry southwest. Uneven texture noted; north guest suite northwest area. Uneven drywall / framing; north arches. Incomplete baseboards viewed; north suite near shower. Damage at drywall; north suite near shower.

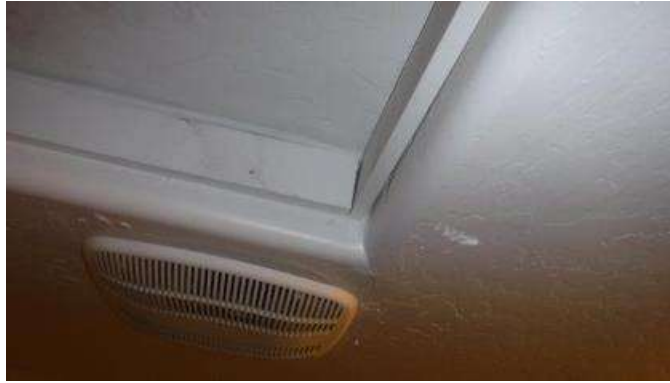
Drywall, Typical cracks noted. Uneven grout viewed; north suite above shower. Separations at attic access trim.

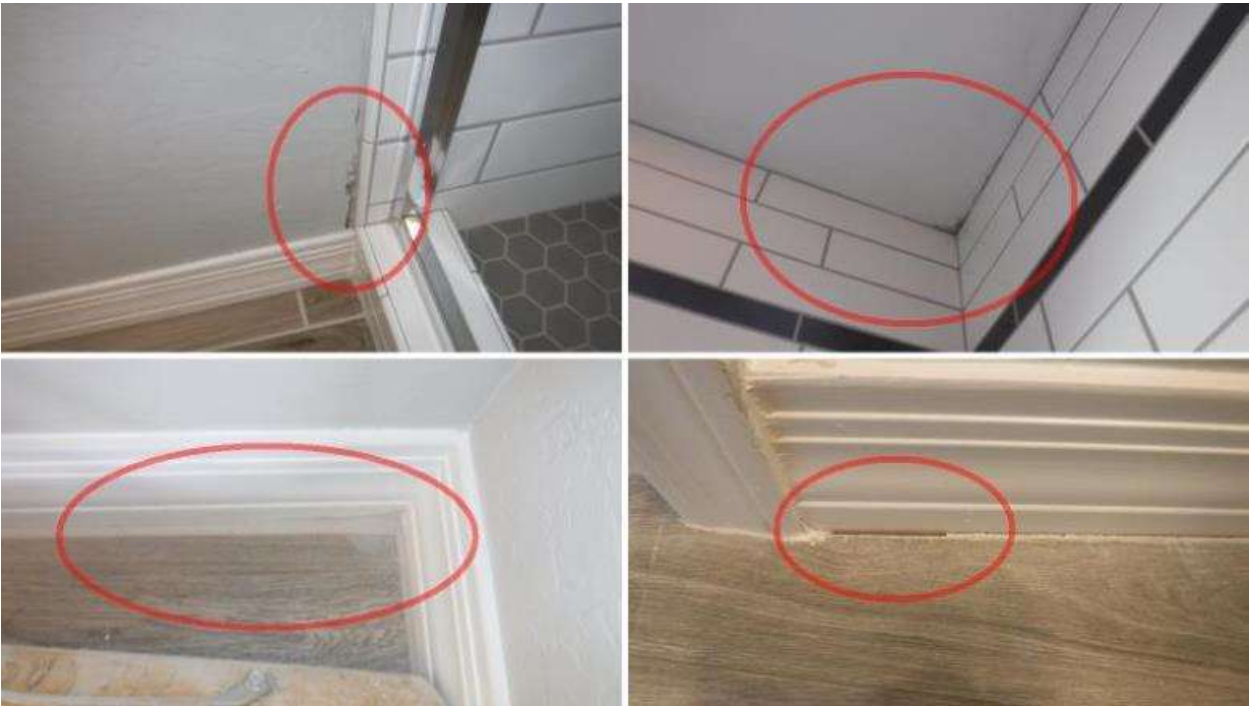
Carpet, Tile. Excessive grout line viewed near entry door. Cracks / separations in grout viewed.

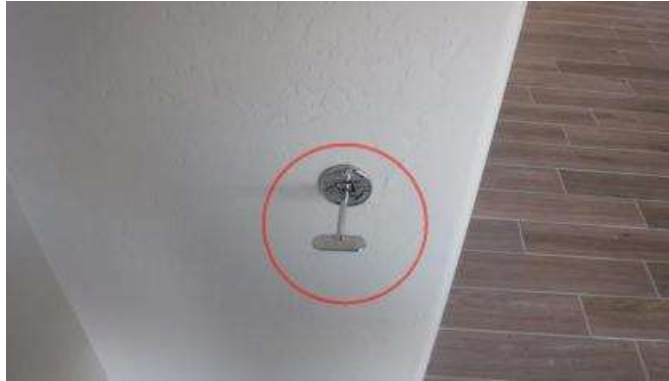
Prefabricated Metal, Gas, Damper has been removed / disabled as required for gas fireplace. Gas is off at meter. Not tested. Loose / uneven gas key noted.

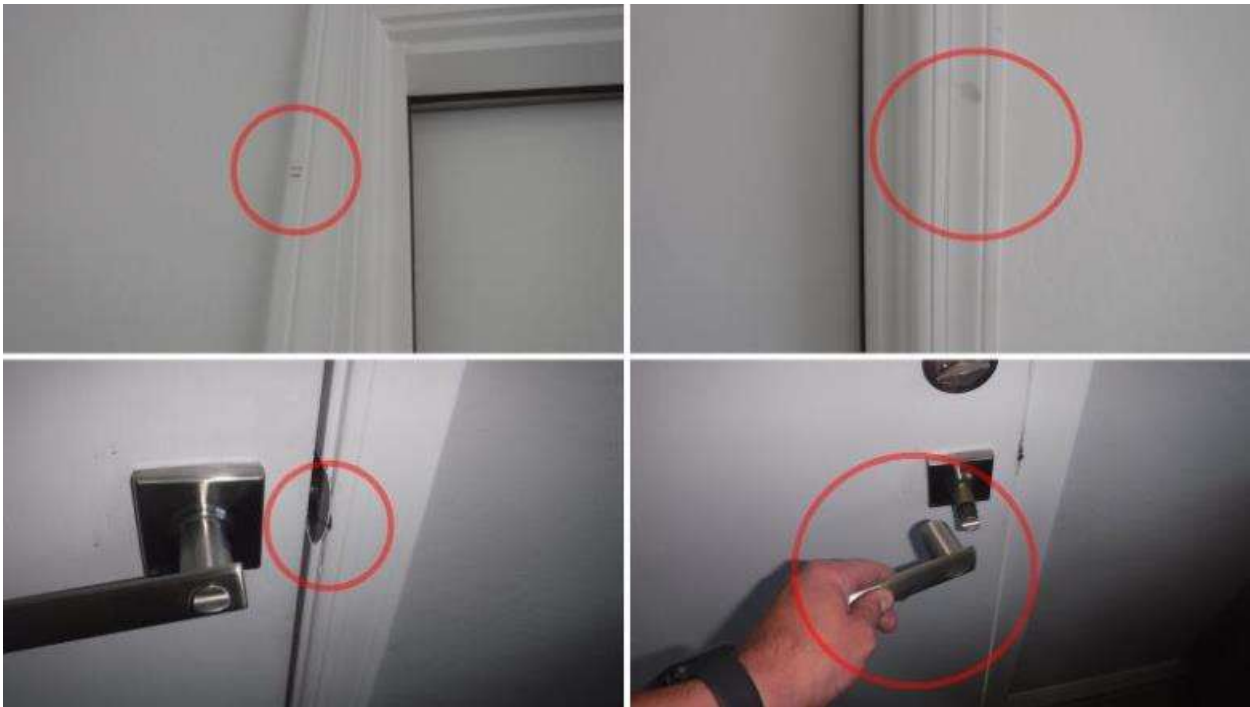
Door seal / hardware needs some adjustment or repair for it to seal and function appropriately. Door latch hits / rubs trim causing wear; recommend extended striker plate installations to prevent wear and damage. Damage / split / chips viewed at door trim. Loose handle.

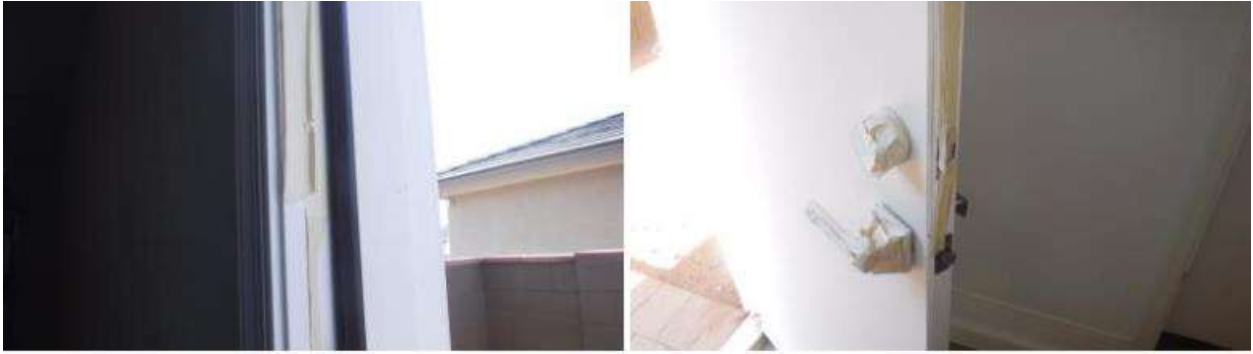
Tape / residue viewed at frame, door edge.

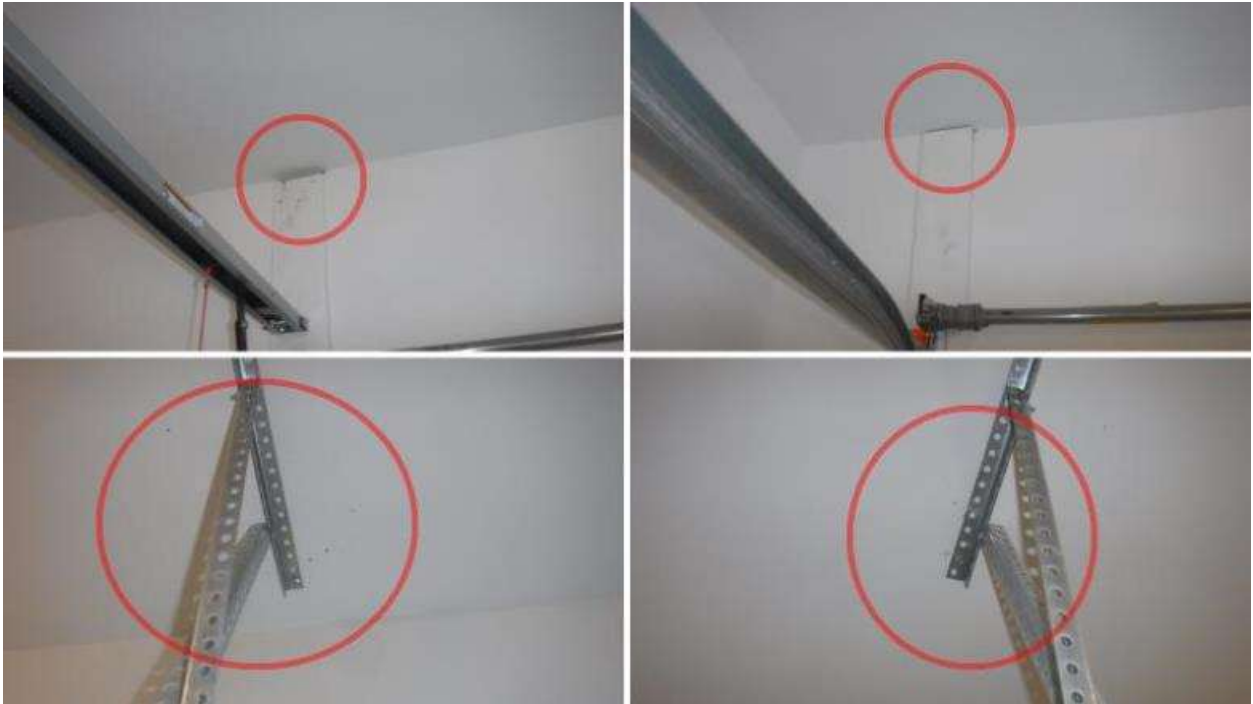
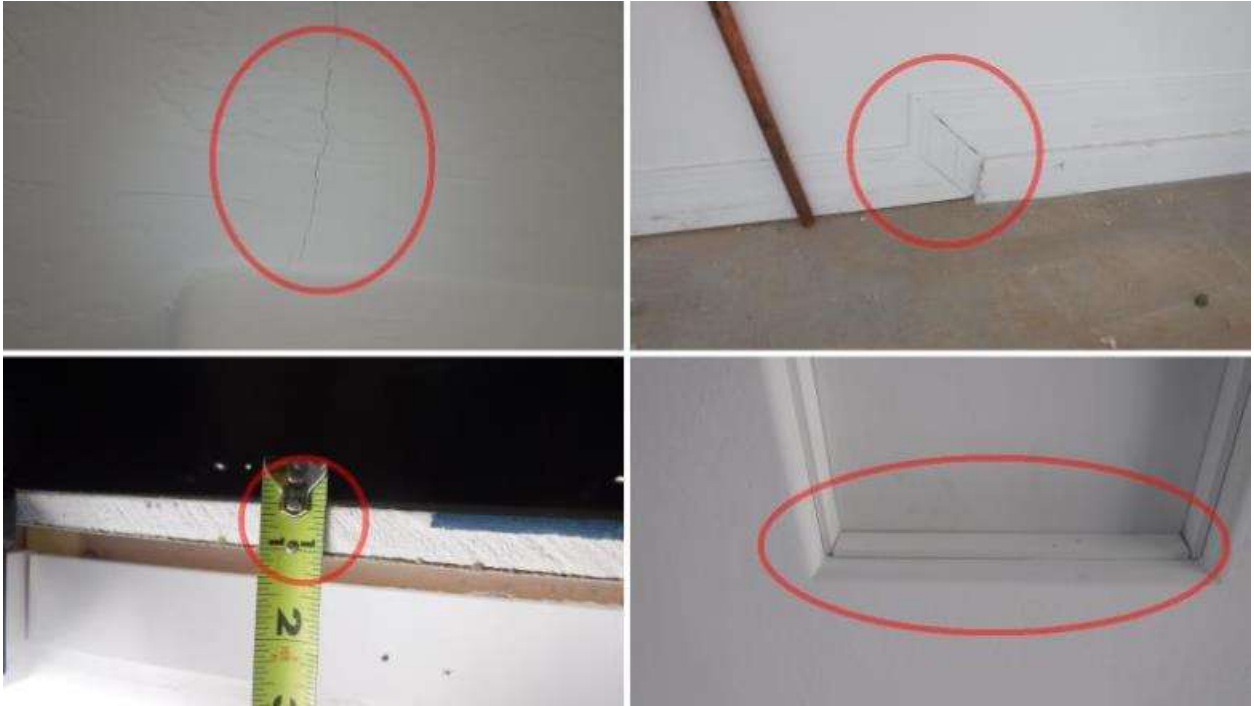
Typical cracks noted, Separations at vehicle door frame / drywall connections noted. Voids viewed near vehicle door tracks. Settlement crack viewed at ceiling near water heater. Separations at baseboards. Scuttle lid does not appear to be fire-rated, Repair any openings with approved materials to restore its fire rating. Separations at attic access trim.

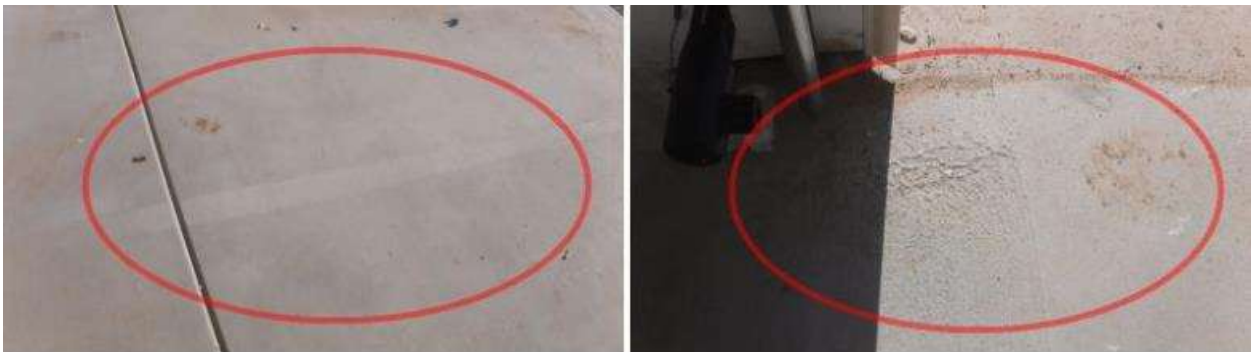
Typical cracks noted. Stains / marks / discoloration / uneven areas noted.

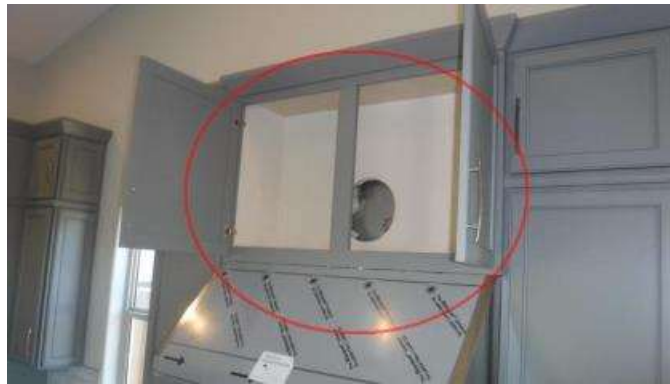
External, Fan/Hood operational. No vent provided to exterior.

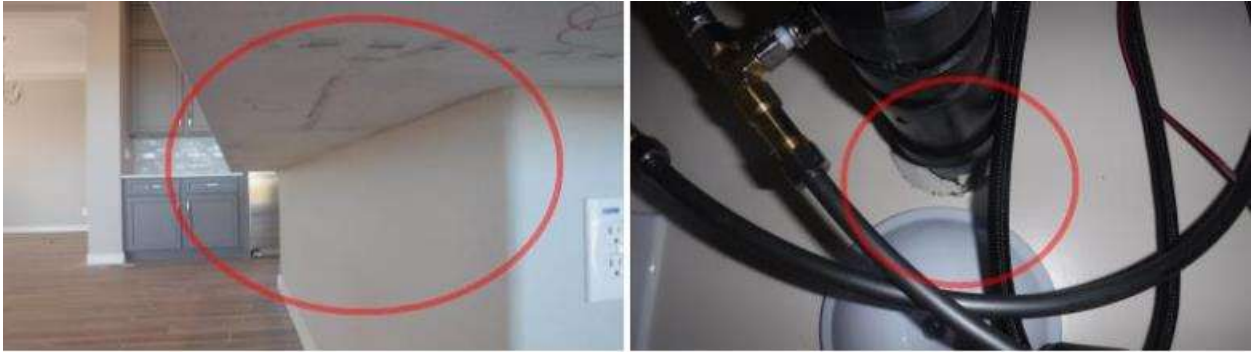
Counters are solid surface type (granite, quartz, concrete, corian). Appears satisfactory, with minor wear. Missing corbels below breakfast bar, needed for support / to prevent possible sagging. Building notes / marks viewed below breakfast bar. Cabinets appear serviceable, with minor wear noted. Bowed / unevenly installed cabinet doors noted. Uneven / over-sized openings at plumbing penetrations noted.

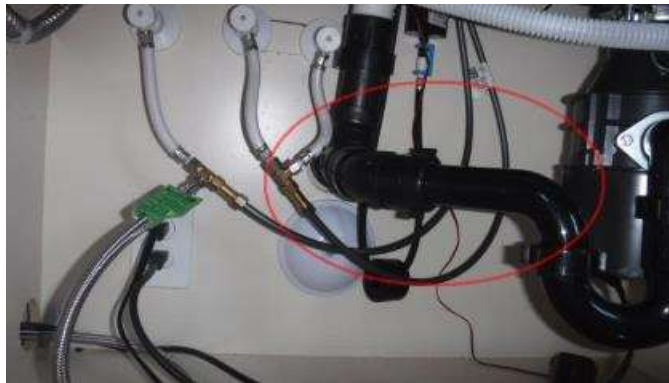
Appears satisfactory. Minor wear noted, Faucet is serviceable, Hand sprayer is serviceable, Improper slope / rise at drain. A licensed plumber should be called to make further evaluation and repairs as needed.

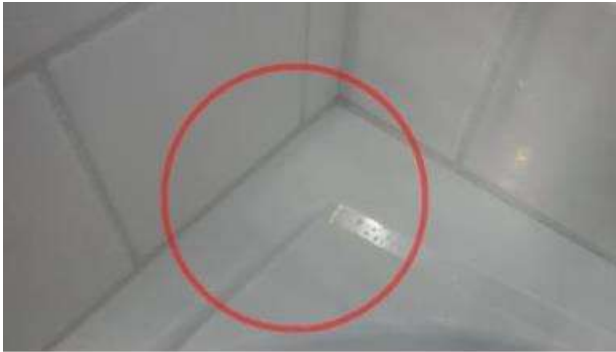
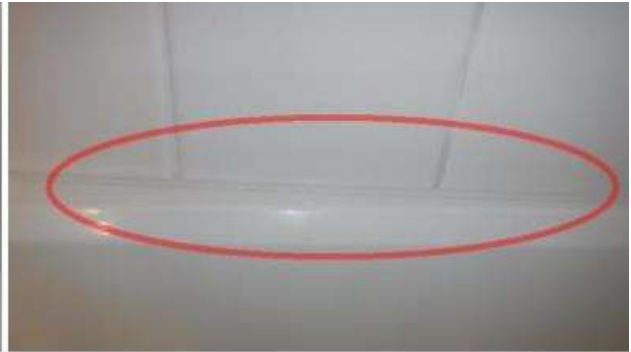
Scratch viewed at back left area.
