Inspection reference: 3187

Confidential Inspection Report

5324 S. Sesame Street

October 14, 2019

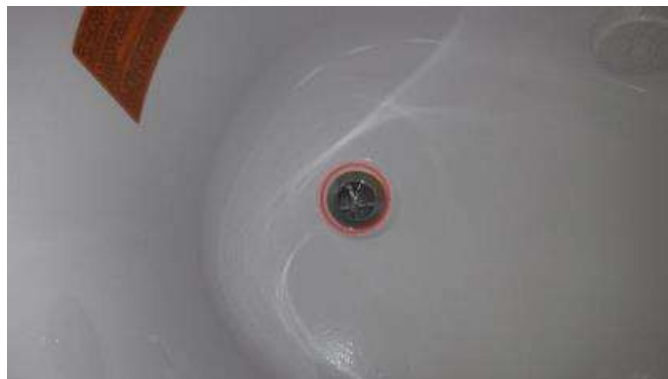
Functional - The tub/shower appears to drain at an acceptable rate. Stopper is missing.

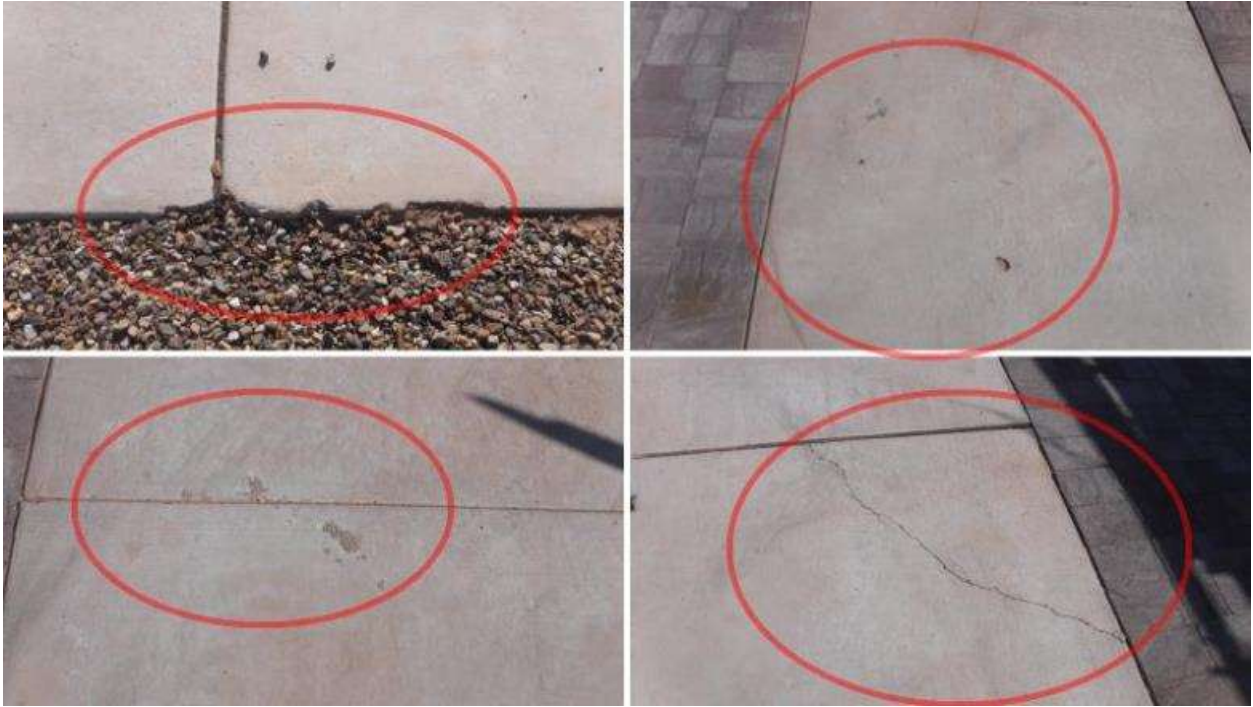
Sidewalk type: Concrete, Paver/Tile, Cracks noted are typical. Chips / marks / debris.

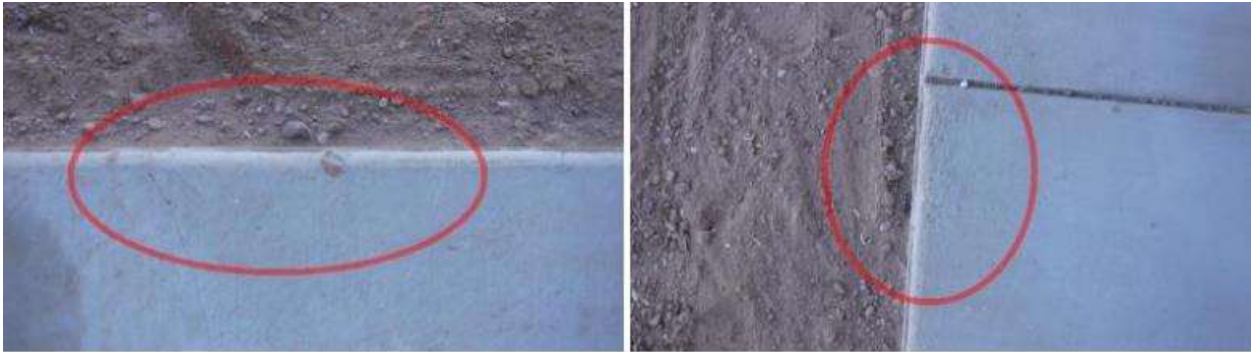
Patio type: Concrete, Paver/Tile, Cracks noted - typical. Chips / marks / debris noted.

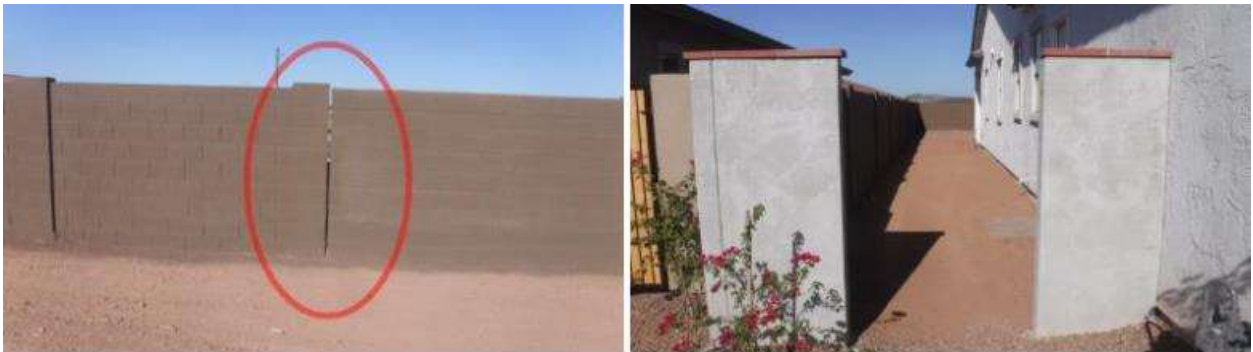
Type: Masonry. Typical cracks viewed, large gap / separation viewed. No gate installed.
