SUMMARY OF INSPECTION REPORT

Summary A: The following is a list of items / conditions that are typically considered significant and / or safety related, and usually will need further evaluation or repair by appropriately Licensed Contractors.

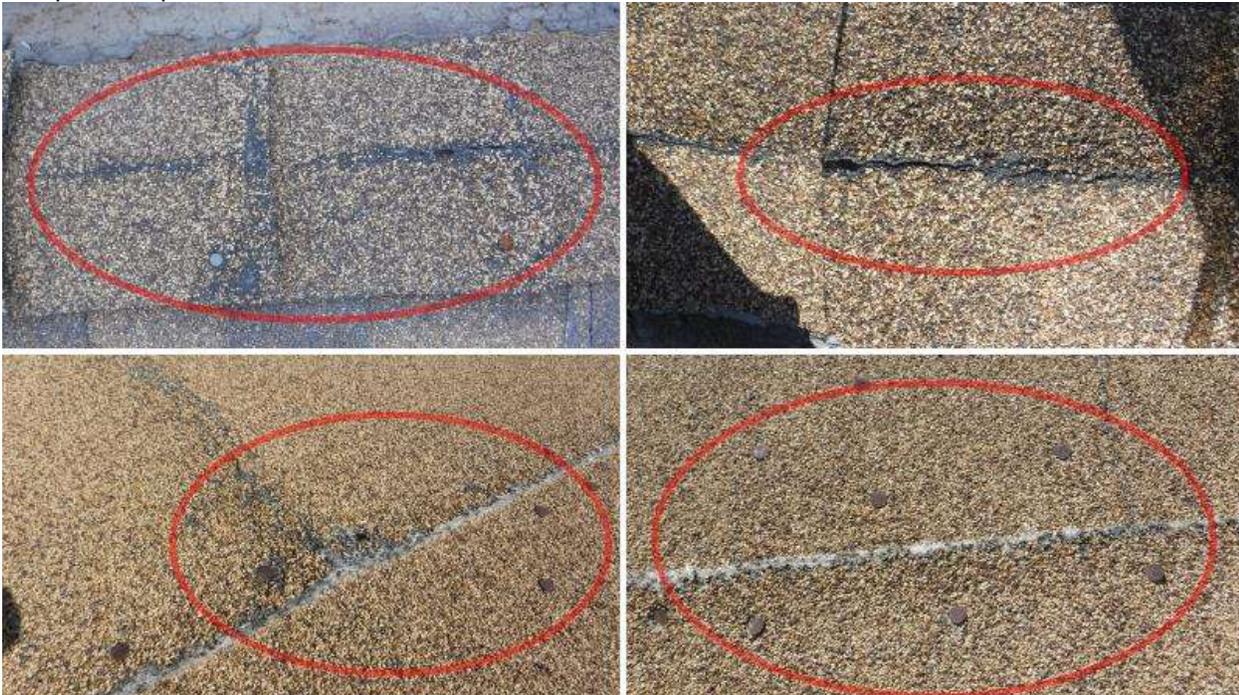
2. Exposed nails / fasteners noted. Damaged Shingles noted; ridge. Repair/Replacement needed. Poor installation, deterioration viewed at patio cover. A licensed roofing contractor should be called in to make further evaluation and to repair or replace as needed.

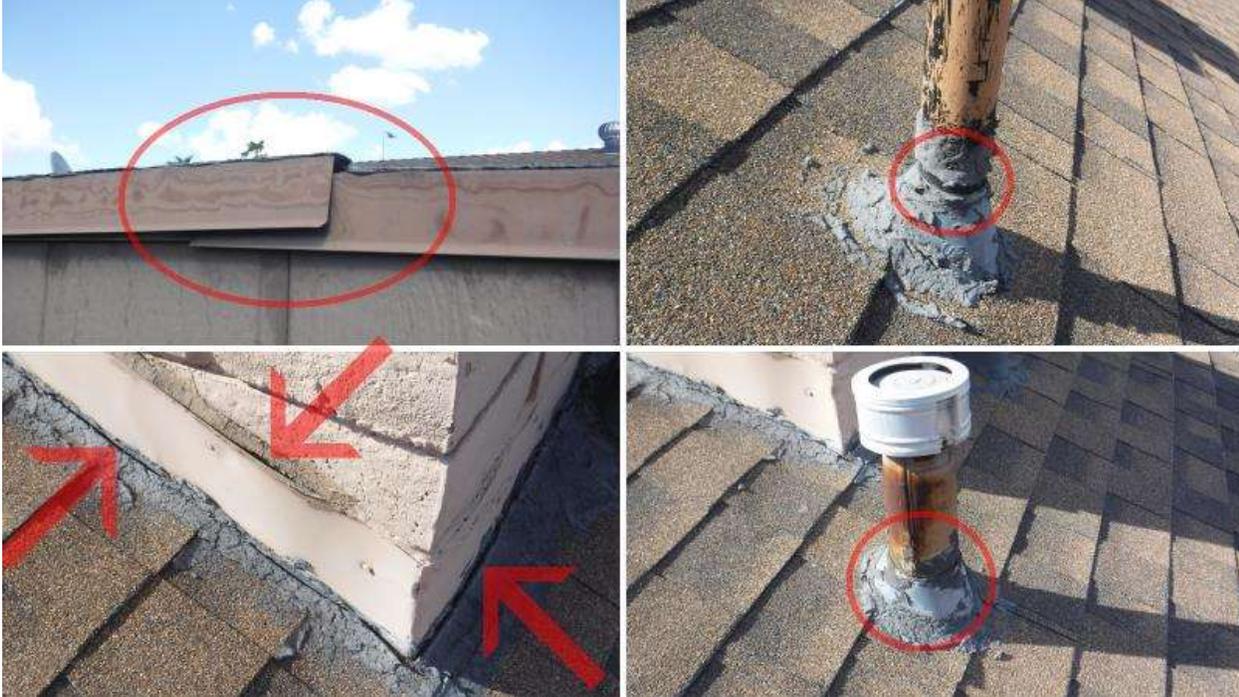
3. Metal, Composition, The potential for water entry is present, separations viewed at edges, at the vents, chimney, at various roof penetrations. Storm Collar(s) are missing / none provided at B-vents. A licensed roofing contractor should be called to make further evaluation and repairs as needed.

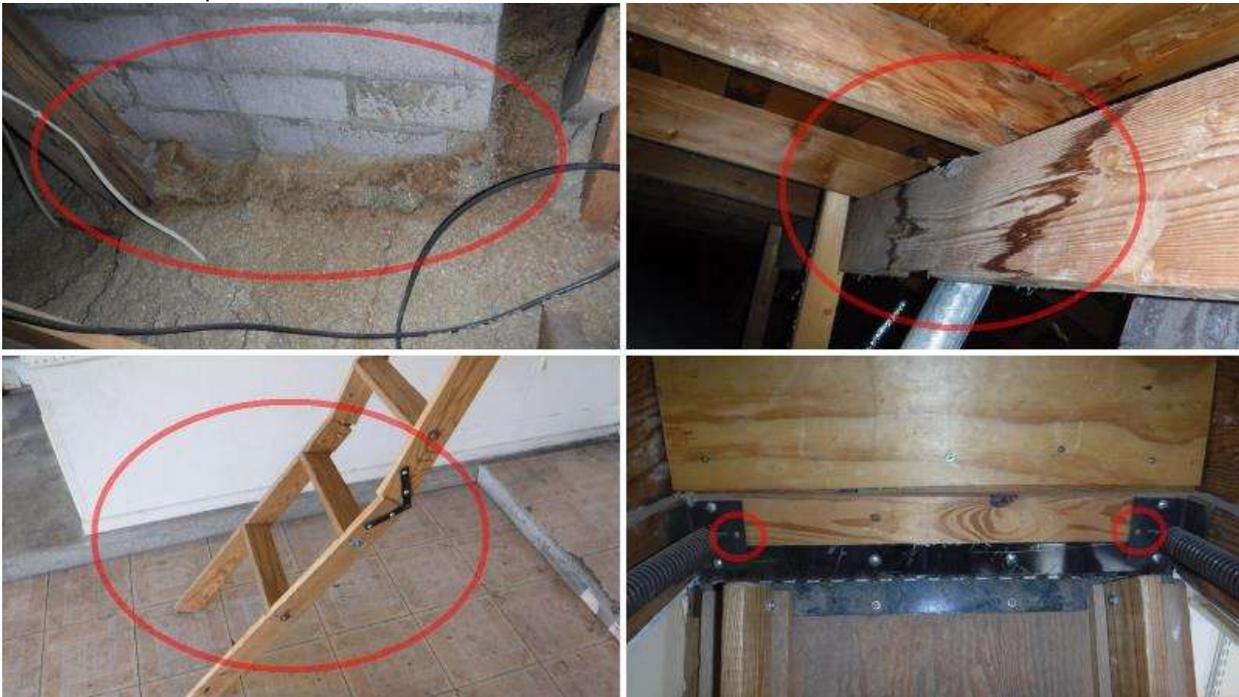
4. Attic is full size, Viewing was limited, due to space, insulation, ductwork etc. Moisture stains are noted, Unable to determine the status of the stains. Active leakage may be present. Ladder to the attic is weak and presents a safety hazard. Make improvements as needed.

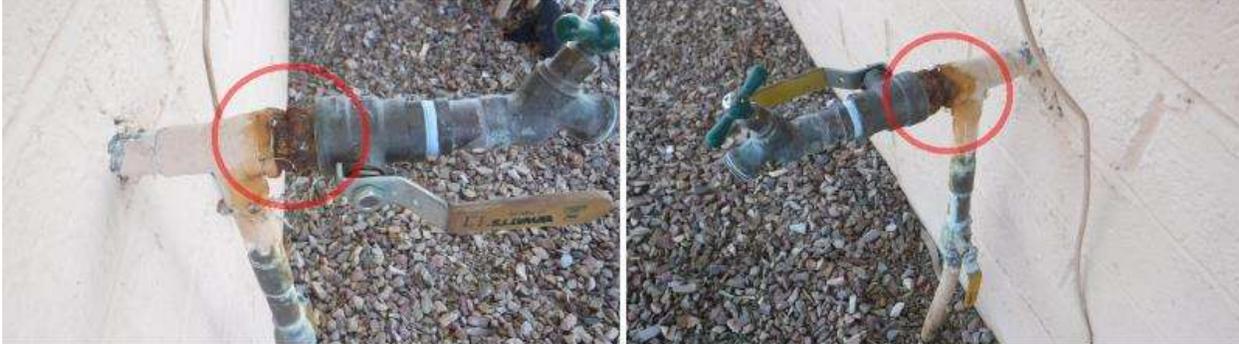
5. Copper, Excessive corrosion is found near the main valve, Repairs will be needed, Main line is 3/4 inch diameter.

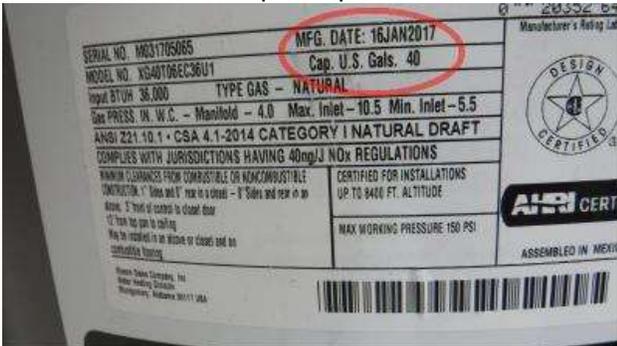
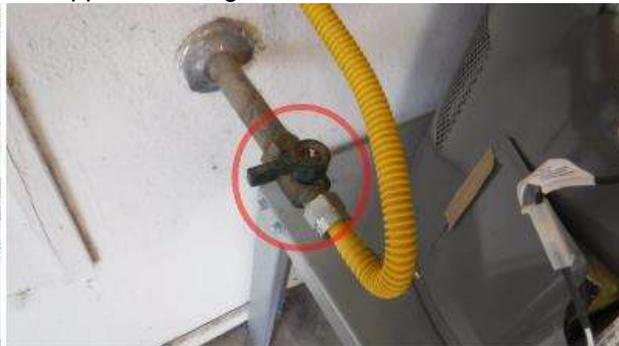
6. Drain pan is recommended. Gas/Pilot is Off - Could not fully inspect, Pressure relief valve and pipe noted, not tested. Poor termination of TPR pipe noted Flue vent intact, missing trim ring at ceiling. Improper clearance to combustibles, Minimum 1 inch clearance needed from combustibles at double wall B-vent. A water shutoff valve is installed. Thermal coupler is present. Manufacture date / approximate age- 1/16/2017.

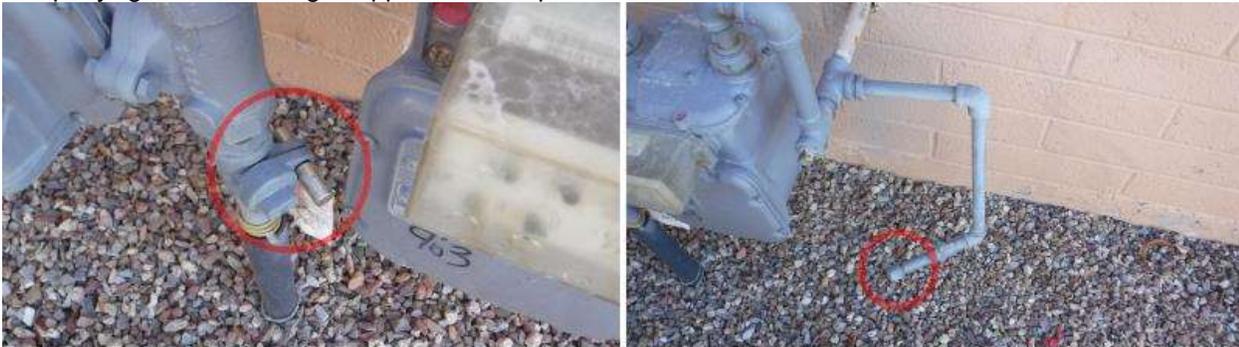
8. Meter located at exterior, North, Lines not fully visible, Gas System Not On at time of inspection - Suggest gas company light and test all gas appliances. Caped line from main noted near meter.

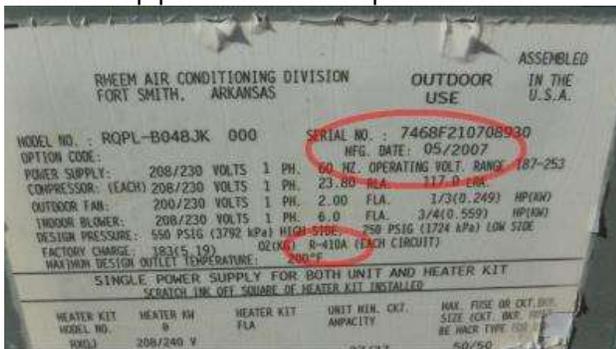
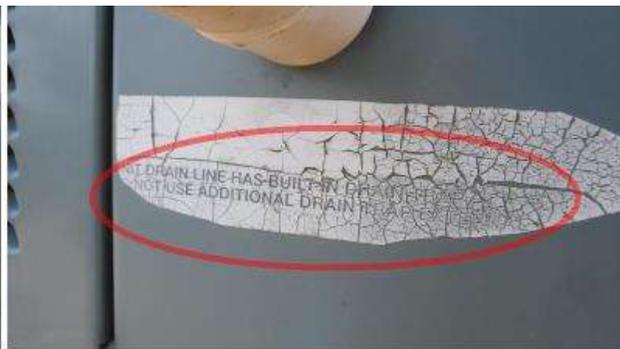
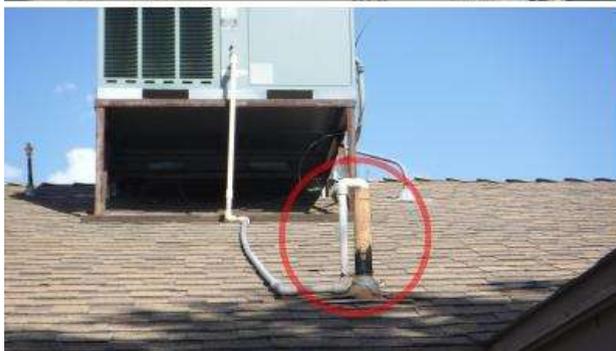
10. Condensate line installed with trap and vent provided; does not appear to have proper slope, should not have external trap per manufacture specifications.

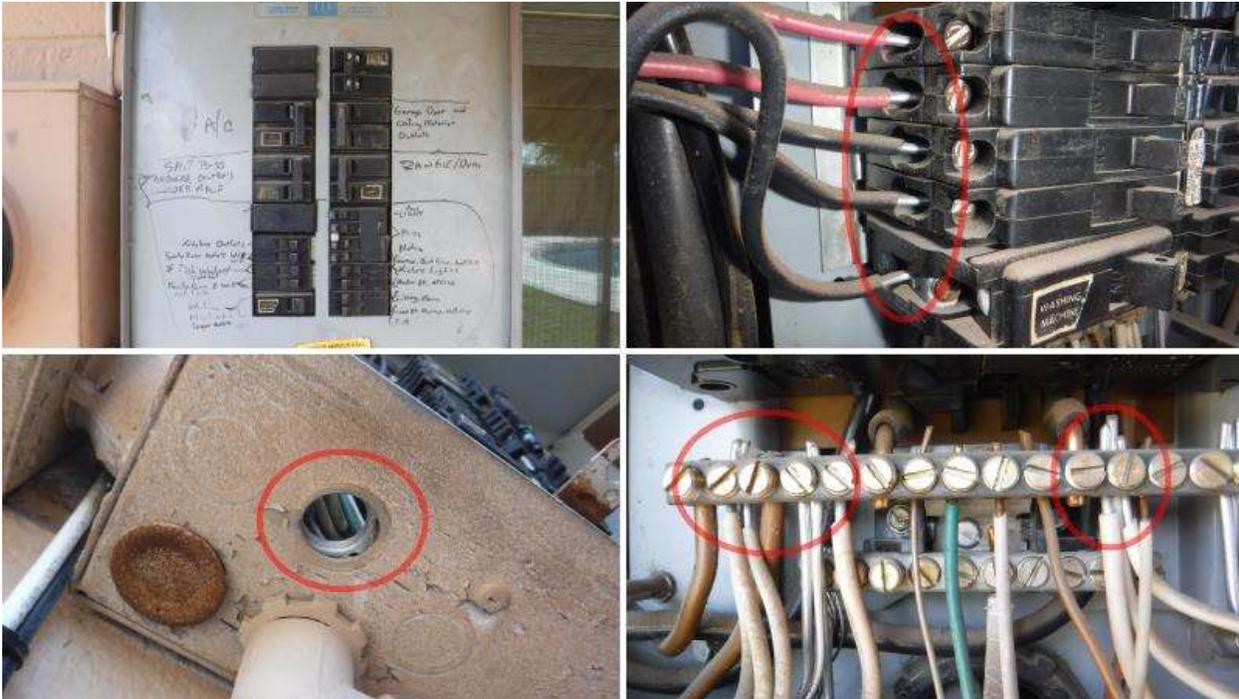
11. Circuit and wire sizing correct so far as visible. Triple lugging at ground/neutral bar noted, typically rated for only two wires. Missing knockouts viewed at panel. Single pole in use at 20 amp 240 volt breaker. Abandoned breaker noted. Different brand breakers are installed, not recommended. NOTE: Six or fewer breakers in one location do not usually require a main breaker. Anti oxidant recommended on aluminum 240 volt connections. Electrical tape around some breakers is noted. Electrical system appears outdated by today's standards. Upgrade should be considered. Have a licensed electrician make further evaluation and corrections as needed.

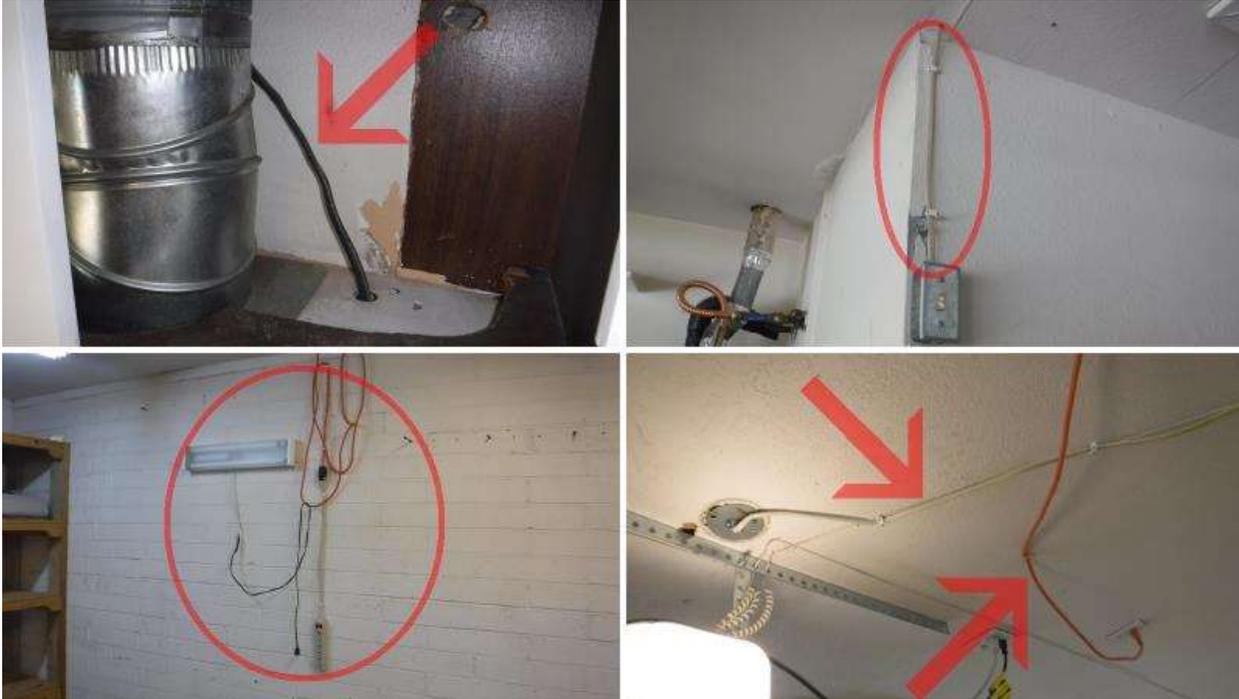
13. Copper, Aluminum (240 volt OK), Aluminum wire on 120 volt circuits - FURTHER EVALUATION RECOMMENDED BY A LICENSED ELECTRICIAN. Cables inadequately attached or protected, exposed wiring noted; kitchen cabinet above vent hood, garage. Damage/Defects noted, Extension cord wiring installed in a permanent manner is considered a fire hazard as its insulation is not formulated to withstand the test of time. Fires can start unexpectedly. Extension cord wiring is noted in the following areas: garage, patio. Wiring is not stapled / secured within 12" of boxes / fixtures; attic.

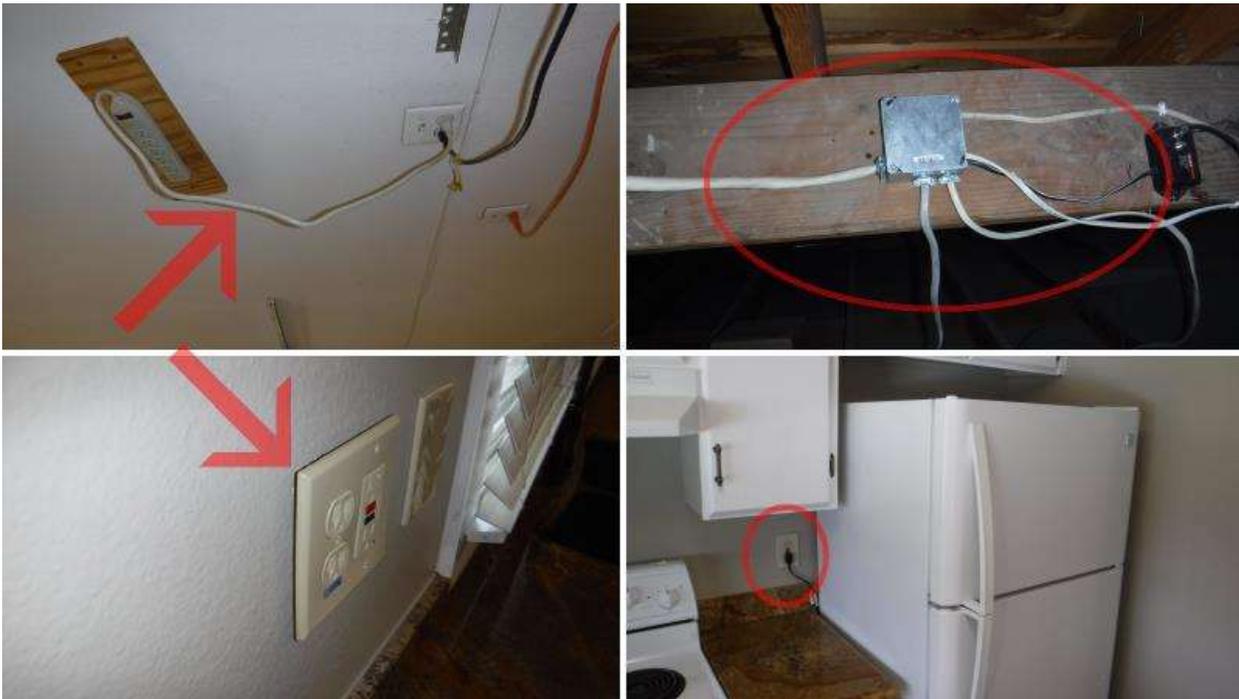
14. A representative sampling of outlets were tested. As a whole, outlets throughout the house are in serviceable condition. Separations at kitchen outlet left of sink; GFCI series with patio outlet at sprinkler timer. GFCI not responding / not operational / not provided at: garage, front eaves, patio, master bathroom. Refrigerator is plugged into a GFCI protected outlet above the kitchen counter; no dedicated appliance outlet provided behind the refrigerator.

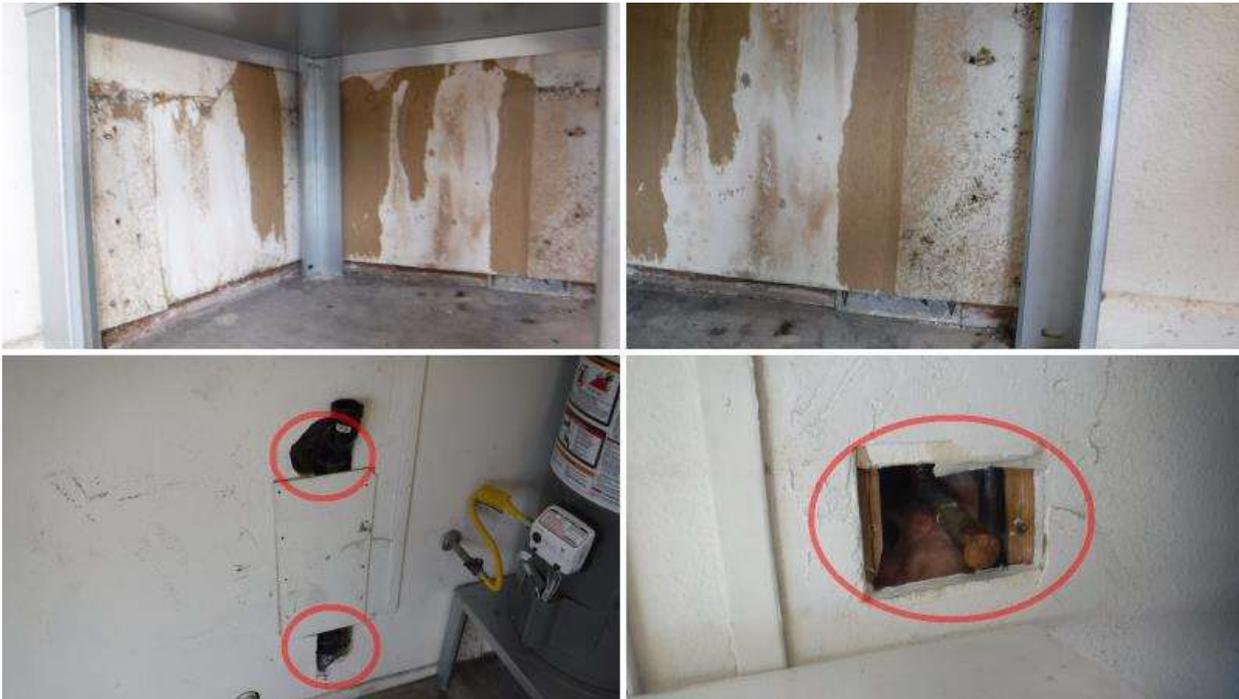
17. Settlement cracks noted. Damage is noted. Moisture stains / damage viewed; possible mold below water heater. Attic access stairs do not appear to be fire-rated. Repair any openings with approved materials to restore its fire rating.

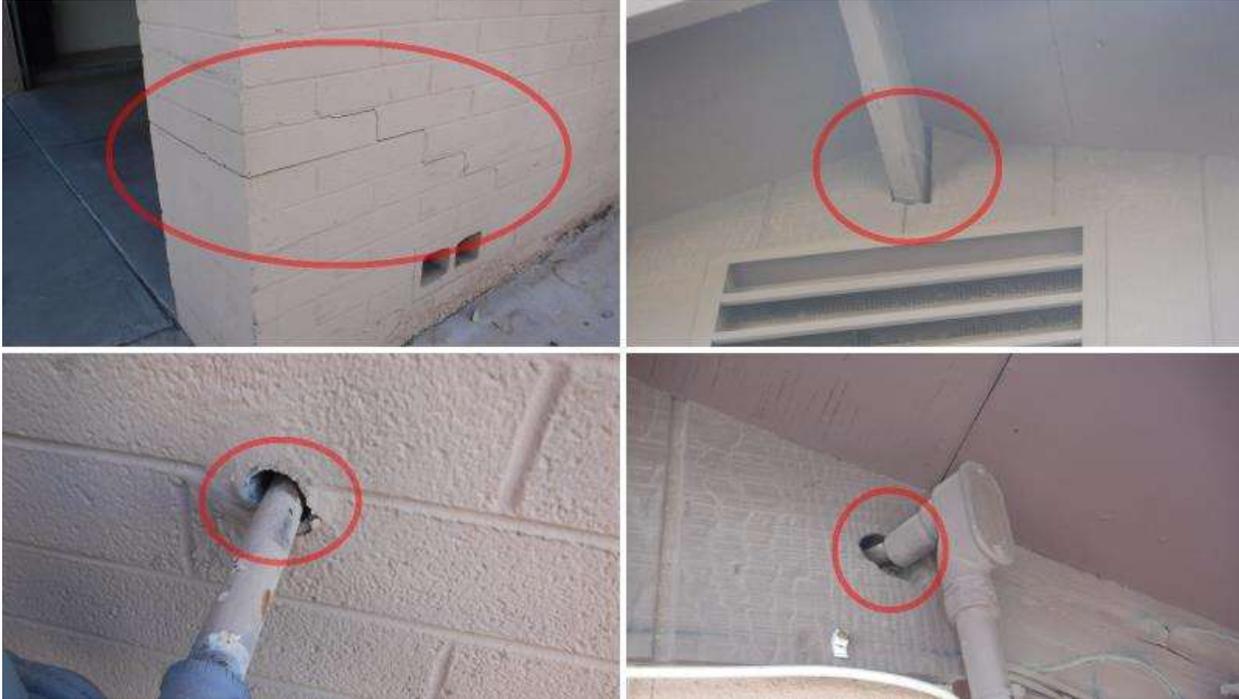
1. Walls are constructed with Frame construction. Block construction Wood siding. Settlement cracks are noted; garage northeast. Separations at wood connections; north gable. Voids / openings in surfaces noted; gas main, northwest at conduit. Pet door is installed.

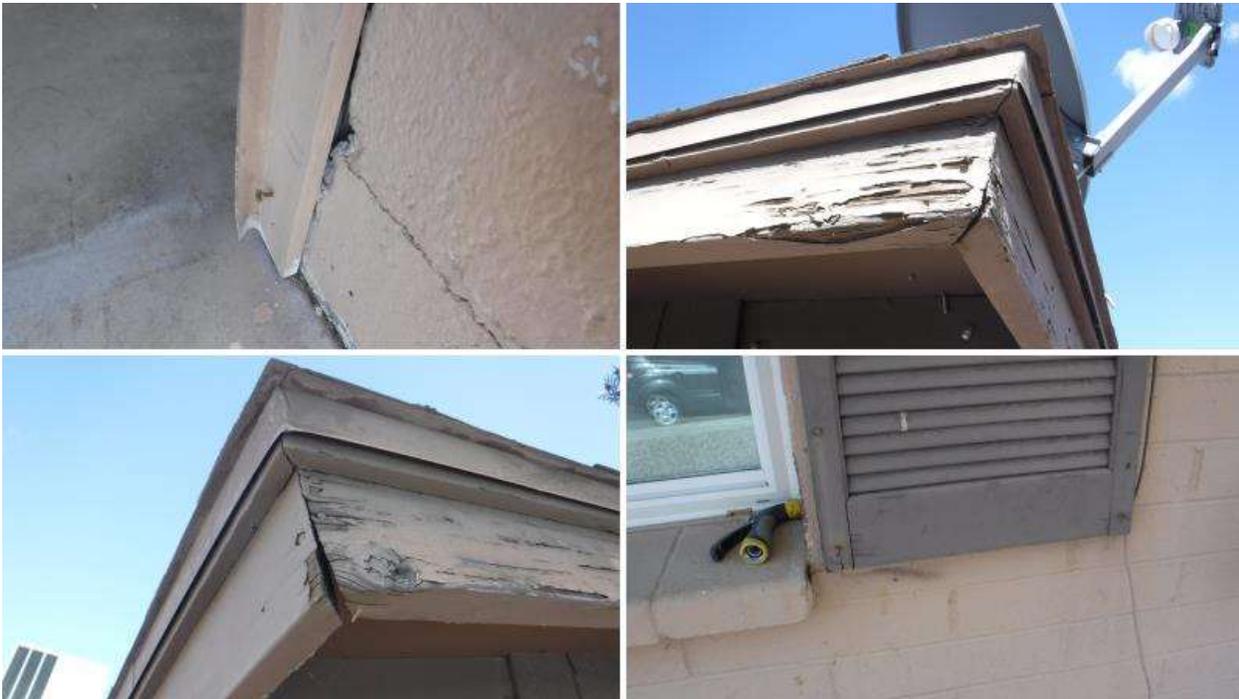
2. Wood materials. Vinyl materials. Separations noted at garage vehicle door trim; exposed screws noted. Weathering and aging, deterioration noted. Peeling / flaking paint noted. Separations at joints / seams / connections noted.

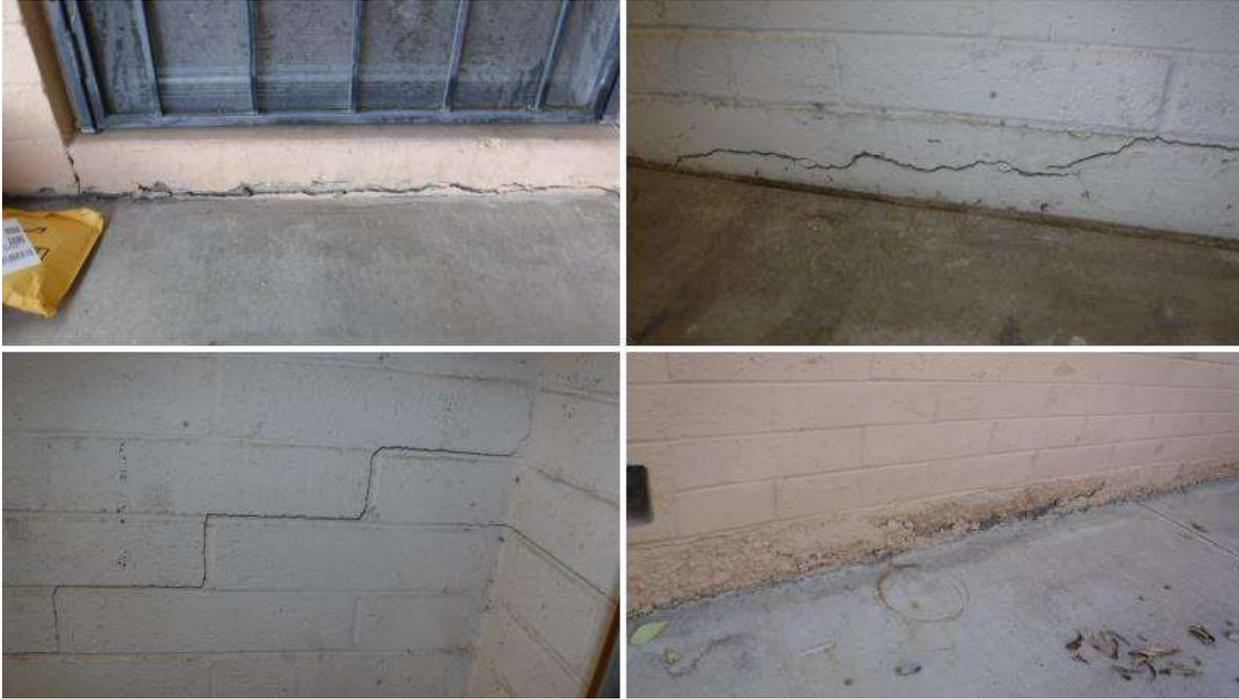
3. Poured in place slab concrete, Slab is not visible due to carpet and/or floor covering, The exterior view of the foundation is limited to the portions visible above grade. Conditions may exist that warrant further investigation by a

Professional Engineer. Cracking, settlement viewed at multiple locations; entry, garage north. The exposed portions of the perimeter foundation walls need maintenance. This is needed to prevent further deterioration.

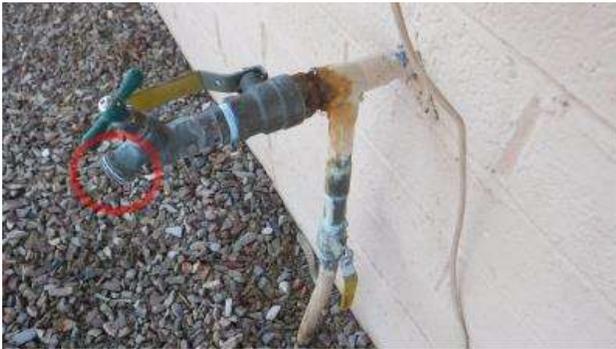
4. Sample operated, appeared serviceable, Anti-siphon devices missing / not installed, front.

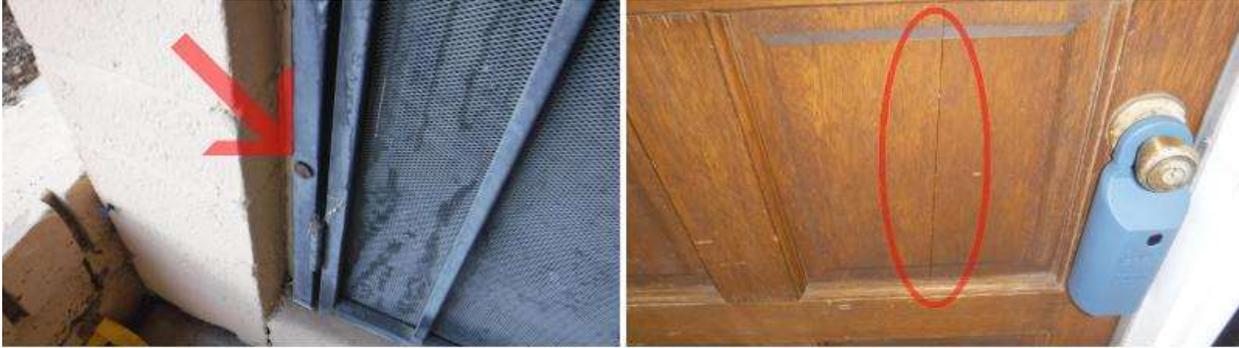
6. Needs attention / maintenance / minor repairs for proper operation; loose hardware at screen door. Weathering, deterioration, split wood noted. Door / frame is not square.

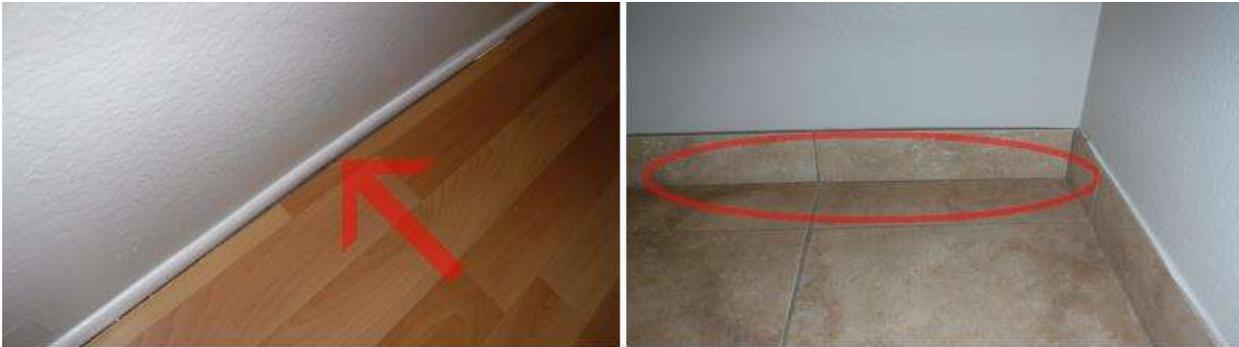
10. Carpet, Tile, Laminate, Appears satisfactory. Wear / stains noted. Separations at wall noted; family room, entry.

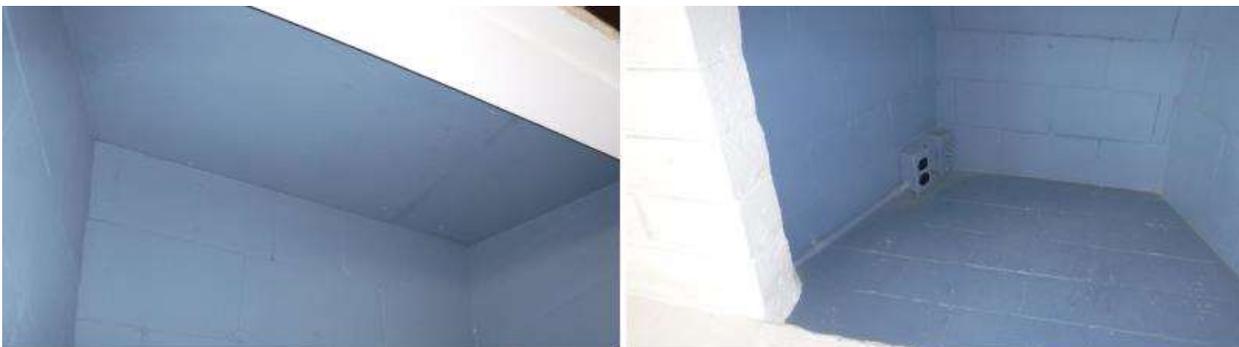
11. Masonry, Damper missing, removed, blocked. Fireplace has been altered, closed, blocked off. Outlet and cable runs into the firebox noted.

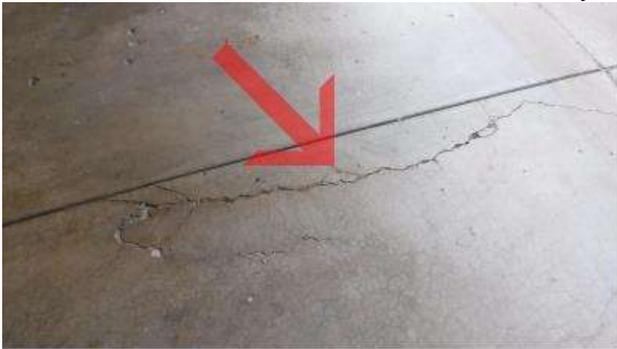
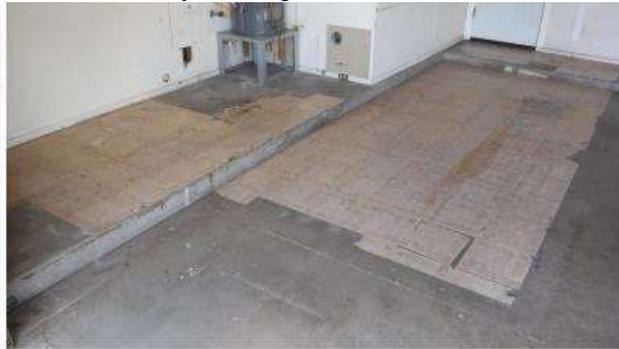
12. Surfaces have raised / settled. Floor is not fully visible, due to vinyl flooring.

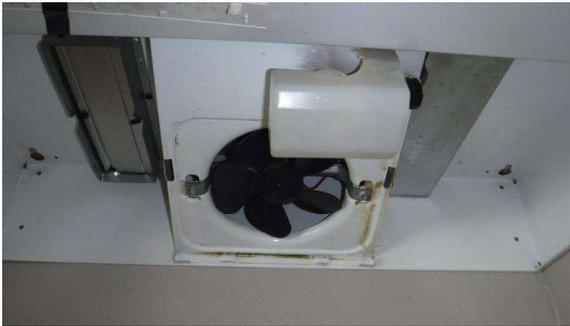
14. External, Fan/Hood operational. Missing filter panel, not installed.

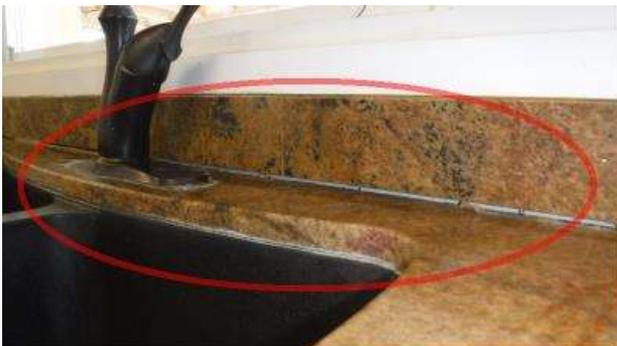
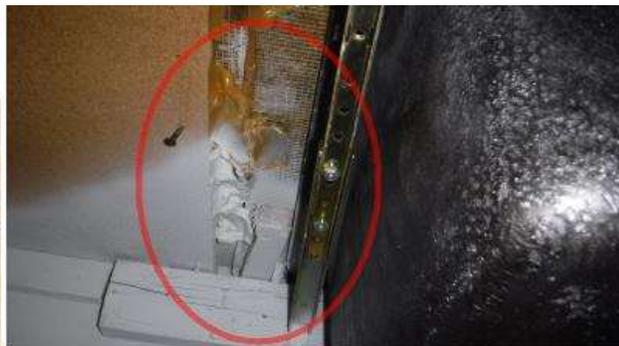
15. Counters are solid surface type (granite, quartz, concrete, corian) with minor wear. Damage is noted; sagging, separations behind sink. Caulking is needed in the vicinity of the sink. Cabinets appear serviceable, with moderate to heavy wear. Stains / damage viewed below sink.

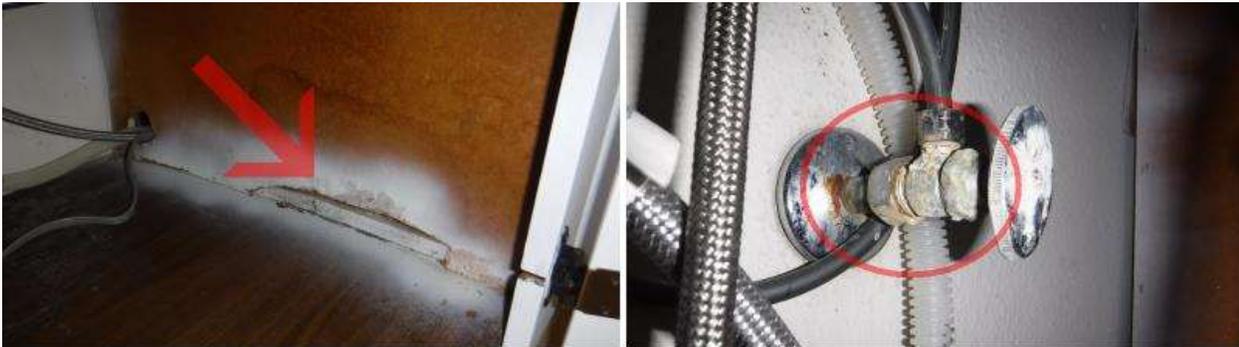
16. Minor wear noted, Faucet is serviceable, Corrosion noted at plumbing below sink; no active leakage detected.

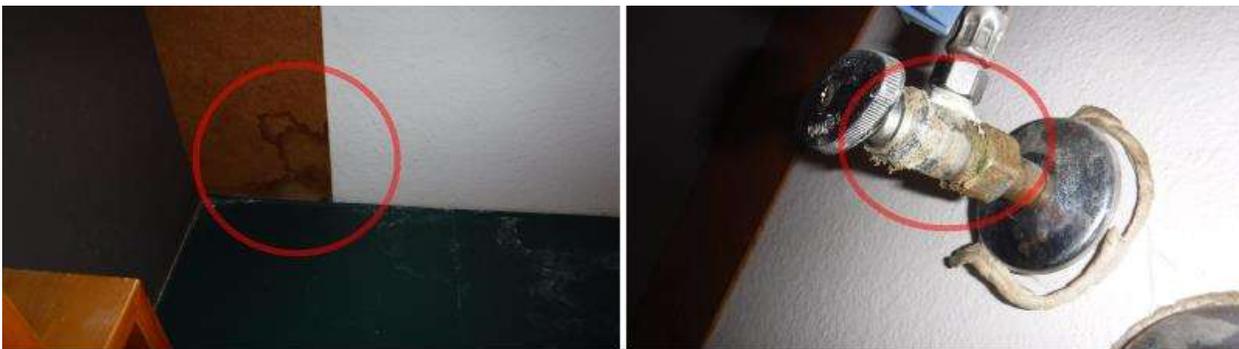
18. Attention Needed - The vanity cabinet and/or top in this bathroom needs attention. Moisture stains noted.

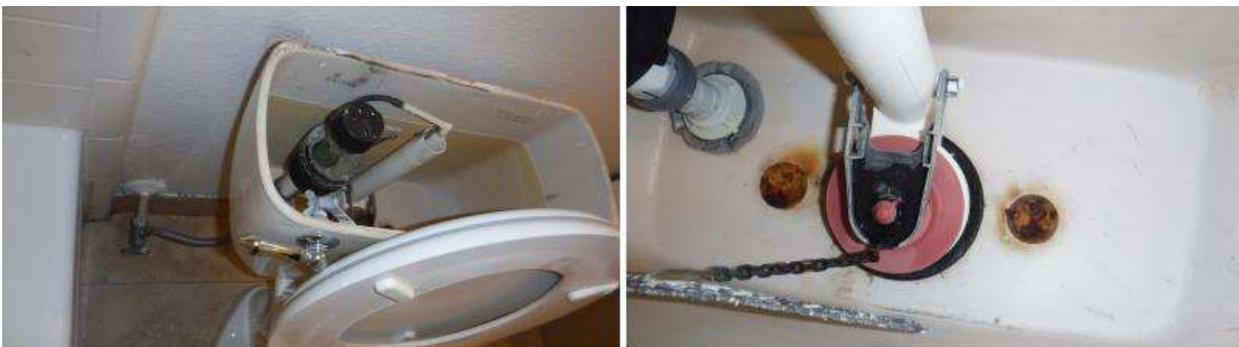
20. Action Necessary - There is evidence of an active leak. Water leaking from tank noted when I arrived. Homeowner shut water off at valve prior to him leaving the home.

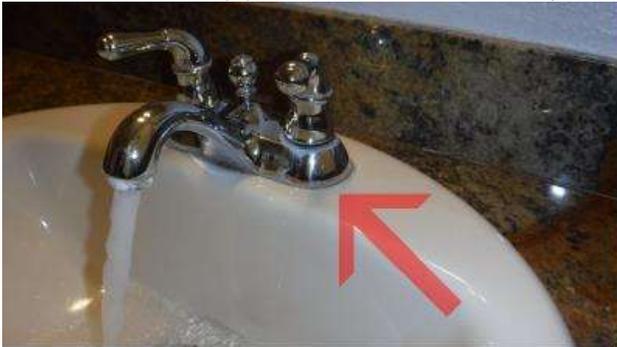
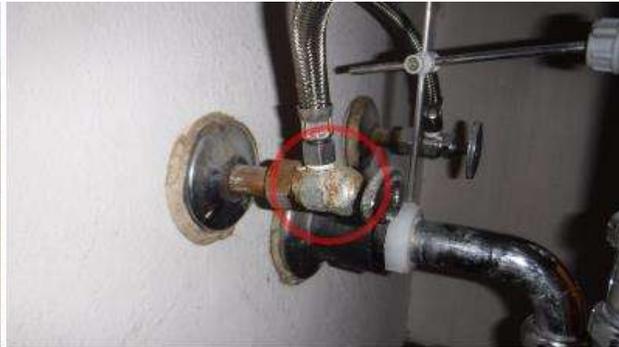
Faucet and Supply Lines:
24. **Attention Needed** - The faucet in the bathroom vanity leaks at handle(s). There are shutoffs installed for both hot and cold water pipes under the basin, not operated. Corrosion noted at supply lines / valves.

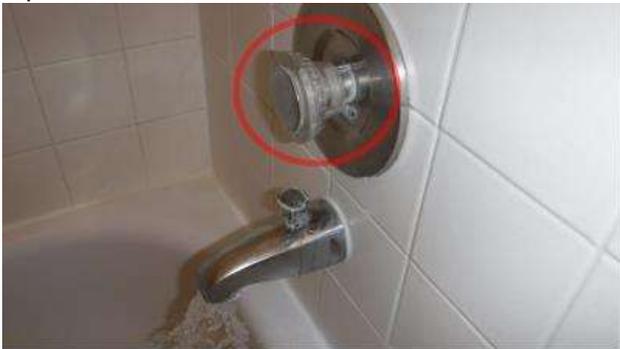
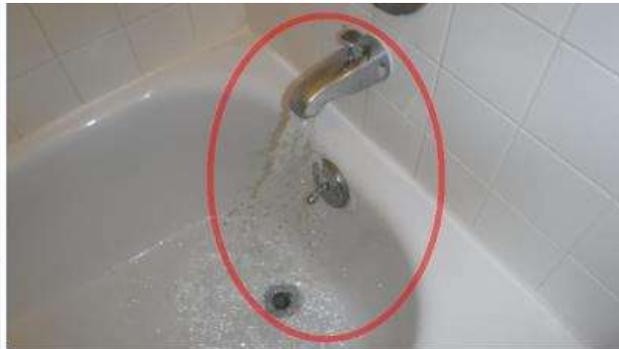
Tub/Shower/Shower Head and Mixing Valves:
25. **Attention Needed** - The tub / shower fixtures need some attention so that it will function as intended. Tub / shower diverter partially diverts water to showerhead. Valve Leaks - The water mixing valve leaks and needs to be repaired.

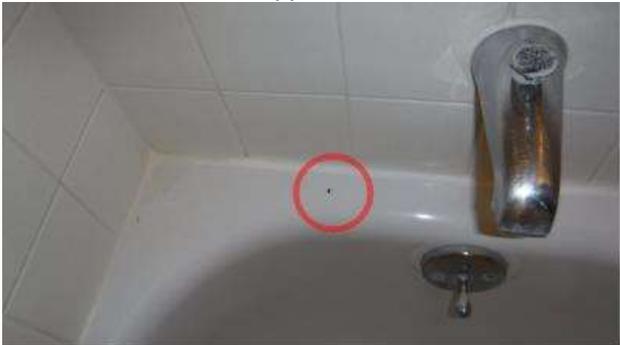
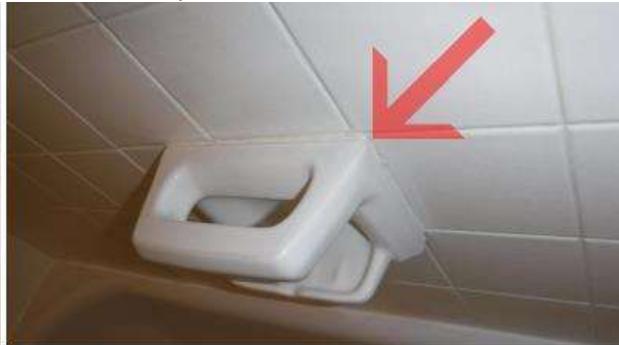
Tub & Shower Walls:
27. The tub and walls appear to be in functional condition. Small chip in tub noted.

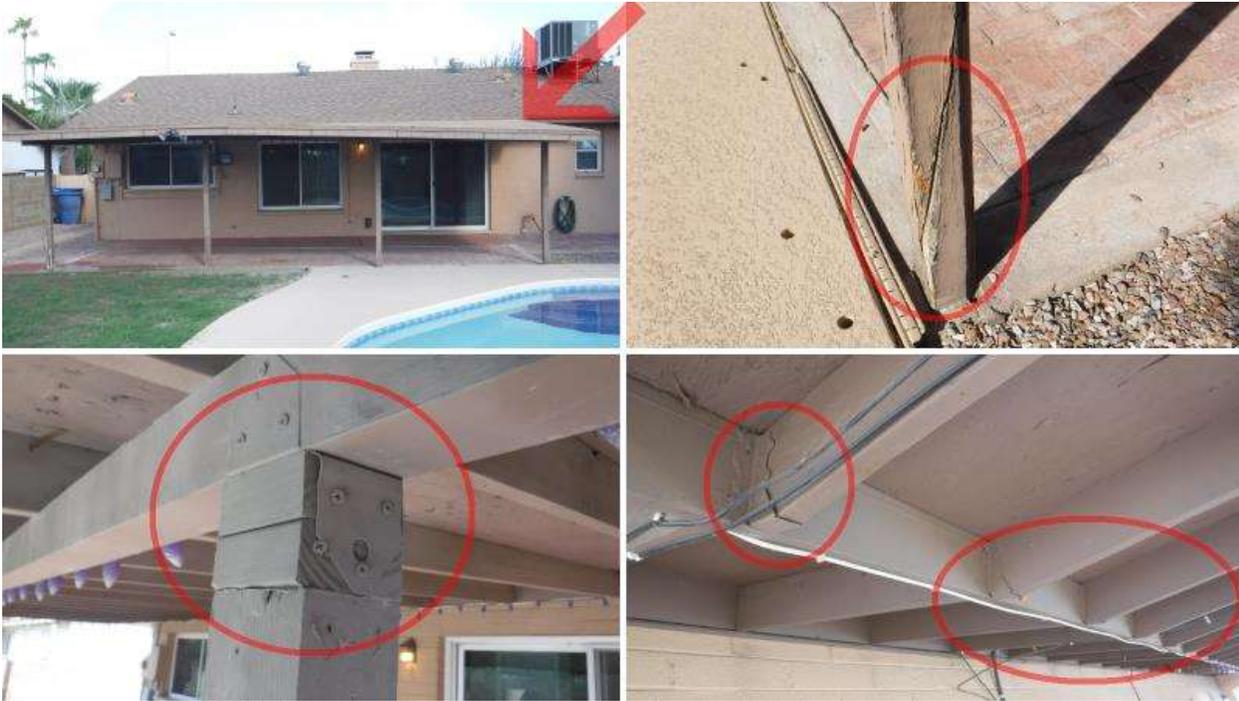
31. Type: Shed roof, Deterioration noted at base of posts, Needs repair or securing, Structure appears over spanned/sagging/damaged. Improper addition of 2x4 blocks at top of post noted. Structure is too low, inadequate headroom clearance noted.

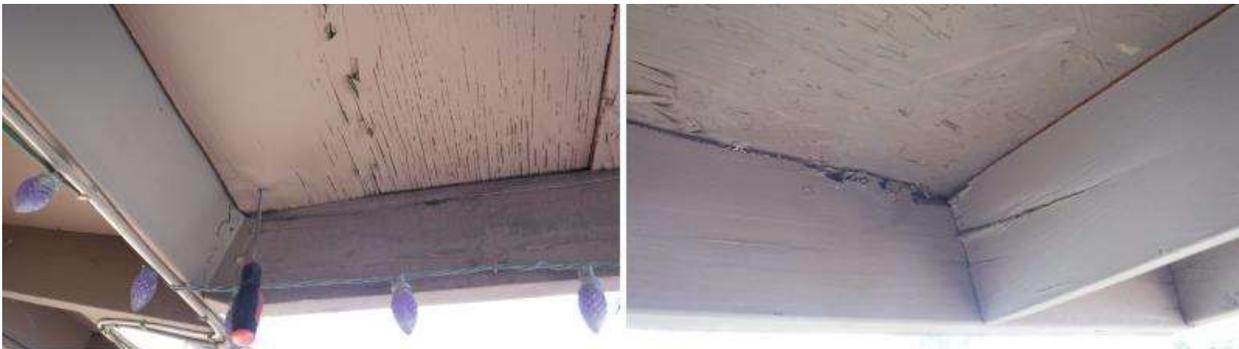
32. The method of patio cover attachment to main roof is incorrect and needs further evaluation and repair to prevent deterioration or water entry into wall and framing areas. Moisture damage viewed.

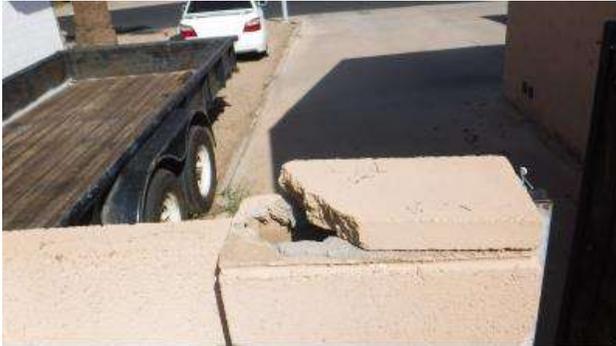
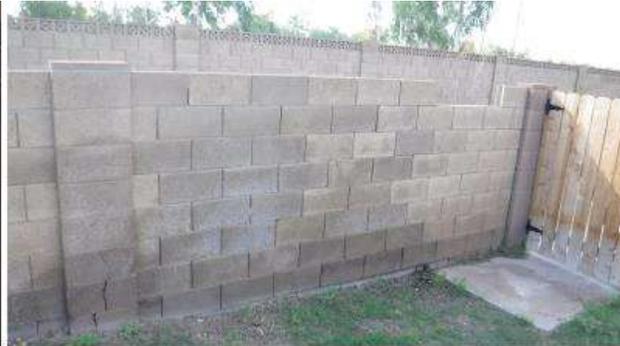
33. Type: Masonry, Cracks / separations / settlement noted, Loose blocks noted, Top row, Cap blocks, Damage / deterioration noted. Moisture stains / deterioration noted. Self-closing / latching devices for pool barrier are missing / needed / damaged / not operational.

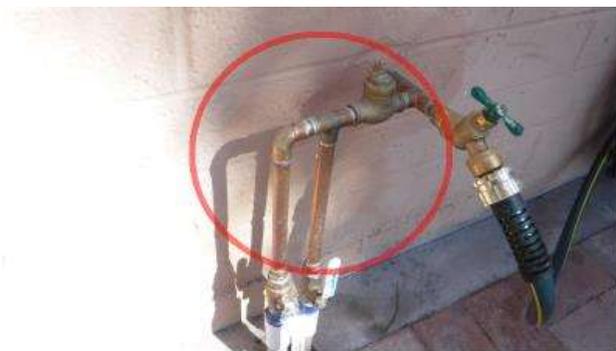
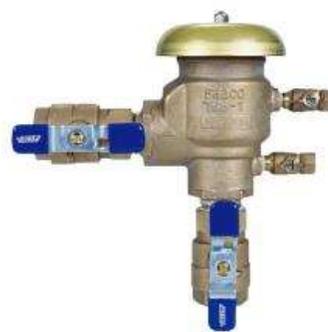
36. DEFICIENCY OBSERVATIONS- Back flow prevention was not present. Each and every individual sprinkler / drip head is not checked for operation. Some sprinkler heads need adjustment as they are over spraying or under spraying their intended range.

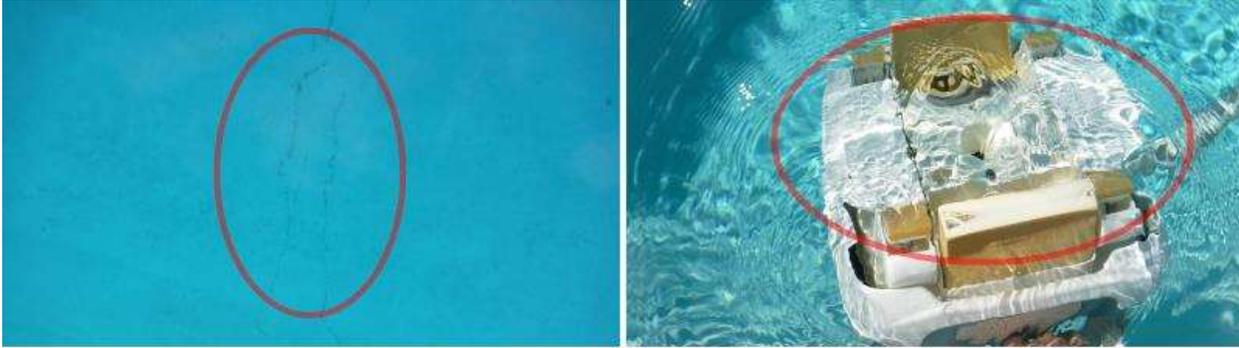
37. Fair overall condition. Drain covers, appear to be entrapment resistant type. Staining / discoloration noted at surface. Call a licensed pool contractor for further evaluation and repairs as recommended.

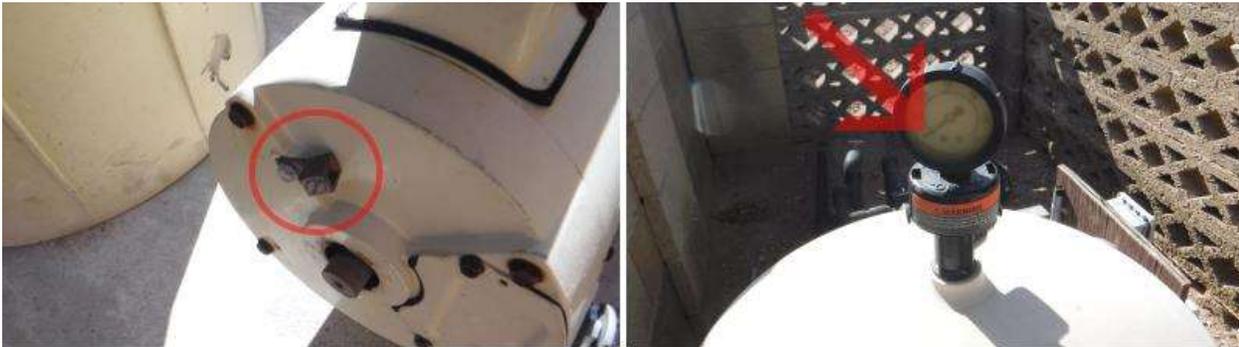
40. Good. Body bond is missing / loose / disconnected.
