Building Inspection Report

7904 Main Street, Anytown, NC

12/3/2010

[Triangle Home Inspection, LLC](#)

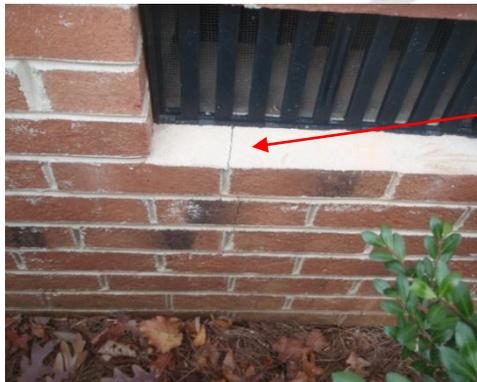
- **Monitor:** There are hairline cracks in the foundation walls. As they are small, there was no apparent movement of the house framing and there was no corresponding cracking of interior walls in these areas. These cracks are most likely normal settling cracks. They should be monitored for movement. Locations: front side right, right side (2 pics).

Crack front side right

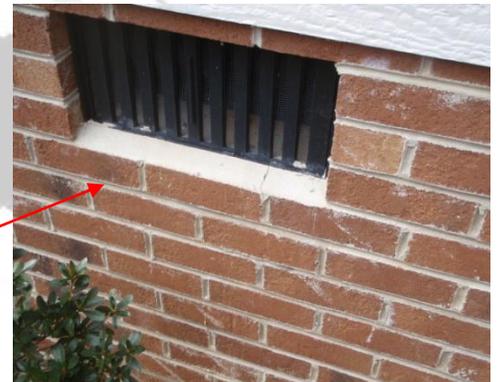
Crack right side

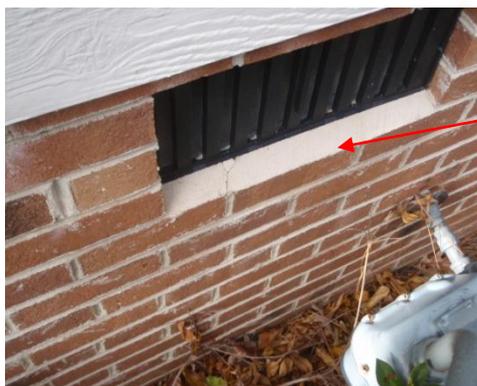
Crack right side

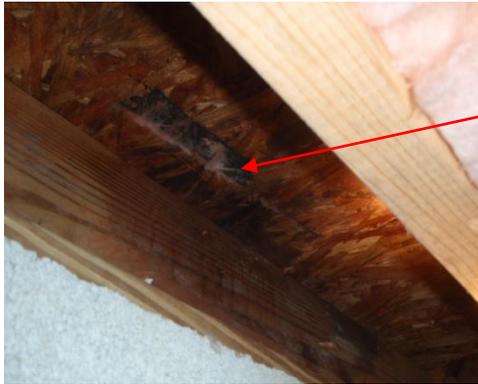
- **Repair:** The floor structure in the crawlspace under the kitchen door to the deck is wet. This will lead to rot in the floor. A licensed general contractor needs to evaluate condition and recommend repairs.

Floor under door to deck is wet

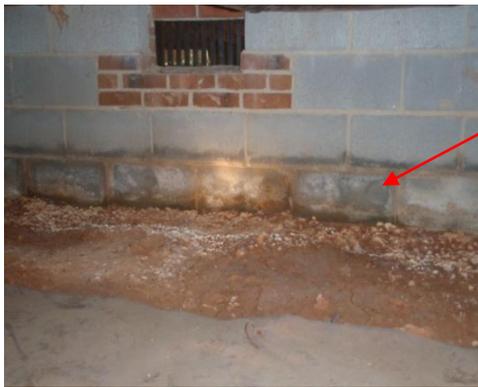
- **Repair:** Moisture is penetrating the right facing foundation wall under the deck. There is evidence moisture has come through some of the other foundation walls (staining on block walls) This can lead to structural issues. A licensed general contractor or other foundation drainage expert needs to evaluate condition and recommend repairs.

Moisture penetrating foundation wall

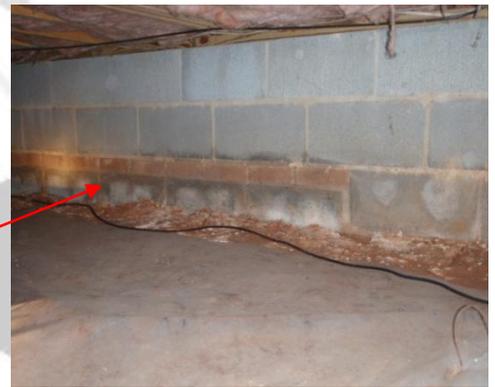
Evidence moisture came through left wall

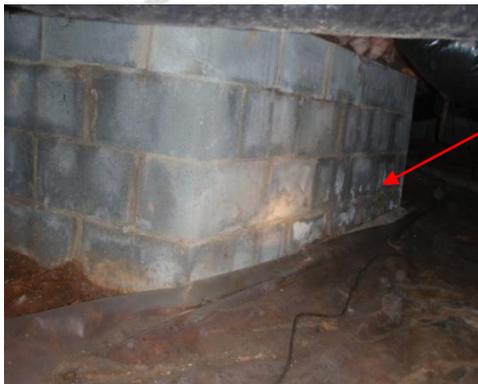
Evidence moisture came through front wall

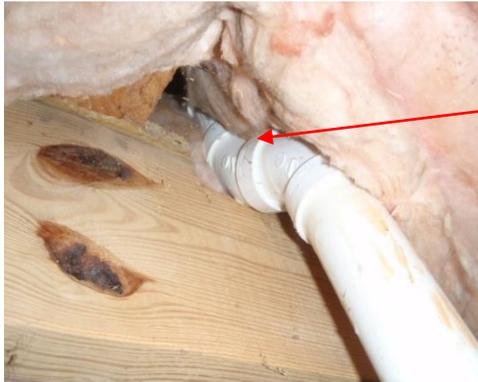
- **Repair:** A floor joist by the crawlspace access has been cut to facilitate the installation of plumbing lines. The joist is designed to support the flooring system with all portions intact. A licensed general contractor needs to evaluate condition and recommend repairs.

Joist has been cut

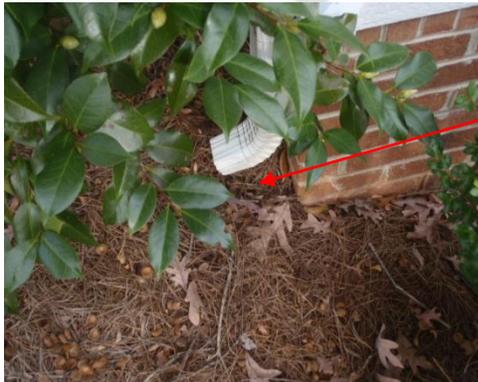
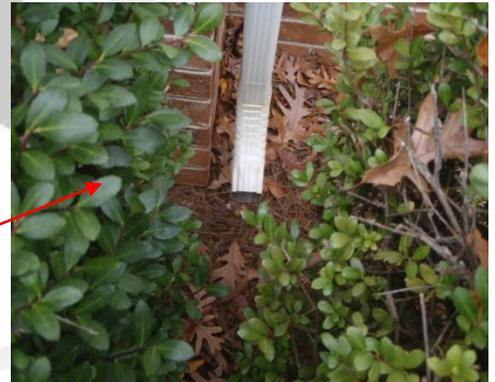
- Discretionary Improvements:** The downspouts need splash blocks or piping (which will allow discharge under the ground). Splash blocks/piping prevent erosion at the downspout discharge. Without splash blocks/piping, the erosion creates an area where water is collected and can cause damage to the house. As an improvement, all downspouts should have a splash block or piping added.

Sample -
downspouts
need splash
blocks or
piping

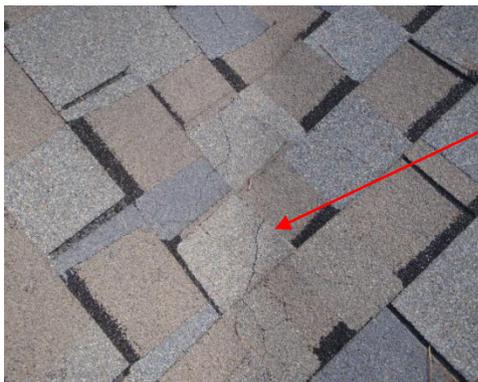
- Monitor:** Some of the shingles have small fissures/cracks. As the shingles are about ten years old and appeared to be intact and secured, these shingles should be monitored. If conditions change, further evaluation should be sought.

Shingles have
small
fissures/cracks

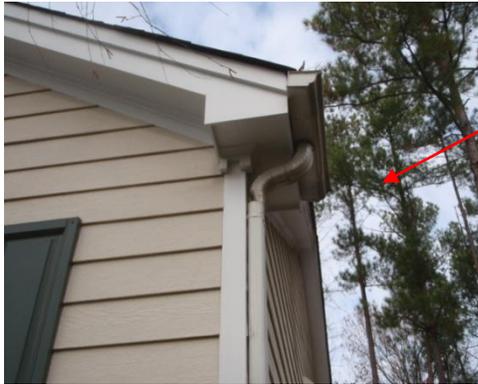
- **Repair:** The right side front downspout is deformed. This will allow the downspout to clog easily and needs to be repaired.

Downspout is deformed

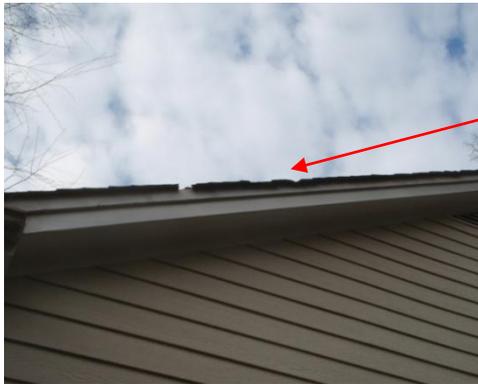
- **Repair:** There are some damaged shingles on the right side front rake area. A qualified roofer should evaluate condition and recommend repairs.

Damaged shingles on right side

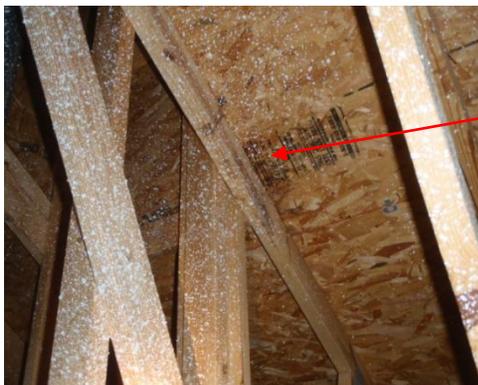
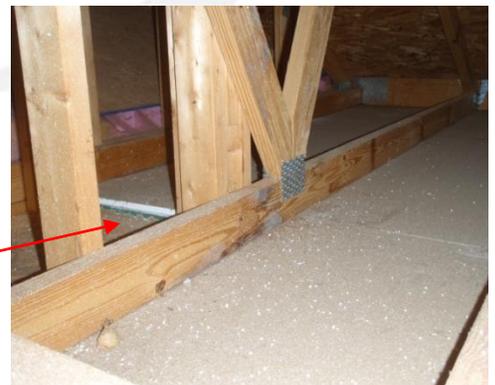
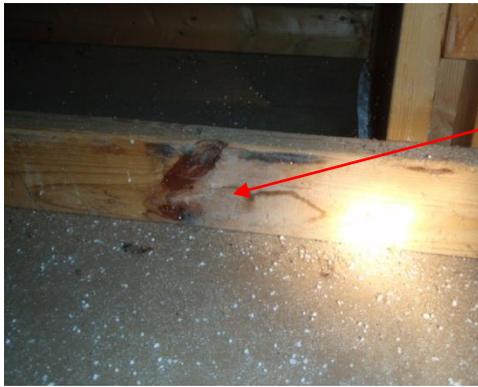
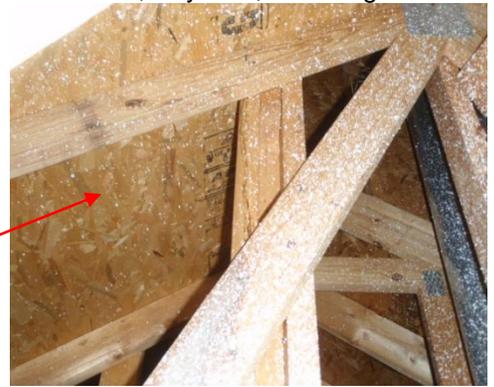
- **Repair:** In the garage there is some staining on the truss members in the attic and on the drywall ceiling below. This suggests there could be a leak above these areas. A qualified roofer should evaluate condition and recommend repairs.

Staining on truss members

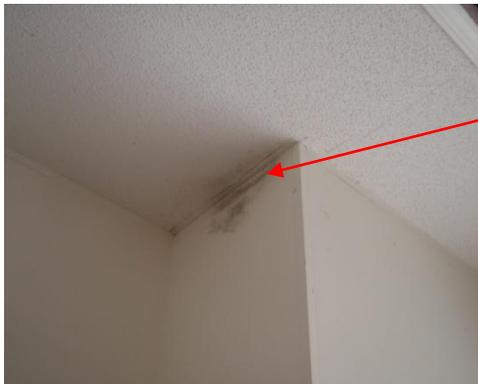
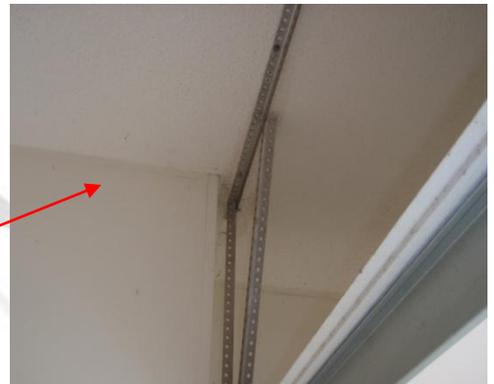
Staining on drywall

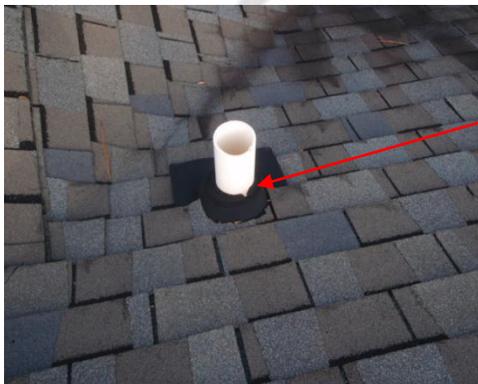
- **Repair:** One of the vent boots on the rear roof is split at the top (around the pipe). This will allow rainwater to run down the pipe. This needs to be repaired or replaced to prevent leakage.

Boot is split at the top

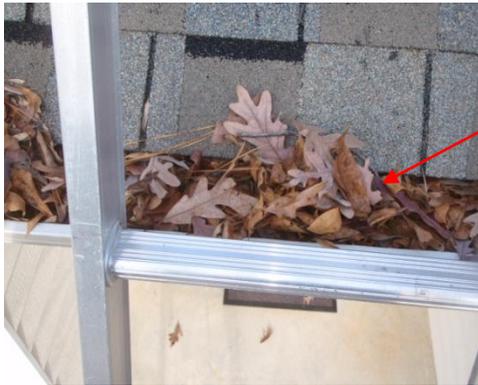
- **Repair:** The gutters need cleaning. The debris in the gutters will hold moisture against the house and promote rot. This debris also prevents the gutters from functioning properly. There was no rot present in the areas examined.

The gutters
need cleaning

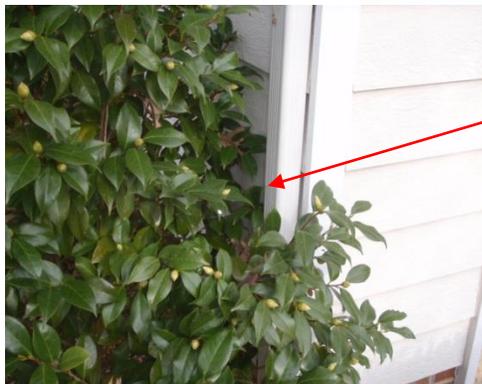
- **Observation:** The deck could use cleaning and re-sealing/staining.
- **Observation:** There are several areas where the caulking is starting to peel/crack (door trim, windowsills, etc.). Caulking is considered normal homeowner maintenance.
- **Observation:** Vegetation should be kept clear of the house. Vegetation close to the house holds moisture close to the house, and provides an entryway for insects.

Vegetation should be kept clear of the house

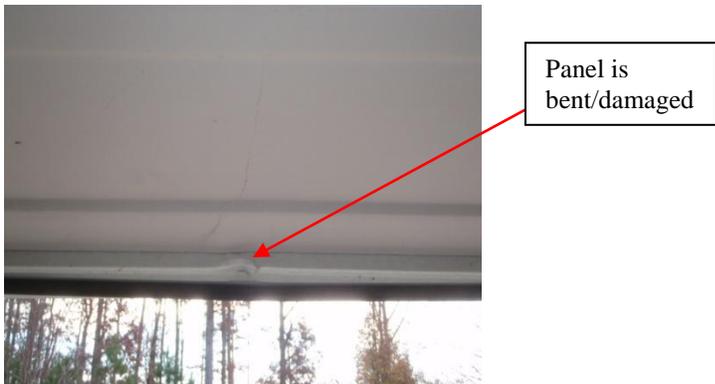
- **Repair:** The lower panel on the garage door is bent/damaged. This needs to be repaired.

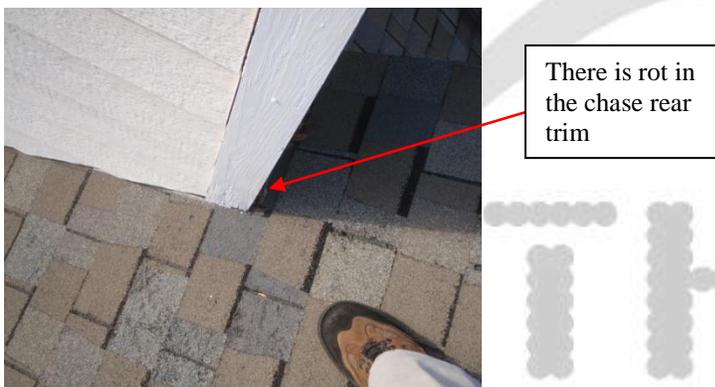
- **Repair:** There is rot in the chase rear trim (this location may have rot in multiple spots). This area needs to be repaired to prevent further deterioration. The repair should include removal and repair of all rotten wood in the areas noted.

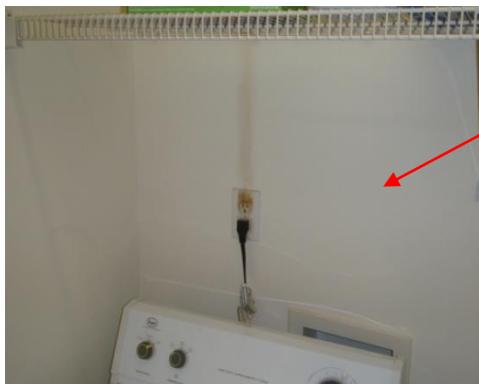
- **Observation:** There is what appeared to be a burned out light bulb in the main house attic. The operation of this fixture should be verified and if bulb replacement does not correct the issue, a repair will be required.
- **Repair:** There is discoloration around the laundry room outlet. This could be charring indicating a short which is a safety hazard. A licensed electrician needs to evaluate condition and recommend repairs.

Discoloration
around the
laundry room
outlet

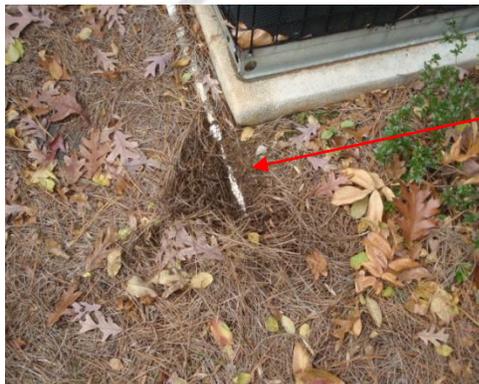
- **Discretionary Improvements:** The installation of carbon monoxide detectors is advisable. A carbon monoxide detector offers protection from the dangers of carbon monoxide.
- **Repair:** The gas pack condensation drain line is buried. This can clog the drain and prevent it from operating properly.

Gas pack
condensation
drain line is
buried

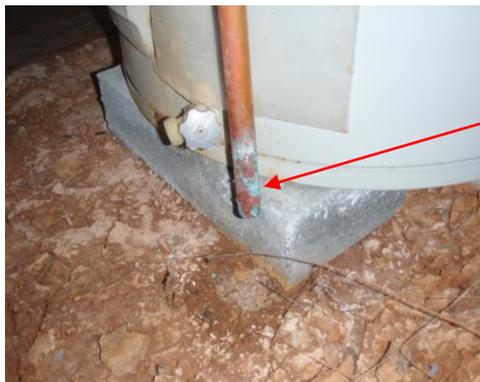
- **Repair:** The hot water tank temperature/pressure relief valve (TPRV) discharge pipe is dripping water in the crawlspace. A licensed plumber needs to evaluate condition of the water heater and recommend repairs.

Discharge
pipe is
dripping

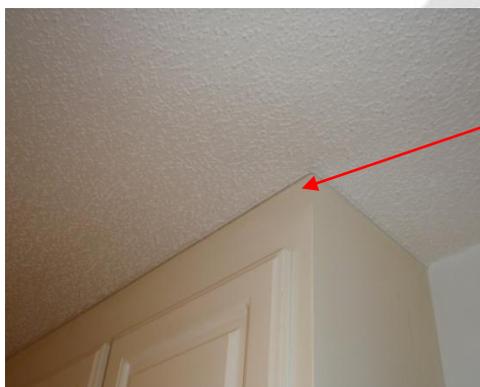
- **Monitor:** The right kitchen cabinet shows some separation at the ceiling. The cabinet appeared to be firmly secured to the wall. This area should be monitored, if conditions change further evaluation should be sought.

Cabinet shows some separation

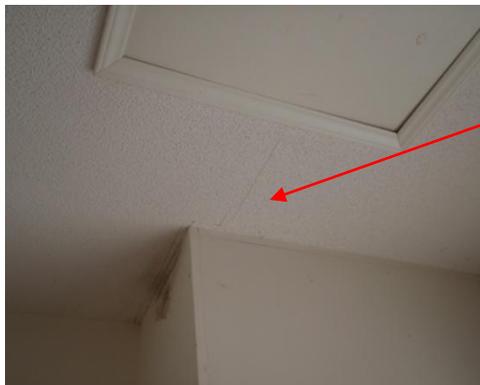
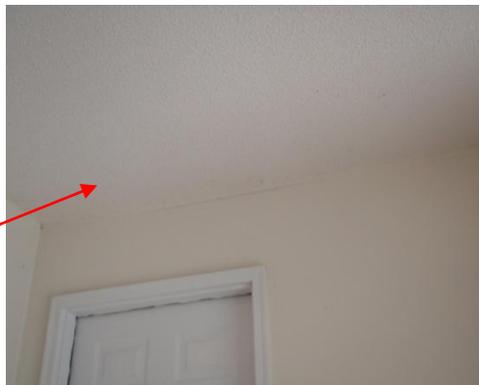
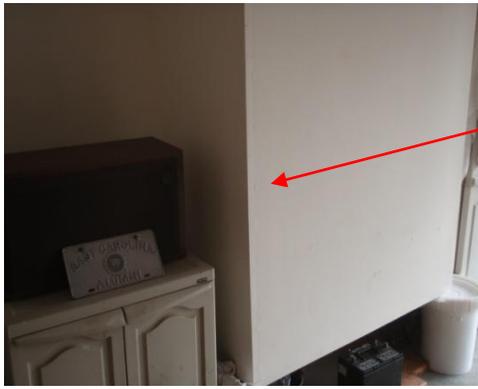
- **Monitor:** There are some hairline cracks in the walls and ceiling. As they are small and there was no apparent movement of the house framing in these areas, these cracks are most likely normal settling cracks. They should be monitored for movement. Locations: garage ceiling and wall, above kitchen door to deck, kitchen front wall at living room interface.

Hairline cracks in garage

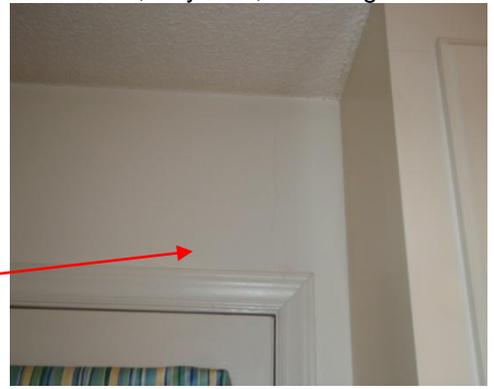
Crack above kitchen door to deck

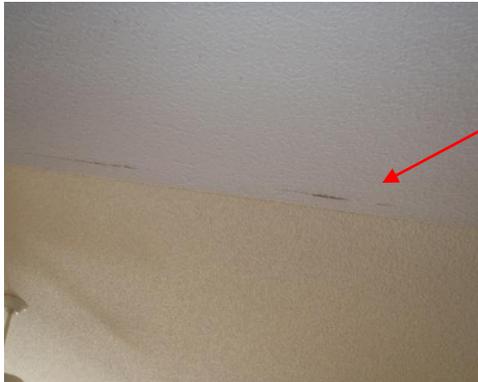
Crack kitchen front wall at living room interface

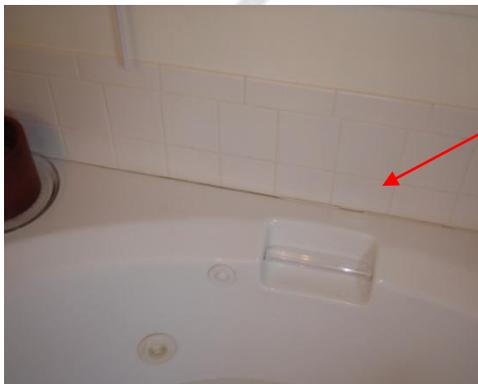
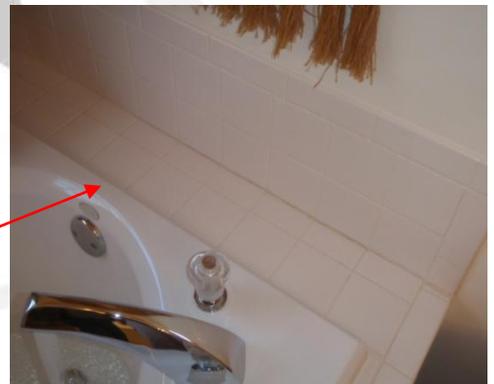
- **Observation:** The tile/bathtub interface on the master bathtub will need normal homeowner maintenance. There are small cracks in this seam.

Interface will need maintenance

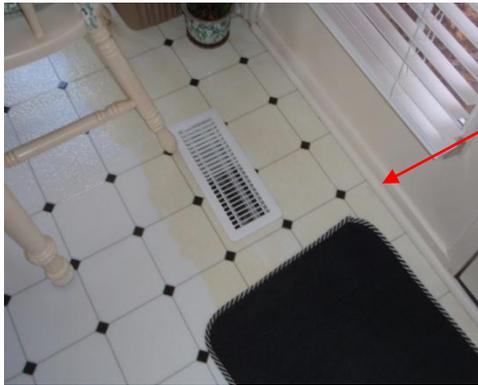
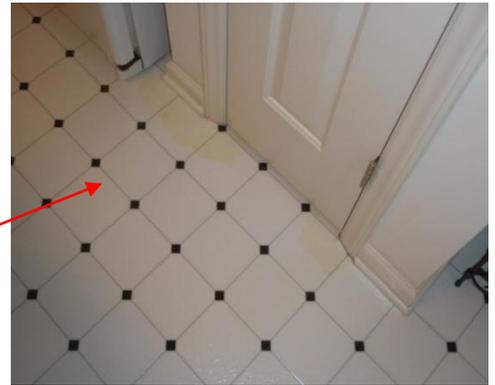
- **Observation:** The kitchen floor has some discoloration. The floor was not wet and this appeared to be a cosmetic issue.

The kitchen floor has some discoloration

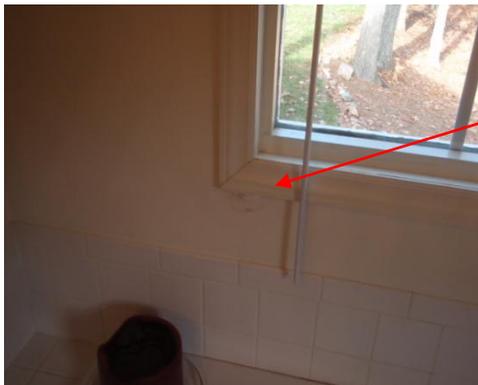
- **Repair:** The hall bathroom toilet paper holder detaches. This needs to be firmly secured as intended.
- **Repair:** There is staining under the master bathroom fixed large window. This may suggest leaking and need to be reviewed by a licensed general contractor.

Staining under window

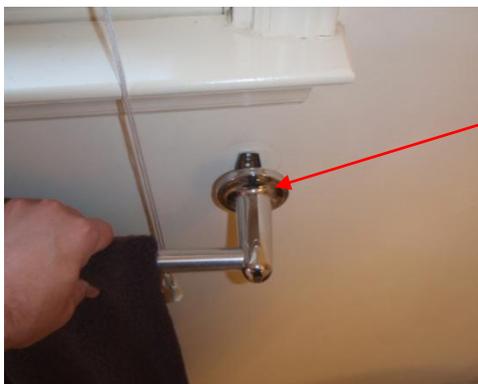
- **Repair:** The master bathroom towel rod detaches. This needs to be firmly secured as intended.

Master bathroom towel rod detaches

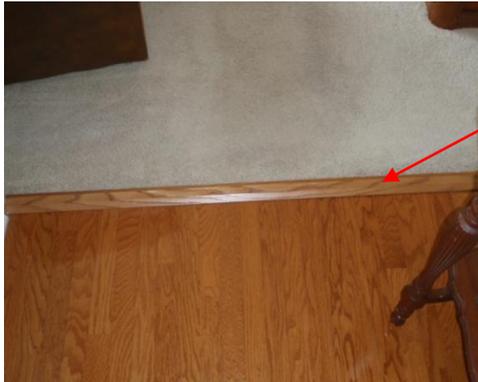
- **Repair:** The front side right bedroom door did not latch when closed. This needs to be repaired such that the door latches when closed as intended.
- **Repair:** The threshold on the left of the foyer is loose. This is a trip hazard and needs to be repaired.

Threshold is loose
