Marine Survey Report For [REDACTED]

## 1988 Brewer 44' Cutter

24044

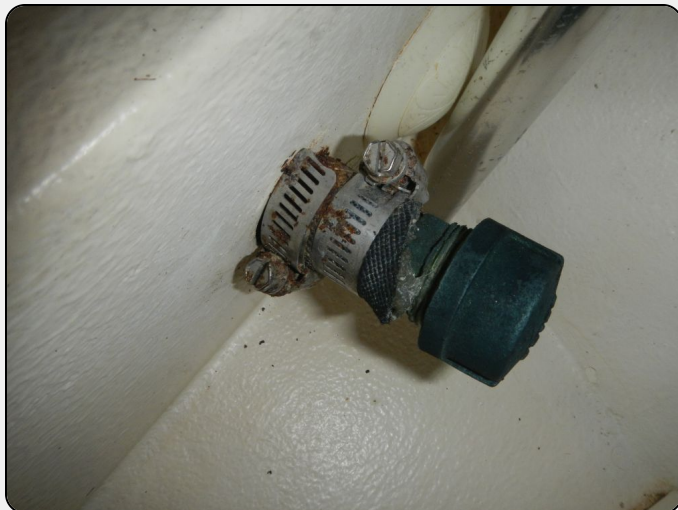
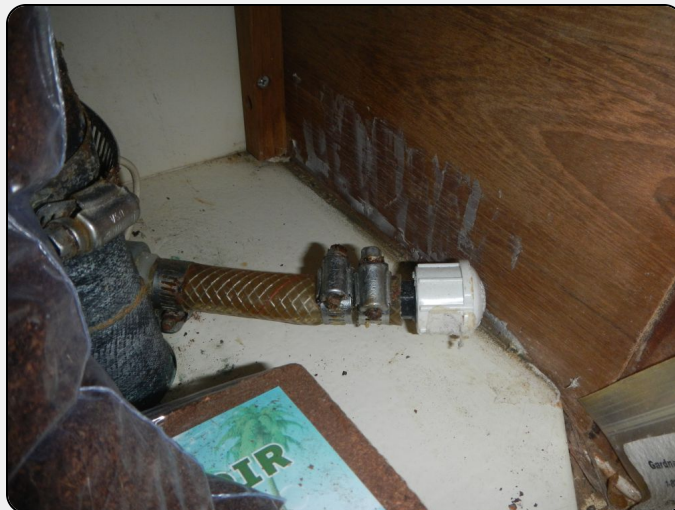
**FINDING B-15 WATER CLOSET(S)**

The V berth water closet sink would not drain and was leaking under the sink cabinetry. In addition there is a broken and corroded hose clamp on the drain line.

Repair V berth water closet sink.

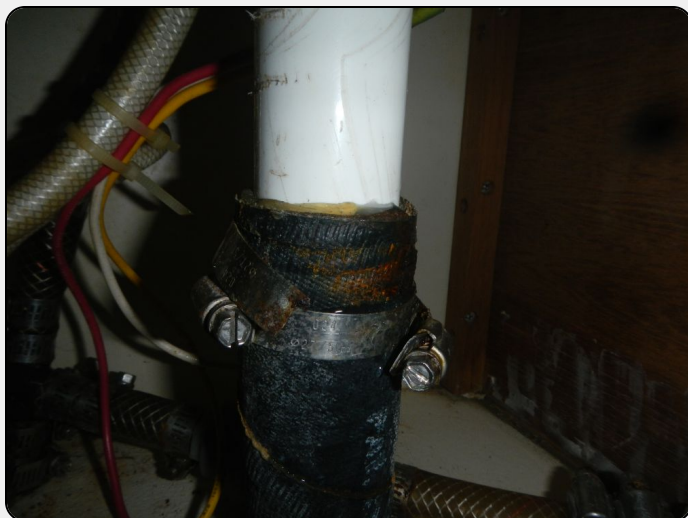
**FINDING B-16 WATER CLOSET(S)**

The shower sump pumps for both water closets were inoperable.

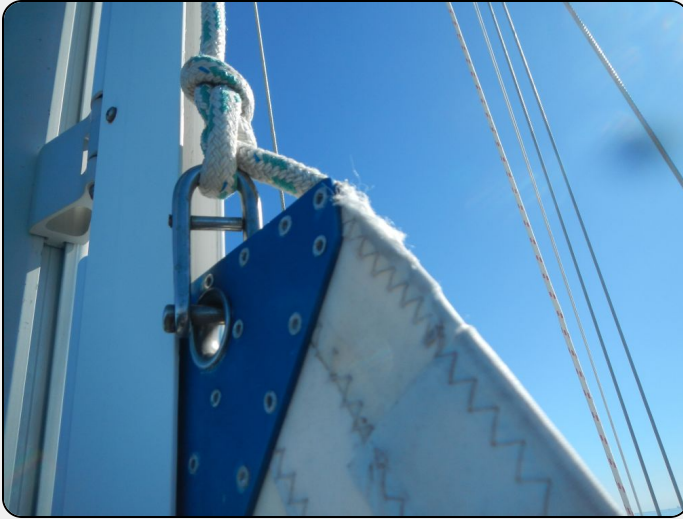
**FINDING C-6 SAILS**

Staysail clew has damage to the Dacron.

Seize or repair area with sail thread or hemming.
