# CONEJOS RIVER

## DIVERSION INFRASTRUCTURE INVENTORY

**Structure Name:** ALAMO D

**Date:** April 17, 2019

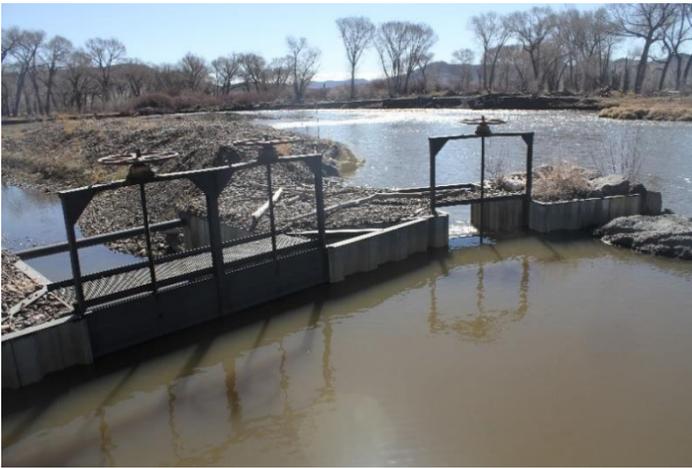
Headgate looking downstream

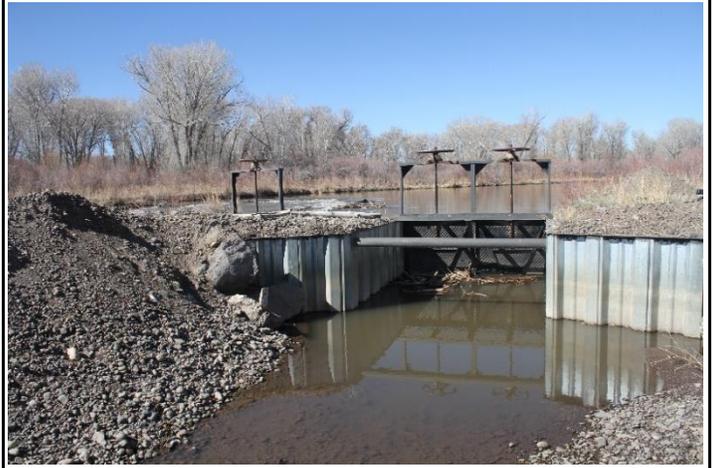
Headgate outlet

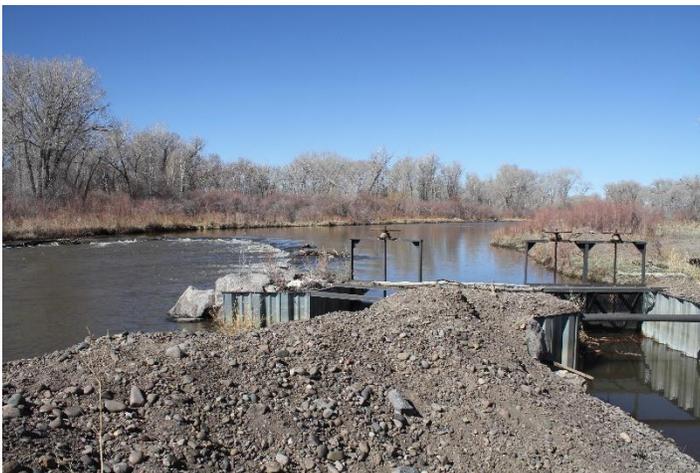
Headgate and diversion dam (upstream)

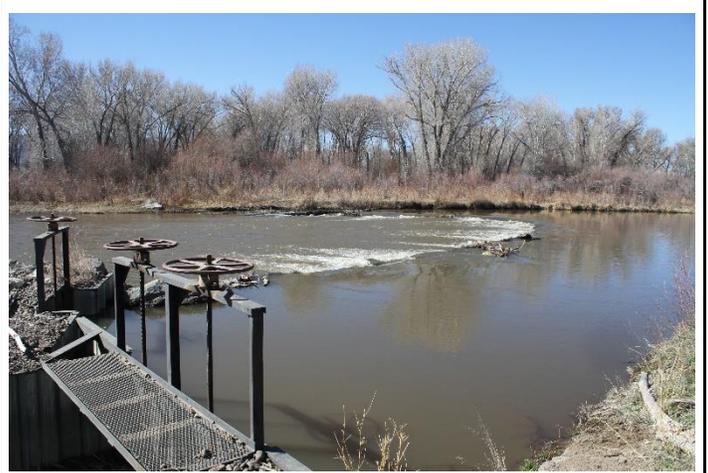
Headgate and diversion dam

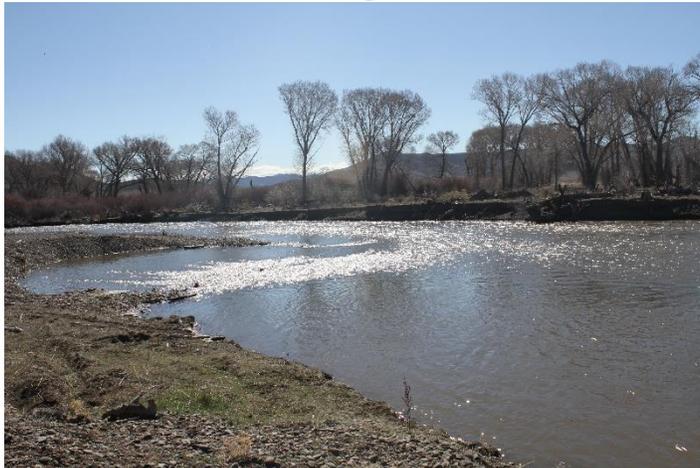
**Structure Description:** A U-shaped rock weir diversion dam directs water to the headgate, which is located on the north bank of Conejos River. The headgate is located on the inside of a meander. A sluice gate sits adjacent to the main headgate. Upstream of the diversion, meanders have been developing over the last 45 years and meander cutoffs are likely in the future. The headgate and diversion dam require regular maintenance due to the sand/small gravel-dominated substrate but otherwise function well. Debris accumulates in the ditch downstream of the headgate and in the flume. This woody debris needs to be regularly removed, especially from the Parshall flume. The south bank of the river immediately downstream of the headgate is experiencing significant erosion and lacks floodplain connection

Channel looking downstream

**Repair(s) or Improvement(s) Currently Needed:** The SMP Technical Advisory Team (TAT) recommends bank restoration by installing rock structures to reduce erosion and reconnecting this part of the river with its floodplain. The TAT also recommends maintaining fish passage to preserve aquatic habitat connectivity in this reach

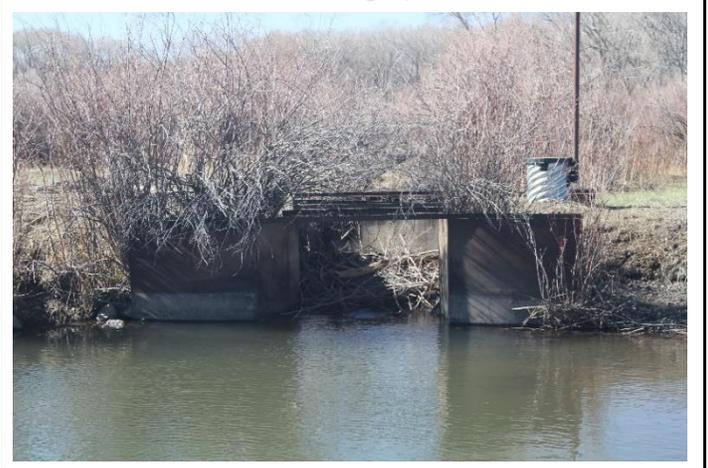
Flume looking upstream

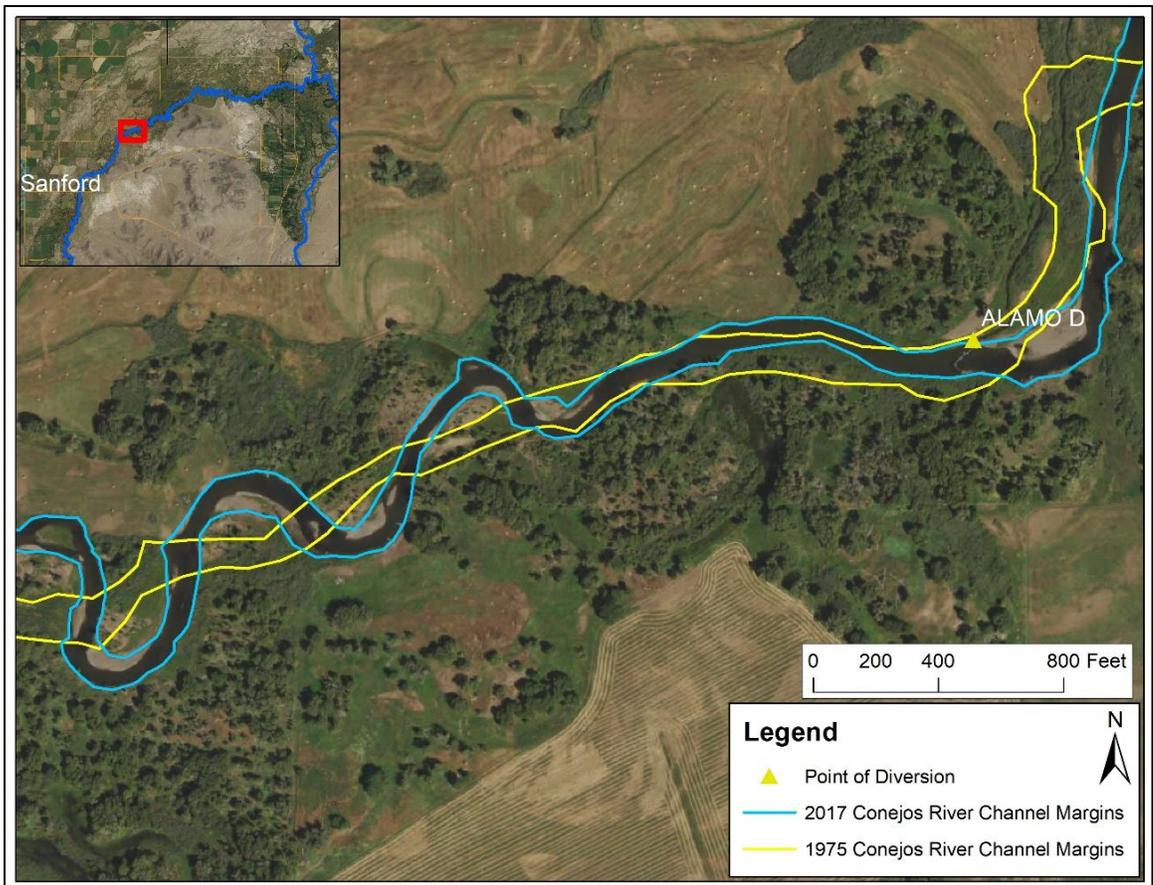
Headgate location with 1975 and 2015 channel margins overlaid, illustrating meander development upstream of diversion
