CONEJOS RIVER

DIVERSION INFRASTRUCTURE INVENTORY

Structure Name: ANGUSTURA D

ANGUSTURA DITCH

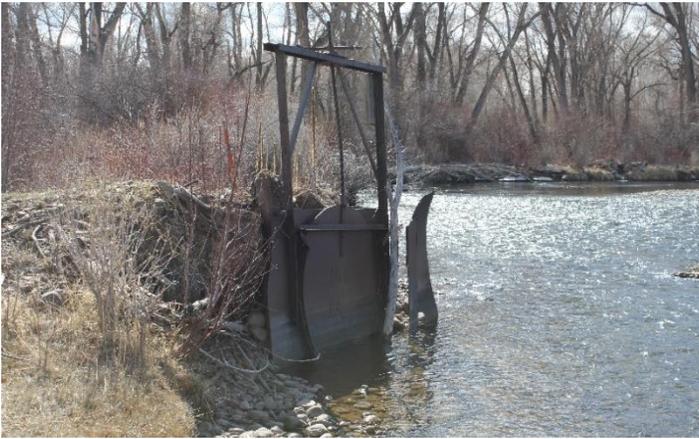
Structure Description: There is no diversion dam for this structure. The headgate is located on the north bank of the river. The bank upstream of the headgate is eroding, causing flows to bypass the headgate and enter the ditch, especially at high flows. The headgate also leaks, causing additional flows to enter the ditch. The headgate needs to be repaired or replaced. Bank stabilization is also recommended to ensure the headgate does not experience catastrophic failure during high flows. Although the channel near this structure has migrated historically (pre-1970s), it has not experienced significant lateral migration since 1998 or earlier. The channel upstream of headgate is widening and flows could bypass the headgate, especially at high flows.

Headgate looking downstream

Repair(s) or Improvement(s) Currently Needed: Given the stressors affecting this structure, the SMP Technical Advisory Team (TAT) recommends bank stabilization upstream of the diversion as well as riparian revegetation and aquatic habitat restoration. The TAT also recommends maintaining fish passage for aquatic habitat connectivity in this reach. Bank stabilization structures and riparian revegetation would help prevent flows from bypassing the headgate. Alternatively, the headgate and point of diversion could be relocated upstream as a long-term solution to localized erosion at the headgate. Aquatic habitat enhancement, especially the creation of a low-flow channel near the diversion, would improve the fisheries.

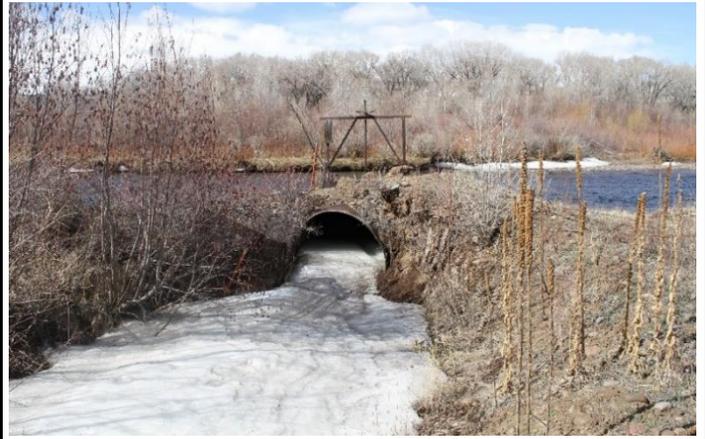
Headgate outlet

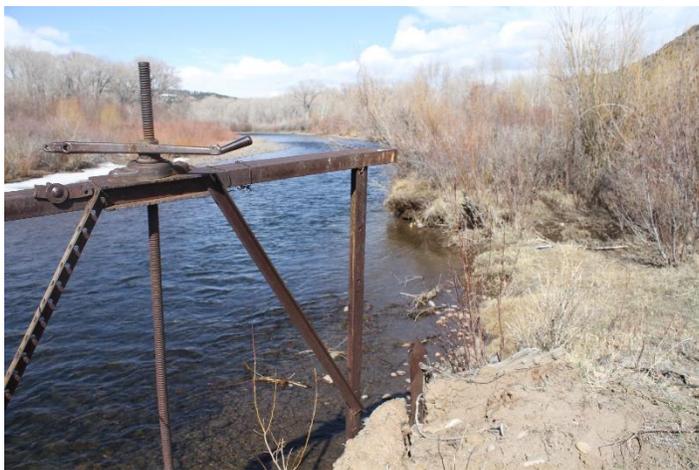
River channel upstream of headgate

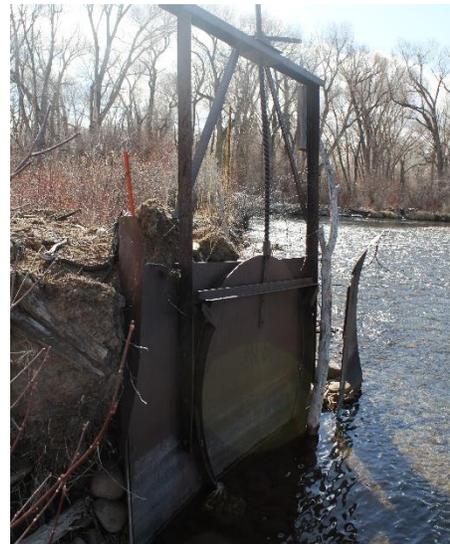
Close up of headgate

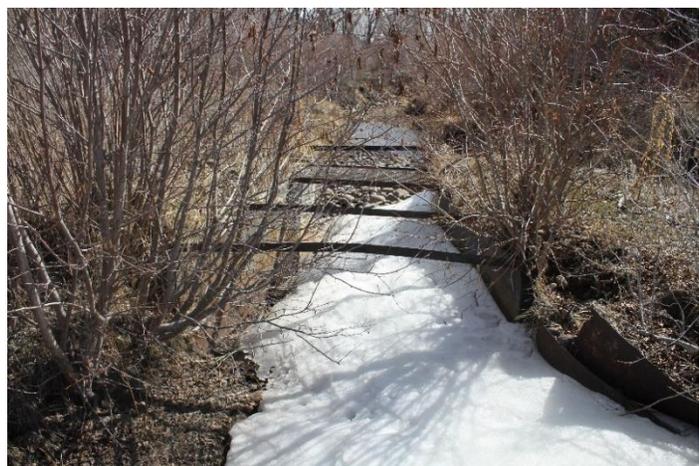
Flume looking downstream

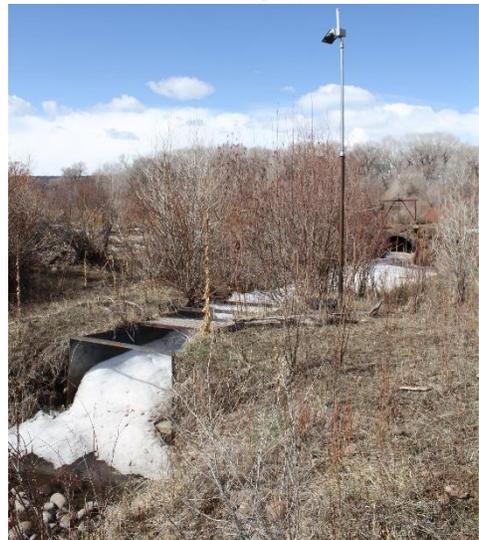
Flume looking upstream

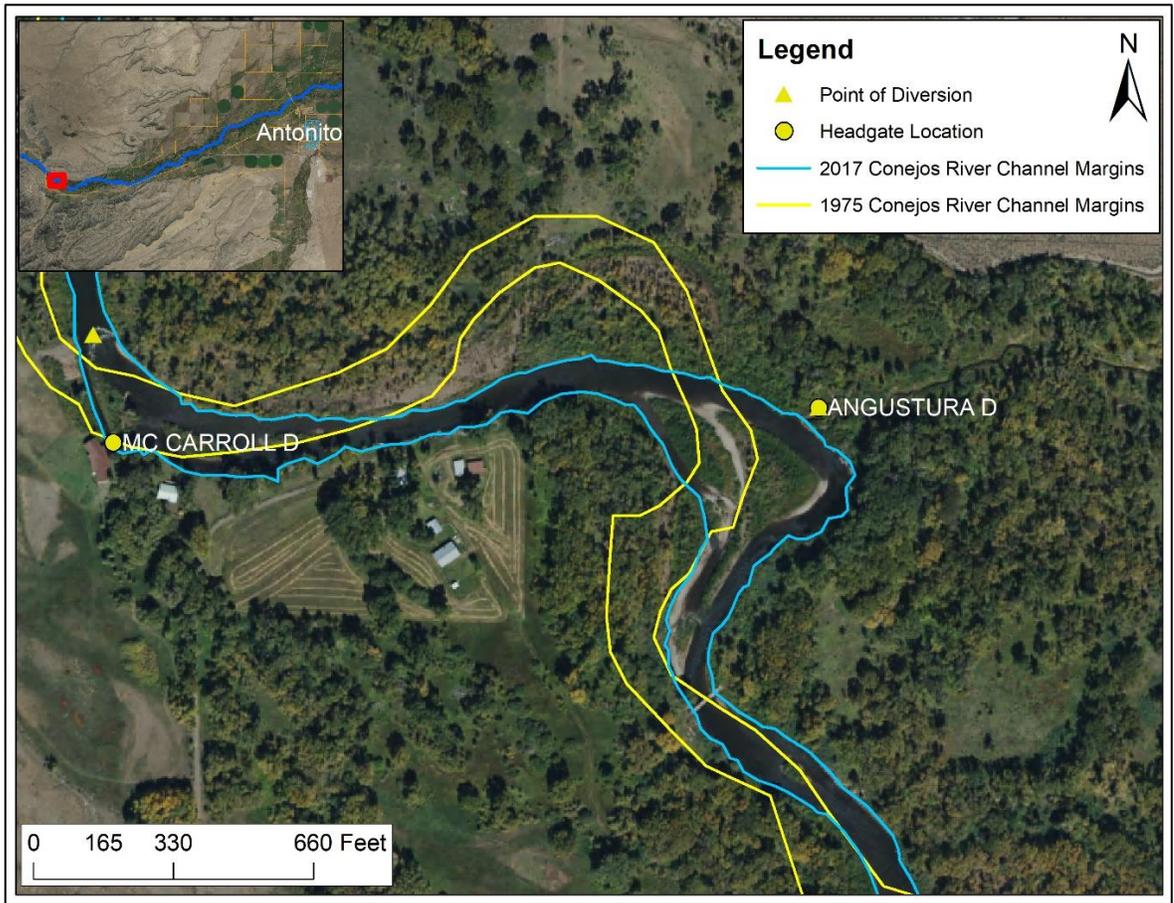
Angustura Ditch point of diversion with 1975 and 2017 channel margins overlaid

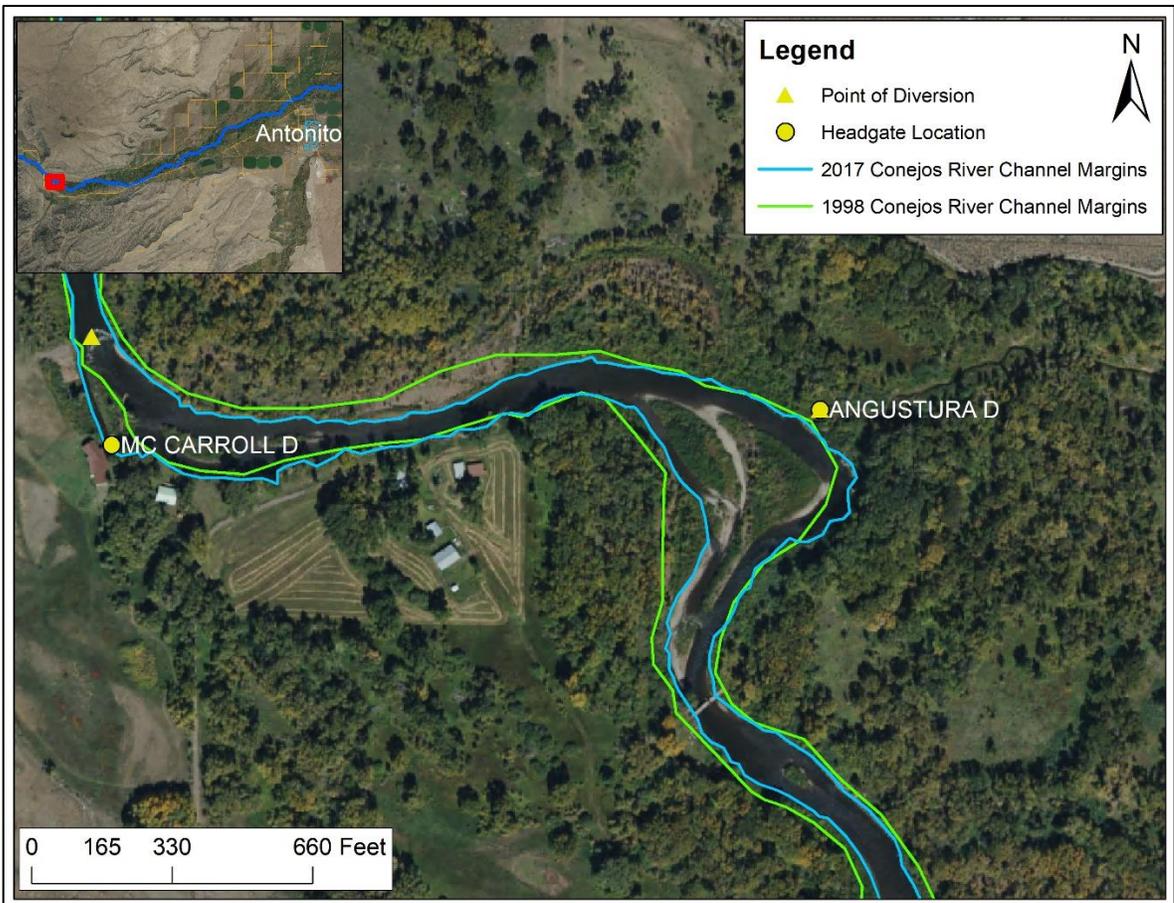
Angustura Ditch point of diversion with 1998 and 2017 channel margins overlaid
