CONEJOS RIVER DIVERSION INFRASTRUCTURE INVENTORY

Structure Name: ANTONITO D

Date: April 15, 2019

ANTONITO DITCH

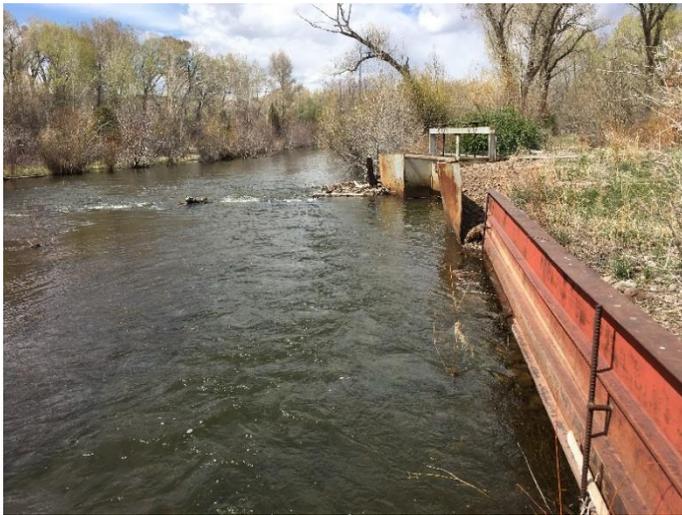
Headgate looking downstream

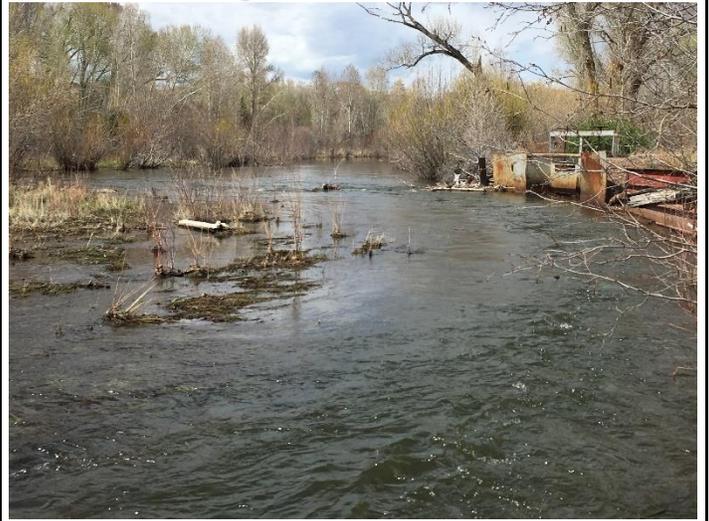
Headgate and diversion dam

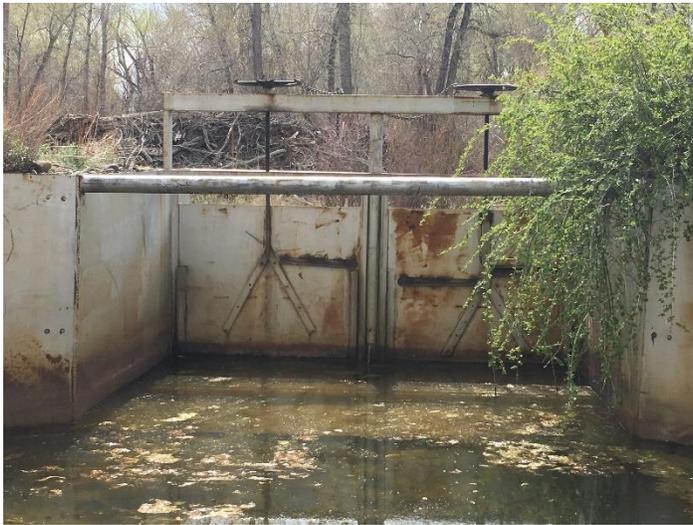
Headgate outlet

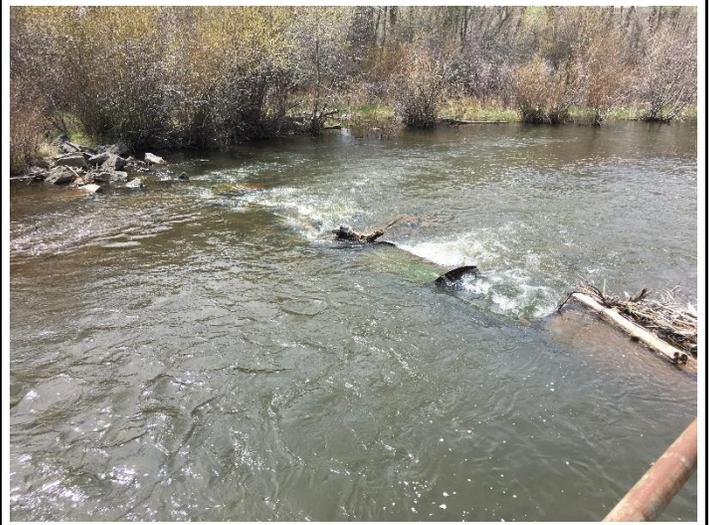
Diversion dam

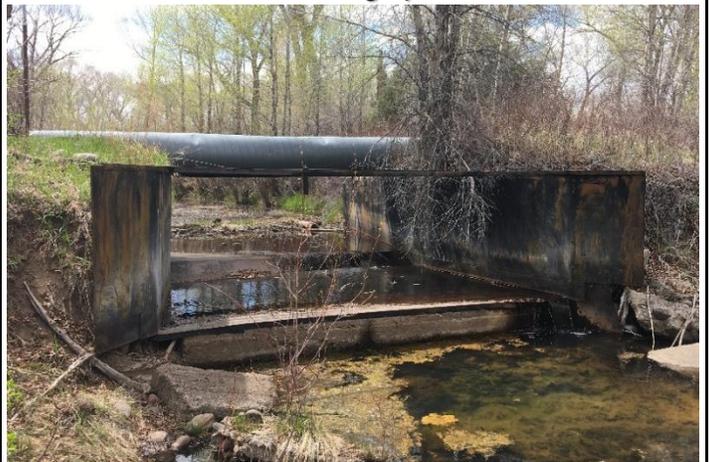
Flume looking upstream

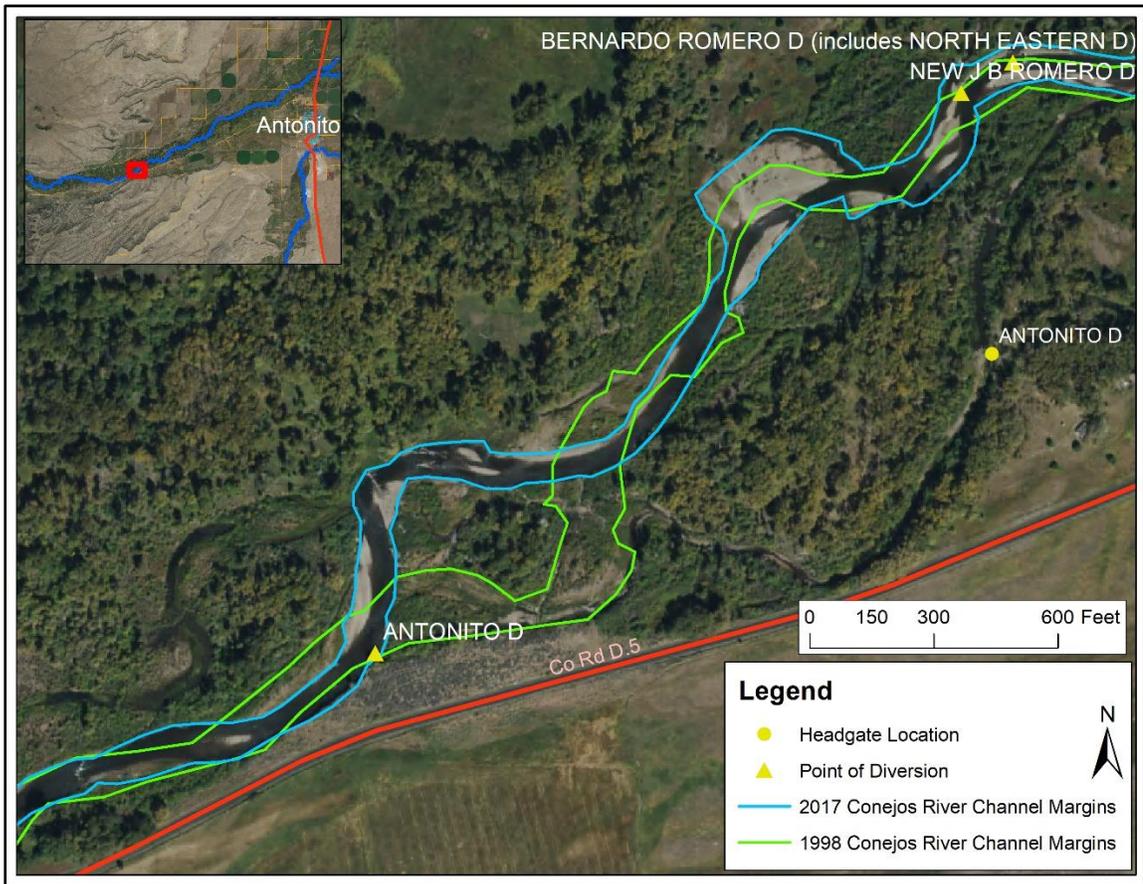
Structure Description: This structure has no formal diversion dam off the Conejos River. Water is delivered to the headgate via a 0.4 mile feeder channel. A small stacked rock diversion dam on the feeder channel directs water to the headgate. Lateral migration is occurring at the point of diversion, and the river has experienced significant avulsion since 1998. Channel migration analysis suggests that in 1960, the river channel followed this structure's feeder channel. This channel may be recaptured in the future.

Antonito Ditch with 1998 and 2017 channel margins overlaid

Repair(s) or Improvement(s) Currently Needed: Aside from monitoring channel migration, no repair needs were noted.

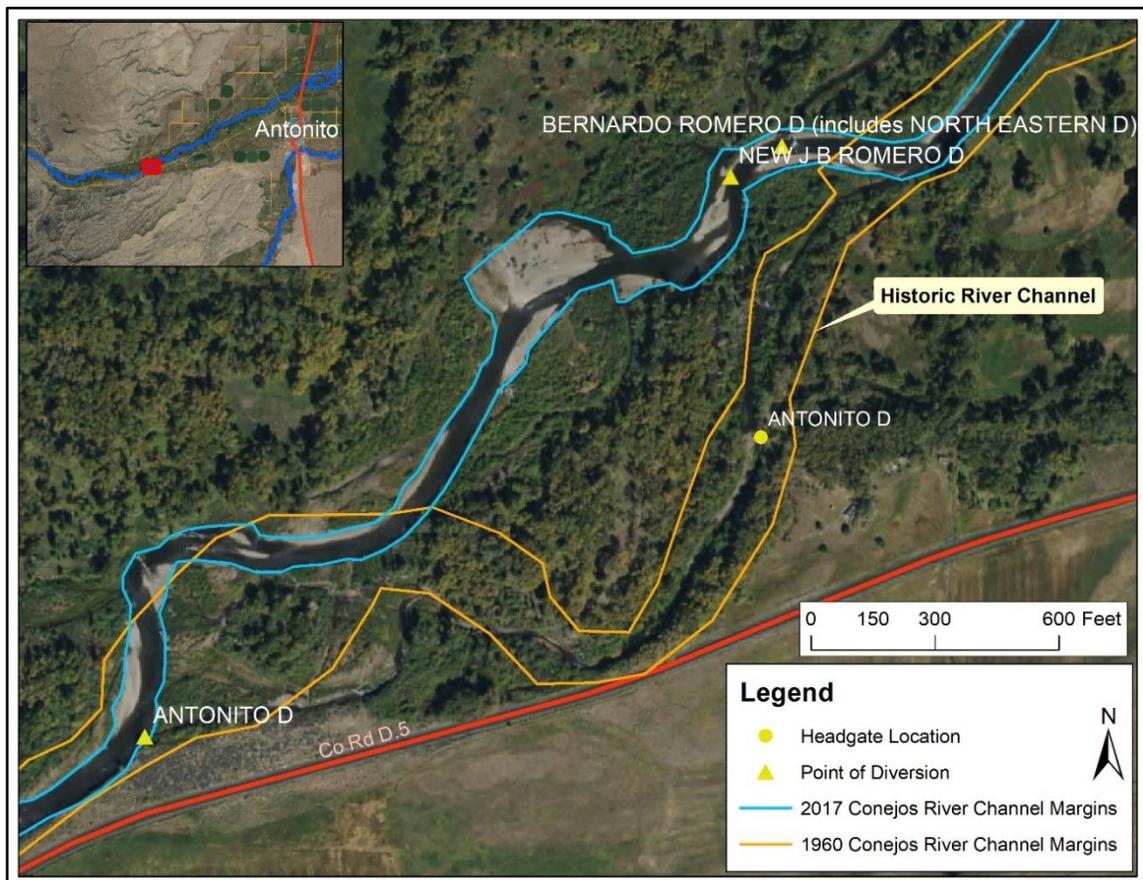
Map of historic river channel (1960), showing potential for river to migrate and recapture the historic channel in the future
