# CONEJOS RIVER

## DIVERSION INFRASTRUCTURE INVENTORY

**Structure Name:** ARCHULETA TROGILLIO NO 1

**Date:** April 15, 2019

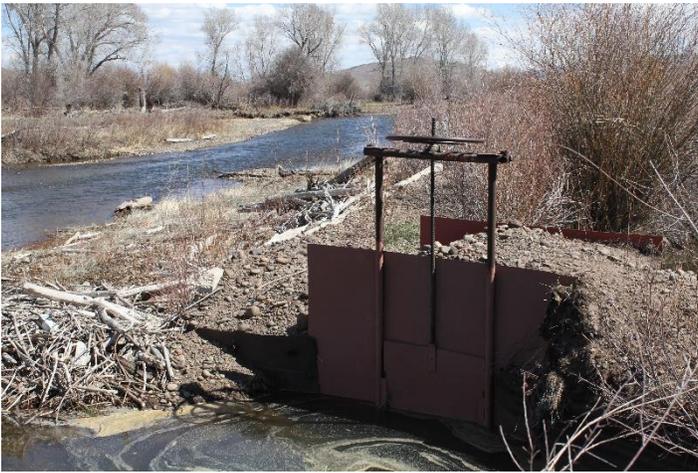
Headgate looking downstream

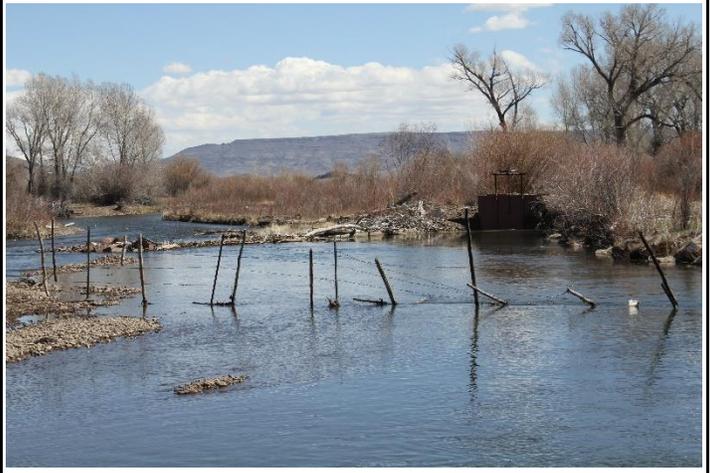
Headgate and diversion dam

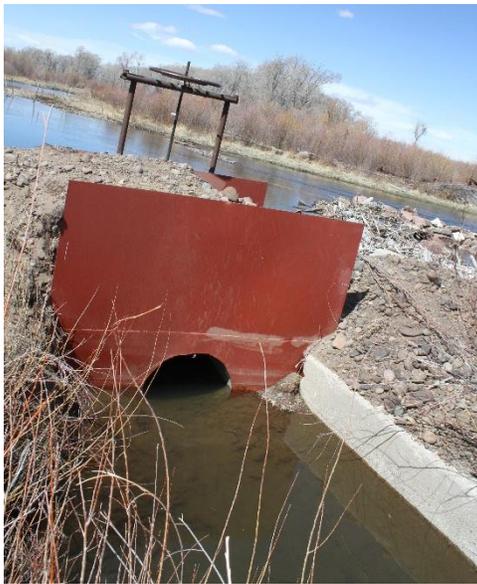
Headgate outlet

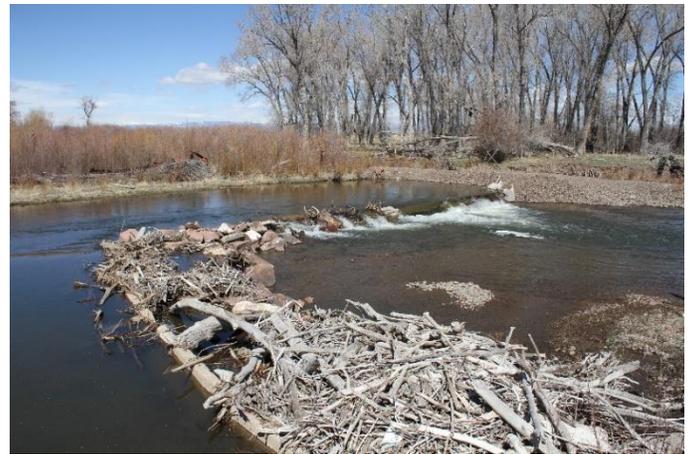
Diversion dam

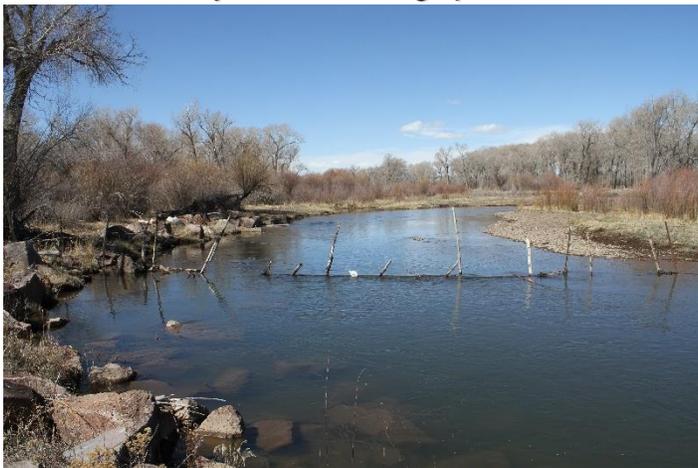
Conejos River looking upstream

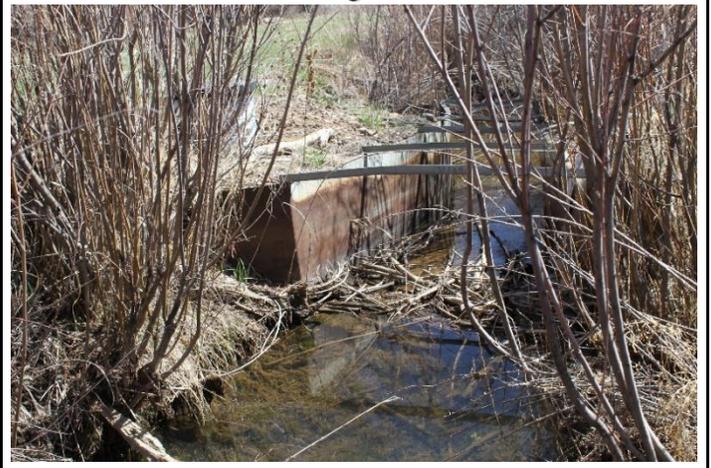
Flume looking downstream

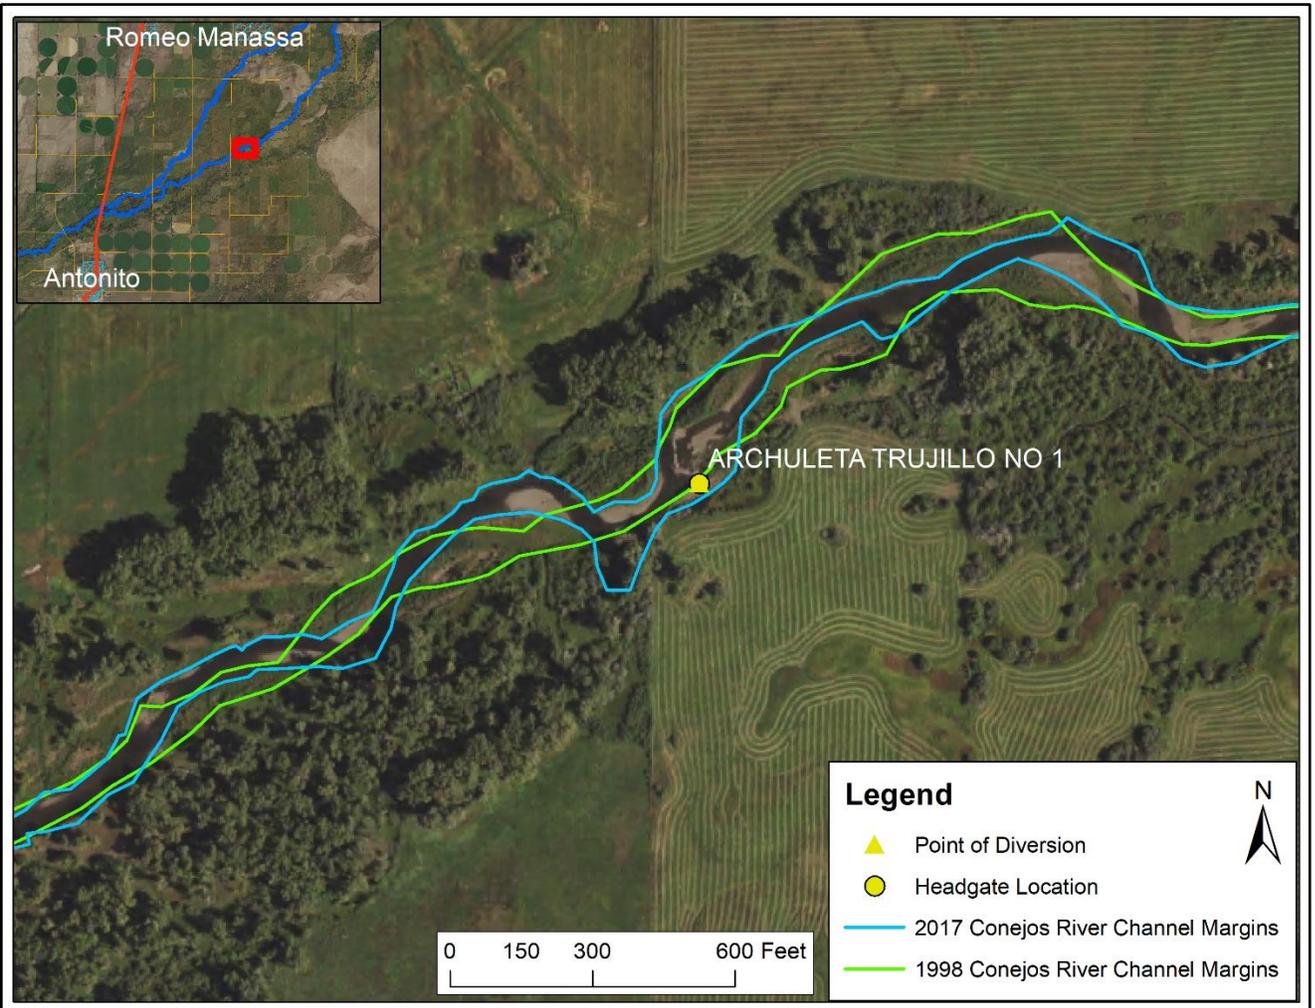
**Structure Description:** There is no diversion dam for this structure. The headgate is located on the north bank of the river. The bank upstream of the headgate is eroding, causing flows to bypass the headgate and enter the ditch, especially at high flows. The headgate also leaks, causing additional flows to enter the ditch. The headgate needs to be repaired or replaced. Bank stabilization is also recommended to ensure the headgate does not experience catastrophic failure during high flows. Although the channel near this structure has migrated historically (pre-1970s), it has not experienced significant lateral migration since 1998 or earlier. The channel upstream of headgate is widening and flows could bypass the headgate, especially at high flows.

Headgate location with 1998 and 2017 channel margins overlaid.

**Repair(s) or Improvement(s) Currently Needed:** Given the stressors affecting this structure, the SMP Technical Advisory Team (TAT) recommends bank stabilization upstream of the diversion as well as riparian revegetation and aquatic habitat restoration. The TAT also recommends maintaining fish passage for aquatic habitat connectivity in this reach. Bank stabilization structures and riparian revegetation would help prevent flows from bypassing the headgate. Alternatively, the headgate and point of diversion could be relocated upstream as a long-term solution to localized erosion at the headgate. Aquatic habitat enhancement, especially the creation of a low-flow channel near the diversion, would improve the fisheries.

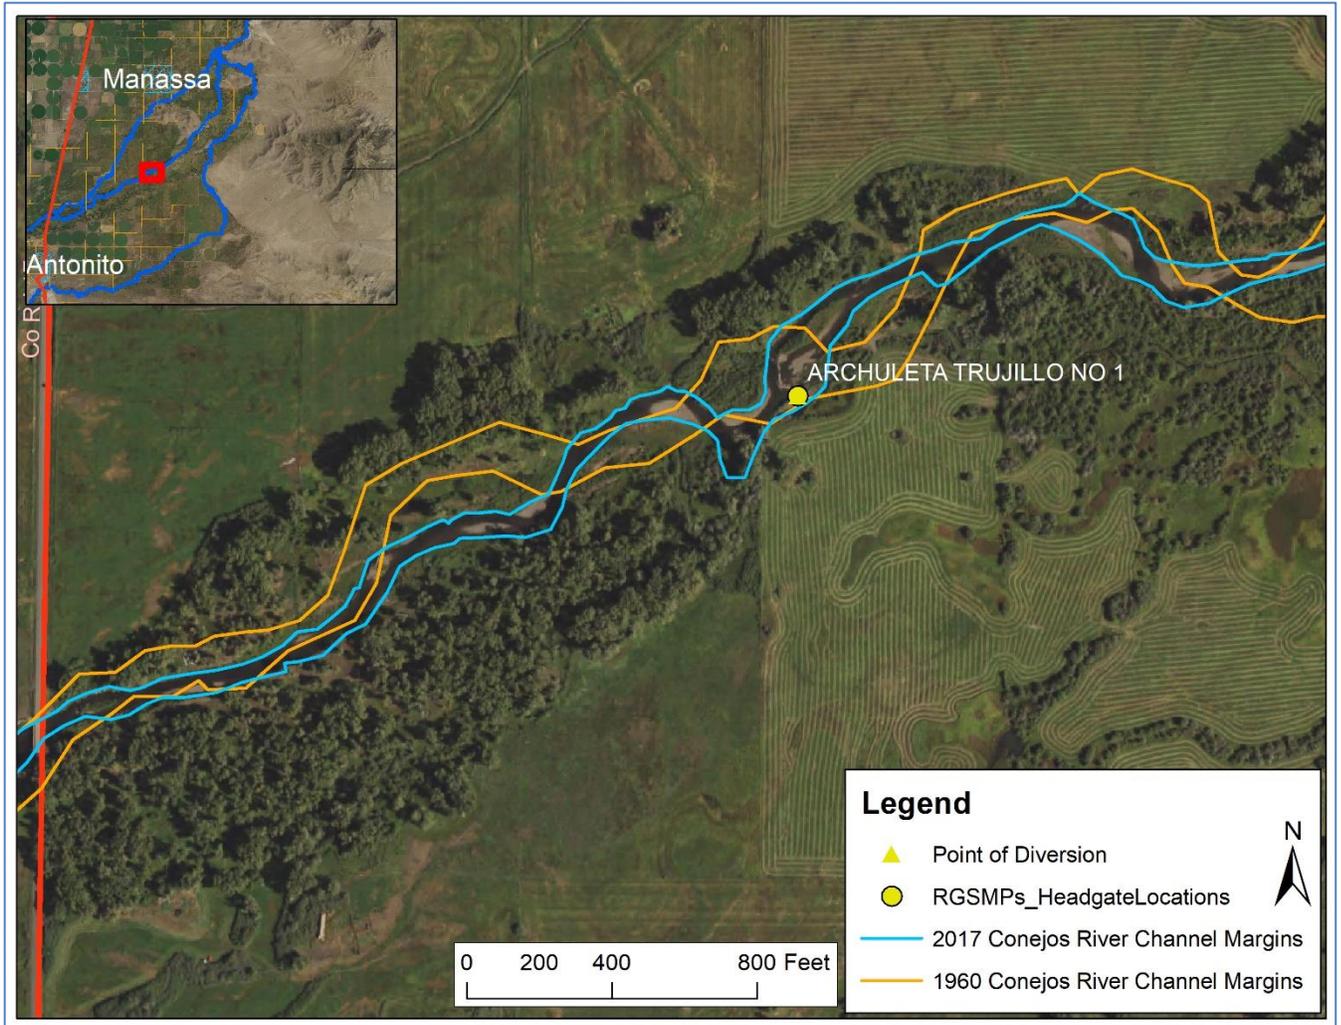
Headgate location with 1960 and 2017 channel margins overlaid.
