# CONEJOS RIVER DIVERSION INFRASTRUCTURE INVENTORY

**Structure Name:** BAGWELL D

**Date:** April 15, 2019

Conejos River Stream  
Management Plan

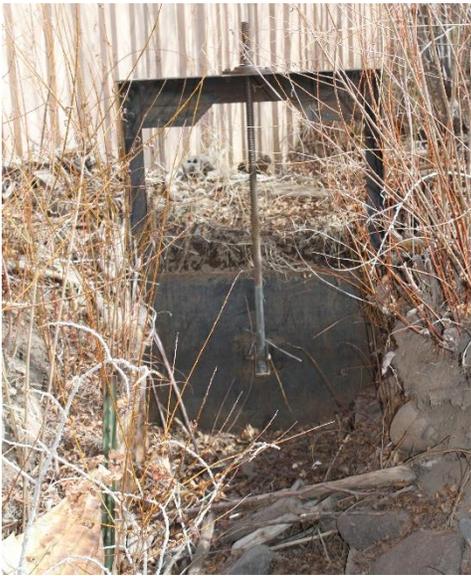
Headgate looking downstream

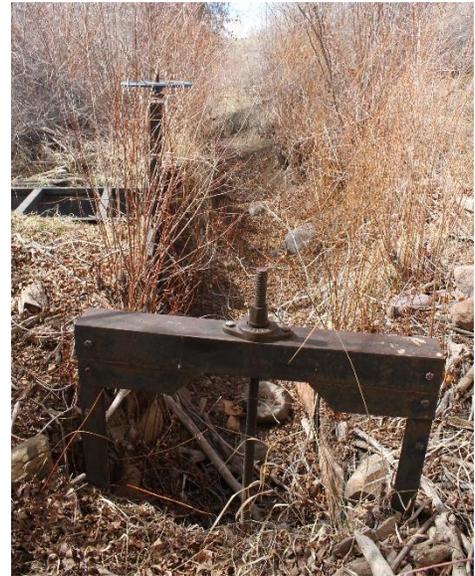
Headgate and sluice gate

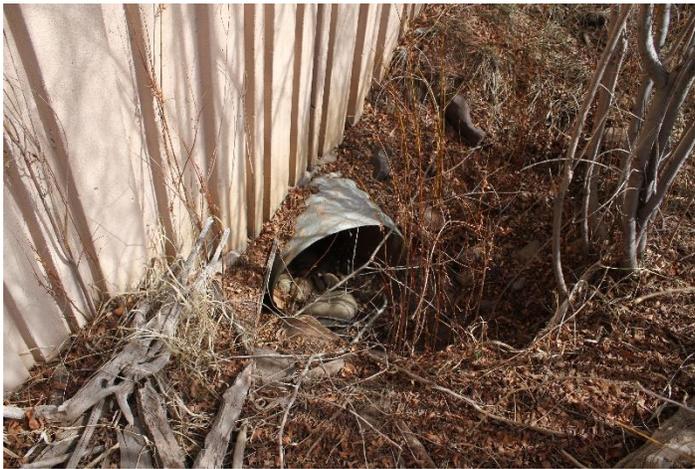
Headgate outlet

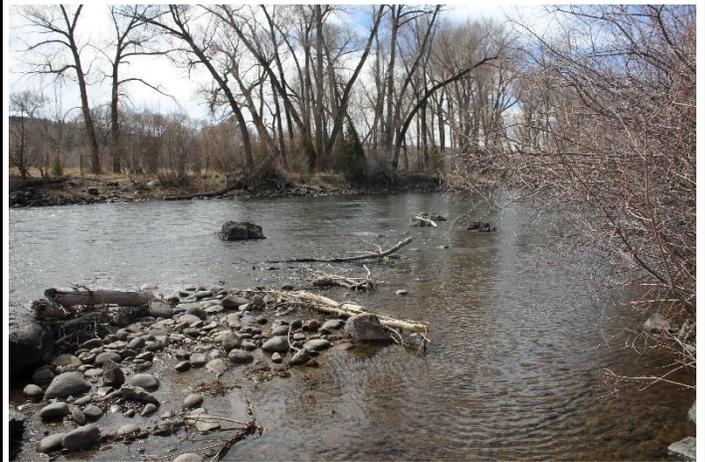
Diversion dam

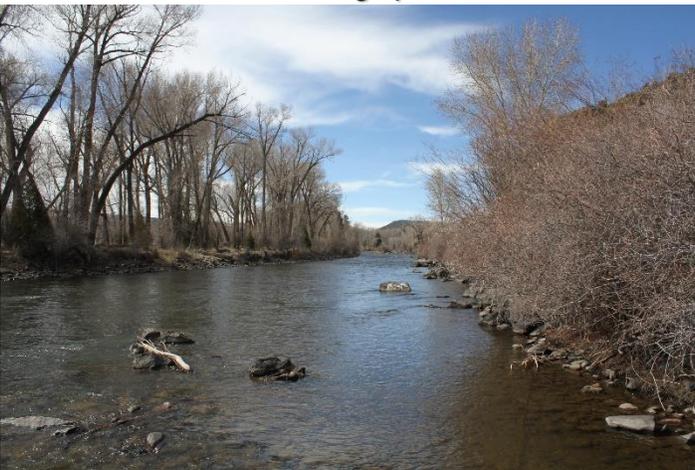
River looking upstream

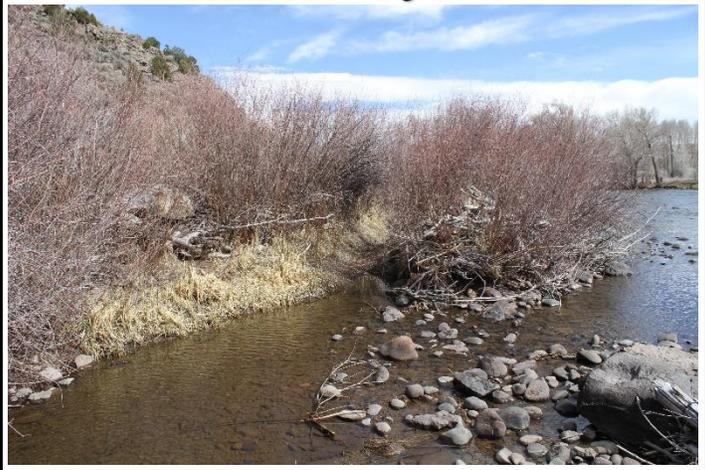
Ditch entrance looking downstream
