# CONEJOS RIVER DIVERSION INFRASTRUCTURE INVENTORY

**Structure Name:** BRANCH D

**Date:** April 15, 2019

PHOTO LOG

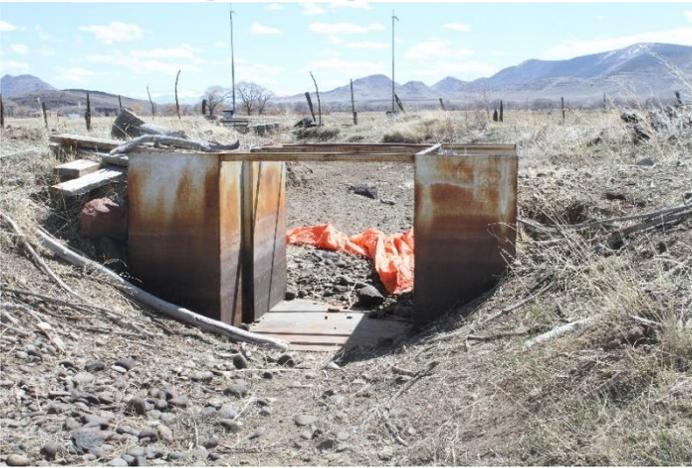
**Structure Description:** The channel is unstable in this location and prone to migration and avulsion. A check board diversion dam supported on either side by tires creates head pressure and directs water to the headgate. The headgate is difficult to operate. The soil supporting the headgate wing walls is eroding. The flume's wing walls are also eroding.

Headgate looking downstream

**Repair(s) or Improvement(s) Currently Needed:** Given the issues identified at this structure, the SMP Technical Advisory Team (TAT) recommends replacing the diversion dam and implementing bank stabilization and riparian revegetation. The diversion dam could be improved with a more easily adjustable structure and bank stabilization and riparian revegetation would address erosion at the diversion and flume.

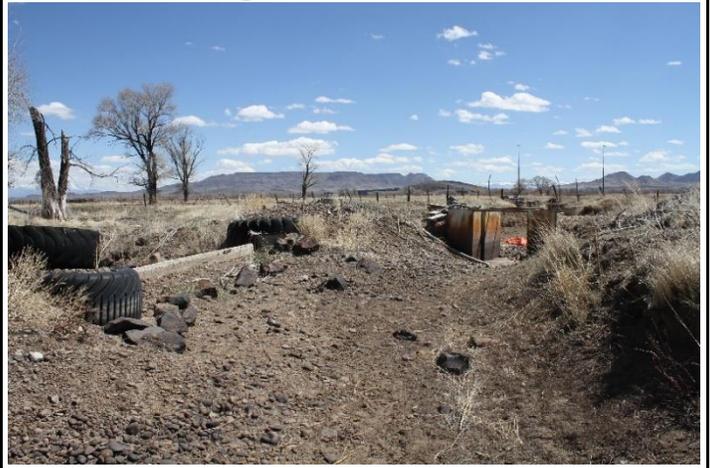
Headgate and diversion dam

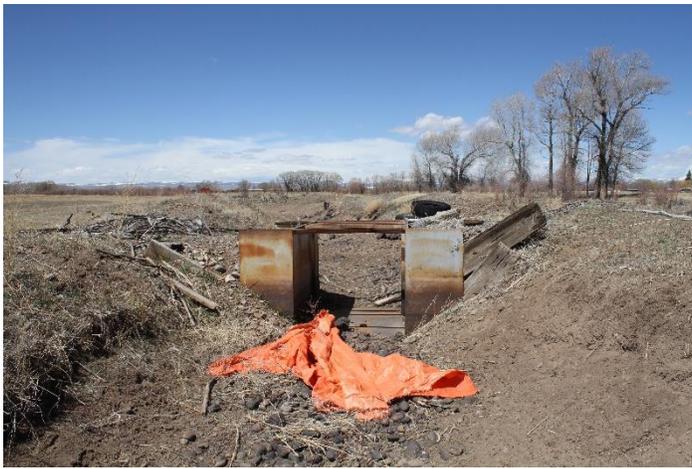
Headgate outlet

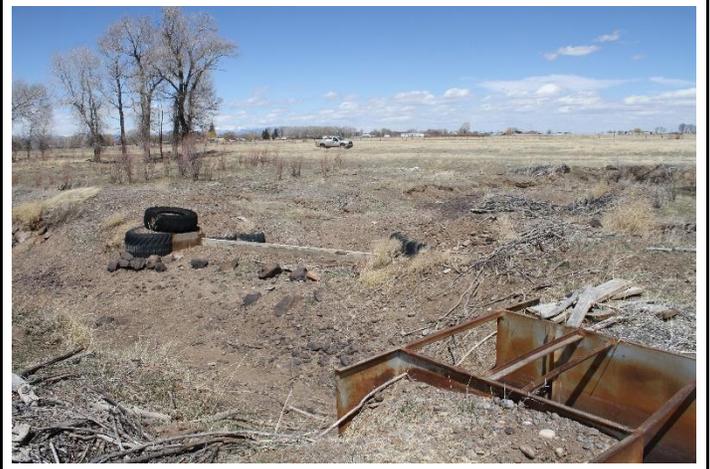
Diversion dam looking upstream

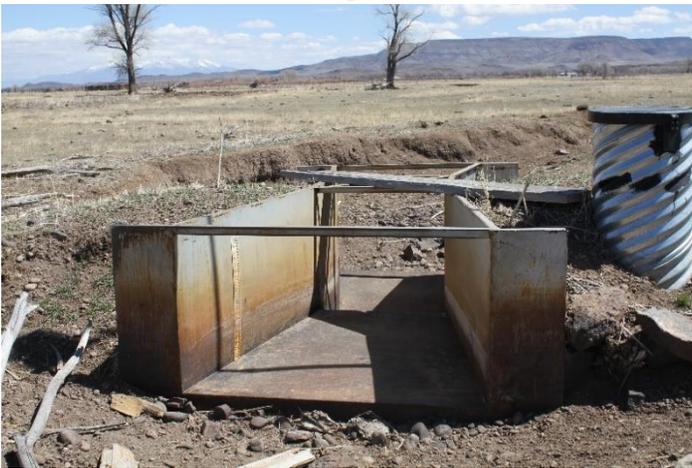
Flume looking downstream

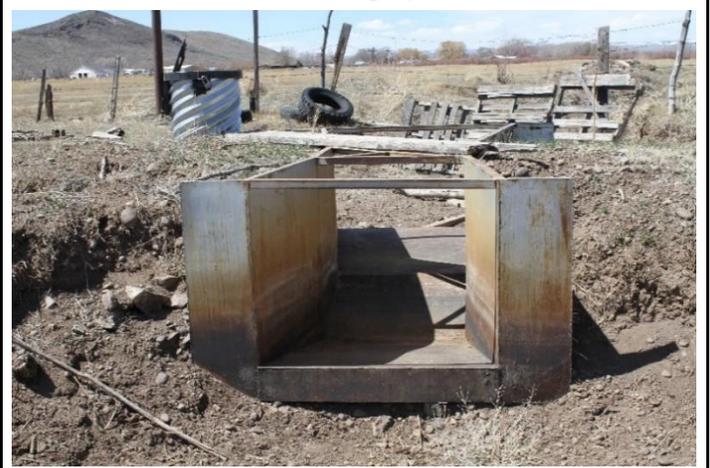
Flume looking upstream
