CONEJOS RIVER

DIVERSION INFRASTRUCTURE INVENTORY

Structure Name: CANON IRRIGATING D

Date: April 15, 2019

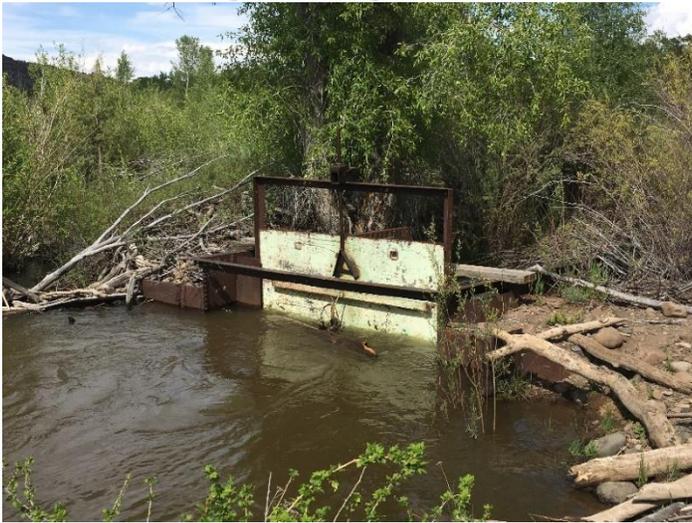
River headgate looking downstream

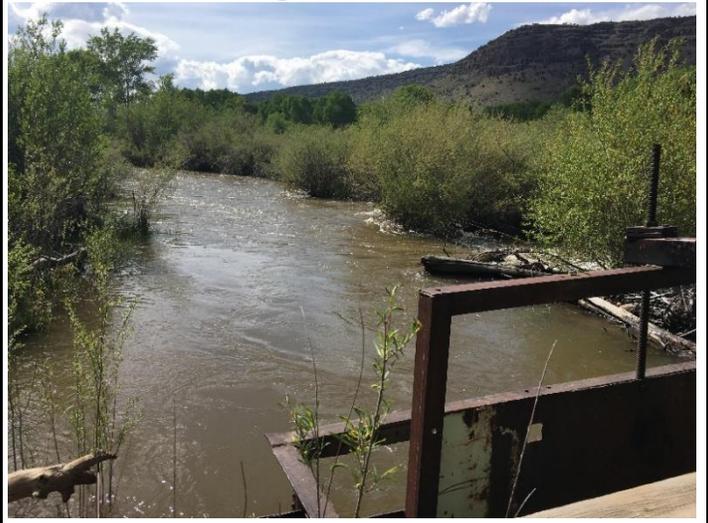
River headgate and diversion dam

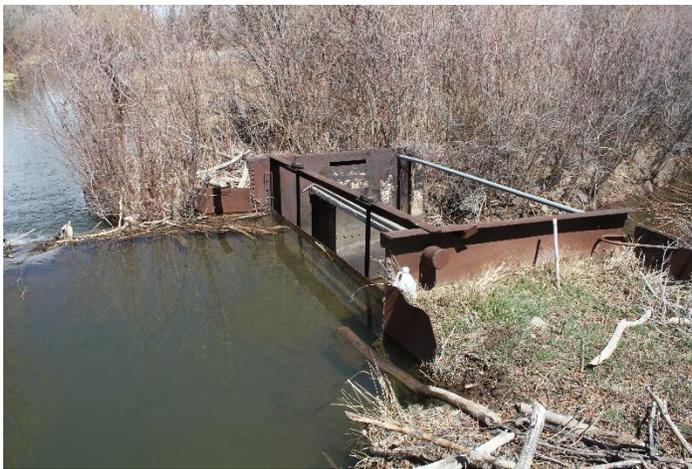
Main headgate

Repair(s) or Improvement(s) Currently Needed: The SMP Technical Advisory Team (TAT) recommends installing a trash rack above the headgate and considering the addition of telemetry to this structure's Parshall flume. A trash rack would minimize debris accumulation and telemetry would increase efficiency. The TAT also recommends maintaining fish passage to preserve aquatic habitat connectivity in this reach.

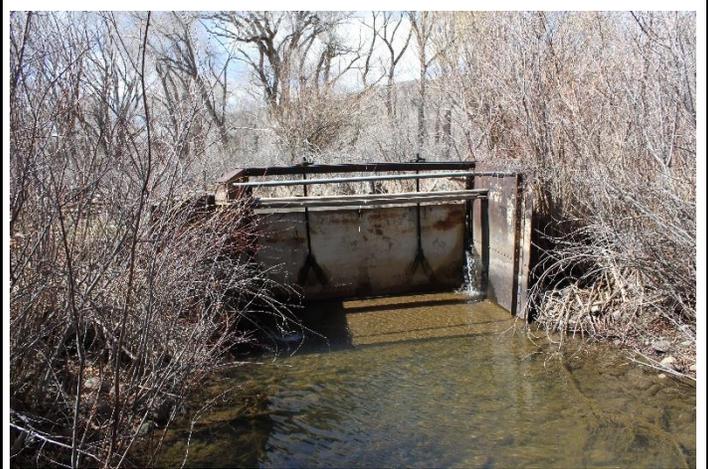
Main headgate outlet

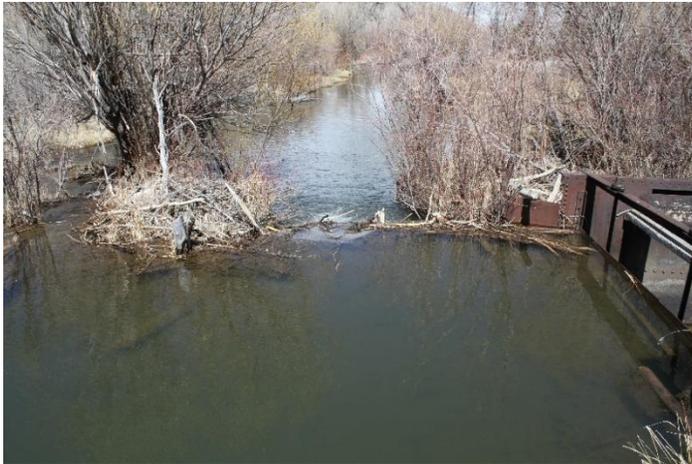
Main headgate and diversion dam

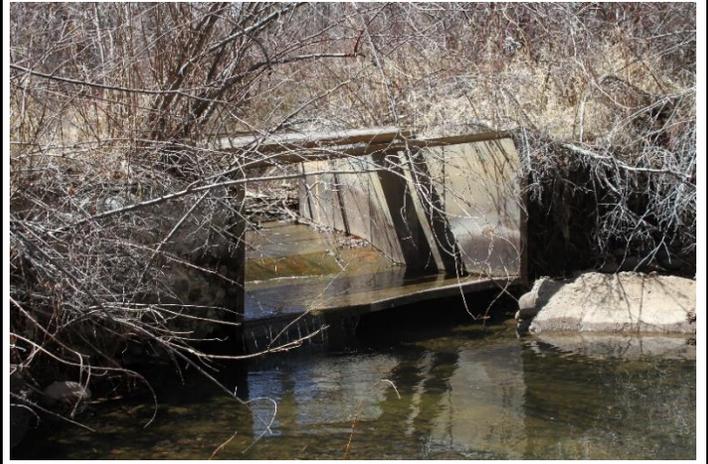
Flume looking upstream
