CONEJOS RIVER

DIVERSION INFRASTRUCTURE INVENTORY

Structure Name: CARPE & REEKERS CANON D

Date: April 15, 2019

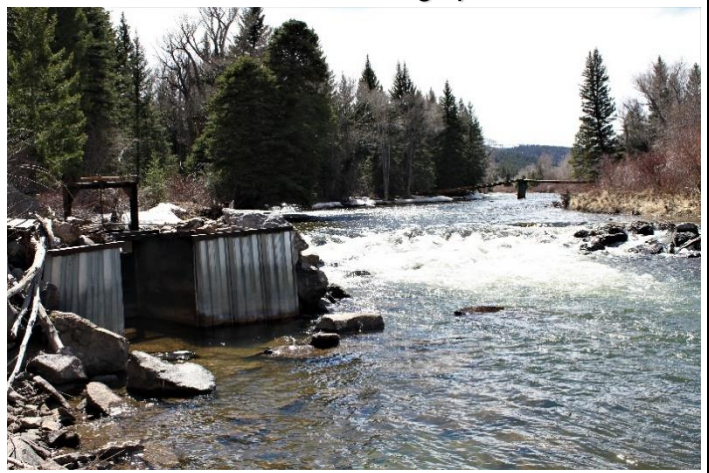
Diversion dam looking upstream

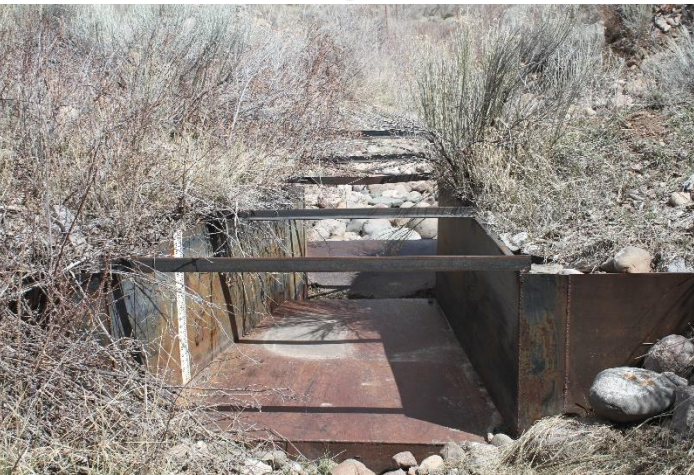
Flume looking downstream
