# CONEJOS RIVER

## DIVERSION INFRASTRUCTURE INVENTORY

**Structure Name:** CHACON D NO 1

**Date:** April 2, 2019

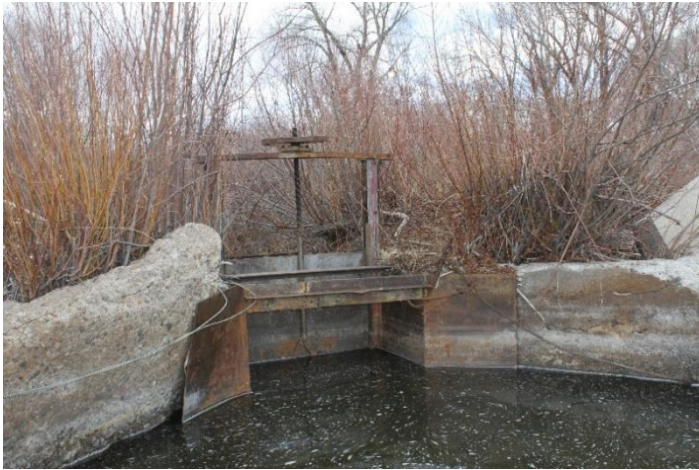
Headgate looking downstream

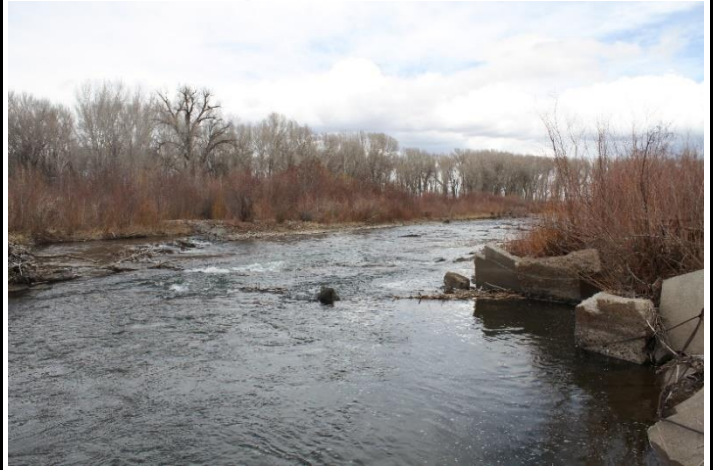
Headgate and diversion dam

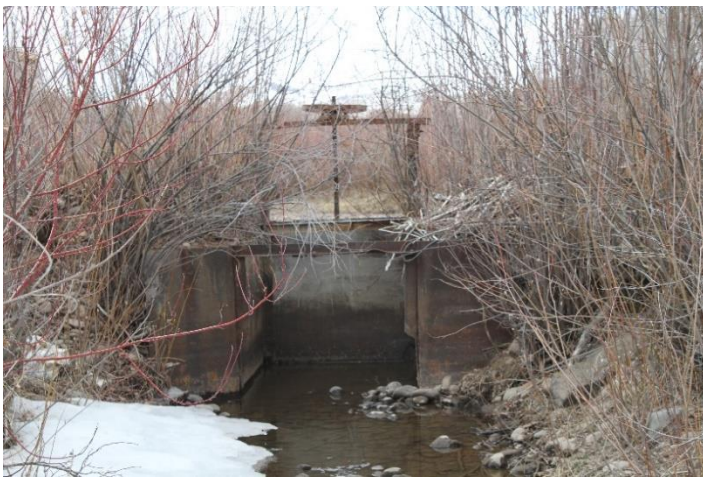
Headgate outlet

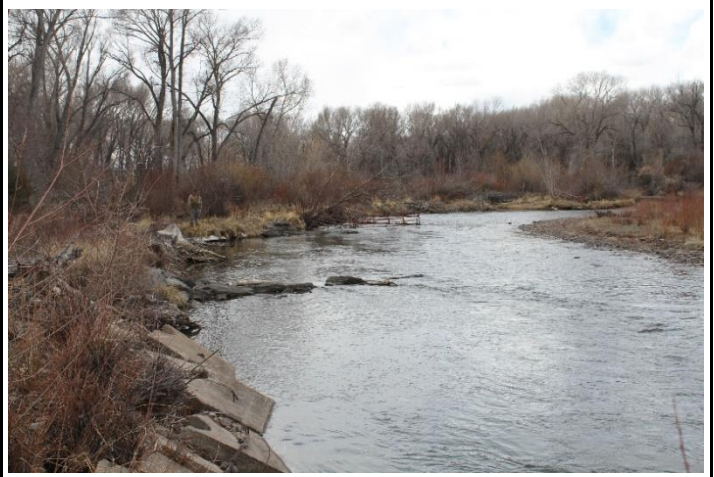
Channel looking upstream

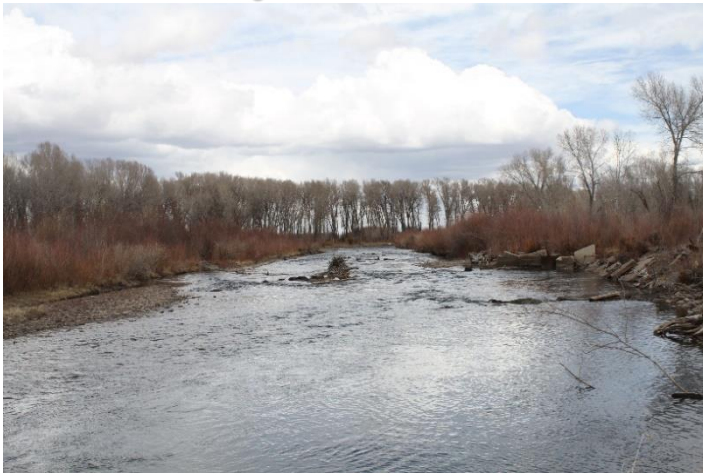
Channel looking downstream at diversion dam

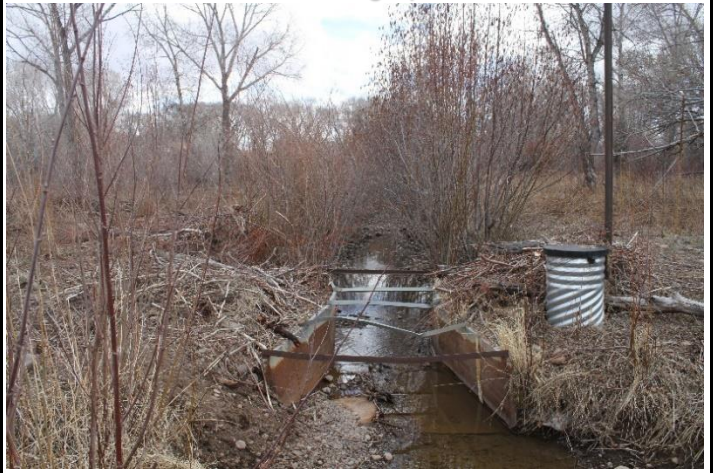
Flume looking upstream

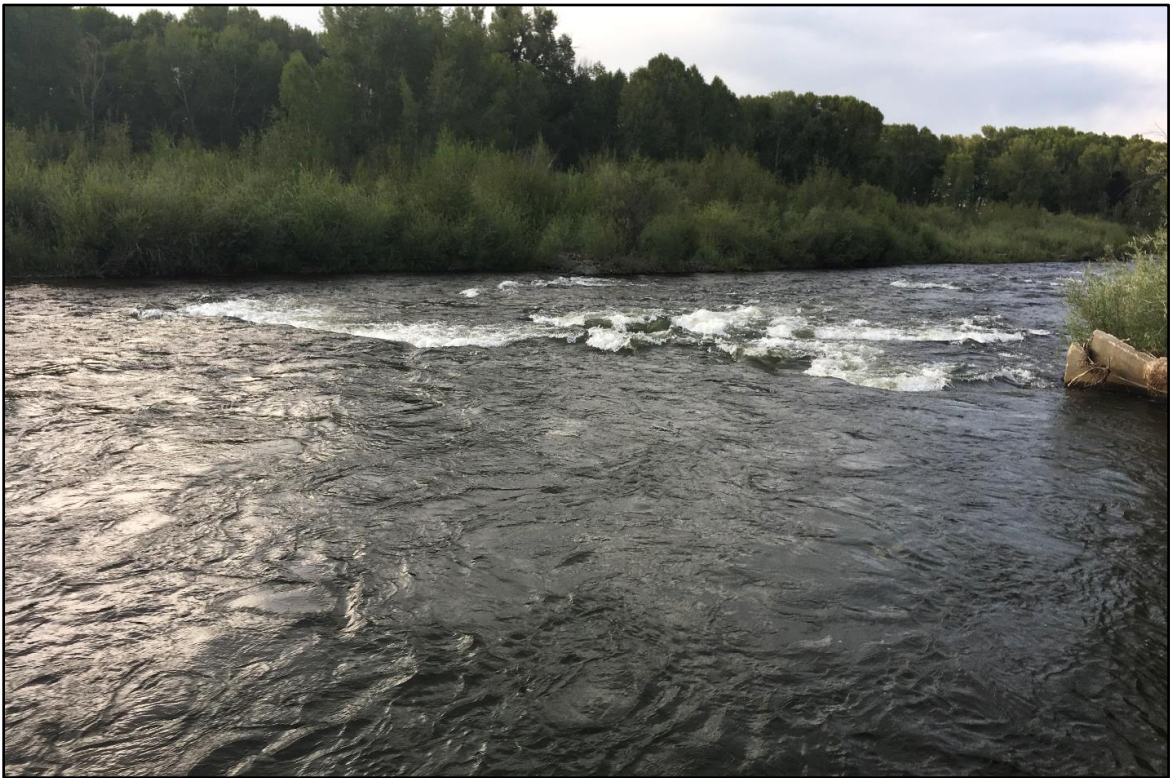
Diversion dam looking downstream post-2019 runoff

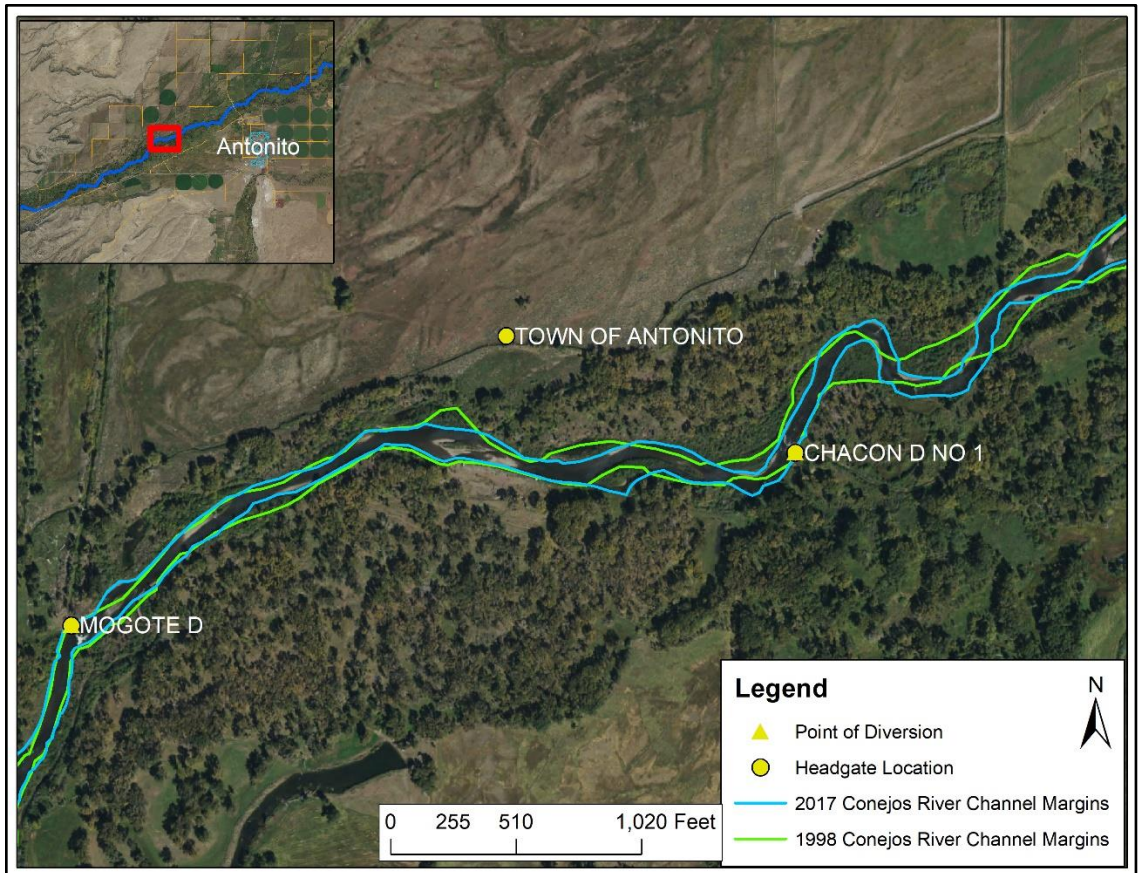
Chacon Ditch No 1 point of diversion with 1998 and 2017 channel margins overlaid

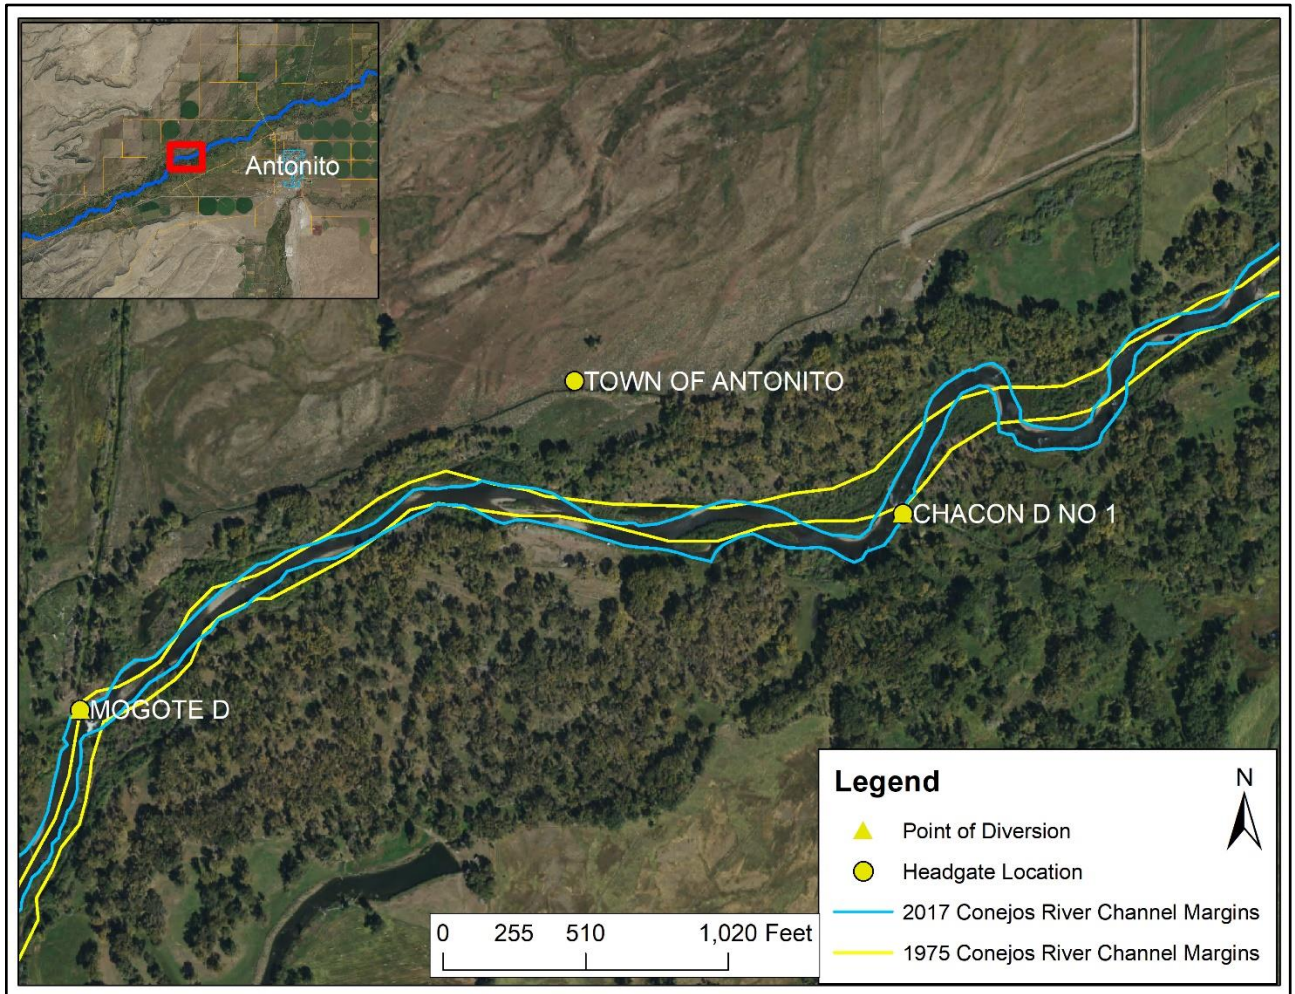
Chacon Ditch No 1 point of diversion with 1975 and 2017 channel margins overlaid
