CONEJOS RIVER DIVERSION INFRASTRUCTURE INVENTORY

Structure Name: CHRISTENSEN D

Date: April 16, 2019

Conejos River Stream
Management Plan

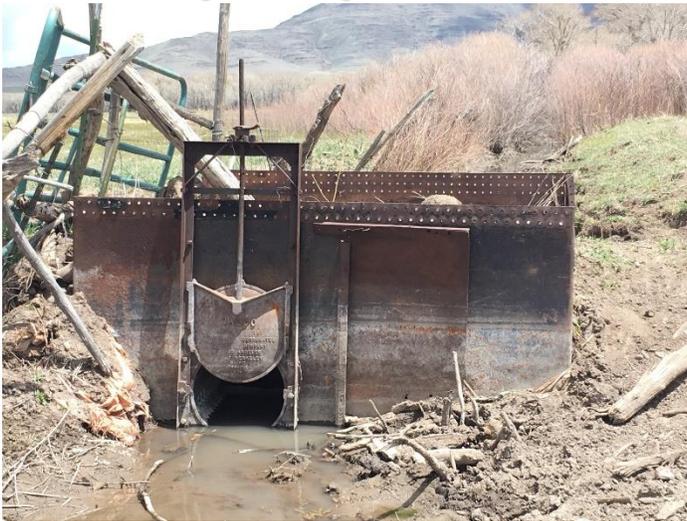
Structure Description: The structure is located in a slough and there is no diversion dam. The headgate is aging and functions poorly. The flume could not be located at the time of visit. The ditch requires general maintenance, including clearing accumulated sediment.

Headgate looking downstream

Repair(s) or Improvement(s) Currently Needed: The SMP Technical Advisory Team (TAT) recommends replacing the headgate to improve efficiency and reduce maintenance.

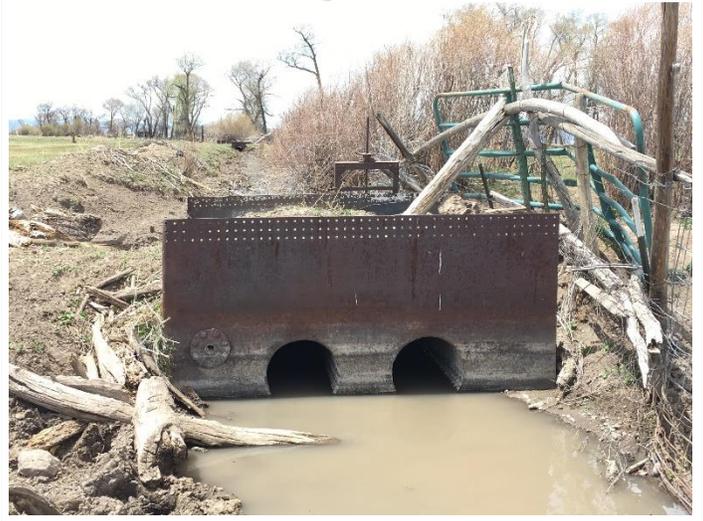
Headgate outlet

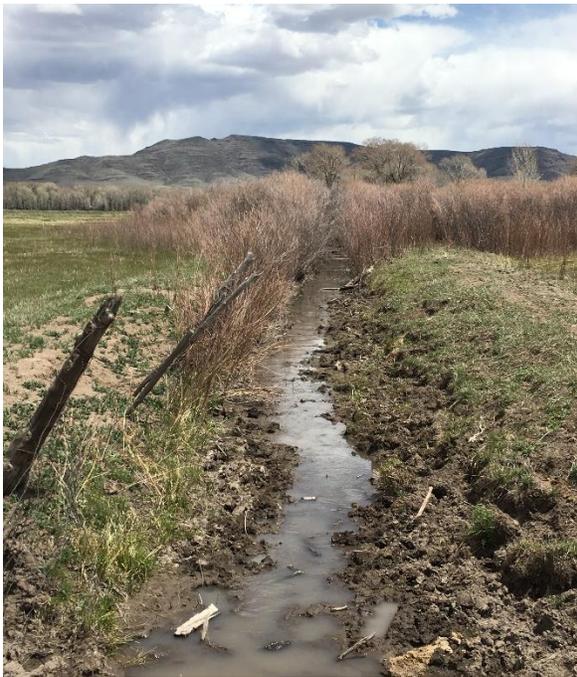
Ditch looking downstream of headgate
