CONEJOS RIVER DIVERSION INFRASTRUCTURE INVENTORY

Structure Name: CORDOVA D

Date: April 15, 2019

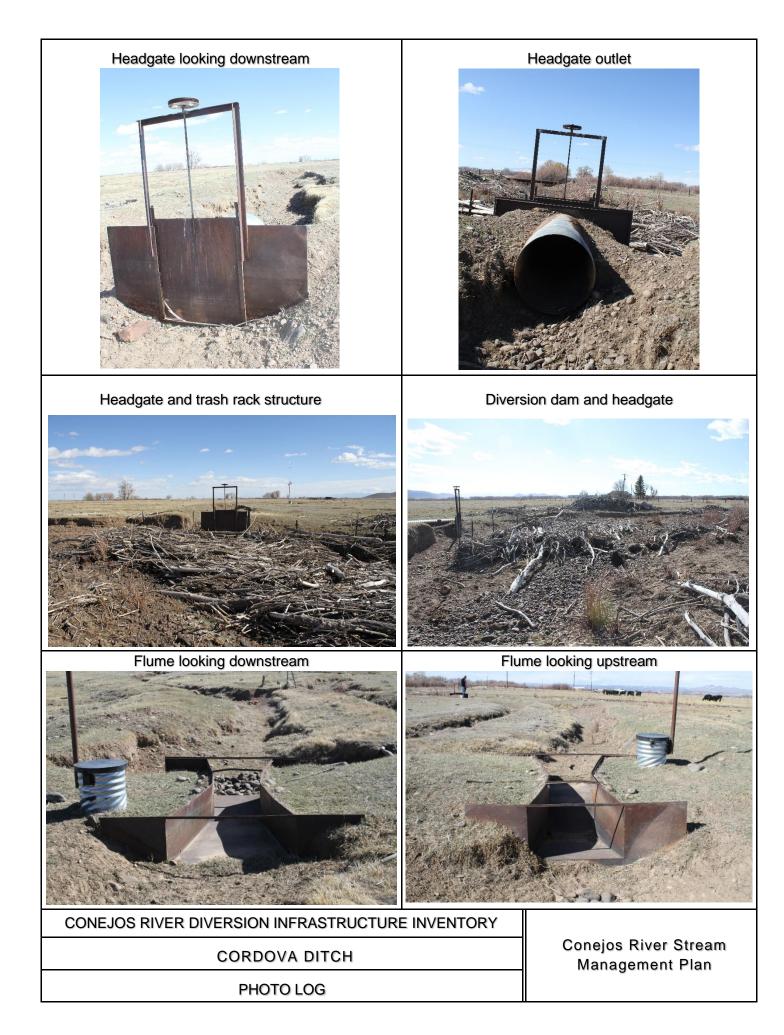
Headgate Location:	Latitude 37.130605			gitude 5.963272			
Headgate Ty	pe: Man	ually opera	ited 3' w	ide steel s	slide gate		
Condition:	A □ B- ⊠ C □ D □ F □	Diversion other Co		A □ s: b □ C ⊠ D □ F □	River Miles from North Branch Conejos Terminus (Point of Diversion): 7.85 mi	Structure Submerged:	Yes □ No ⊠

Structure Description: The headgate sits along the east bank of the river. There is a trash rack consisting of a log boom, t-posts, and check boards upstream of the headgate, which is tilted. The structure has a minimal stacked rock diversion dam which accumulates woody debris and sediment.

Repair(s) or Improvement(s) Currently Needed: Given these issues, the SMP Technical Advisory Team (TAT) recommends improving or replacing the diversion, channel shaping or rock structures to direct debris away from the diversion, and riparian revegetation. An improved diversion would reduce maintenance and riparian revegetation would reduce erosion and improve river function.
