CONEJOS RIVER DIVERSION INFRASTRUCTURE INVENTORY

Structure Name: COTTONWOOD D

Date: April 16, 2019

COTTONWOOD DITCH

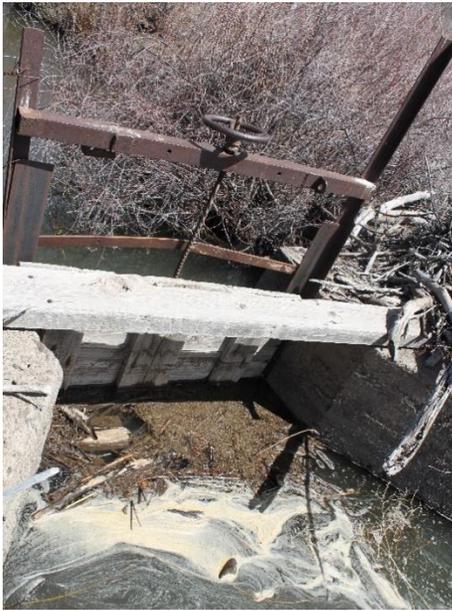
Structure Description: This structure is located just downstream of the North Branch Conejos and Rio San Antonio confluence. The river is relatively stable in this area, however localized erosion is occurring at the diversion. A repurposed tank serves as the diversion dam, directing water to the headgate on the north bank of the river. The diversion functions but is a partial barrier to fish passage. The headwall is made of concrete and has significant spalling. A portion of the upstream side of the headwall has broken off and the river is eroding the bank around the headgate. The headgate is a wood screw gate and does not function well.

Headgate looking downstream

Repair(s) or Improvement(s) Currently Needed: The SMP Technical Advisory Team (TAT) recommends replacing the diversion, headgate and headwall, and flume. A new diversion and headgate would create fish passage and increase efficiency. A new Parshall flume would improve the measurement accuracy.

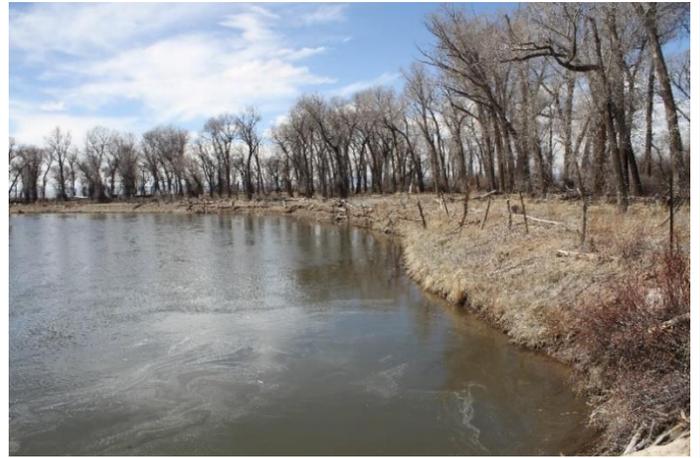
Conejos River upstream of headgate

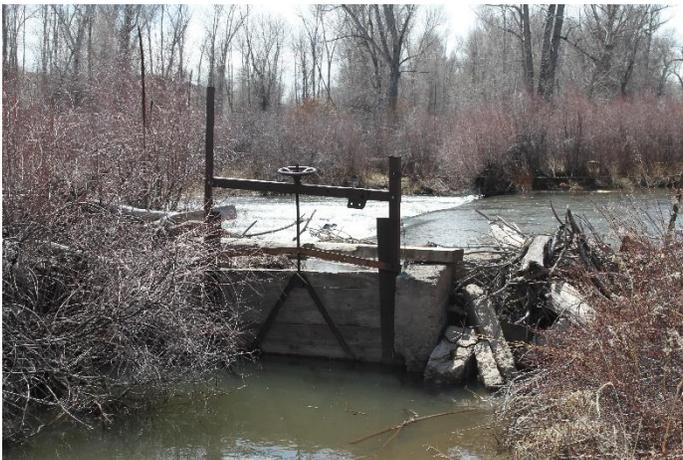
Headgate outlet

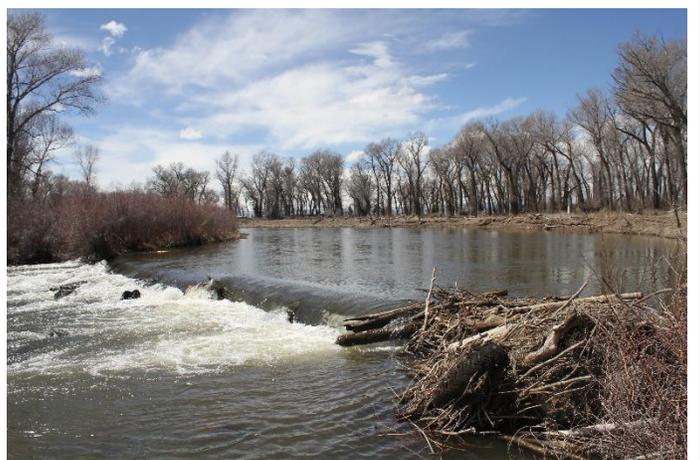
Diversion dam

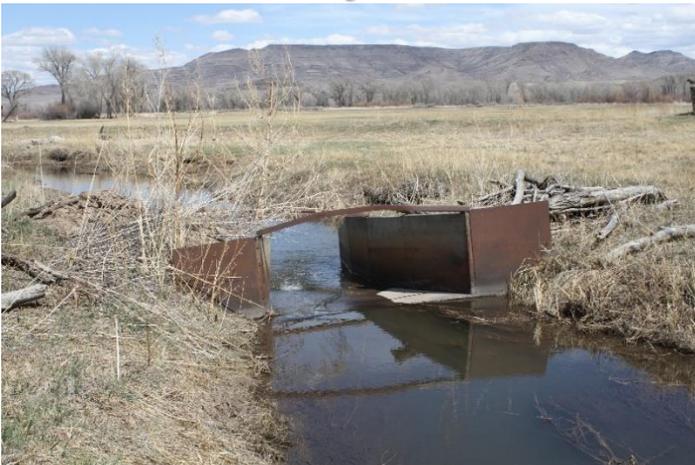
Flume looking downstream

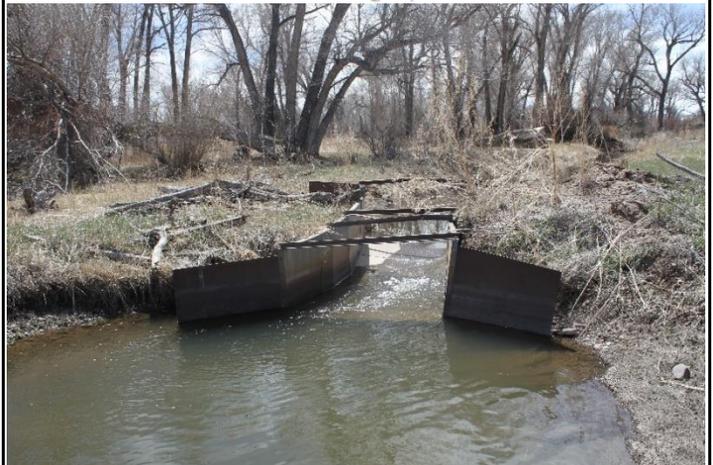
Flume looking upstream

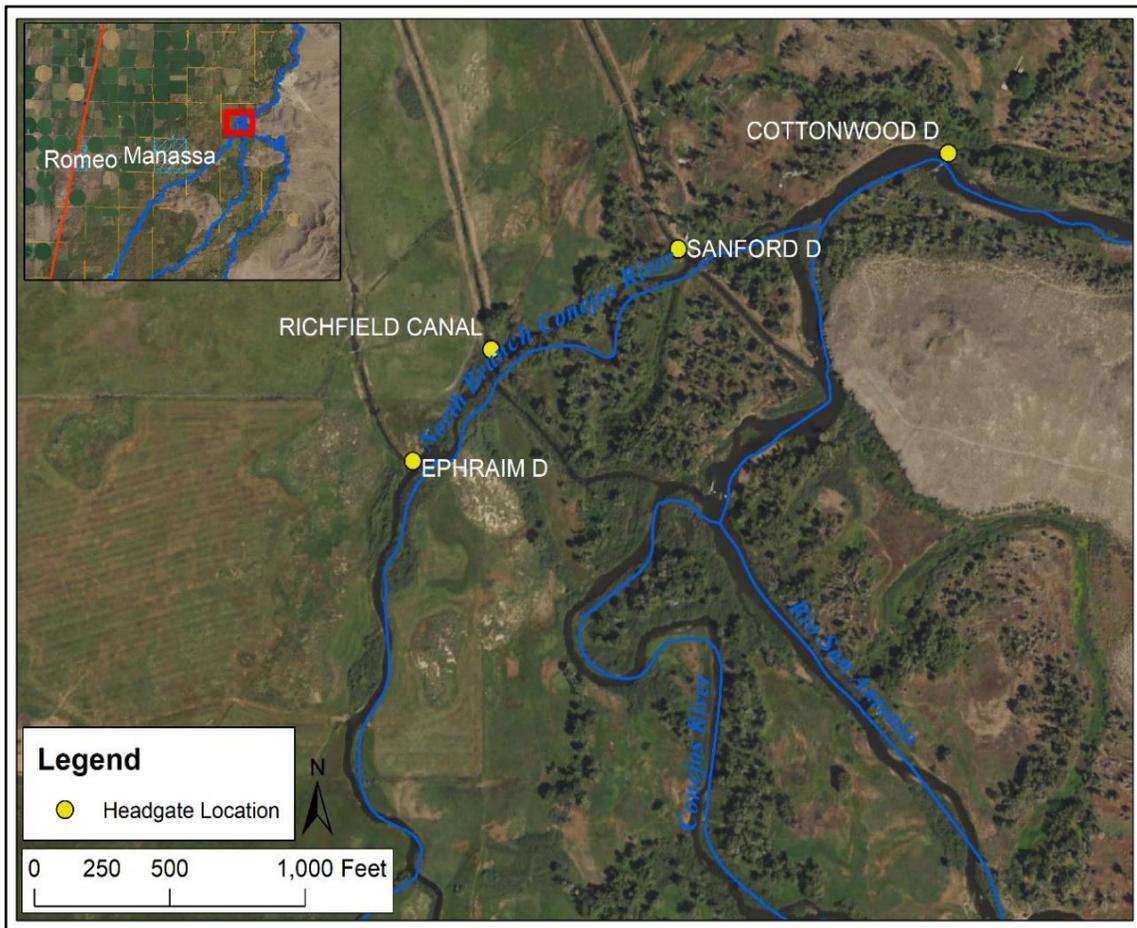
Headgate location and upstream channel configuration.

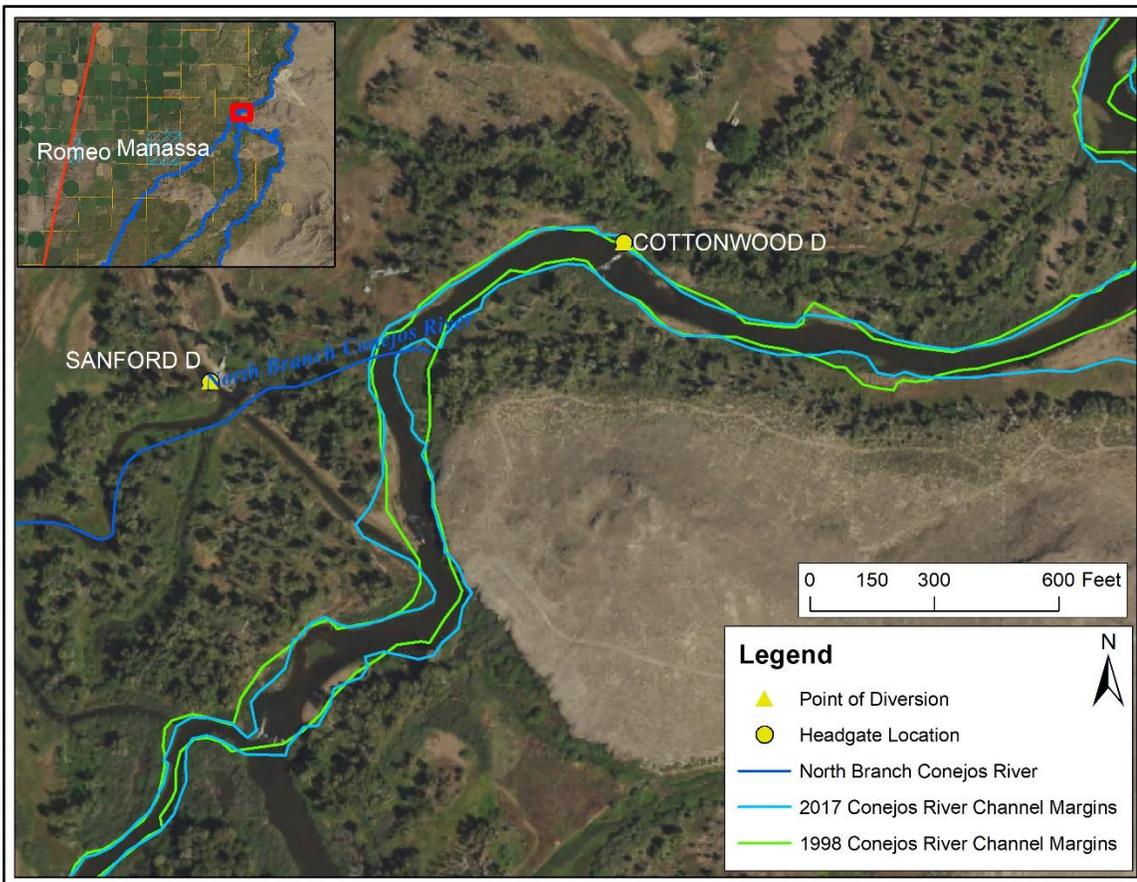
Headgate location with 1998 and 2015 channel margins overlaid.
