CONEJOS RIVER

DIVERSION INFRASTRUCTURE INVENTORY

Structure Name: DEL PUERTICITO D

Date: April 15, 2019

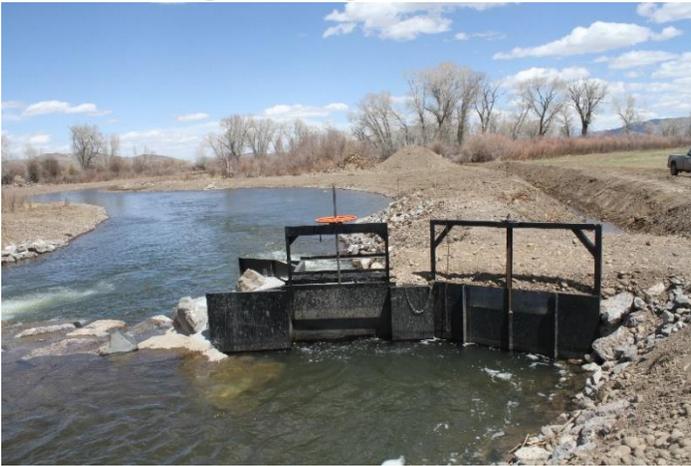
Headgate looking downstream

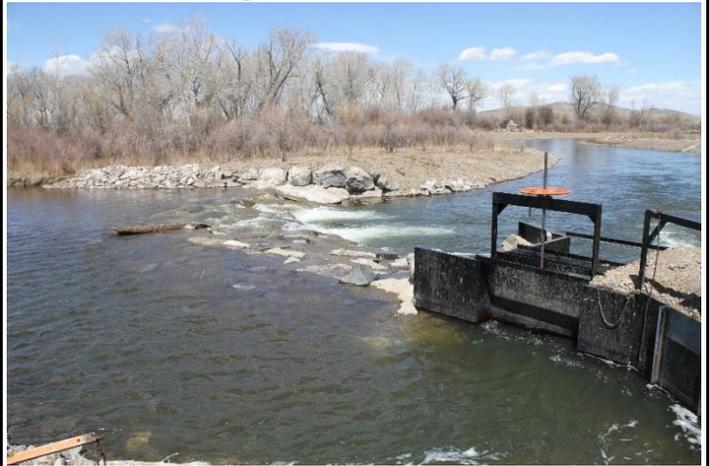
Headgate and diversion dam

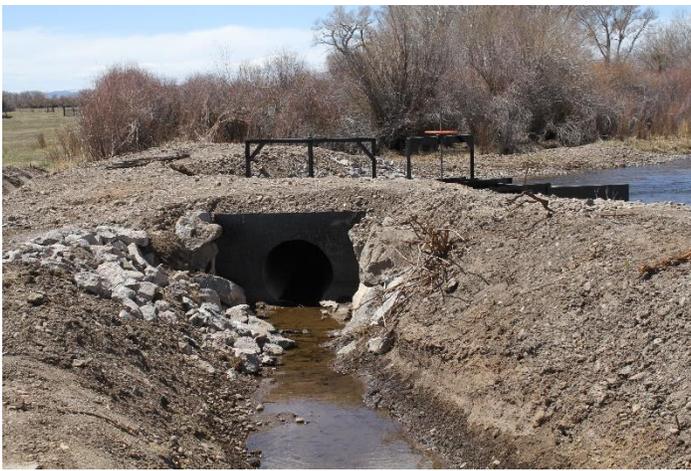
Headgate outlet

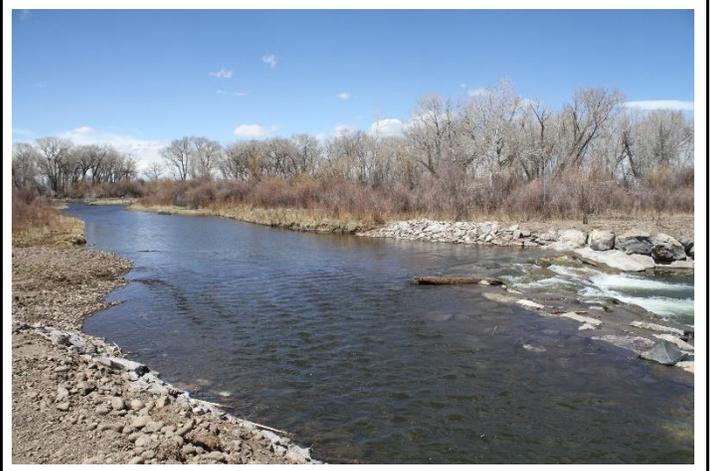
Diversion dam

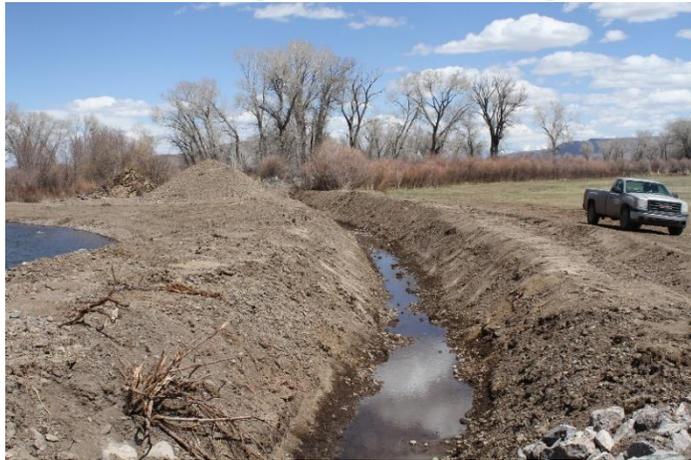
Repair(s) or Improvement(s) Currently Needed: Prior to the 2019 improvements, the portion of the ditch running parallel to the river experienced significant erosion and could fail in the future. The SMP Technical Advisory Team (TAT) recommends reinforcing the ditch to avoid potential failure.

Ditch looking downstream of headgate

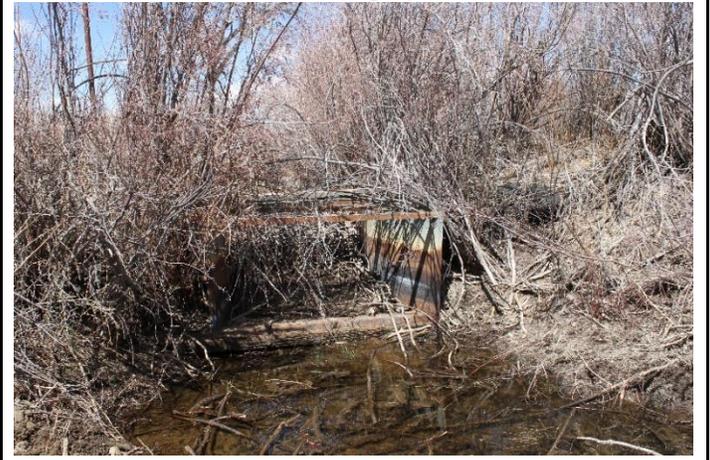
Flume looking upstream

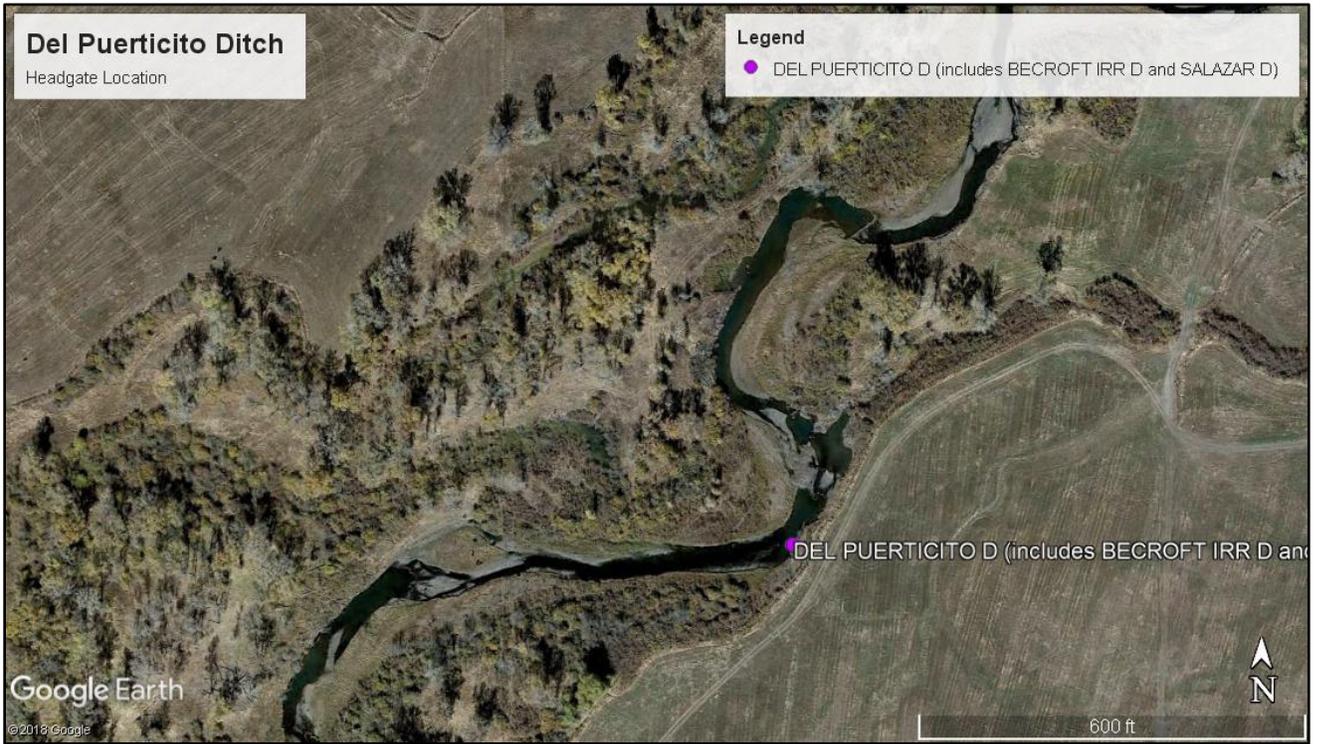
Headgate location and view of channel prior to channel improvements

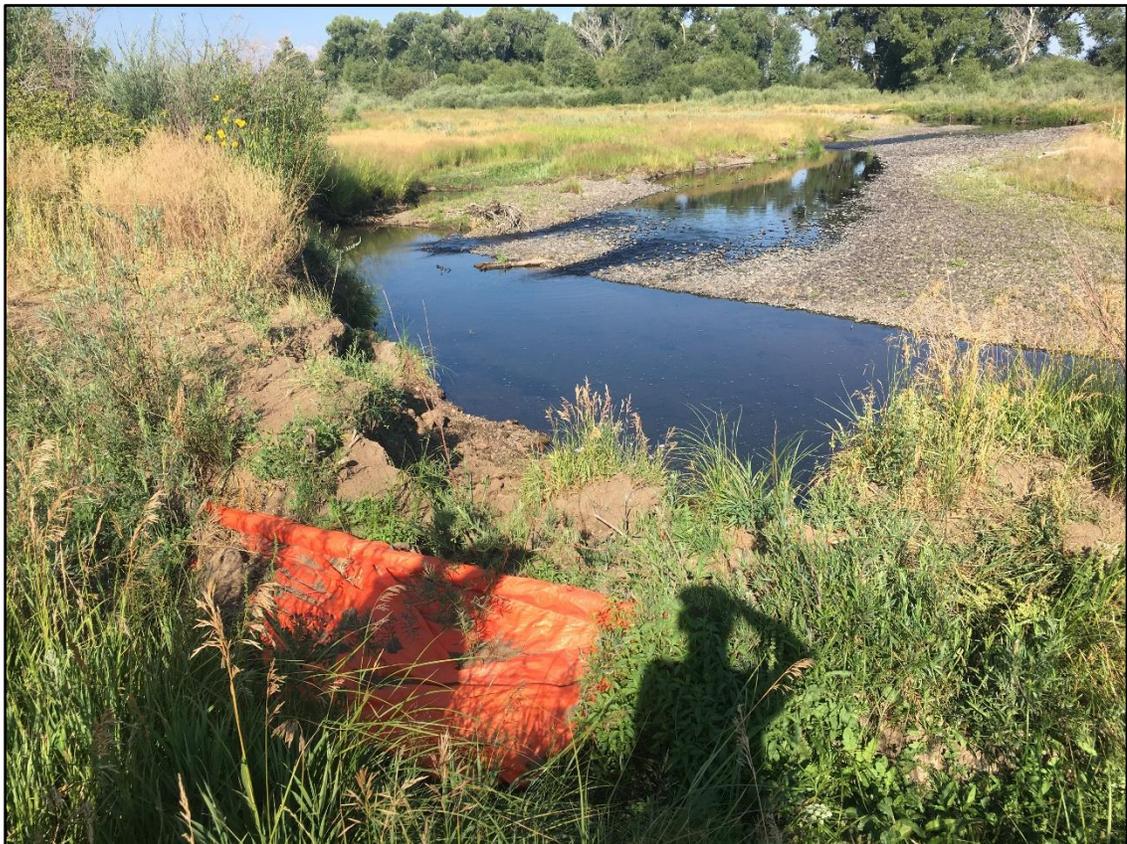
Bank erosion on Salazar Ditch, downstream of Del Puerticito Ditch

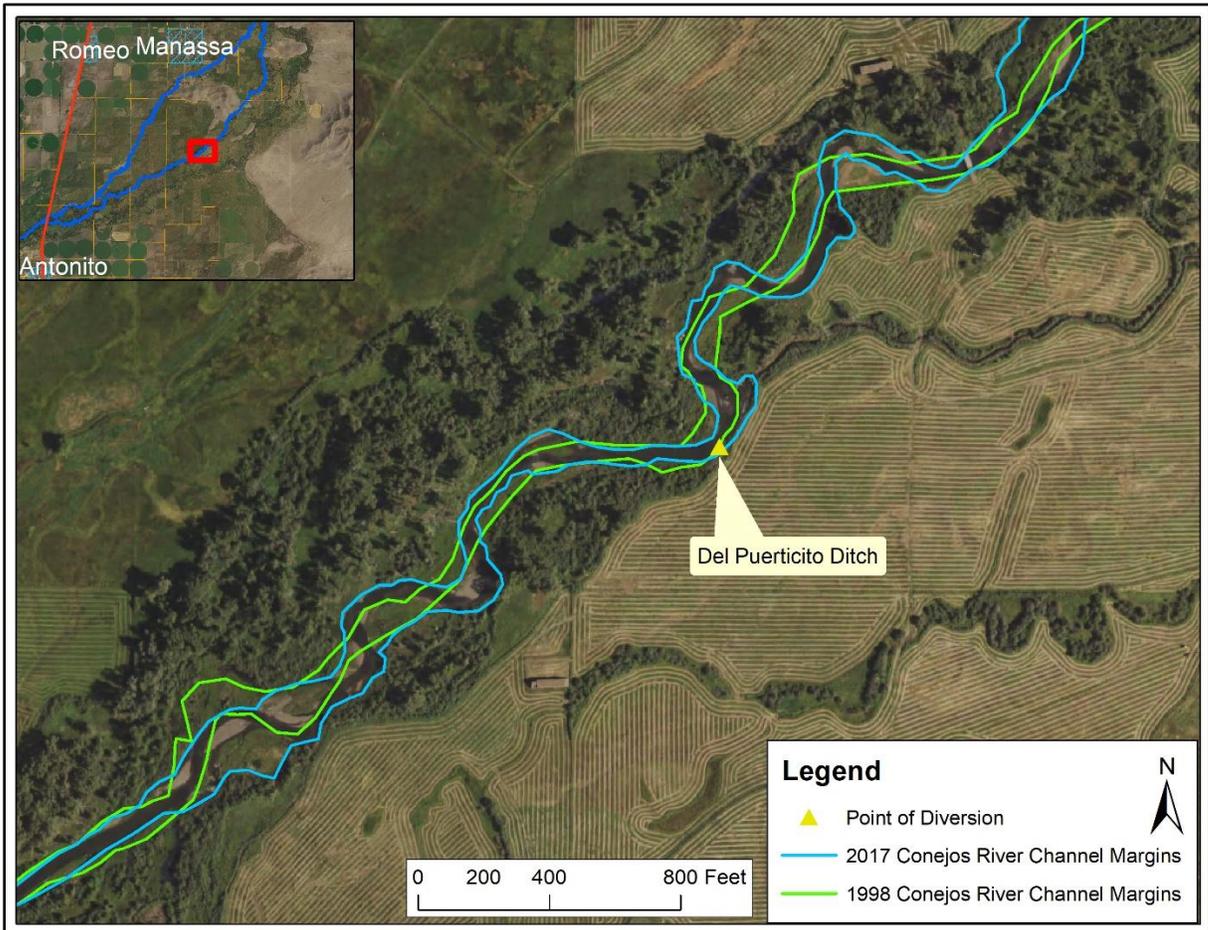
Structure Description: The river is unstable in this reach and is prone to avulsion and significant migration during high flows. In 2019, the headgate and diversion dam were replaced. The banks upstream and downstream of the structure were also reinforced with boulders. The new structure features a grouted rock diversion dam that directs water to the headgate, which is located on the south bank of the river. The ditch runs parallel to the river for approximately 250 ft before turning east and away from the river.

Headgate location with 1998 and 2017 channel margins overlaid

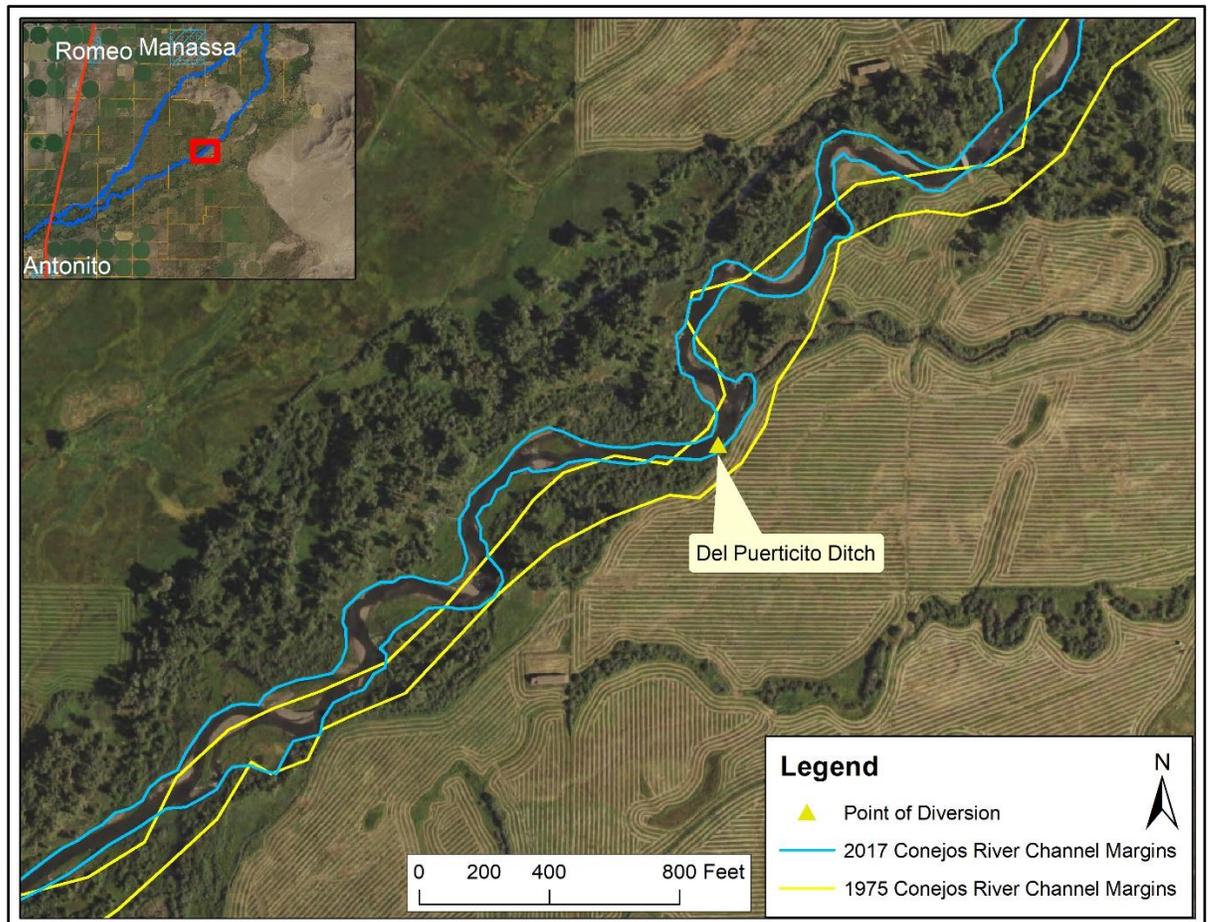
Headgate location with 1975 and 2017 channel margins overlaid
