# CONEJOS RIVER

## DIVERSION INFRASTRUCTURE INVENTORY

**Structure Name:** EAST BEND NO 2 D

**Date:** April 16, 2019

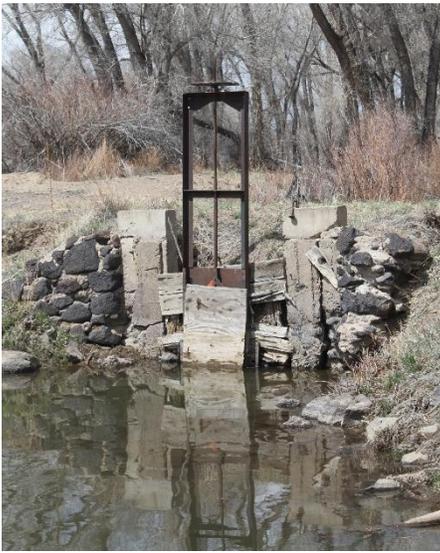
Headgate looking downstream

**Structure Description:** The meanders upstream of the diversion have tightened over the last 45 years and channel avulsion may occur at high flows. A minimal stacked rock diversion dam directs water to the headgate, which is located on the east bank of the river. The head wall is made up of a combination of boards, concrete and grouted rock. The headgate has plywood covering the opening to reduce leakage.

**Repair(s) or Improvement(s) Currently Needed:** Given the issues identified at this structure, the SMP Technical Advisory Team (TAT) recommends replacing the diversion, headgate and Parshall flume. A new diversion would require less maintenance and improves sediment transport and river function. A new headgate and flume would increase efficiency. The TAT also recommends maintaining fish passage to preserve aquatic habitat connectivity in this reach.
