# CONEJOS RIVER

## DIVERSION INFRASTRUCTURE INVENTORY

**Structure Name:** ELLEDGES D

ELLEDGES DITCH

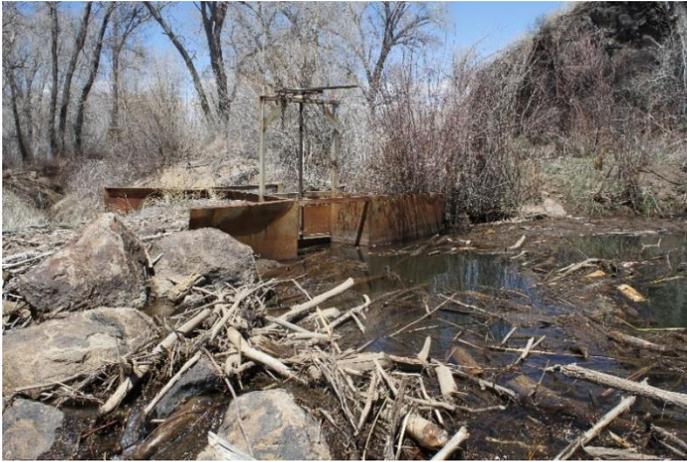
Headgate looking downstream

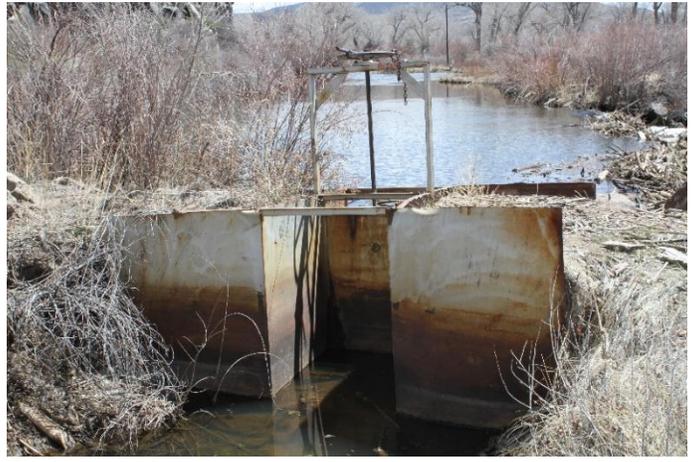
Headgate outlet

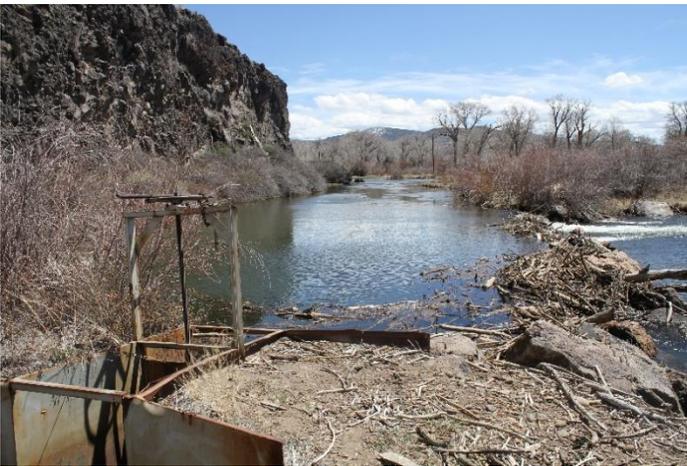
**Structure Description:** The river is relatively stable in this location due to bedrock controls on the east side of the river. The stacked rock diversion dam, which directs water to the headgate on the east bank of the channel, forms a barrier to fish passage. Woody debris accumulates on the diversion dam and at the headgate. The ditch runs parallel to an access road for approximately 0.5 mile. Downstream of the headgate, the ditch is very close to the river in two locations. During past high flow events, the river bank has failed and washed the ditch out in these locations, which are approximately 450 and approximately 950 ft downstream of the headgate, respectively. At the closer location, a j-hook spans the river but does not appear to be mitigating erosion that is threatening the ditch.

Headgate and diversion dam

**Repair(s) or Improvement(s) Currently Needed:** Given these issues, the SMP Technical Advisory Team (TAT) recommends installing a new diversion, installing a trash rack, and implementing streambank stabilization at the two vulnerable locations, including replacement of the existing j-hook. A new diversion and trash rack would allow for fish passage and reduce debris accumulation and maintenance. Bank stabilization would reduce erosion and help prevent the ditch from washing out.

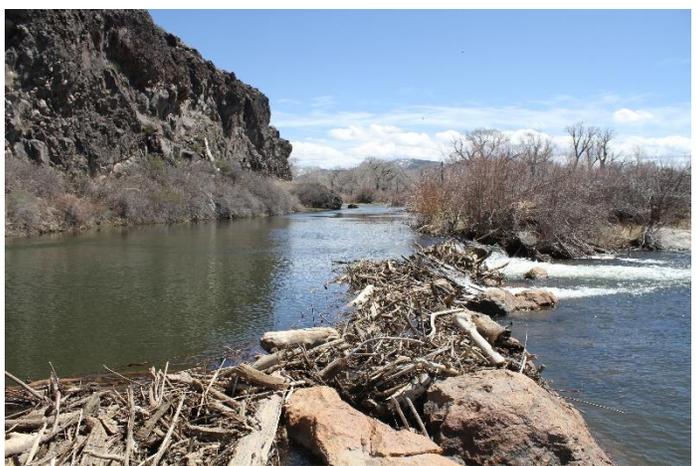
Diversion dam looking upstream

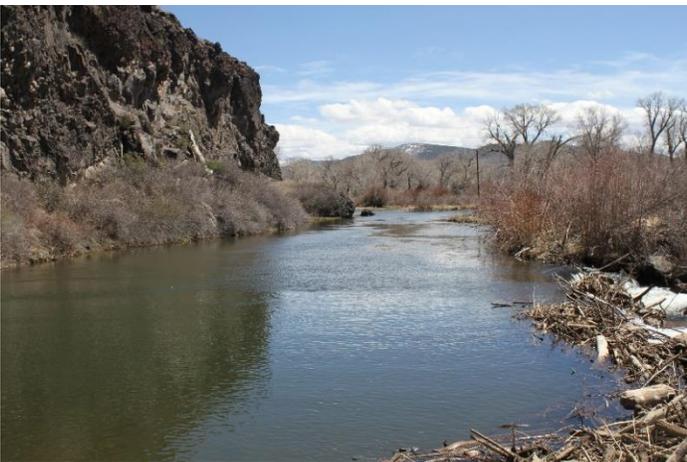
River channel upstream of headgate

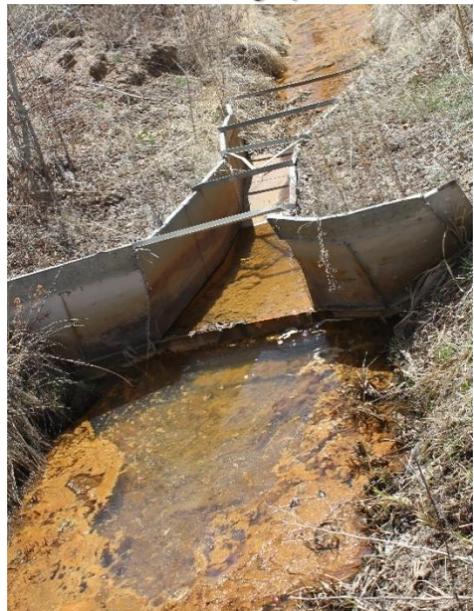
Flume looking upstream

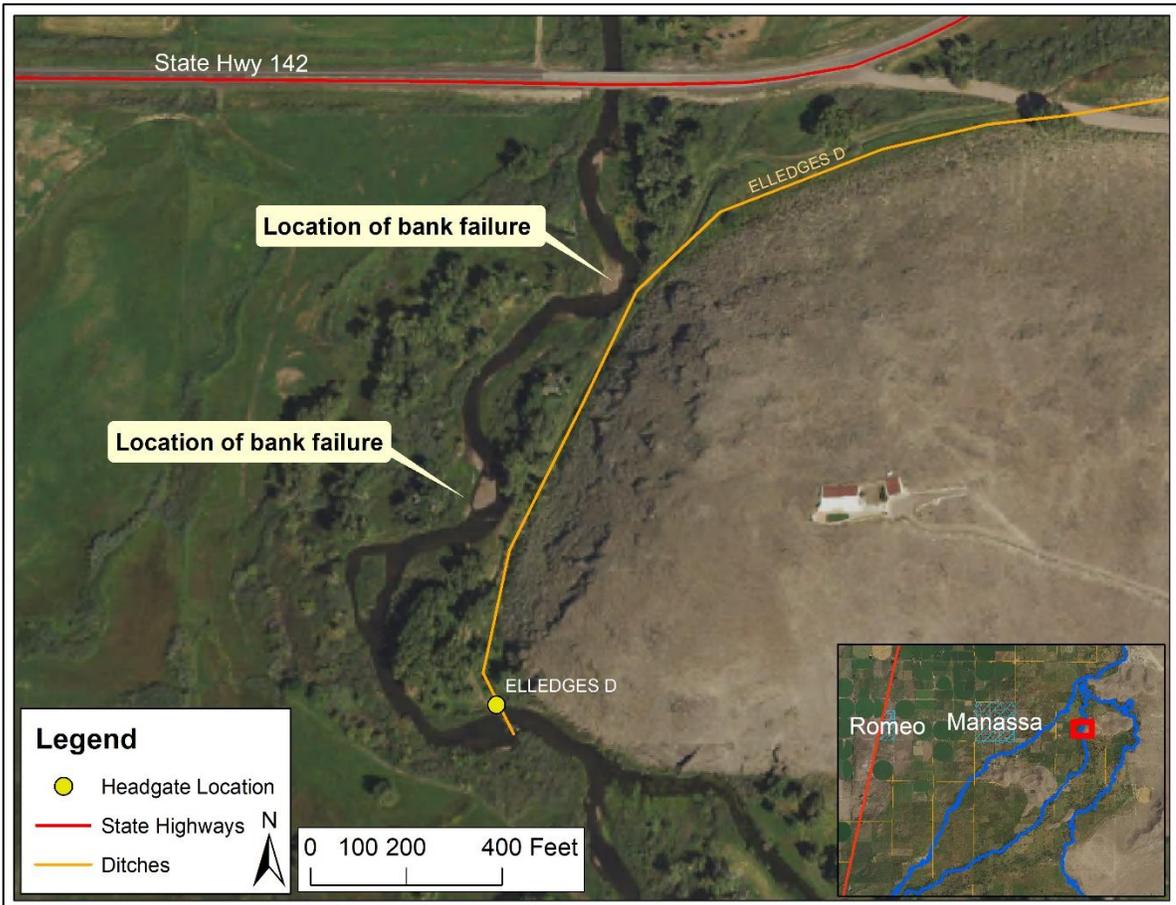
Headgate location and locations of potential ditch failure at high flows.

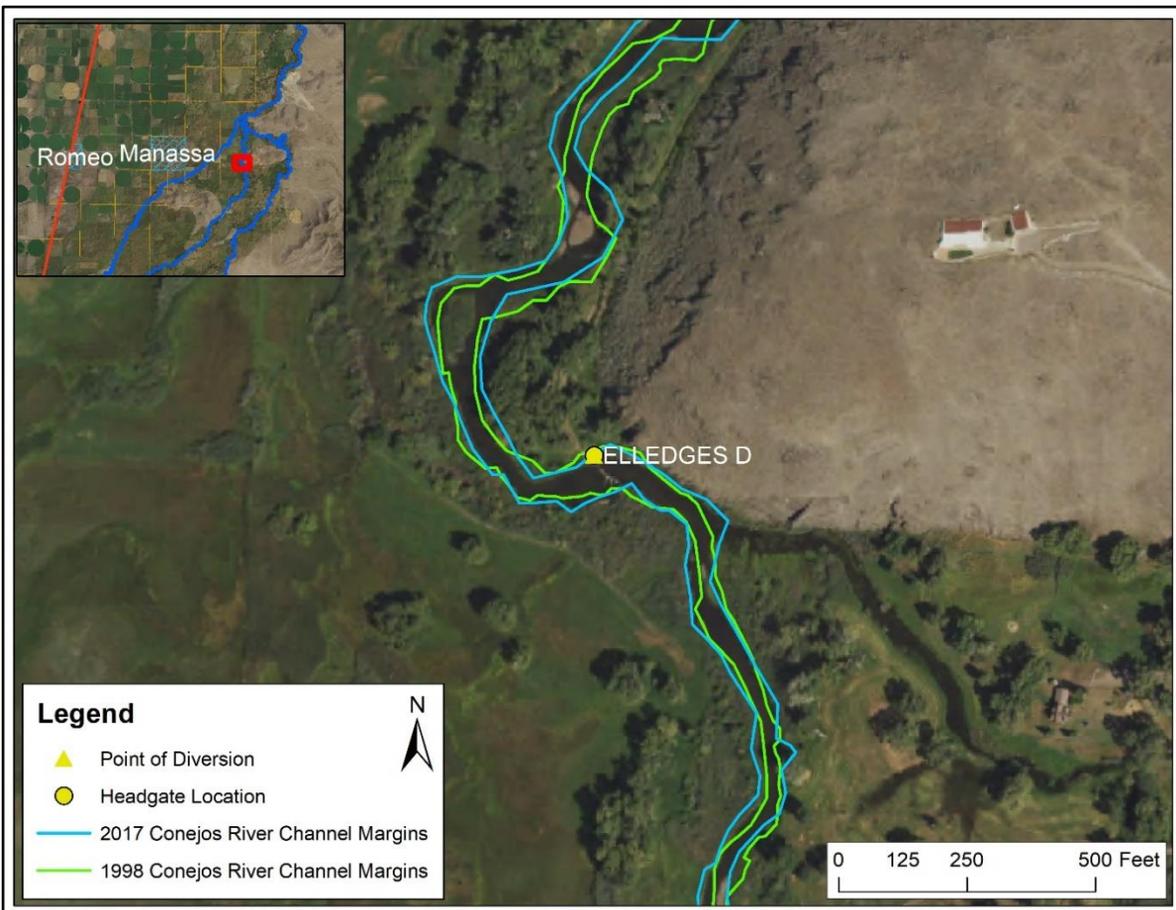
Headgate location with 1998 and 2015 channel margins overlaid.
