CONEJOS RIVER

DIVERSION INFRASTRUCTURE INVENTORY

Structure Name: EPHRAIM D

EPHRAIM DITCH

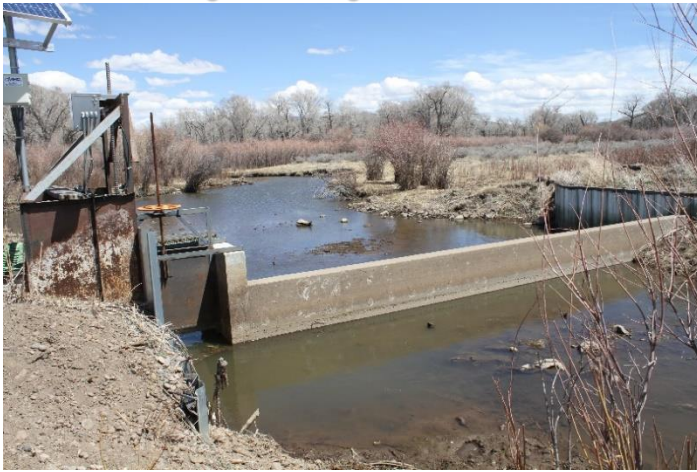
Headgate looking downstream

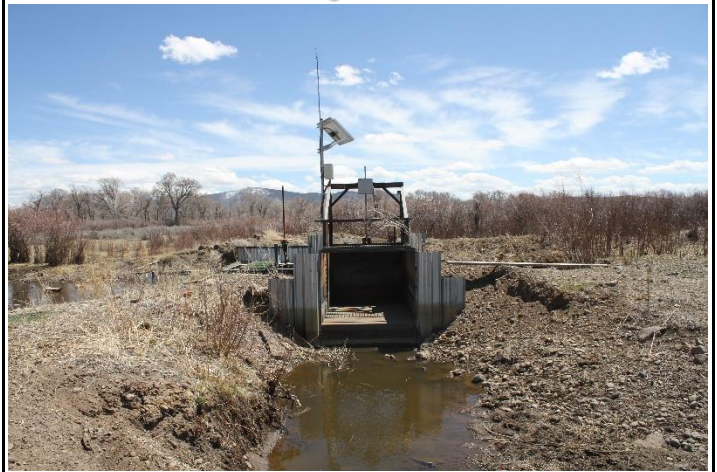
Headgate outlet

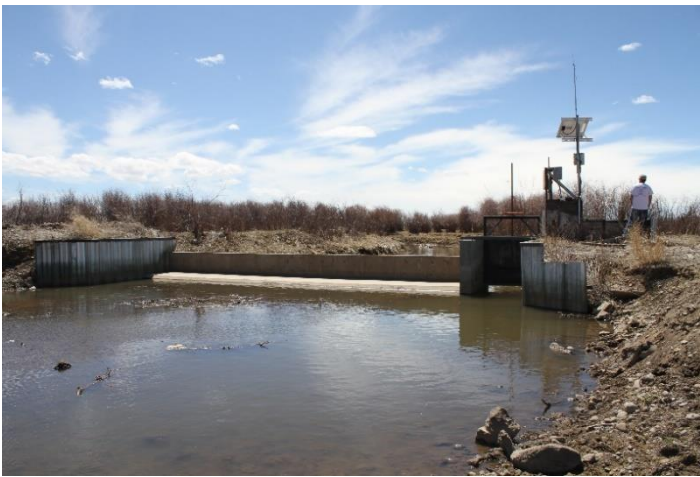
Diversion dam looking upstream

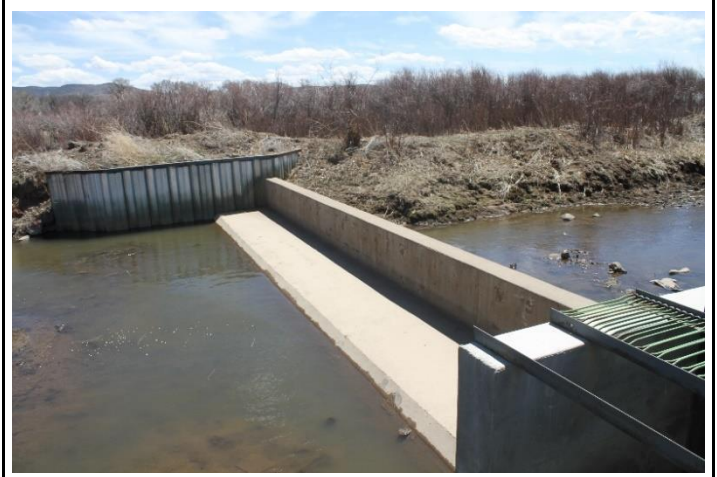
Diversion dam

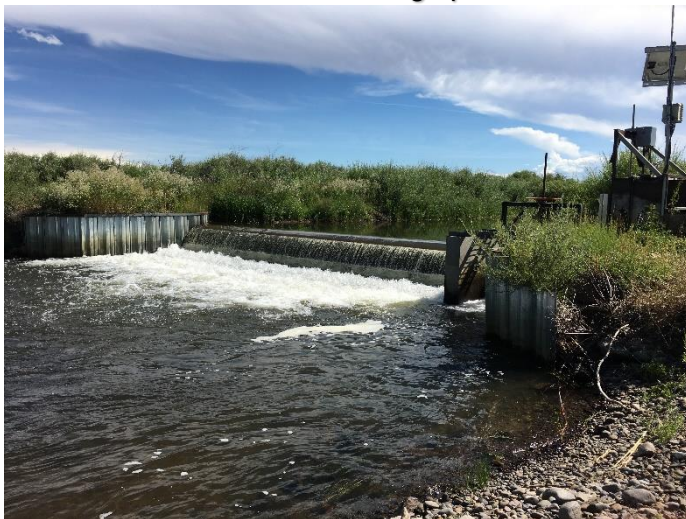
Diversion dam looking upstream

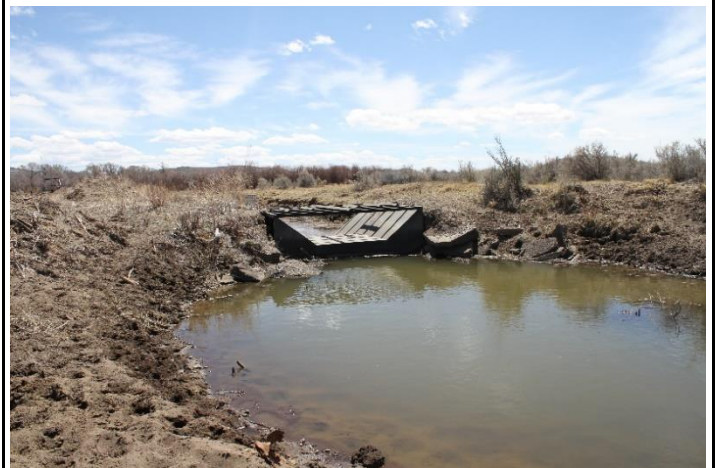
Flume looking upstream
