CONEJOS RIVER

DIVERSION INFRASTRUCTURE INVENTORY

Structure Name: FUERTICITOS D

Date: April 15, 2019

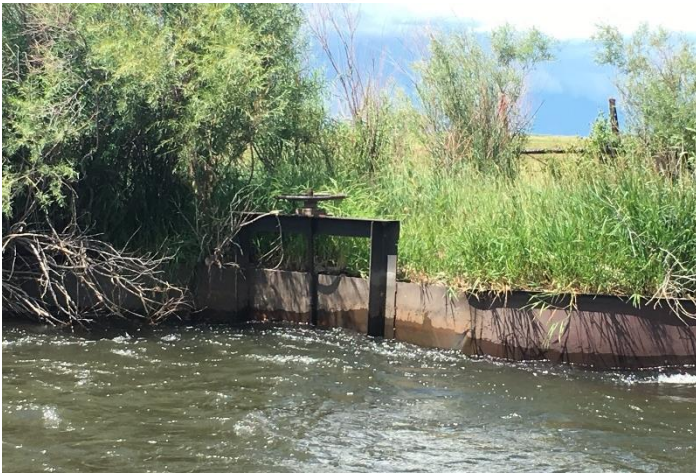
Headgate looking downstream

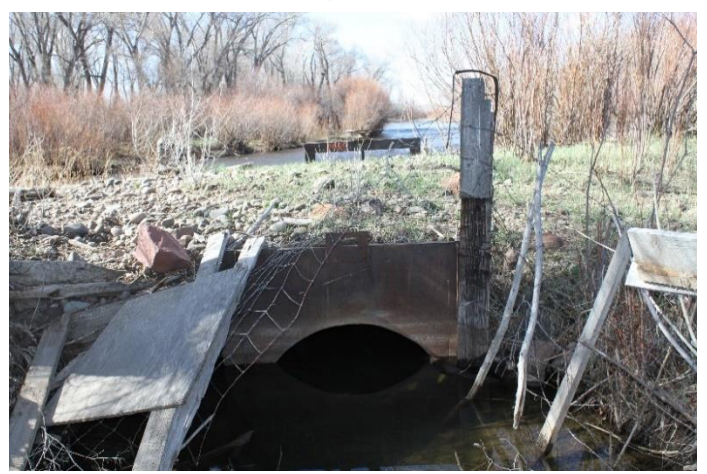
Headgate outlet

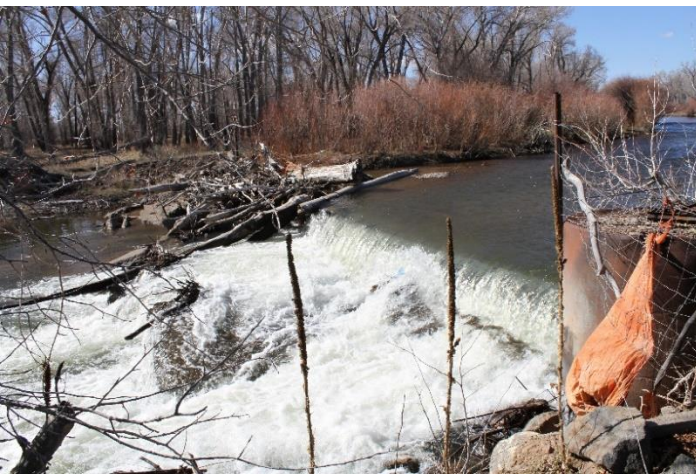
Structure Description: A large metal beam spans the channel, functioning as the diversion dam. This diversion is currently a barrier to fish passage. A significant amount of the river's flow travels underneath the diversion. The headgate is located on the north bank of the river on the outside of a meander. Debris accumulation is a significant issue at this structure, both on the diversion dam and at the headgate. Upstream of the diversion, the river is wide and two gravel bars have formed. Both upstream and downstream of the diversion, meanders have been tightening over time, which is not currently adversely affecting the structure, but may lead to future channel avulsion.

Diversion dam looking upstream

Repair(s) or Improvement(s) Currently Needed: The SMP Technical Advisory Team (TAT) recommends replacing the diversion dam and headgate, implementing bank stabilization, and resetting the Parshall flume. The TAT also recommends fish passage in this reach and ensuring adequate sediment transport at this structure. An improved diversion would improve the sediment transport regime and create new fish passage and habitat in this reach. A new headgate would increase efficiency and reduce maintenance. Targeted bank stabilization would help prevent potential channel avulsion and ensure water is delivered to this structure. Additionally, resetting the Parshall flume would improve its measurement accuracy.

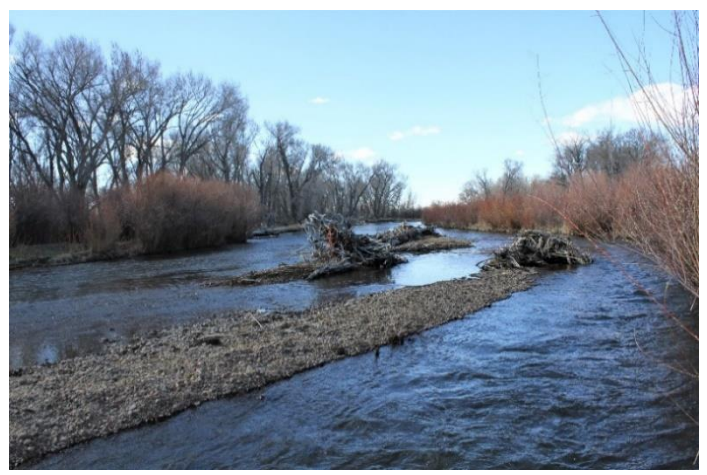
Conejos river channel looking upstream

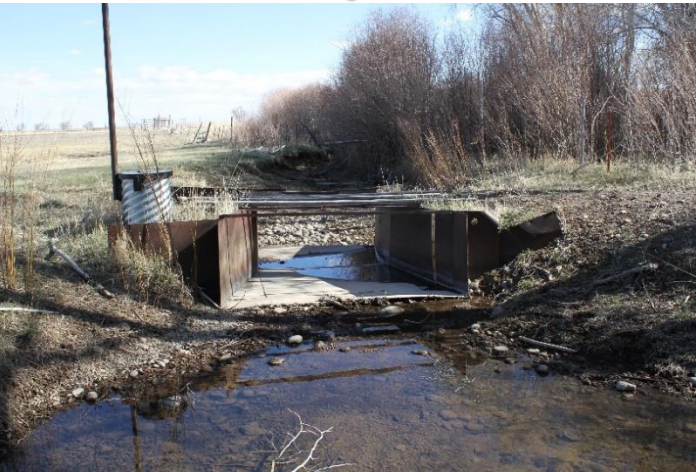
Flume looking downstream

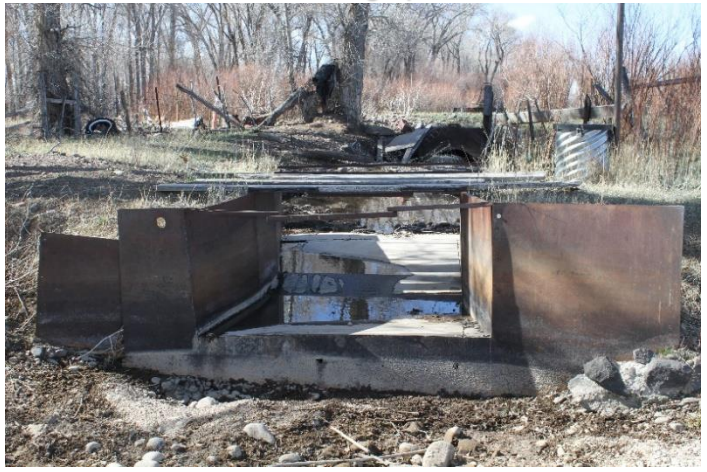
Flume looking upstream

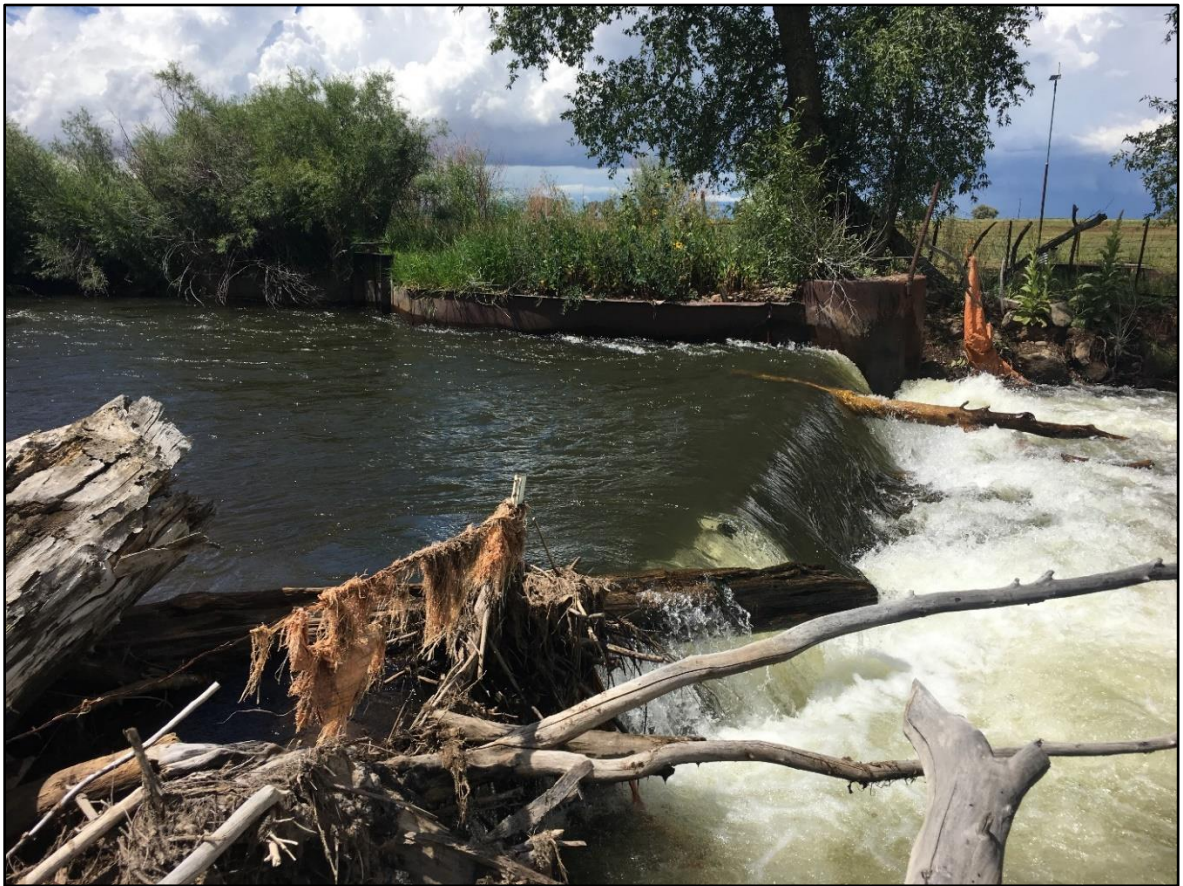
Diversion dam and headgate (post-2019 runoff)

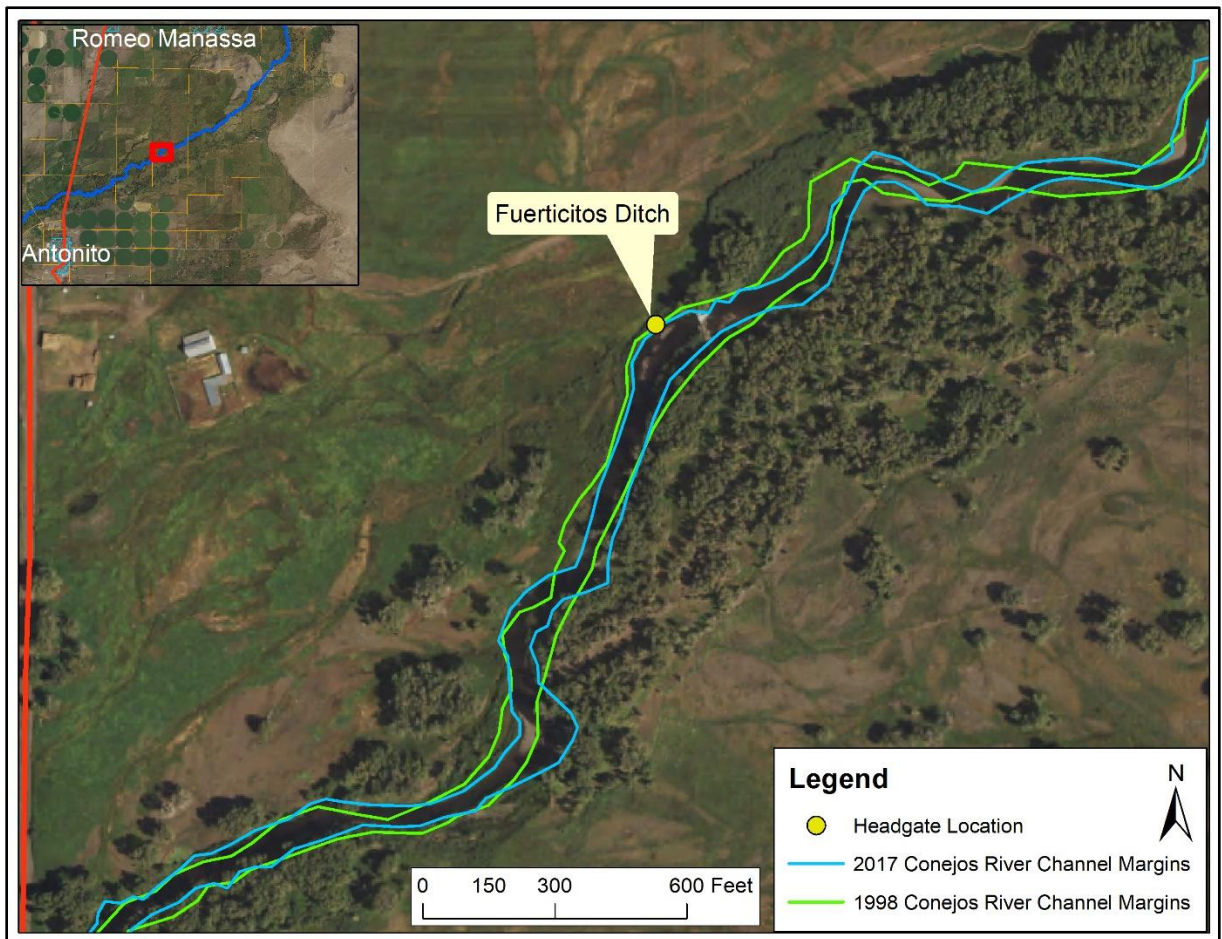
Headgate location with 1998 and 2017 channel margins overlaid

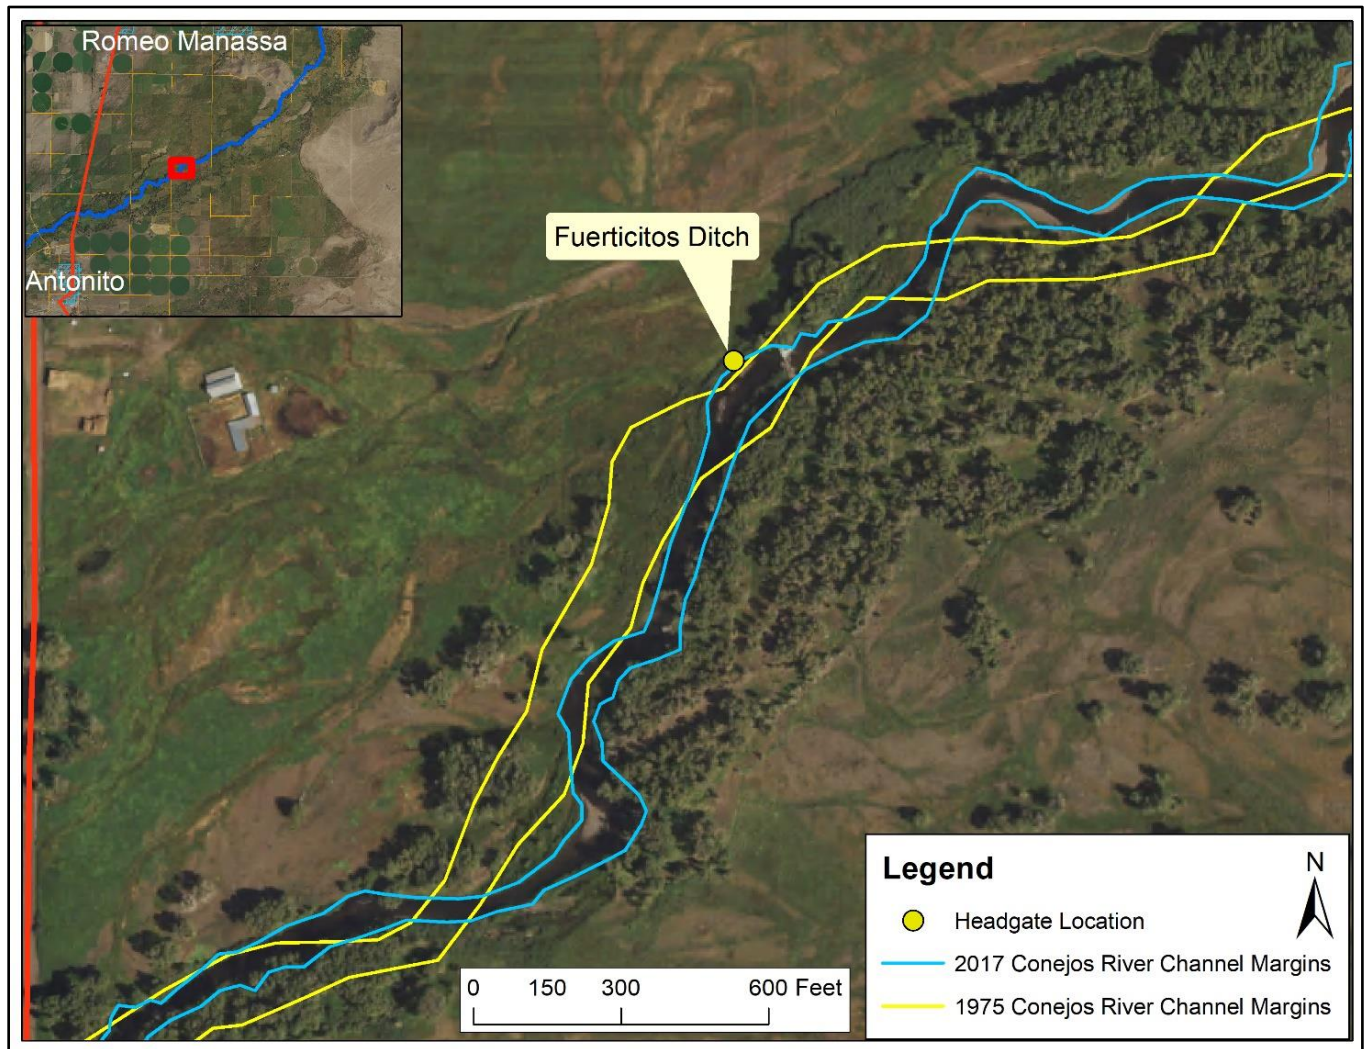
Headgate location with 1975 and 2017 channel margins overlaid
