CONEJOS RIVER DIVERSION INFRASTRUCTURE INVENTORY

Structure Name: GABRIEL MARTINEZ D

Date: April 2, 2019

Conejos River Stream
Management Plan

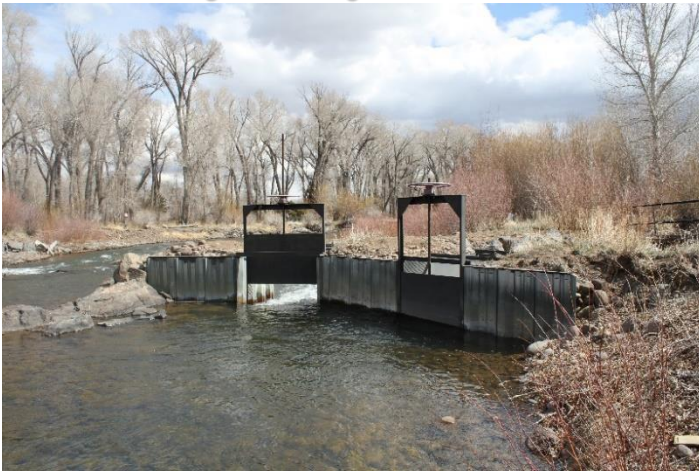
Headgate looking downstream

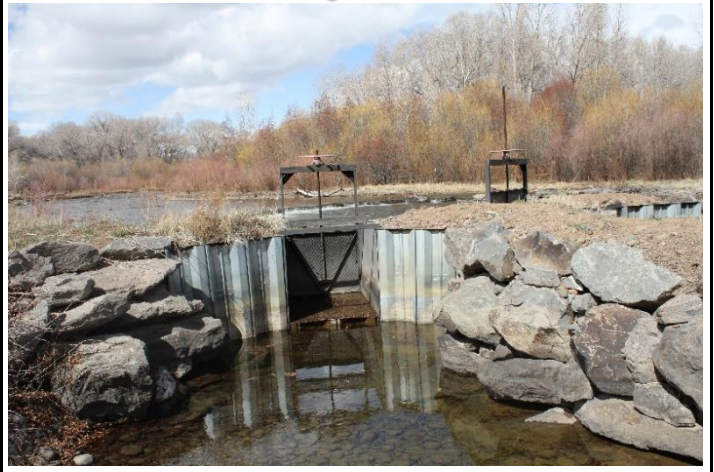
Headgate outlet

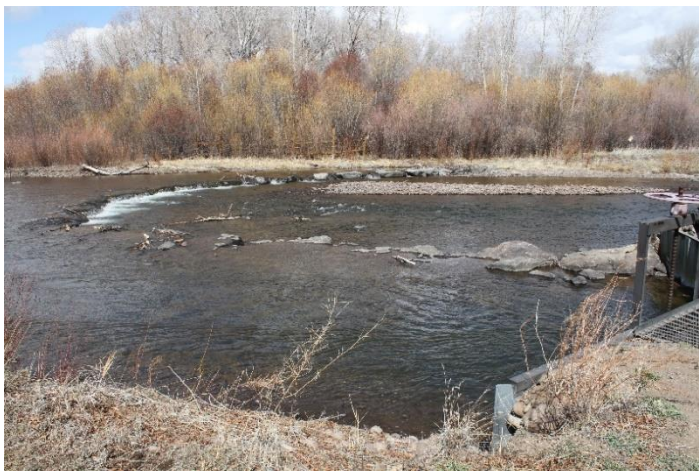
Diversion dam

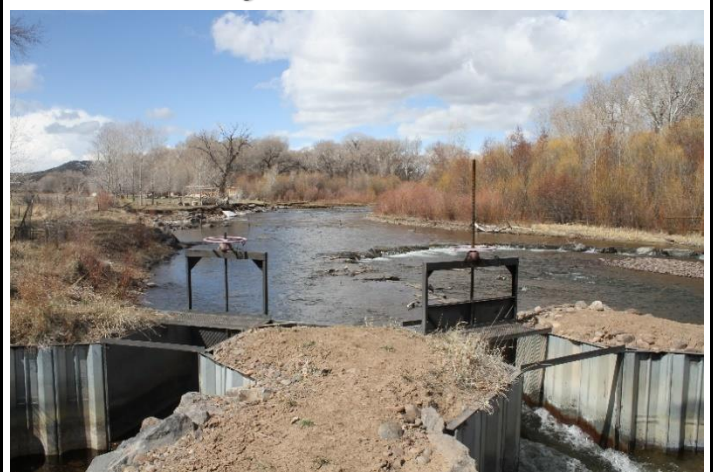
Headgate and diversion dam

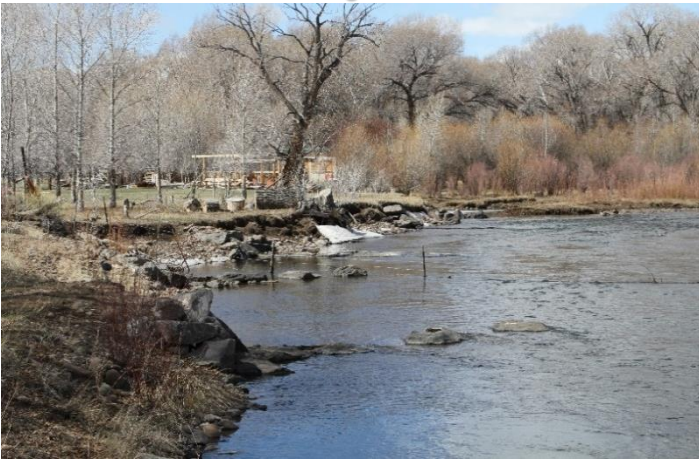
Flume looking downstream

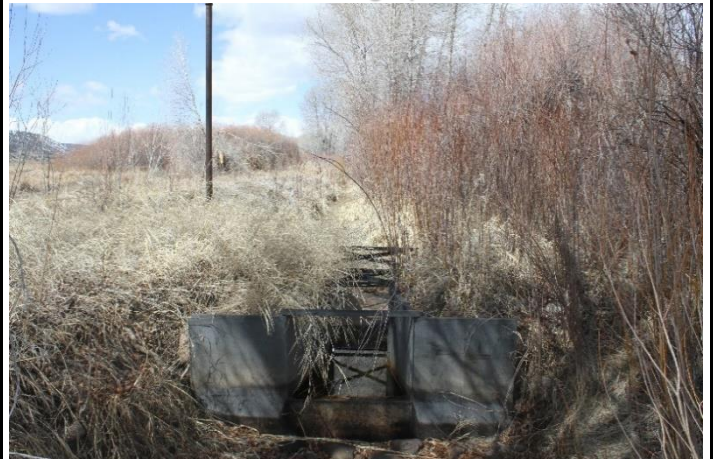
Flume looking upstream

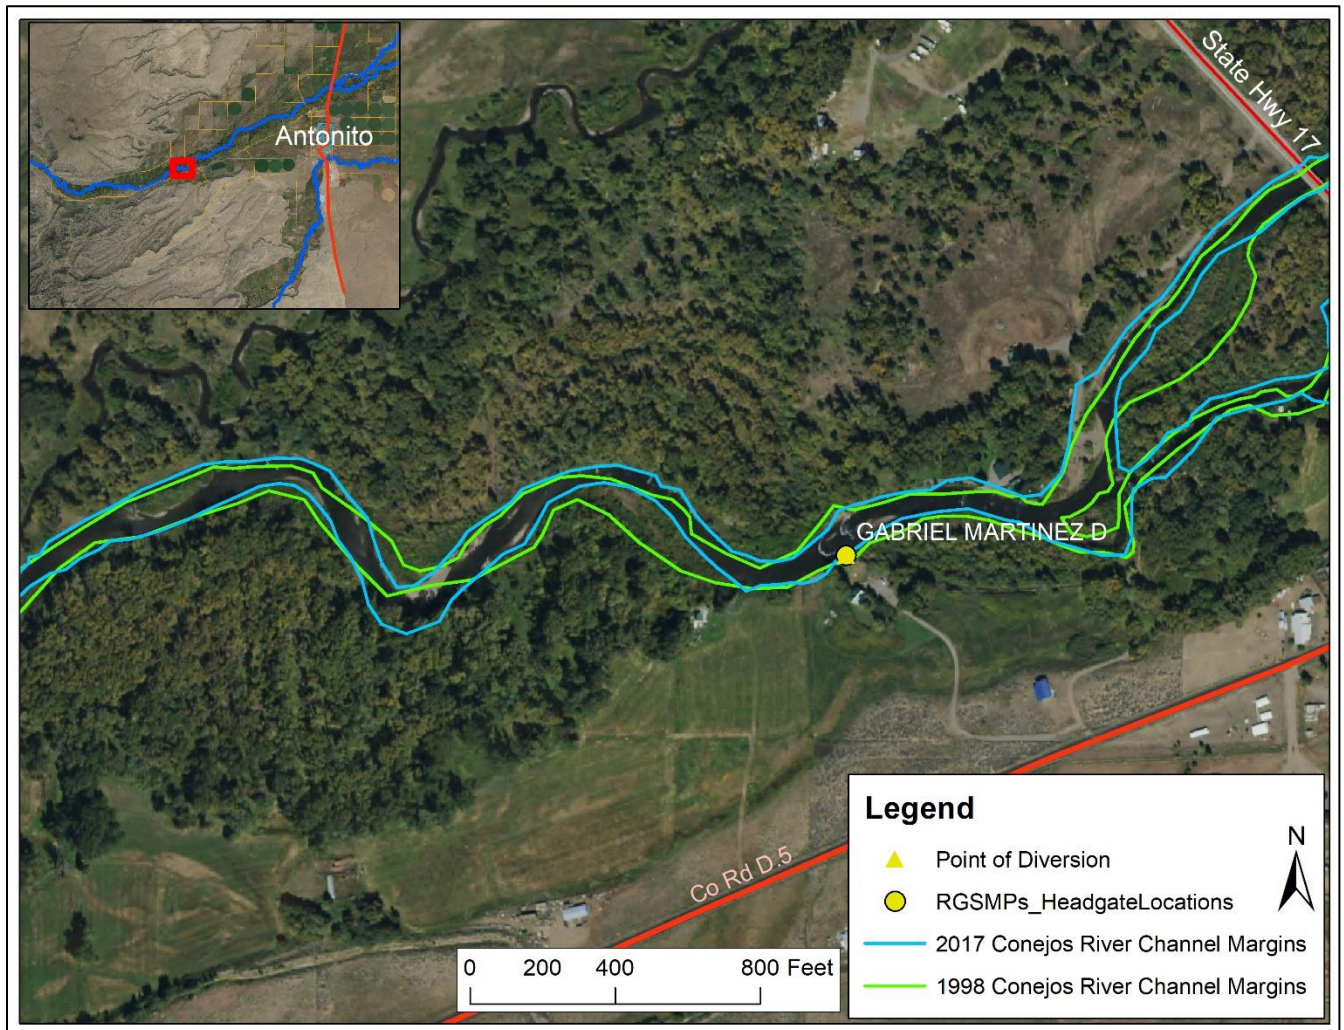
Structure Description: A U-shaped rock weir diversion dam directs water to the headgate, which is located on the south bank of Conejos River. A sluice gate is adjacent to the headgate. Downstream of the structure, a series of several U-shaped rock structures were installed. Meanders upstream of the structure are growing and channel avulsion has occurred in the past. A series of j-hooks were installed upstream of the structure on the south bank of the river. However, significant bank erosion has continued upstream of the j-hooks.

Aerial image showing headgate location and in-stream improvement projects

Repair(s) or Improvement(s) Currently Needed: The SMP Technical Advisory Team (TAT) recommends bank stabilization and riparian revegetation upstream of the structure to reduce erosion and increase channel and bank stability.
