# CONEJOS RIVER DIVERSION INFRASTRUCTURE INVENTORY

**Structure Name:** GARCIA R D

**Date:** April 3, 2019

Conejos River Stream Management Plan

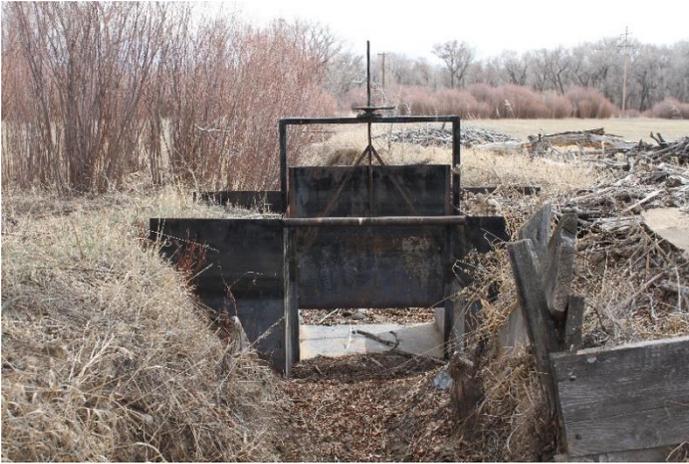
Headgate looking downstream

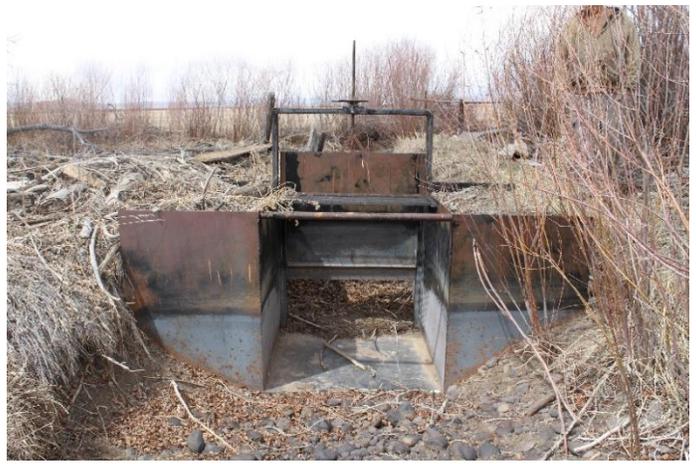
Headgate outlet

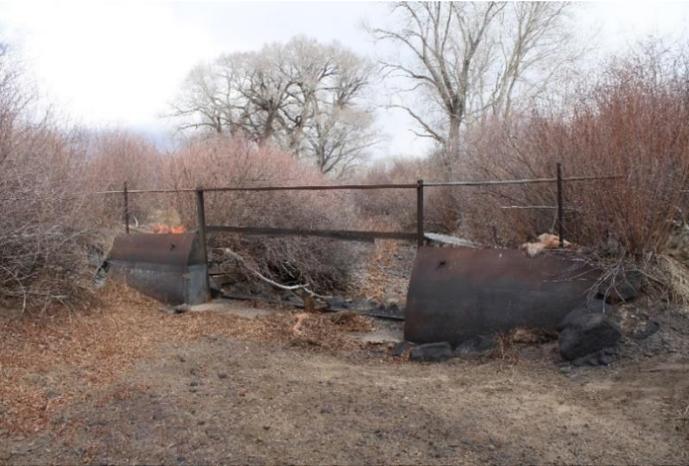
Diversion dam looking downstream

**Repair(s) or Improvement(s) Currently Needed:** The SMP Technical Advisory Team (TAT) recommends erosion mitigation and riparian revegetation as well as improving the diversion. A new or improved diversion would improve efficiency and reduce maintenance.

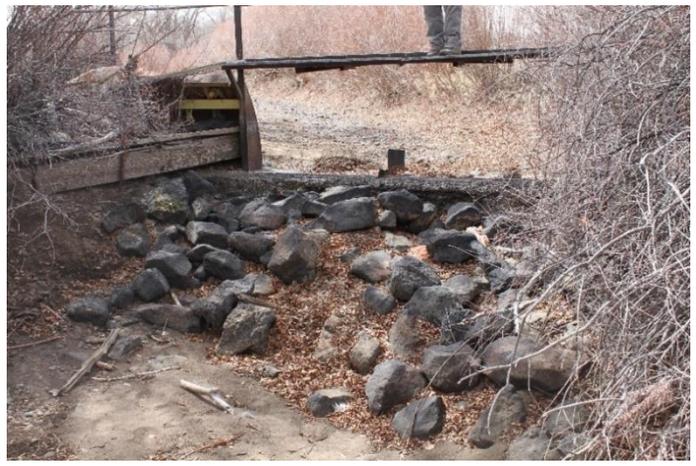
Diversion dam looking upstream

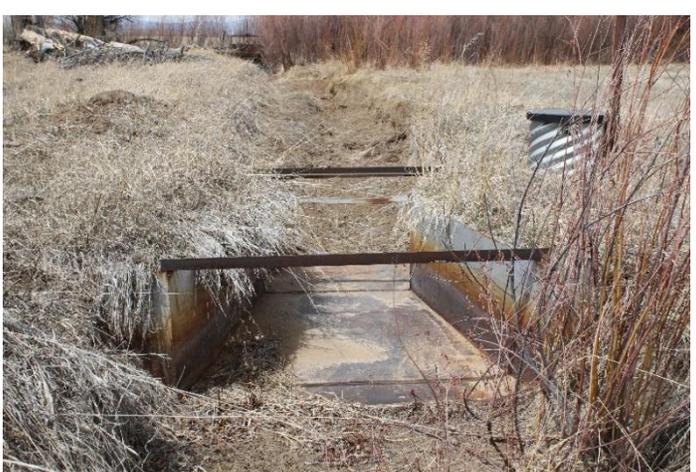
Flume looking upstream
