CONEJOS RIVER

DIVERSION INFRASTRUCTURE INVENTORY

Structure Name: GUADALUPE MAIN D

Date: April 14, 2019

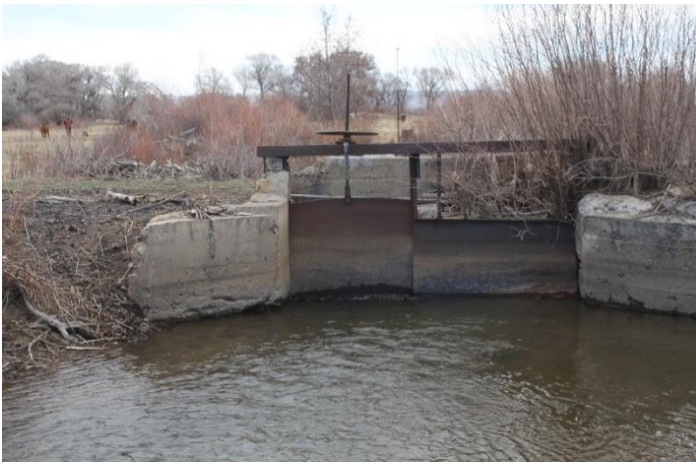
Headgate looking downstream

Repair(s) or Improvement(s) Currently Needed: Given the issues identified at this structure, the SMP Technical Advisory Team (TAT) recommends bank stabilization upstream of the diversion, including riparian revegetation and floodplain reconnection, improving the return flow channel, and replacing the headgate. Bank stabilization and floodplain reconnection will help reduce future bank erosion on the bend and create low flow fish habitat. Return flow channel improvements will allow the channel to effectively convey return flows and headgate replacement will improve efficiency and reduce maintenance. If improvements are made to the diversion, the TAT also recommends maintaining fish passage to preserve aquatic habitat connectivity.

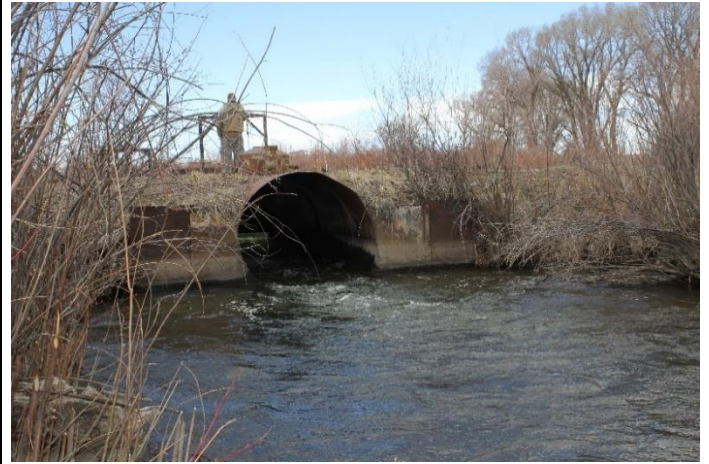
Headgate outlet

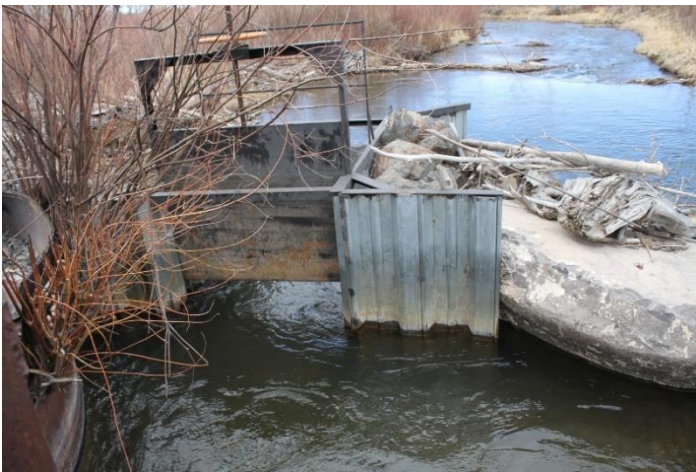
Sluice gate adjacent to headgate

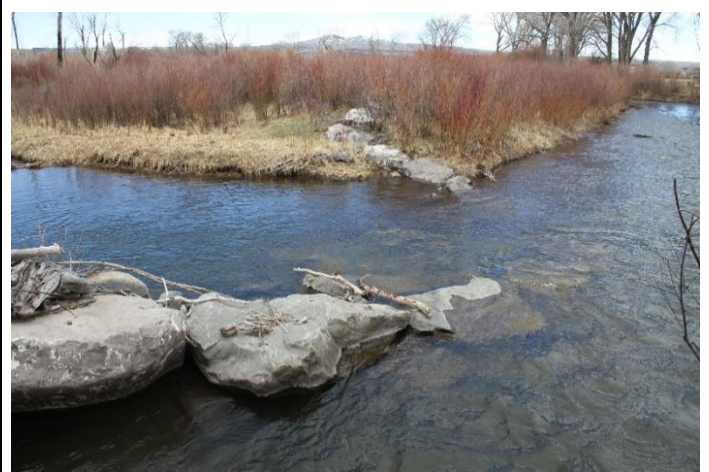
Diversion dam on feeder channel

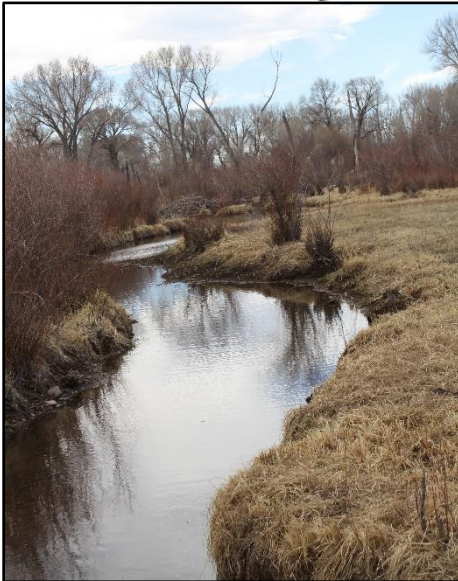
Return flow channel looking downstream

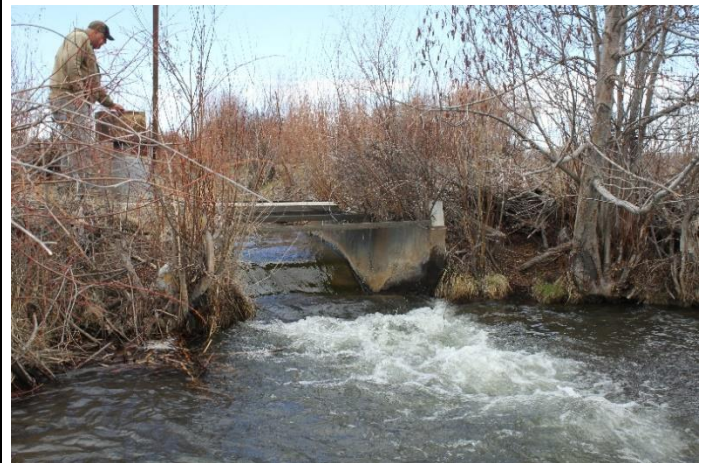
Flume looking upstream

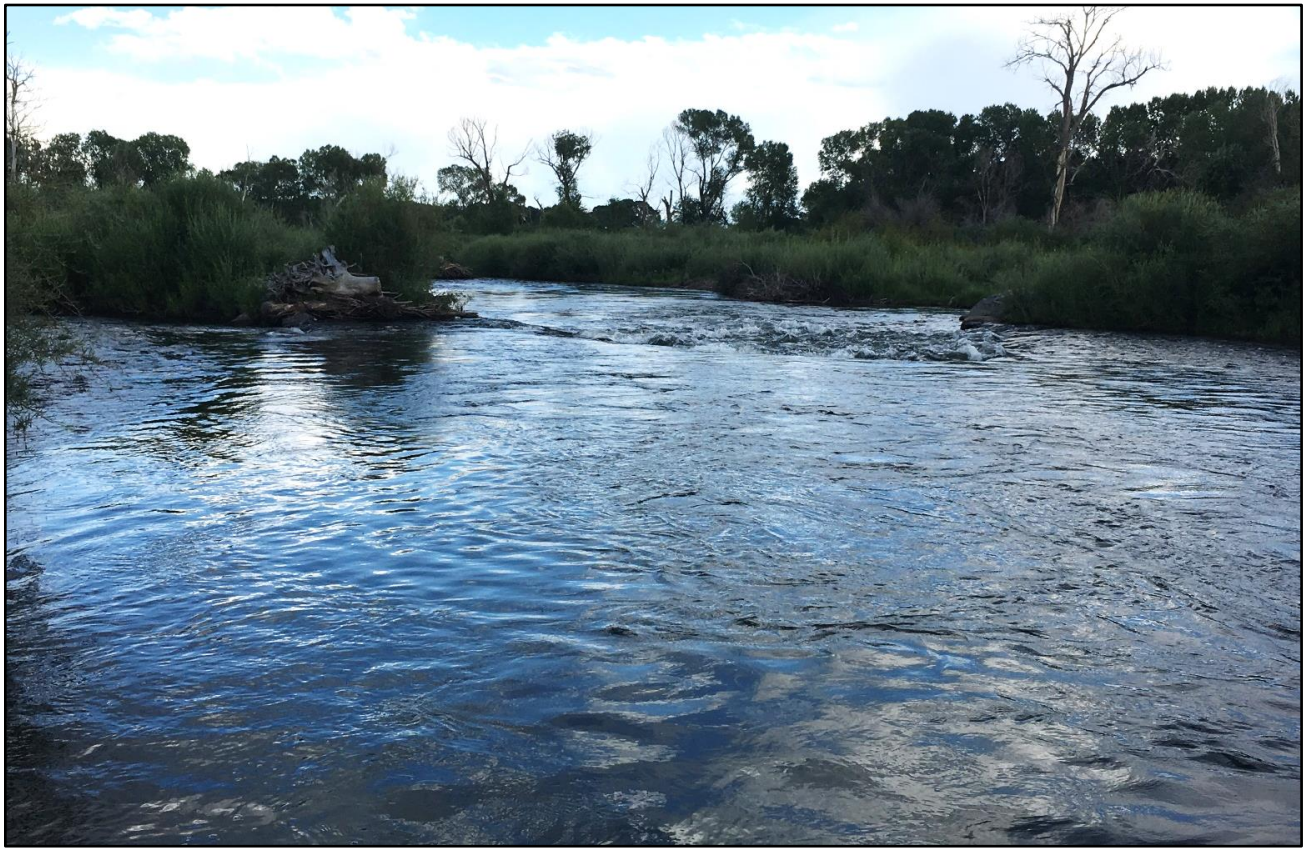
Diversion dam on Conejos River looking downstream

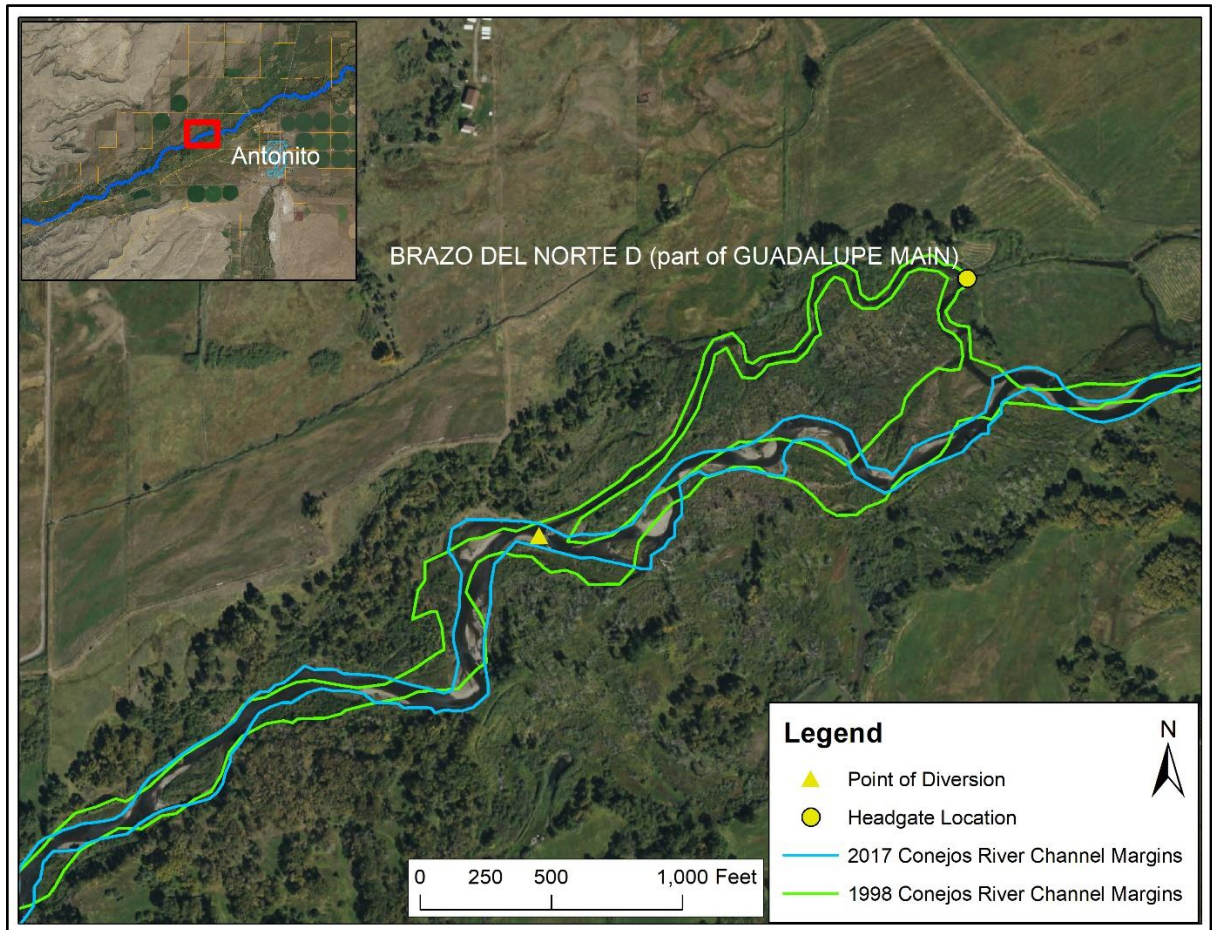
Guadalupe Main point of diversion with 1998 and 2017 channel margins overlaid.

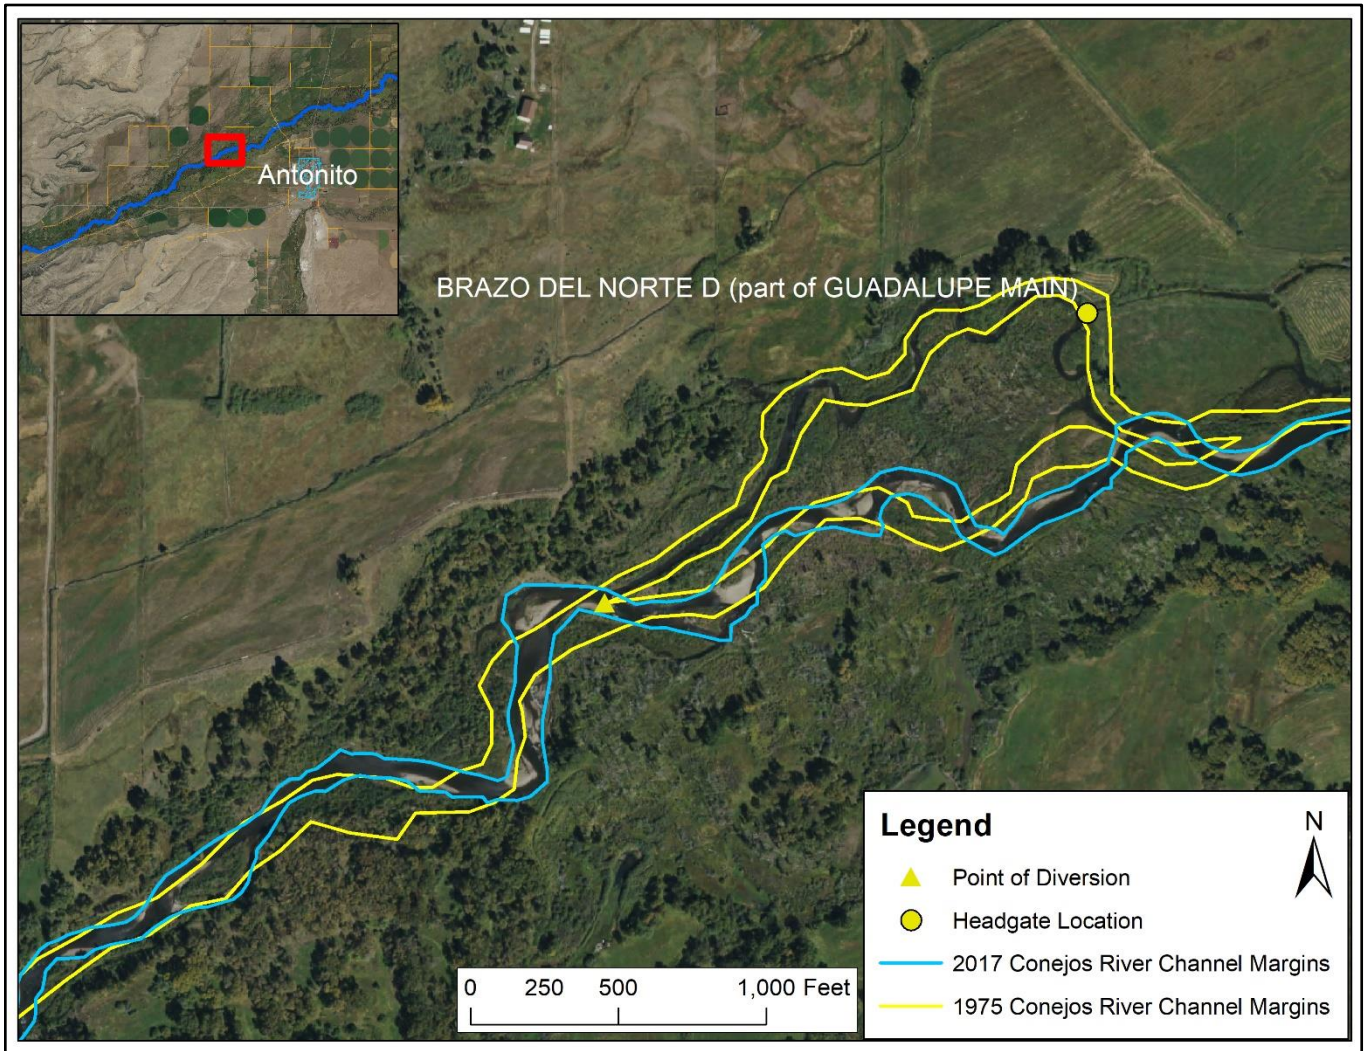
Guadalupe Main point of diversion with 1975 and 2017 channel margins overlaid.
