CONEJOS RIVER

DIVERSION INFRASTRUCTURE INVENTORY

Structure Name: HEADS MILL & IRRIGATION D

Date: April 2, 2019

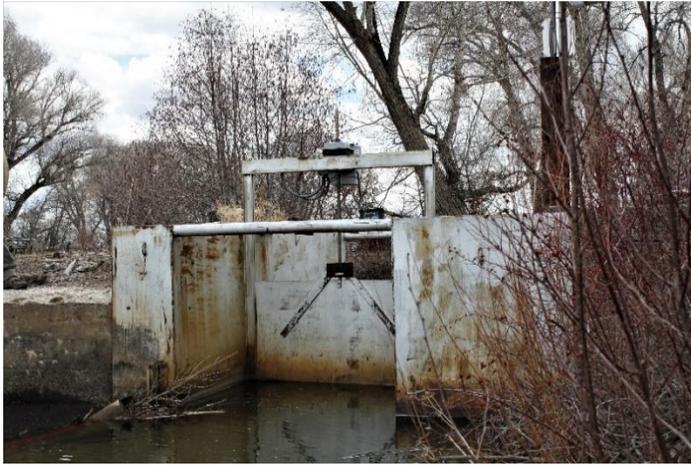
Headgate looking downstream

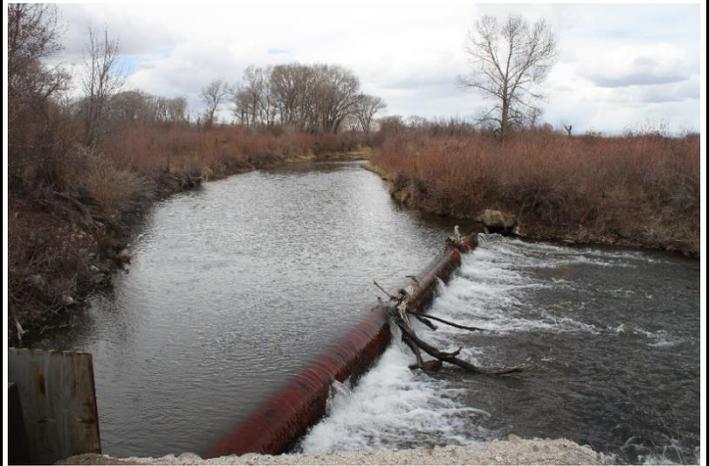
Diversion dam looking upstream

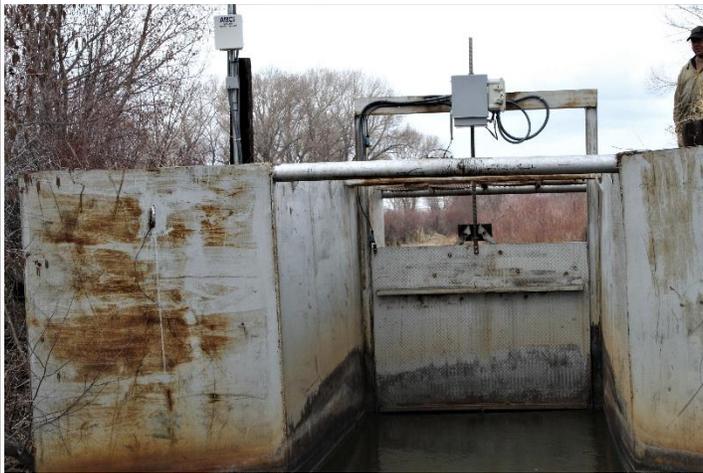
Headgate outlet

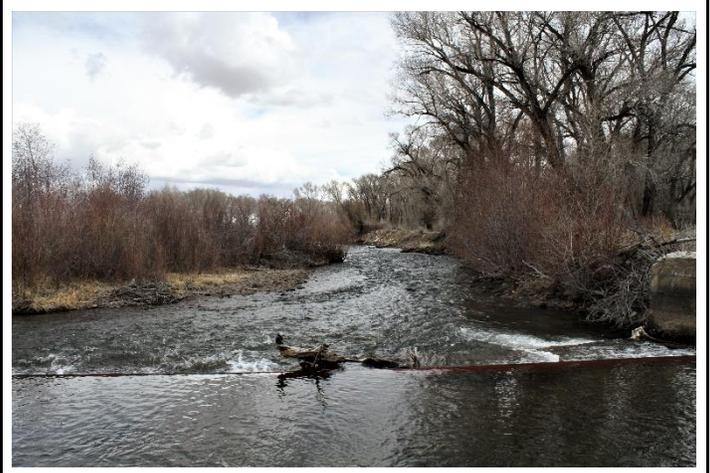
Diversion dam looking downstream

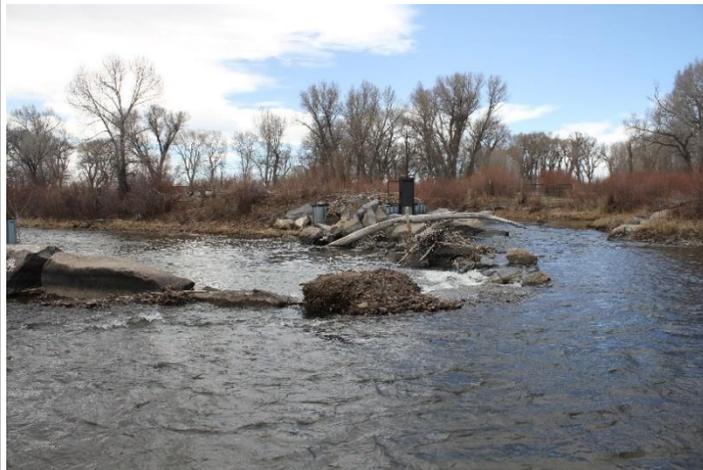
Repair(s) or Improvement(s) Completed Since 2006: The entrance to the feeder channel was relocated during repairs of the Romero Ditch, which was completed in winter 2019. An overflow/slucice gate was also installed at the entrance of the feeder channel and is built into the Romero Ditch diversion dam's rock structure.

Feeder ditch entrance

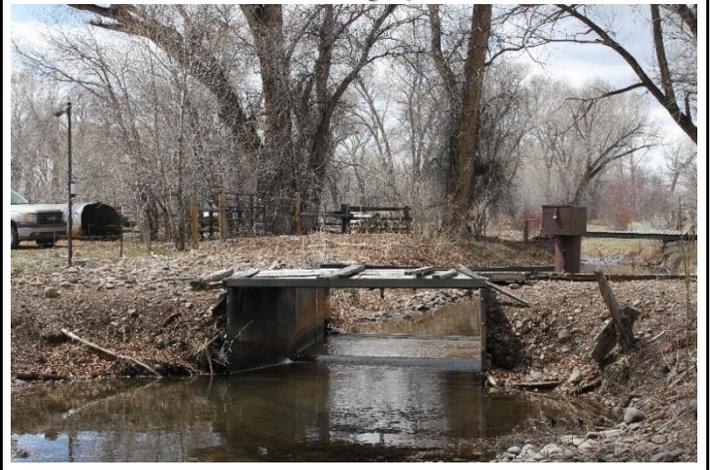
Flume looking upstream

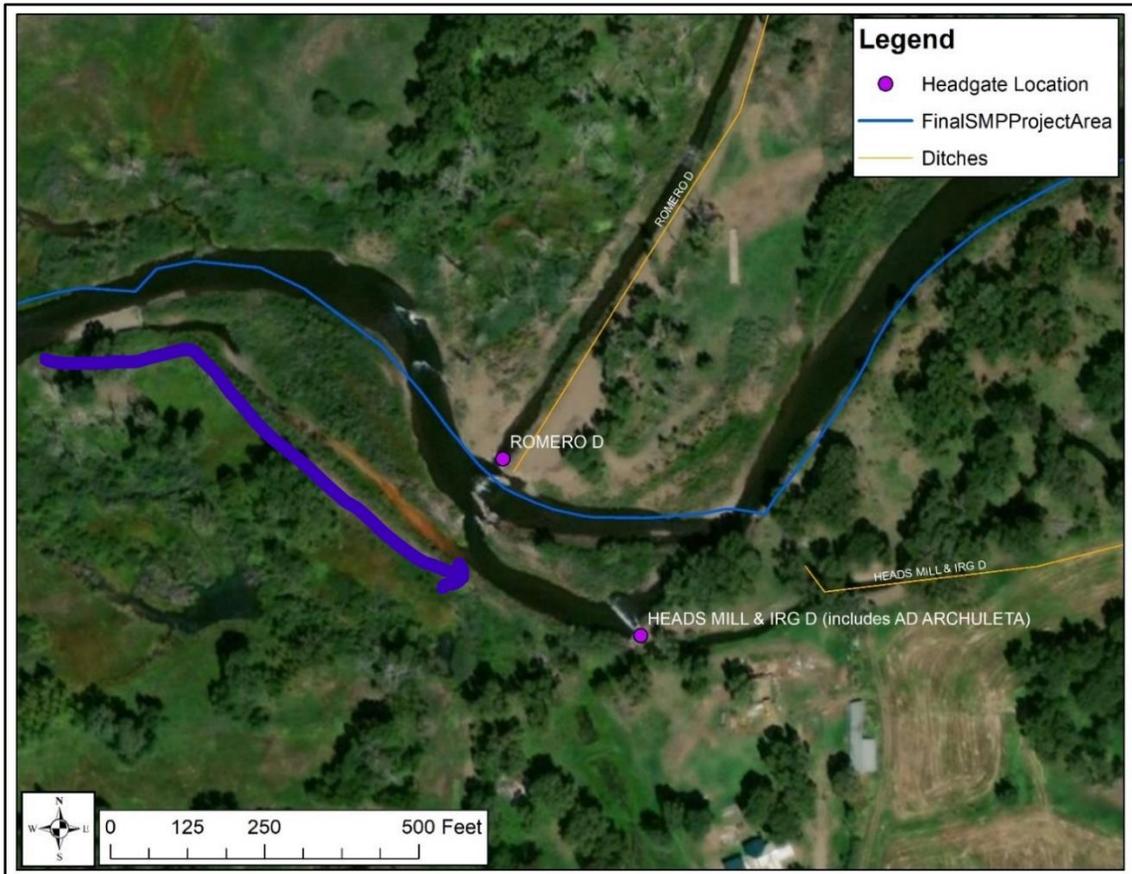
Aerial image showing Heads Mill Irrigation Ditch and Romero Ditch headgates. The old Heads Mill feeder channel is traced in blue in this image.

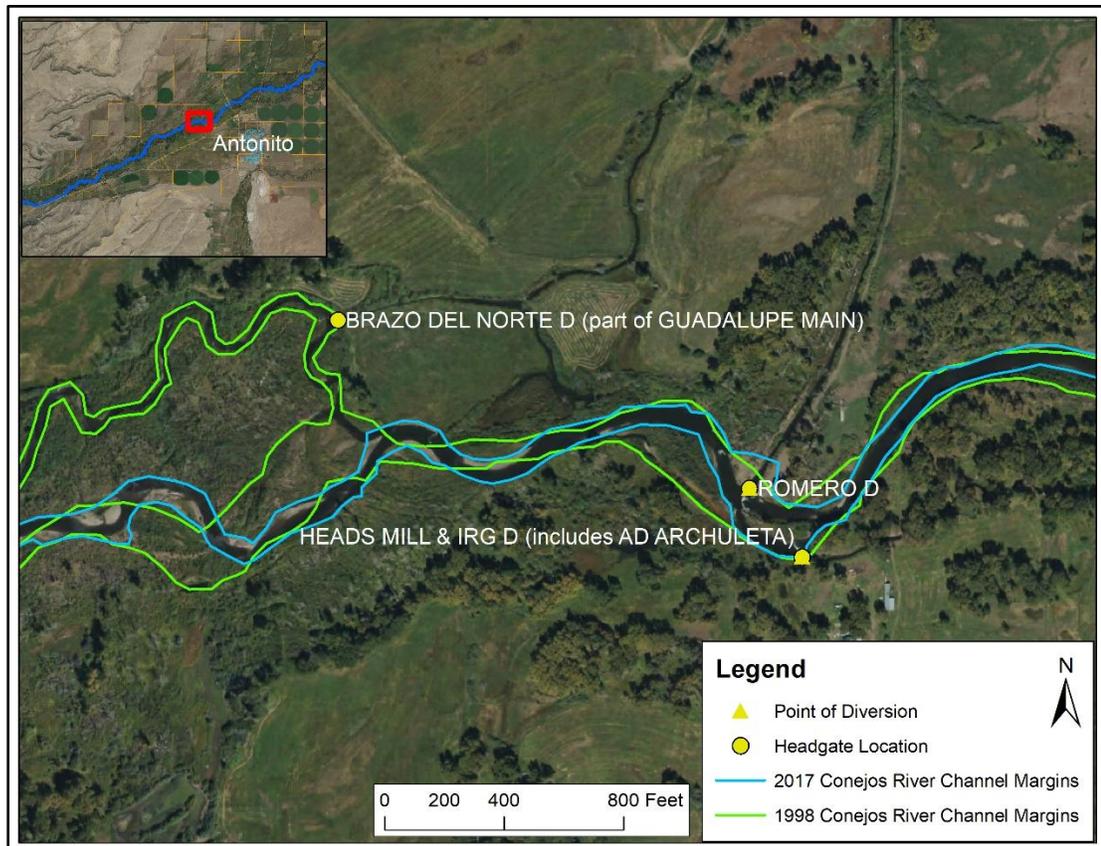
Repair(s) or Improvement(s) Currently Needed: The channel has migrated significantly in this area, especially upstream of the diversion dam. J-hooks were installed upstream to stabilize banks. If future channel migration occurs, other solutions may need to be considered. No immediate repair needs were noted at the time of inspection.

Headgate location with 1998 and 2017 channel margins overlaid

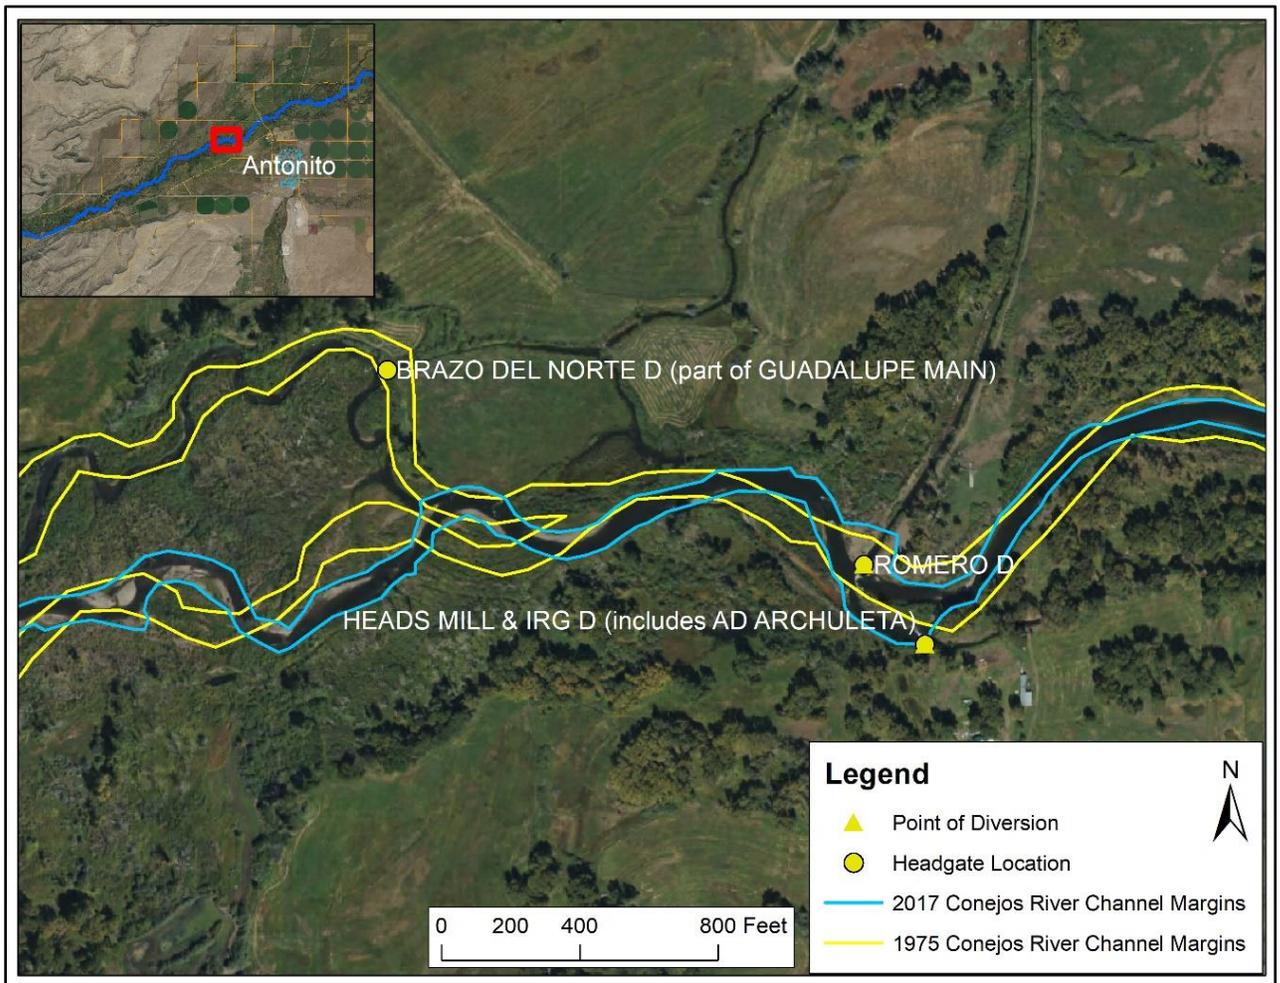
Headgate location with 1975 and 2017 channel margins overlaid
