CONEJOS RIVER DIVERSION INFRASTRUCTURE INVENTORY

Structure Name: HOME D

HOME DITCH

Conejos River Stream Management Plan

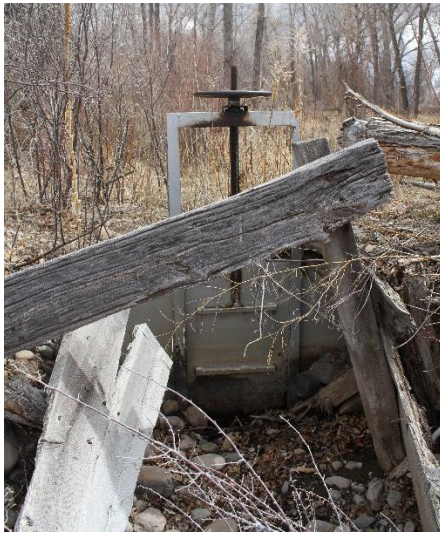
Headgate looking downstream

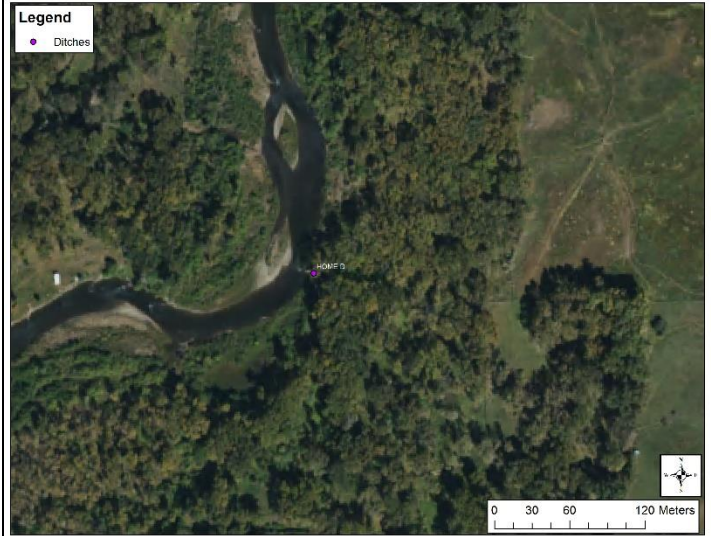
Structure Description: The river is relatively stable in this reach, although channel migration has occurred prior to 1998 (see maps in report card). There is no diversion dam for this ditch. Water is diverted from the mainstem Conejos River to the headgate, which is located on the east bank. Significant bank erosion is occurring near the headgate.

Point of Diversion

Repair(s) or Improvement(s) Currently Needed: The SMP Technical Advisory Team (TAT) recommends implementing bank stabilization and riparian revegetation to prevent further erosion.

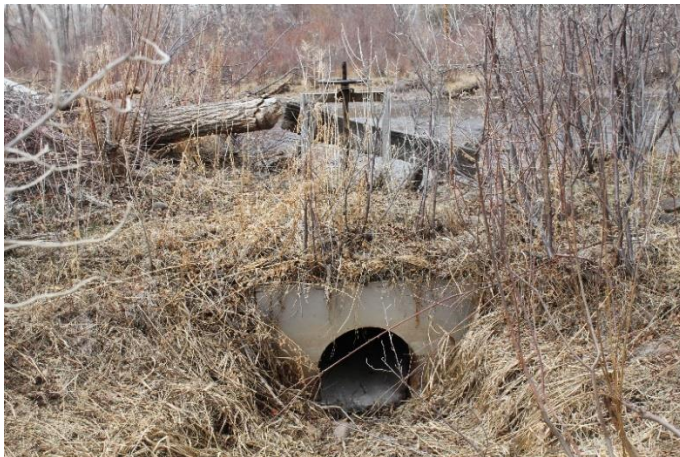
Headgate outlet

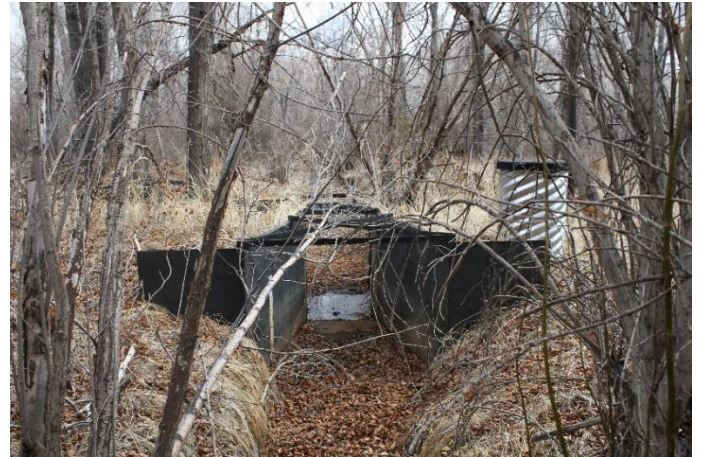
Flume looking downstream

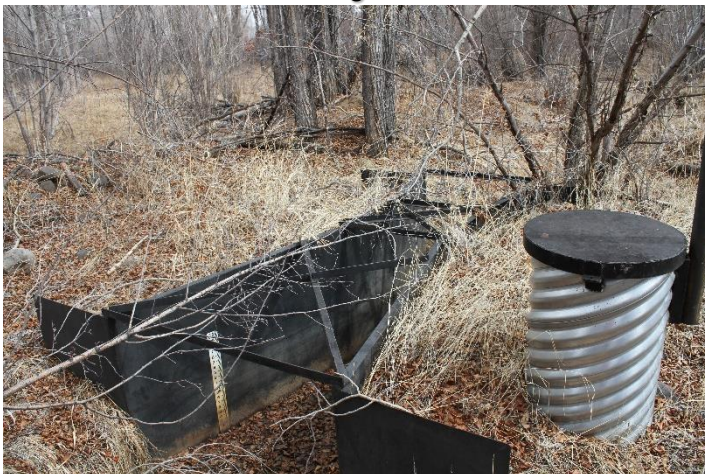
Flume looking downstream

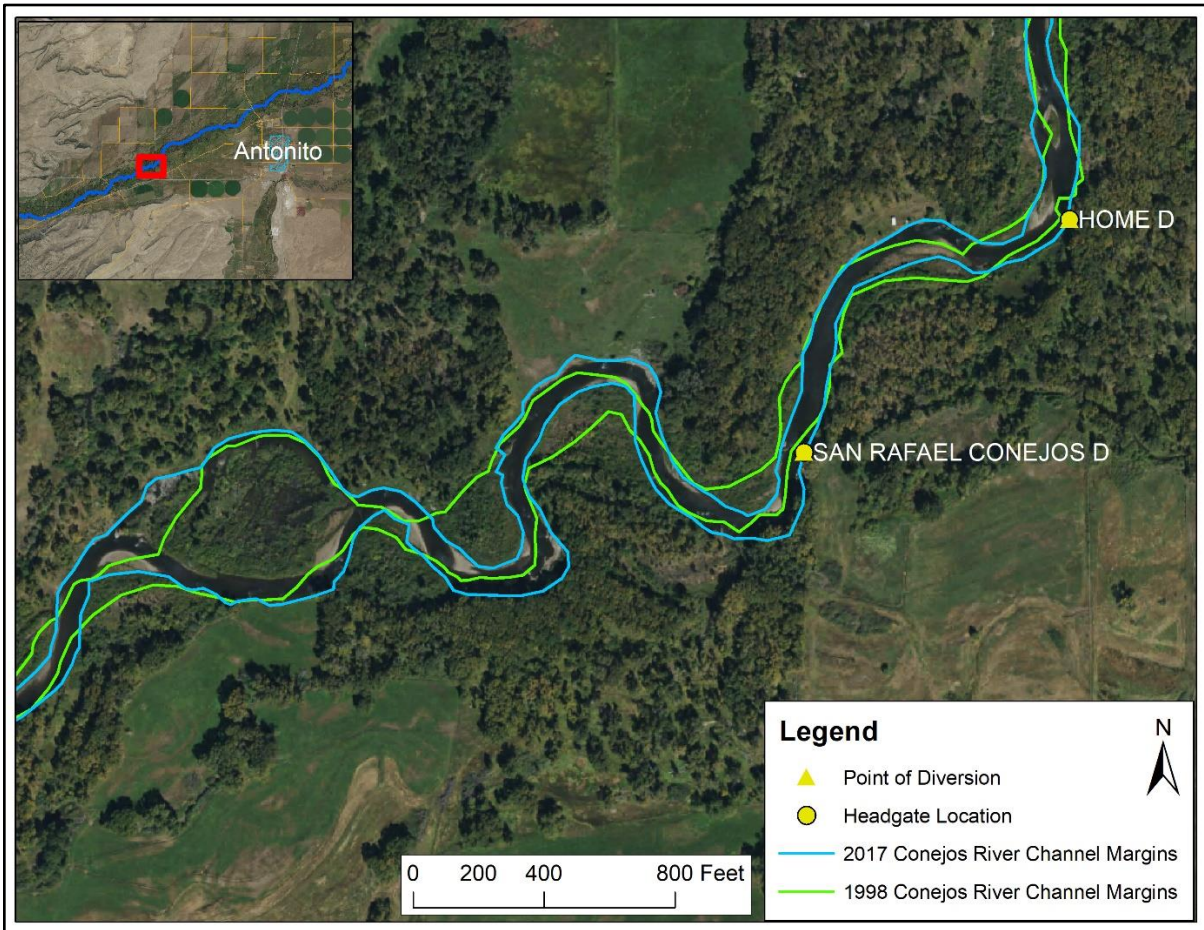
Home Ditch point of diversion with 1998 and 2017 channel margins overlaid.

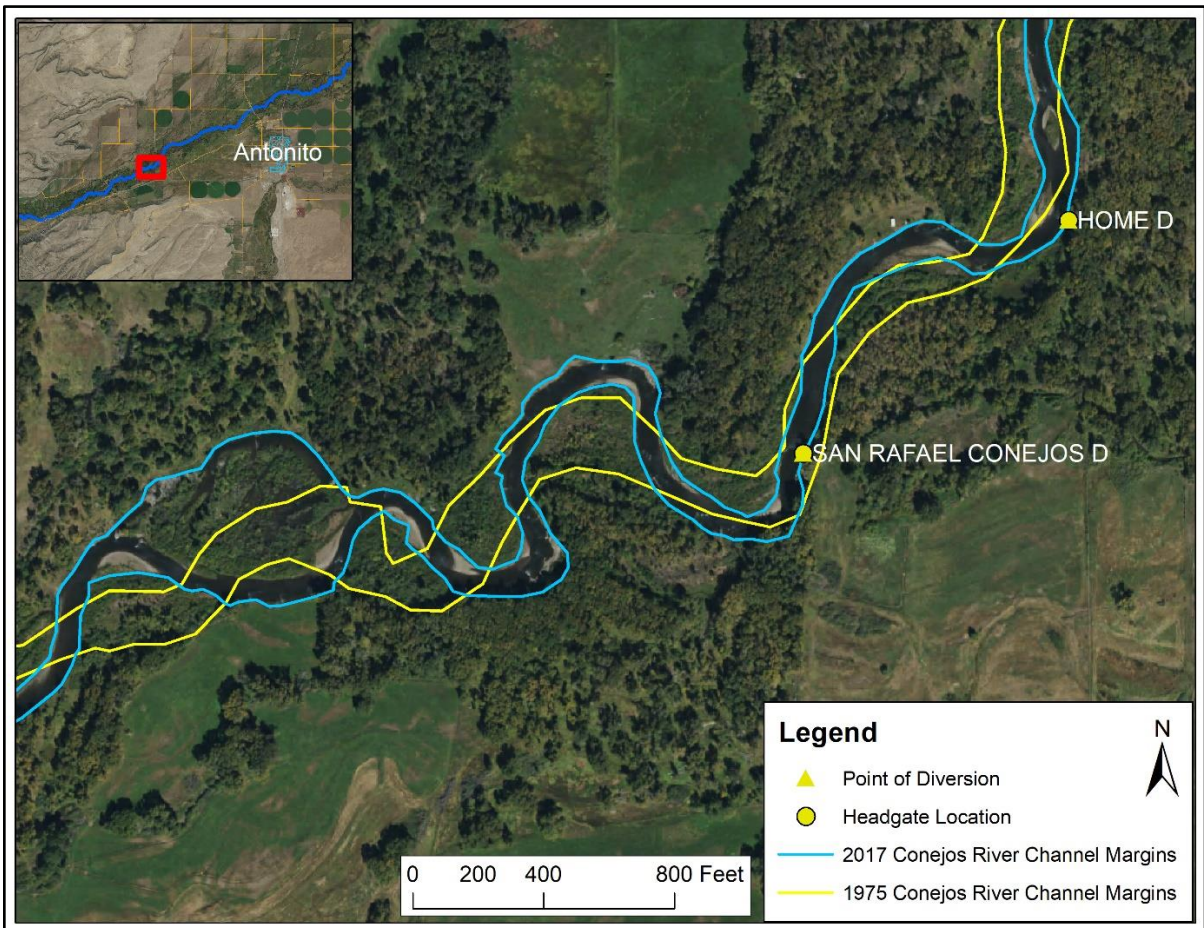
Home Ditch point of diversion with 1975 and 2017 channel margins overlaid.
