CONEJOS RIVER DIVERSION INFRASTRUCTURE INVENTORY

Structure Name: JACKS IRRIGATING D

Date: April 15, 2019

Conejos River Stream
Management Plan

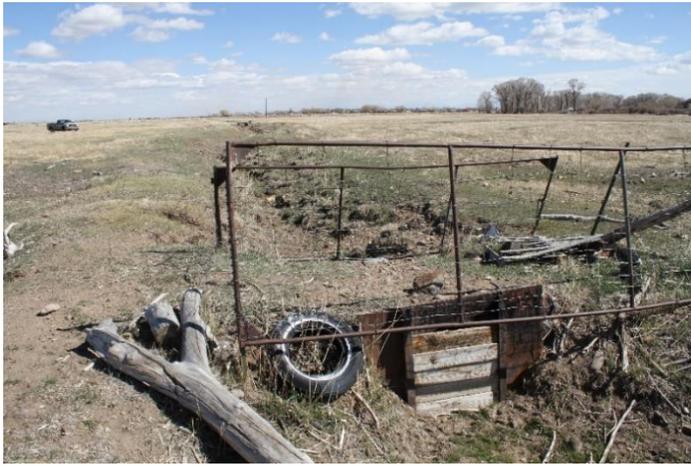
Structure Description: A diversion dam made up of concrete blocks, boulders, and debris diverts water to a short feeder channel, about 130 ft long, located on the west bank of the channel. Debris accumulation and sedimentation is an issue at this structure, particularly for the diversion dam. The headgate is protected from livestock by two metal fences but functions poorly. Significant erosion downstream of the flume and around the wing walls may cause it to fail and/or not measure accurately.

Headgate looking downstream

Repair(s) or Improvement(s) Currently Needed: Given these issues, the SMP Technical Advisory Team (TAT) recommends replacing the headgate, maintaining the flume, and implementing riparian revegetation. A new headgate would increase efficiency and reduce maintenance and ditch maintenance at the flume would ensure long-term function. Riparian revegetation would reduce erosion and structure maintenance.

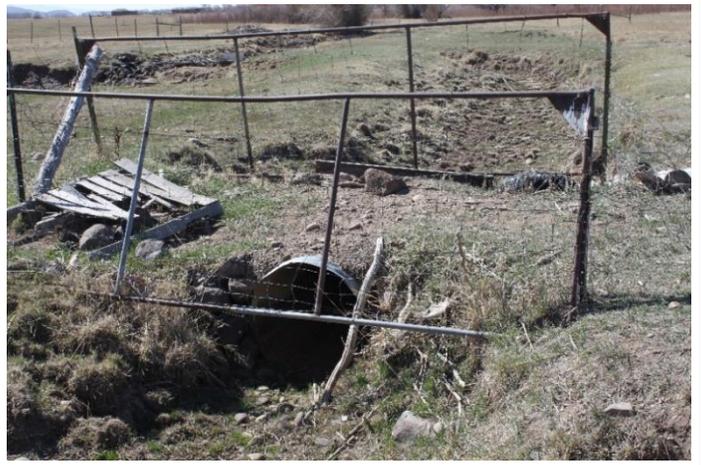
Headgate outlet

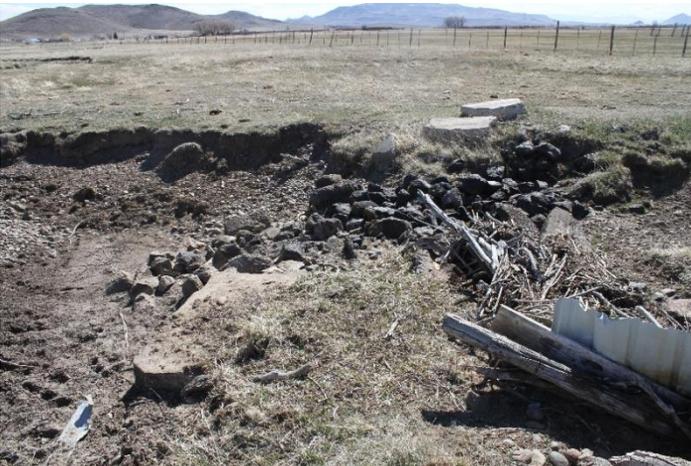
Diversion dam

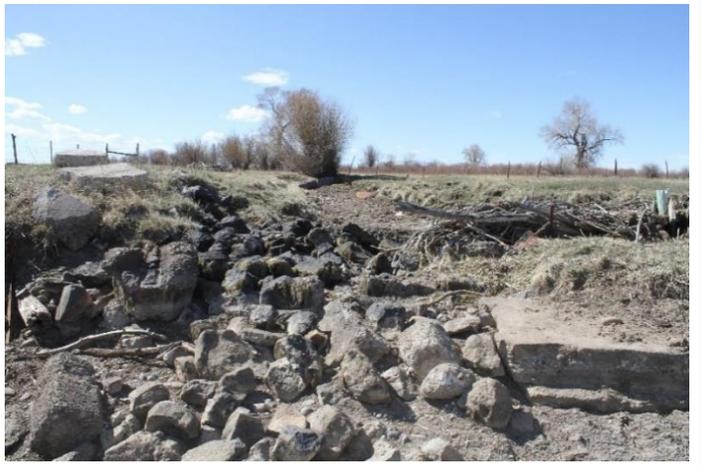
Diversion dam looking upstream

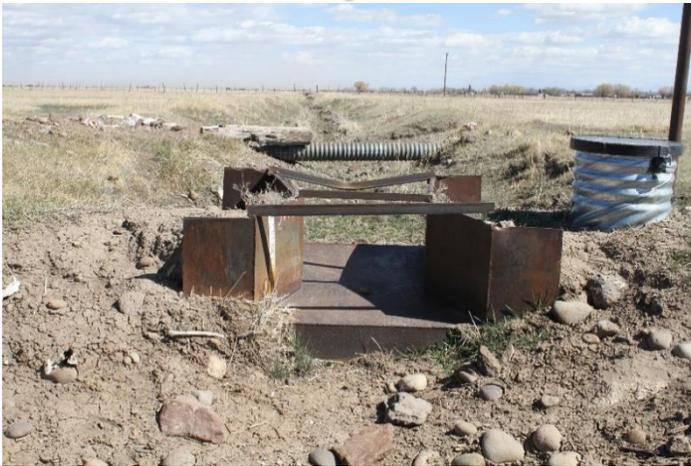
Flume looking downstream

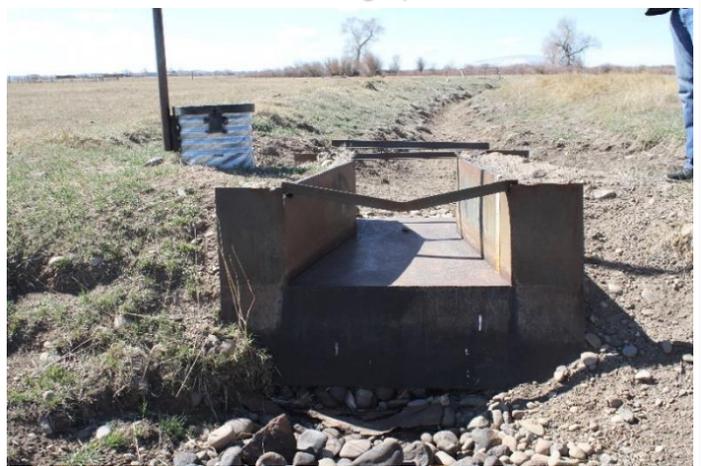
Flume looking upstream
