# CONEJOS RIVER

## DIVERSION INFRASTRUCTURE INVENTORY

**Structure Name:** JF CHACON D NO 3

**Date:** April 14, 2019

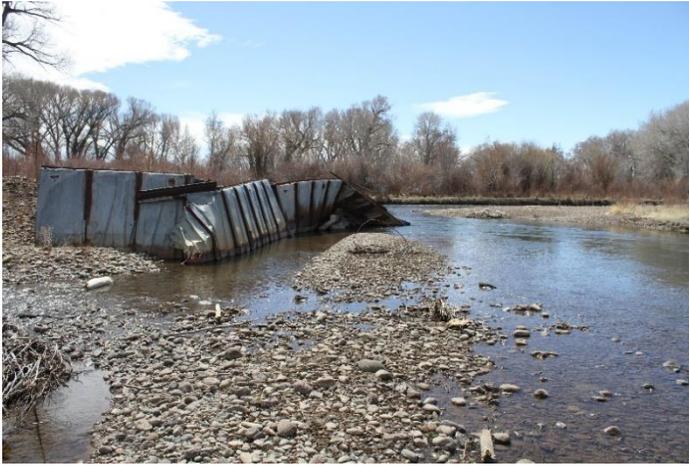
**Diversion for feeder ditch looking upstream**

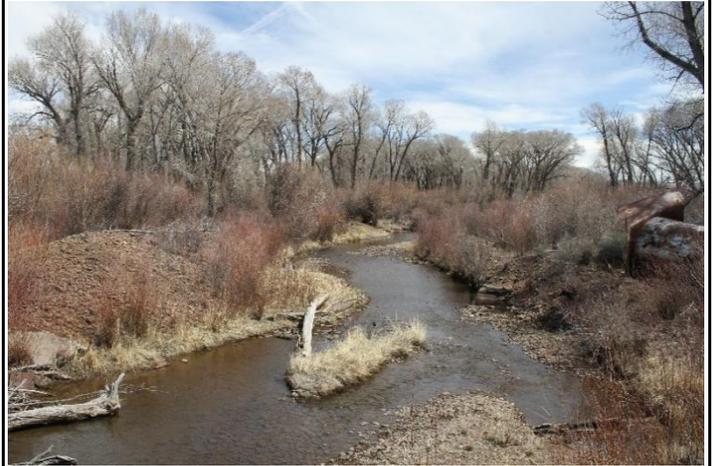
**Feeder ditch looking downstream**

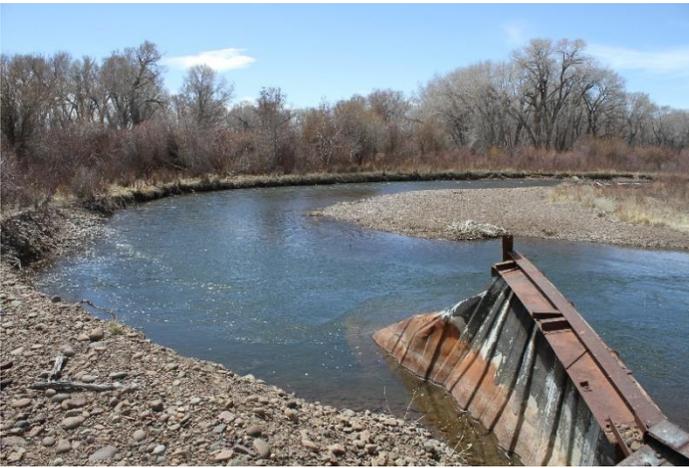
**Structure Description:** A long feeder channel (approximately 0.3 miles long) comes off the east bank of the river. A sheet metal diversion dam on the feeder channel directs water to the headgate. There is no formal diversion dam for the feeder channel. Steel wing walls are used to stabilize the bank upstream and downstream of the diversion but are failing. This ditch also services the An Con Irrigation Ditch, which includes priorities 42 and 100 for a total decreed amount of 18.8 cfs. Both upstream and downstream of the structure, meanders are tightening and lateral migration is occurring. Additionally, the meander on which the diversion is located is growing and could be cut off during high flows.

**Failing bank stabilization**

**Repair(s) or Improvement(s) Currently Needed:** Given the issues identified at this structure, the SMP Technical Advisory Team (TAT) recommends improving the diversion off the mainstem Conejos River, replacing the steel wing walls used for bank stabilization upstream of the diversion, and performing regular maintenance on the feeder channel's diversion dam to prevent debris accumulation. If the diversion dam and bank stabilization structures are improved, the TAT also recommends riparian revegetation and maintaining fish passage to preserve aquatic habitat connectivity in this reach. Diversion and streambank stabilization improvements will increase efficiency, reduce maintenance, mitigate erosion, and improve aquatic and riparian habitat.

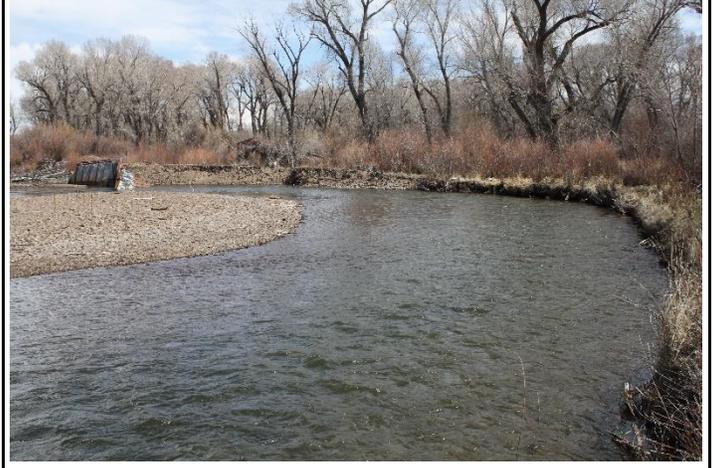
**East bank of Conejos River upstream of diversion**

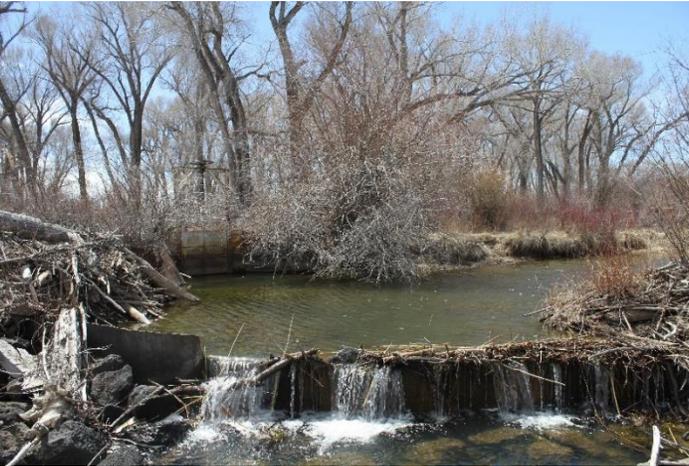
**Headgate and diversion dam**

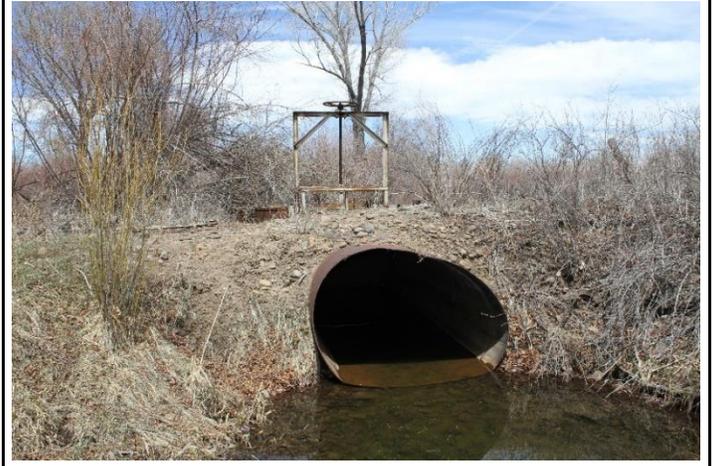
**Headgate outlet**

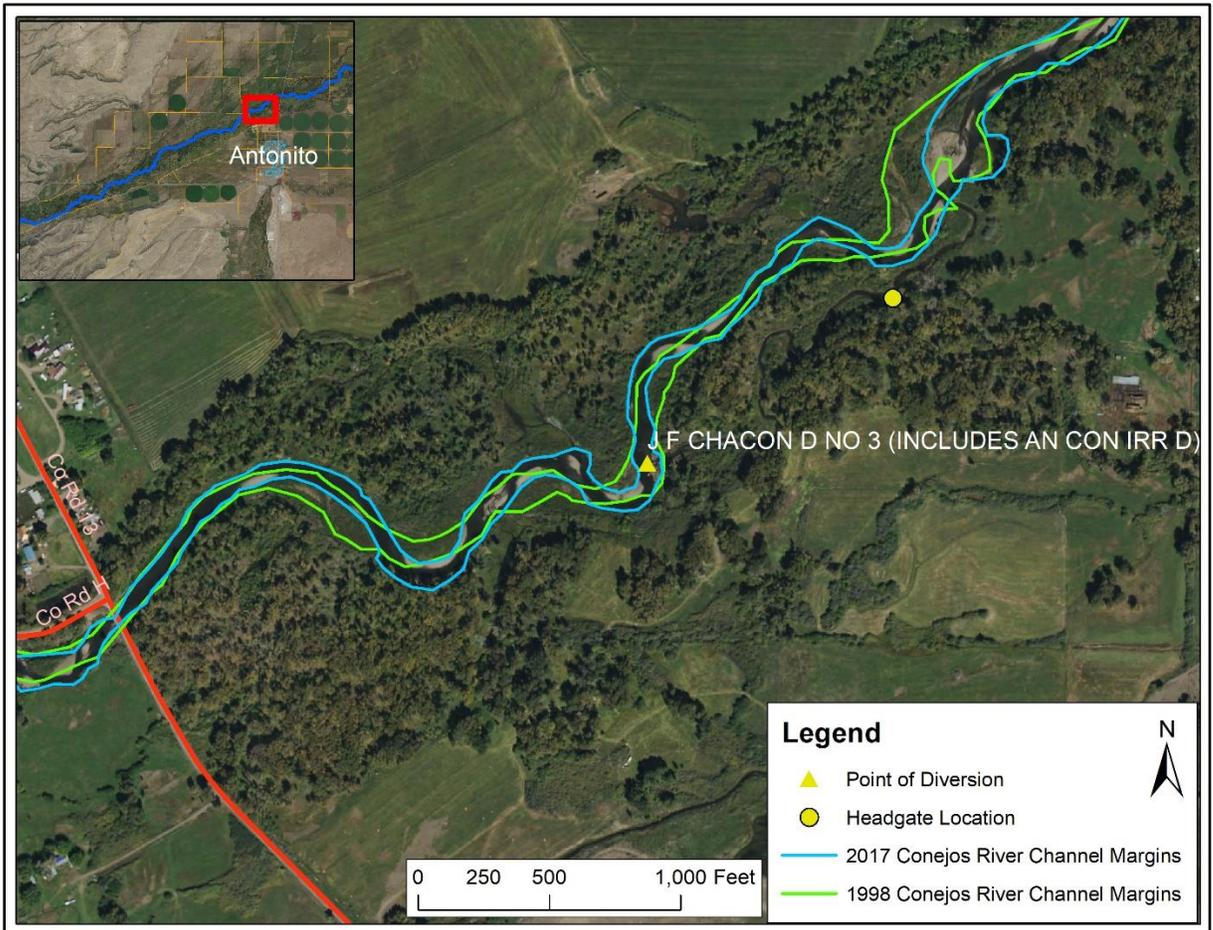
JF Chacon No 3 point of diversion location with 1998 and 2017 channel margins overlaid.

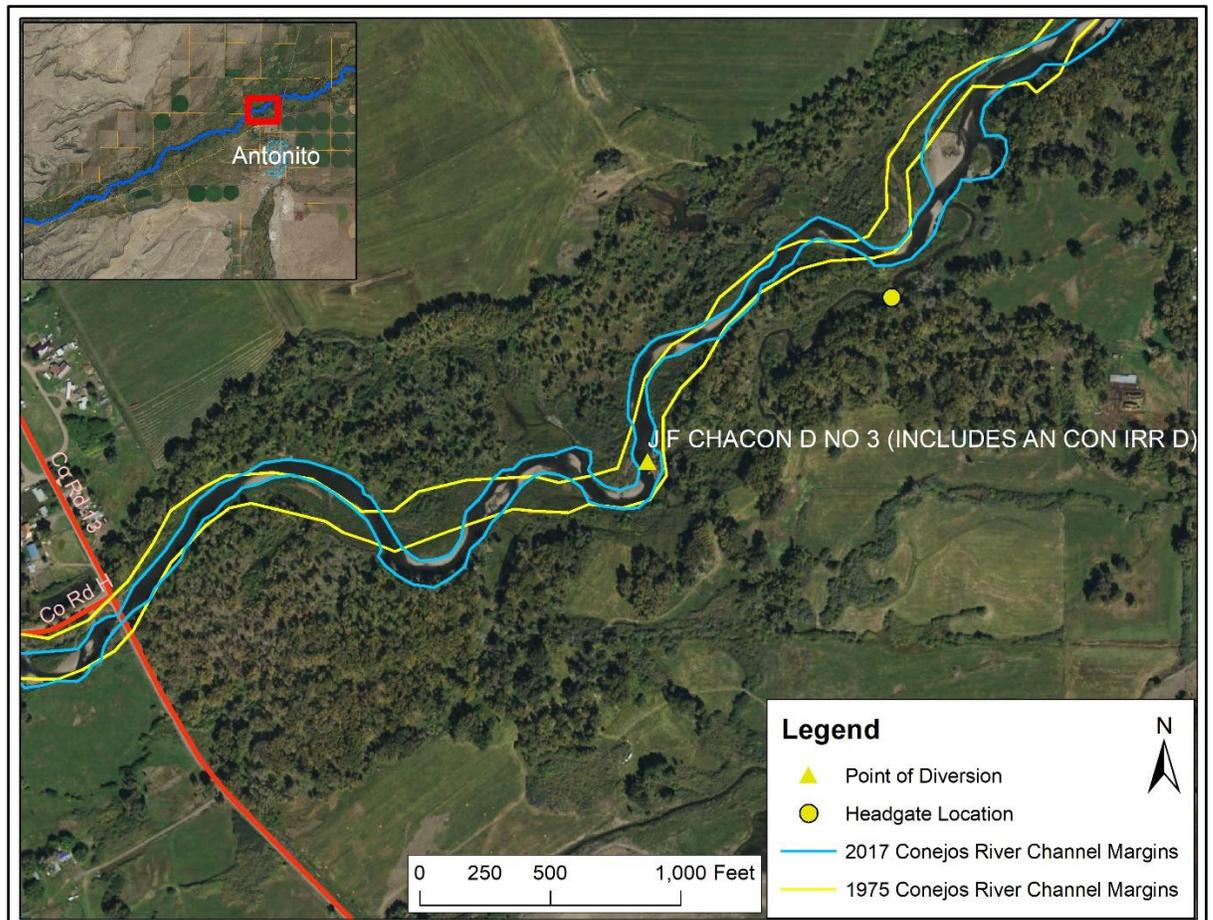
JF Chacon No 3 point of diversion location with 1975 and 2017 channel margins overlaid.
