CONEJOS RIVER DIVERSION INFRASTRUCTURE INVENTORY

Structure Name: JM ESPINOSA D

Date: April 15, 2019

JM ESPINOSA DITCH

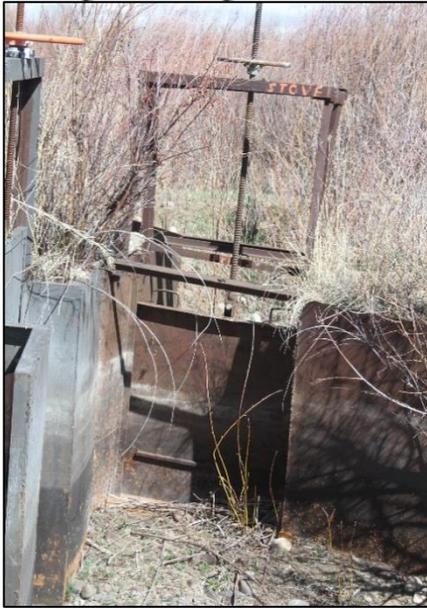
Structure Description: A rock diversion dam directs water to the headgate, which is located on the east bank of the channel. The headgate is located near the downstream end of a bend in the river. The sluice gate was recently replaced. The flume is aging and the headgate is tilted.

Headgate looking downstream

Repair(s) or Improvement(s) Currently Needed: The SMP Technical Advisory Team (TAT) recommends resetting the headgate and replacing the flume to increase efficiency and reduce maintenance.

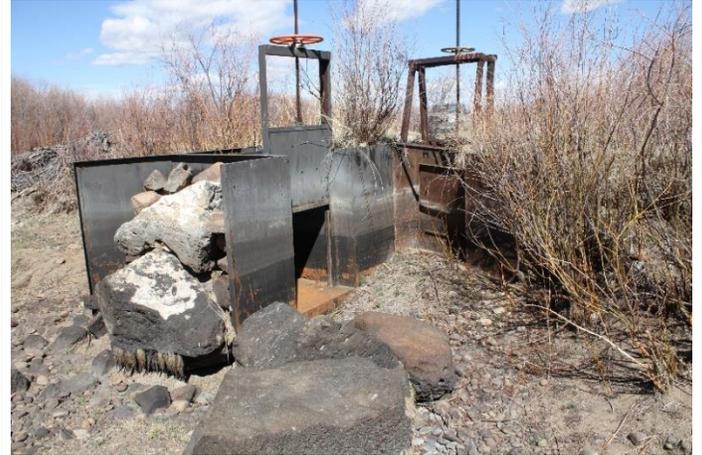
Repair(s) or Improvement(s) Completed Since 2006: The sluice gate was recently replaced.

Headgate and sluice gate

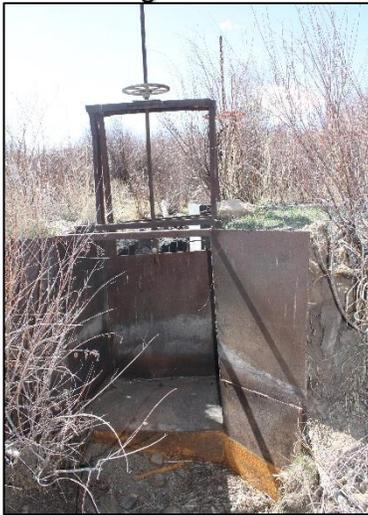
Headgate outlet

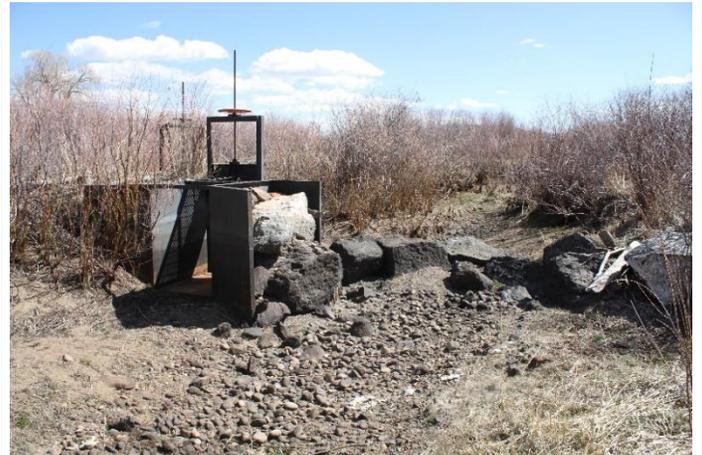
Diversion dam looking upstream

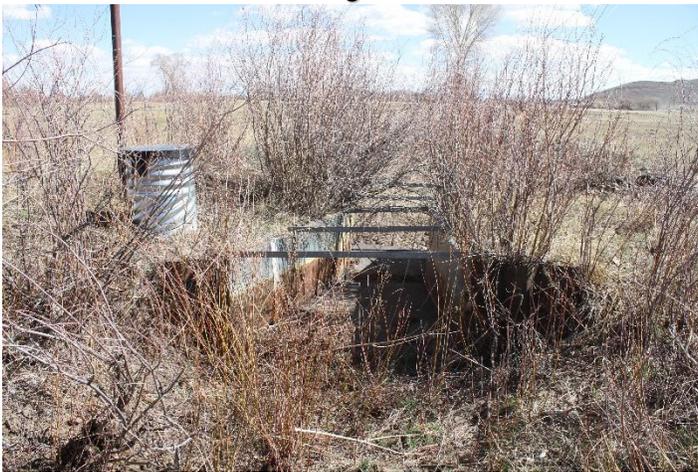
Flume looking downstream

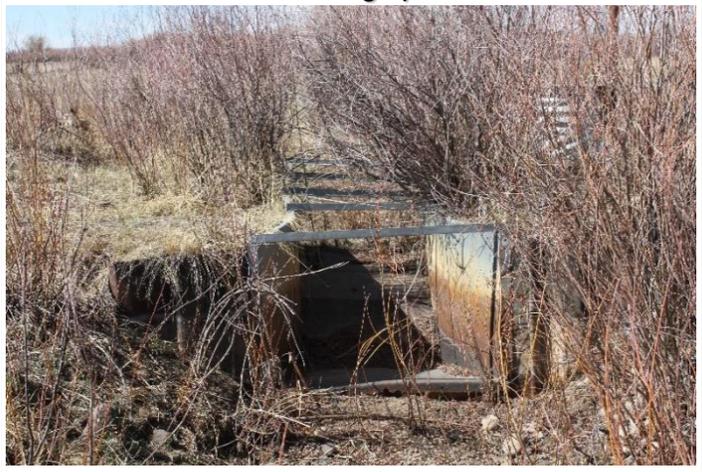
Flume looking upstream
