CONEJOS RIVER

DIVERSION INFRASTRUCTURE INVENTORY

Structure Name: LA DEL RIO D

Date: April 14, 2019

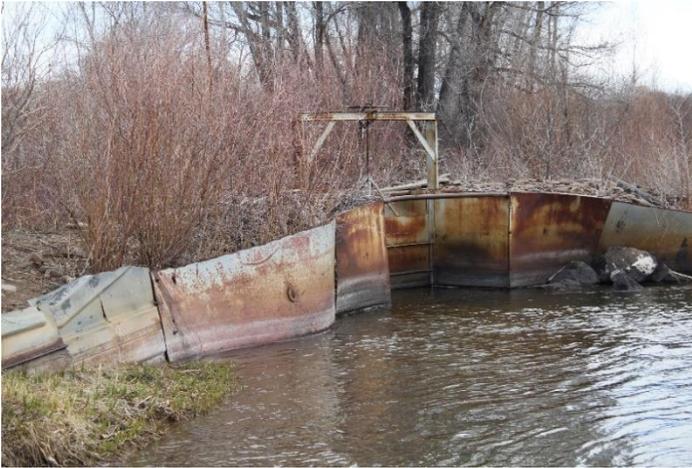
Structure Description: The ditch's diversion dam is made up of a recycled molasses tank and concrete blocks which divert water to headgate, which is located on the north bank of the river. Steel wing walls extend approximately 20 ft both upstream and downstream of the ditch. J-hooks were installed upstream of the structure just prior to 2006. This structure is located downstream of the return flow channel from the Bernardo Romero Ditch. The river in this location is relatively stable. The headgate leaks and the steel wing walls that make up its headwall are aging.

Headgate looking downstream

Repair(s) or Improvement(s) Currently Needed: The SMP Technical Advisory Team (TAT) recommends headgate repair (e.g., rubber mat) or replacement. Additionally, if any future improvements are made to the diversion, the TAT recommends aquatic habitat enhancement to create a low flow channel and also recommends maintaining fish passage to preserve aquatic habitat connectivity in this reach.

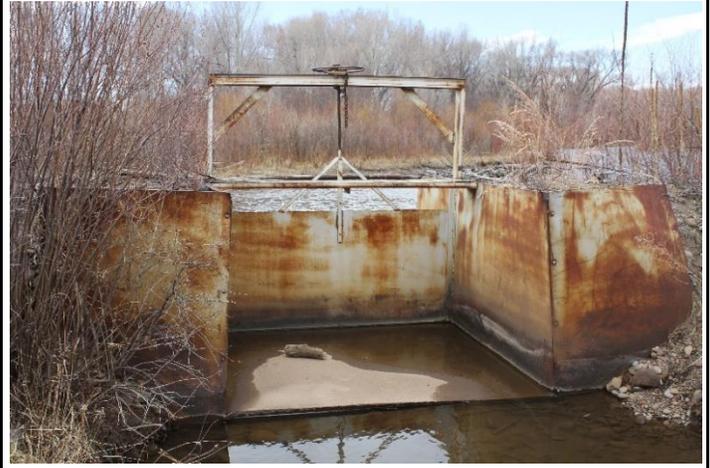
Headgate outlet

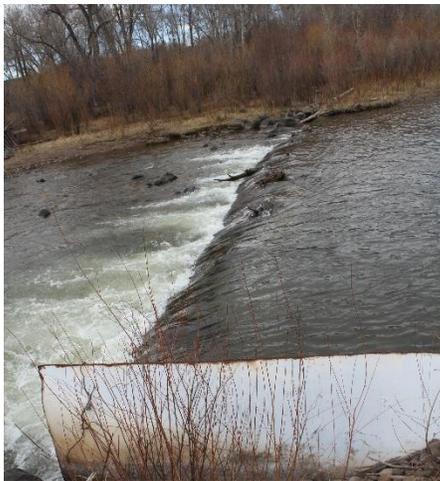
Diversion dam looking toward south bank

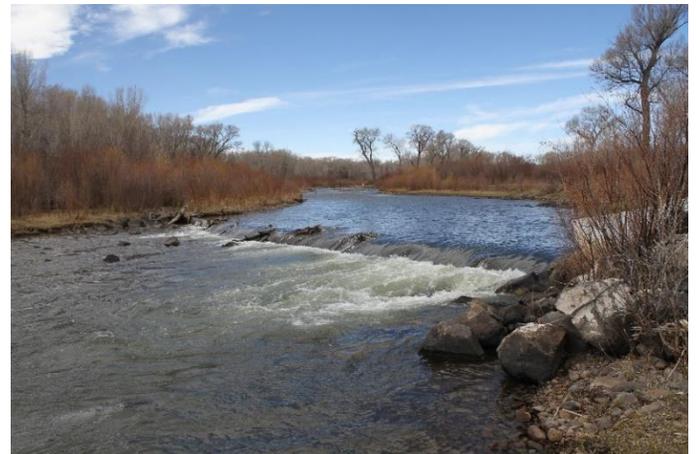
Diversion dam looking upstream

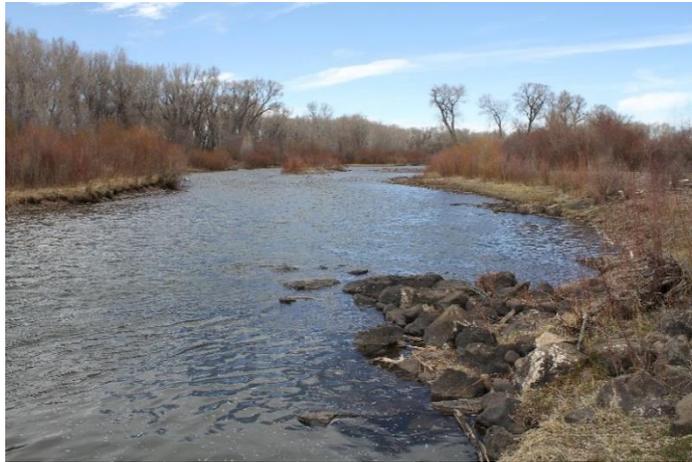
Conejos River upstream of structure

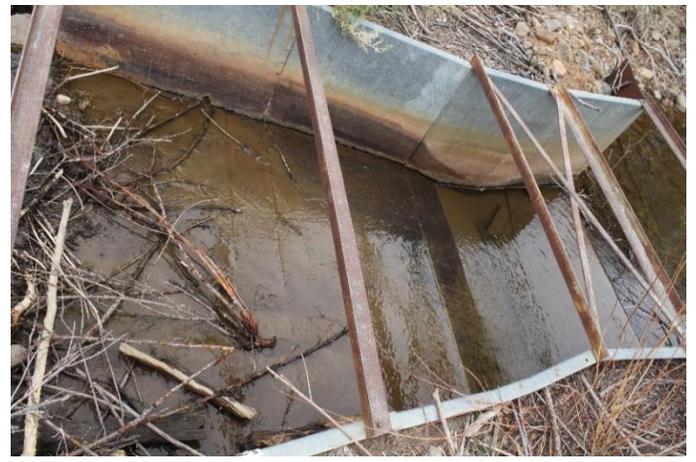
Flume looking downstream

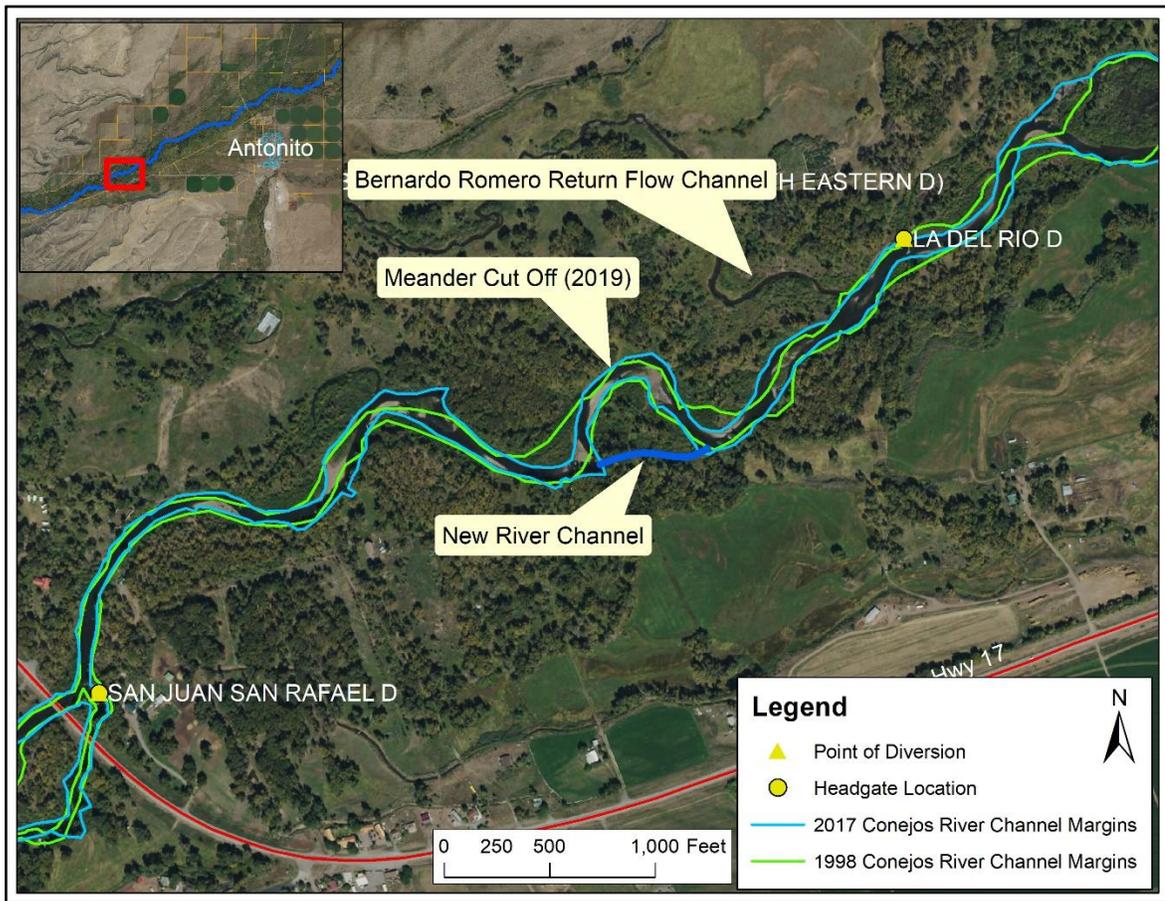
Point of diversion with 1998 and 2017 channel margins overlaid.
This map also shows meander cut off in 2019.

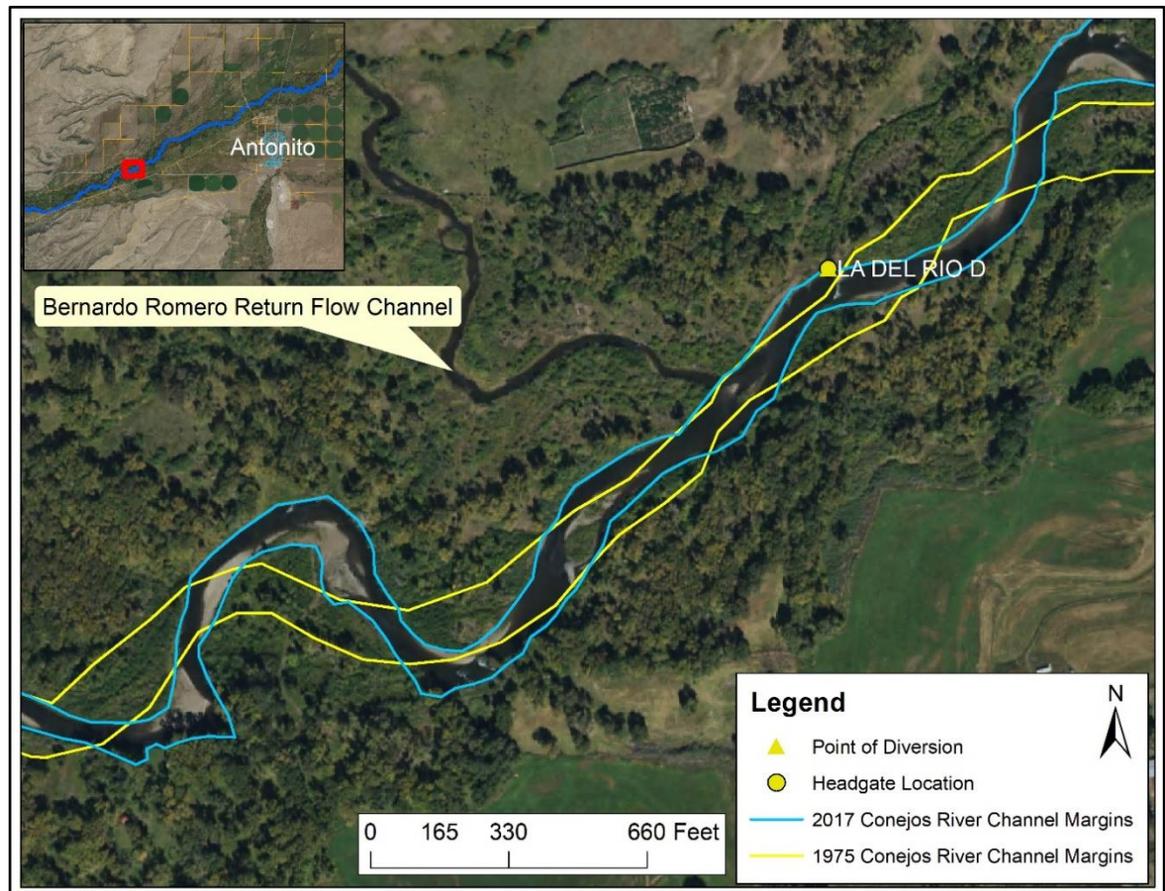
Point of diversion with 1975 and 2017 channel margins overlaid
