CONEJOS RIVER DIVERSION INFRASTRUCTURE INVENTORY

Structure Name: LE DUC D				
Reported By: Daniel Boyes				
Date: April 2, 2	019			
Headgate Location:	Latitude 37.06346667	Longitude -106.212883		
Headgate Type: Manually operated 3' wide steel slide gate				
Condition: E	Diversion other Co	n and A □ nditions: B ⋈ C □ D □ F □	River Miles From Rio Grande Confluence (Point of Diversion): 45.33 mi	Structure Yes ⊠ Submerged: No □
Repair(s) or Improvement(s) Completed Since 2006: None				
Structure Description: This structure's river headgate is located on the north bank of the Conejos River. It leads to an approximately 720 ft long feeder channel which leads to the main headgate. No formal 4diversion dam exists, but the elevation of the river headgate is sufficient to deliver water when the ditch is in priority. Debris accumulates at the river headgate, but does not pose a significant maintenance issue for the structure. There is minor erosion occurring downstream of the river headgate, but it does not appear to be adversely affecting the structure. Repair(s) or Improvement(s) Currently Needed: The SMP Technical Advisory Team (TAT) recommends improving or replacing the main headgate and

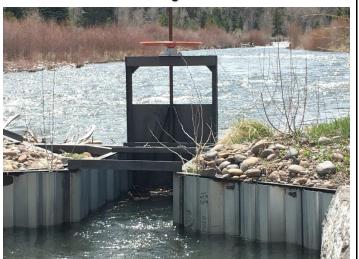
Main headgate looking downstream

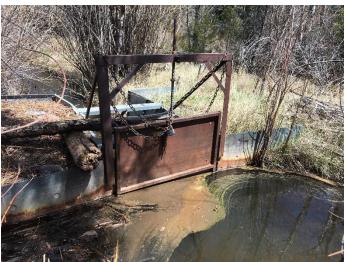
Main headgate outlet

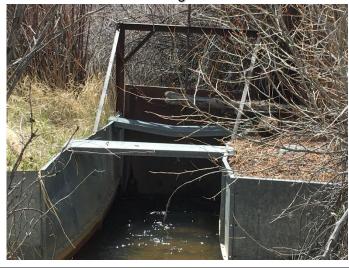
Flume looking downstream
