# CONEJOS RIVER DIVERSION INFRASTRUCTURE INVENTORY

**Structure Name:** LOPEZ D

LOPEZ DITCH

Conejos River Stream Management Plan

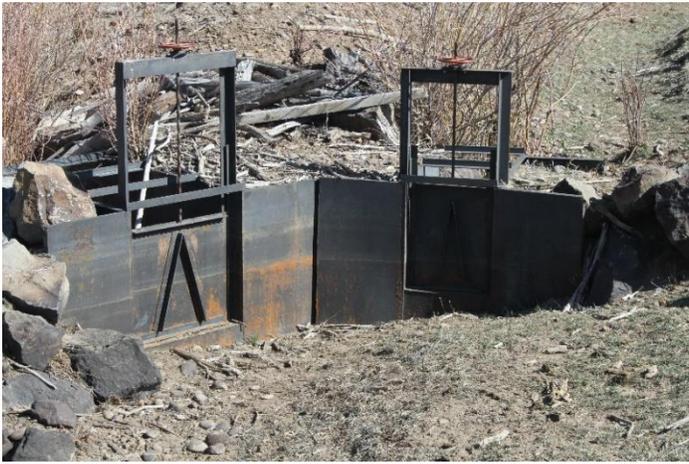
Headgate looking downstream

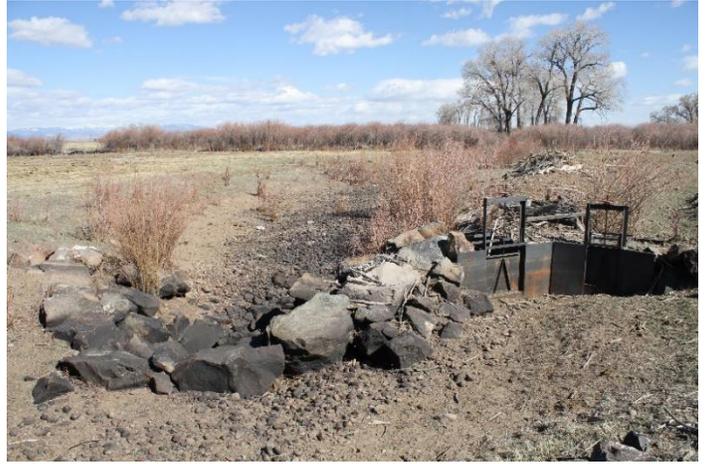
Headgate and diversion dam

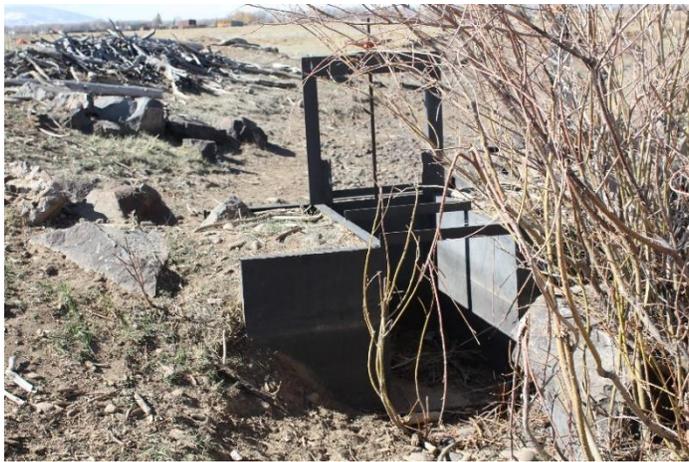
Headgate outlet

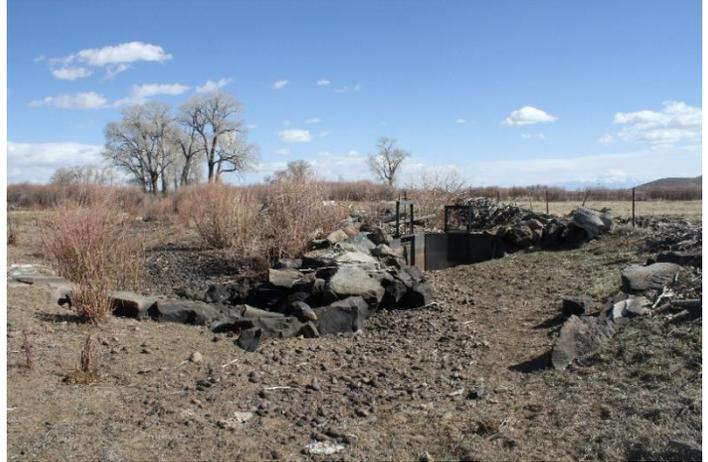
Diversion dam looking downstream

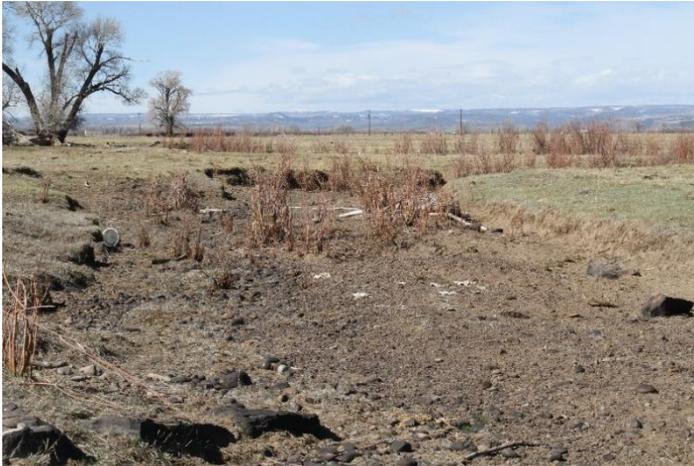
North branch Conejos River looking upstream

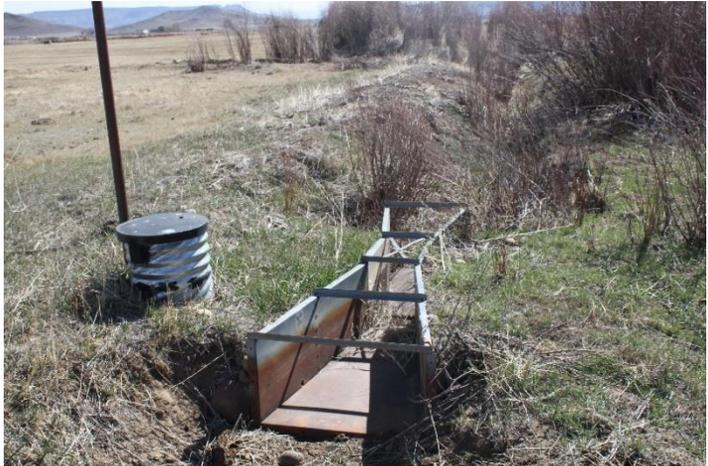
Flume looking downstream
