CONEJOS RIVER

DIVERSION INFRASTRUCTURE INVENTORY

Structure Name: LOS OJOS D NO 2

Date: April 16, 2019

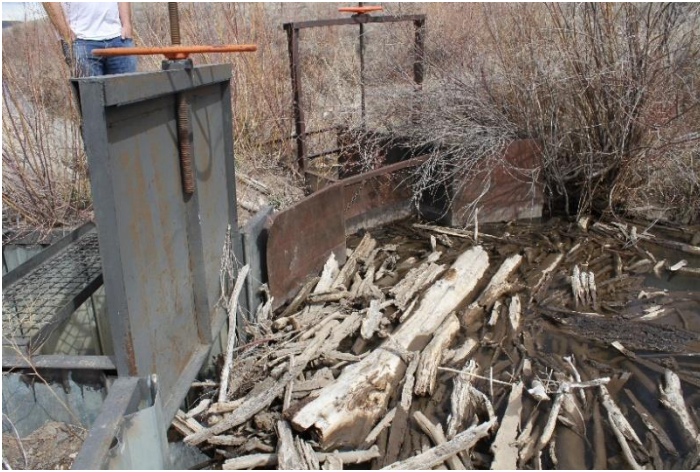
Headgate looking downstream

Repair(s) or Improvement(s) Currently Needed: The SMP Technical Advisory Team (TAT) recommends installing a trash rack to prevent debris accumulation in front of the headgate. If any improvements are made to the diversion and/or headworks in the future, the TAT also recommends incorporating fish passage to improve aquatic habitat connectivity in this reach.

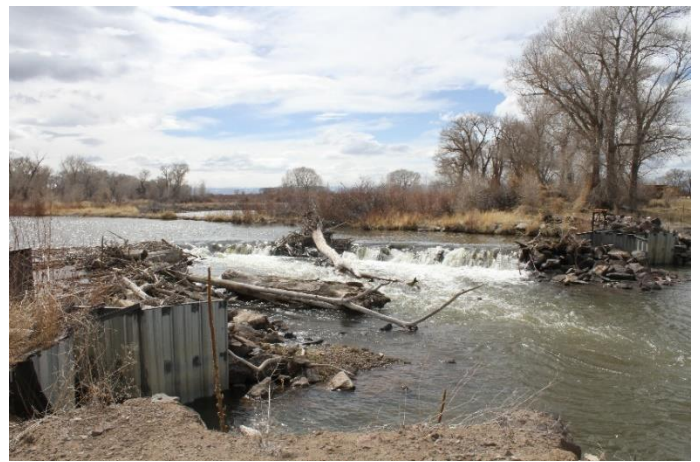
Diversion dam

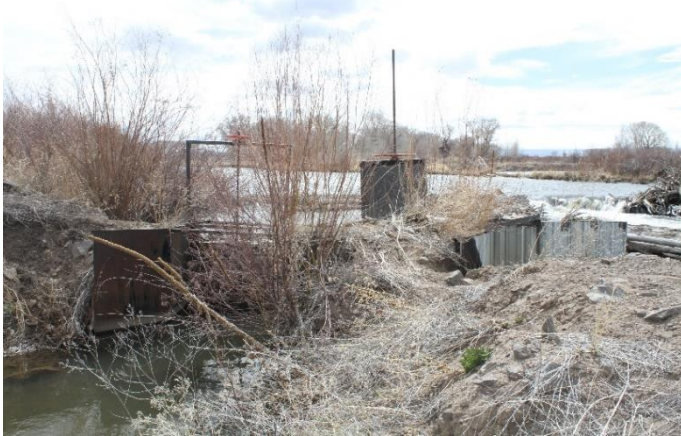
Headgate outlet

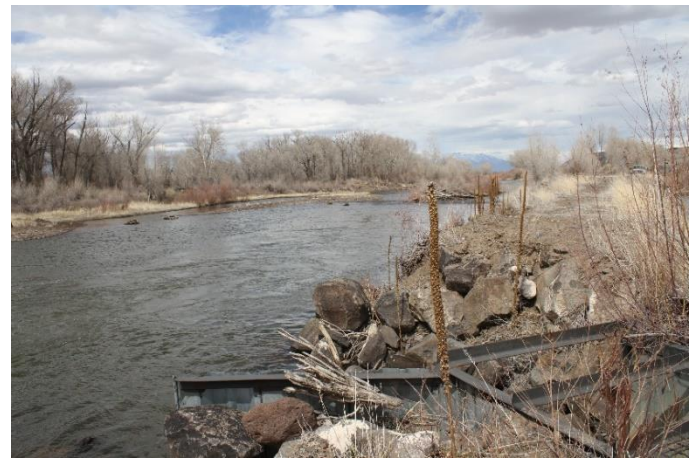
Channel downstream of headgate

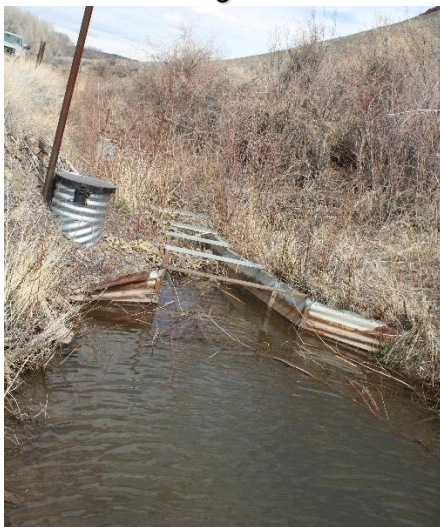
Flume looking downstream

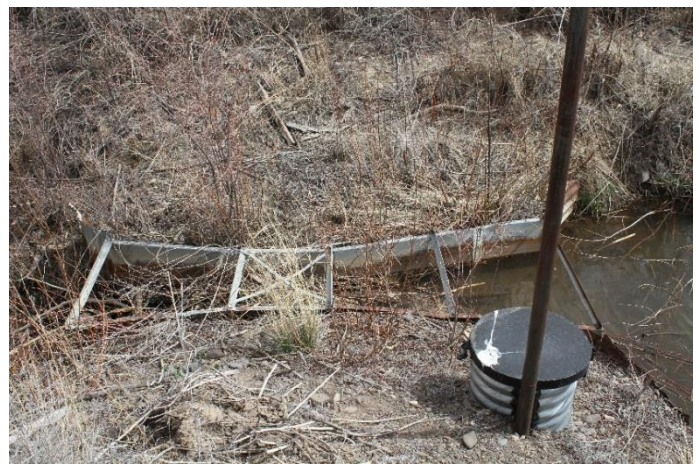
Flume from west bank of ditch
