CONEJOS RIVER

DIVERSION INFRASTRUCTURE INVENTORY

Structure Name: MANASSA CORE

Date: April 14, 2019

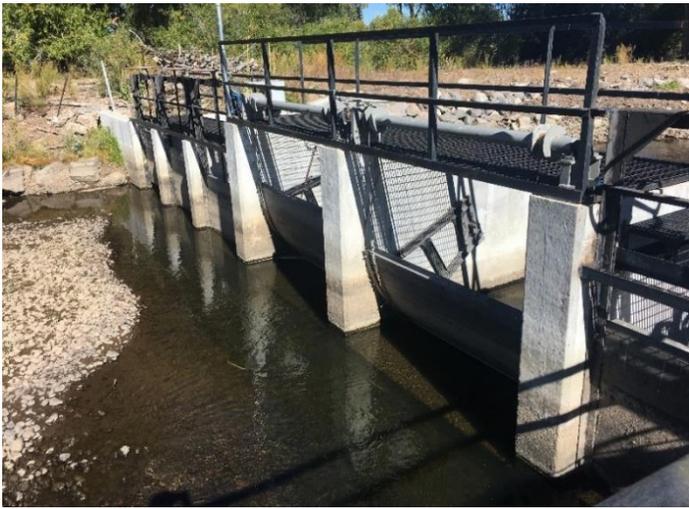
Headgate looking downstream

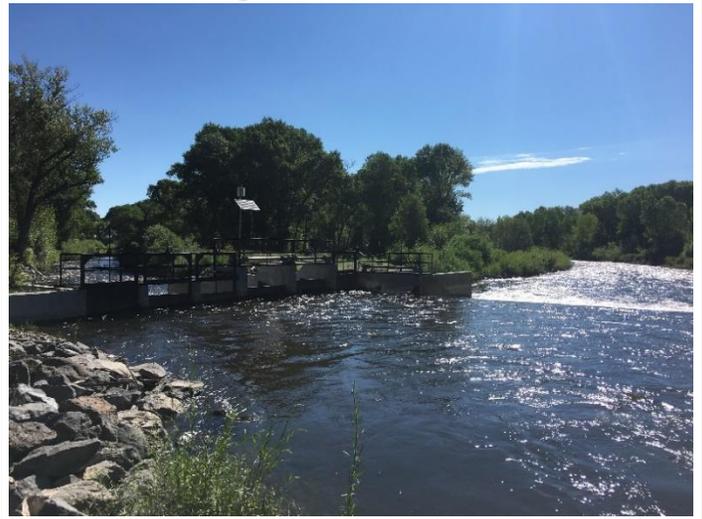
Headgate and diversion dam

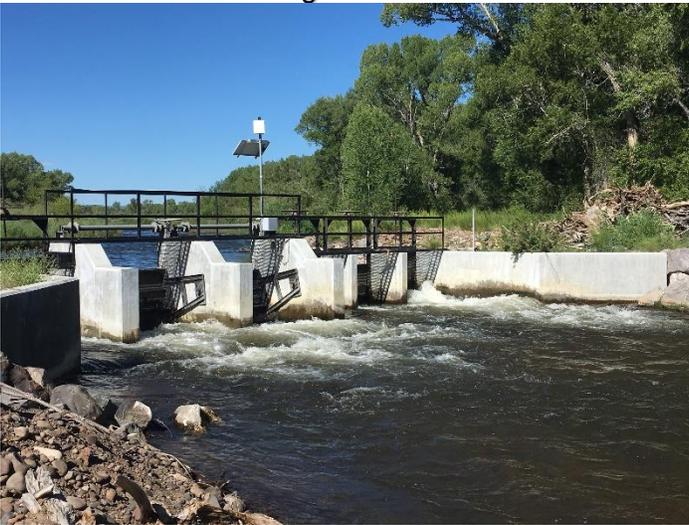
Headgate outlet

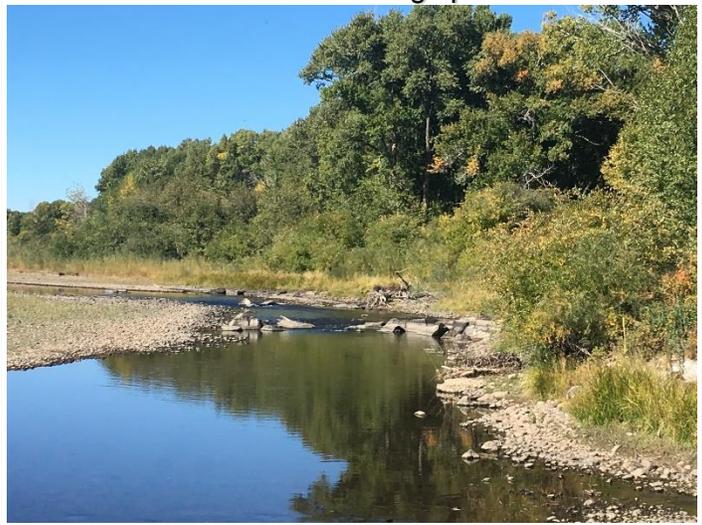
Repair(s) or Improvement(s) Currently Needed: Some lateral channel migration has occurred upstream of the structure, but is not expected to affect this structure. The stilling well at the gage downstream of this structure could use maintenance, which the SMP Technical Advisory Team (TAT) recommends in the near future. No additional repairs are needed.

River channel looking upstream

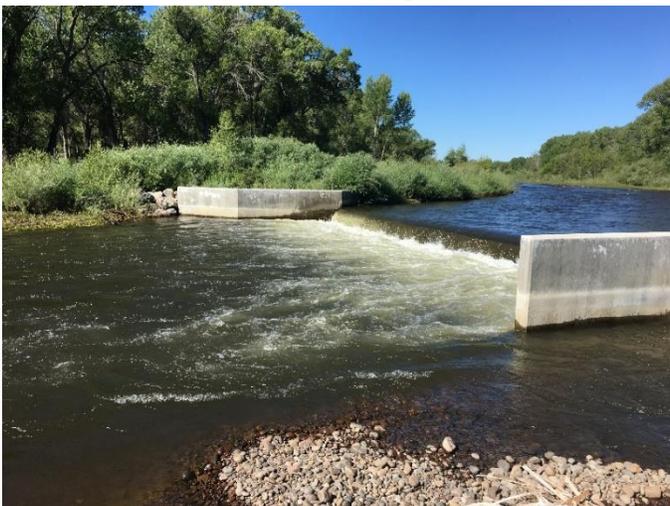
Diversion dam looking upstream

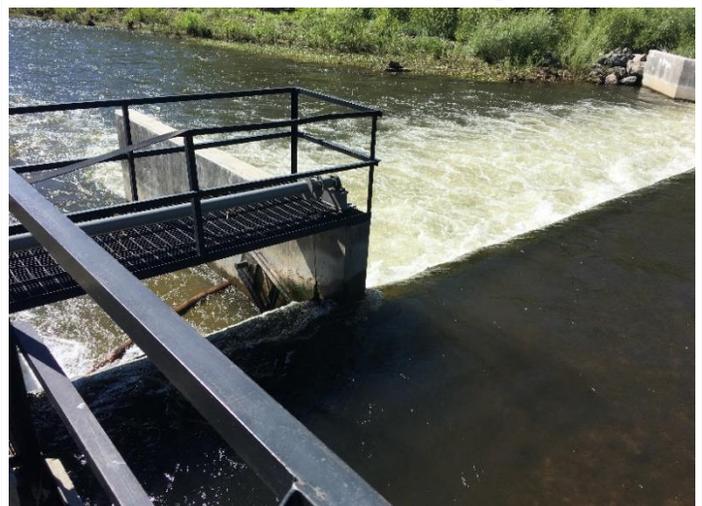
Diversion dam and sluice gate

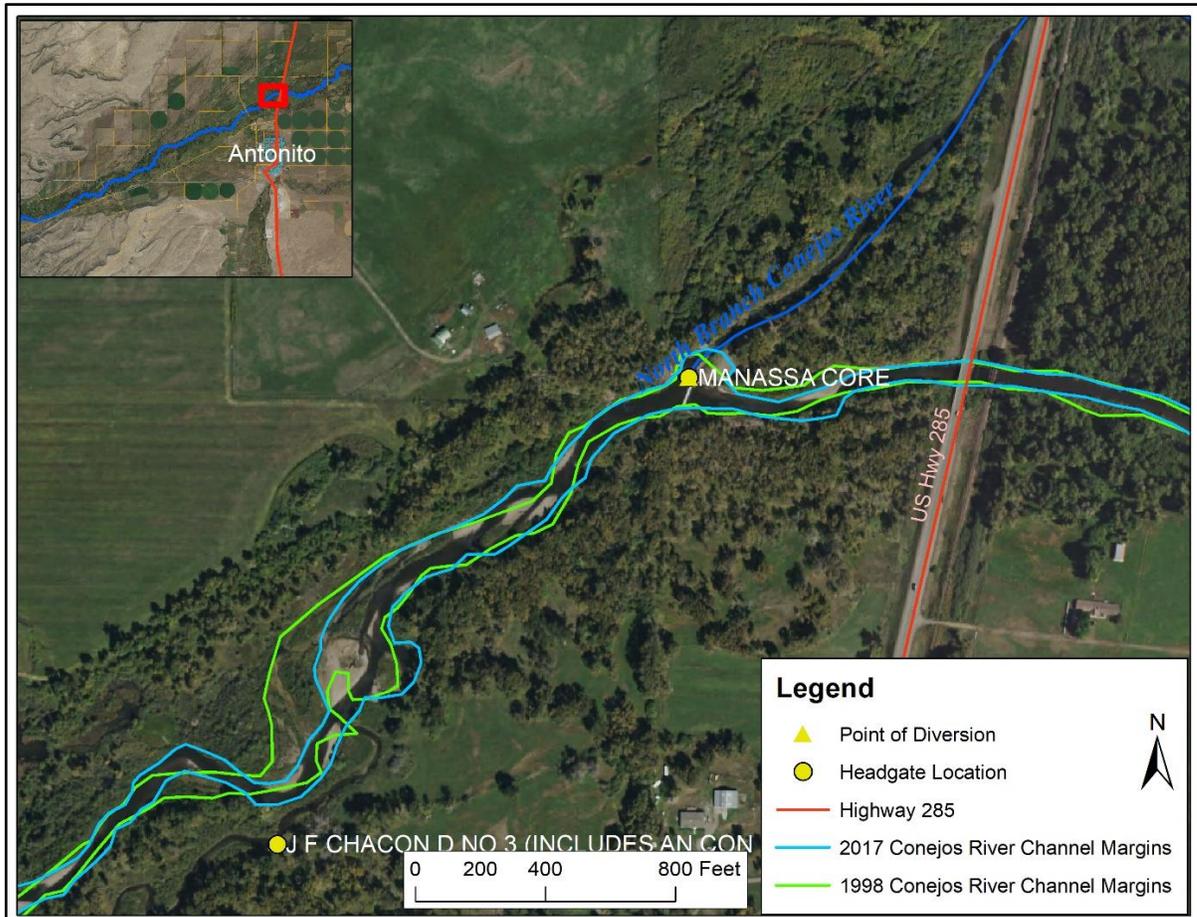
Manassa Core location with 1998 and 2017 channel margins overlaid.
