CONEJOS RIVER

DIVERSION INFRASTRUCTURE INVENTORY

Structure Name: MARTINEZ D

PHOTO LOG

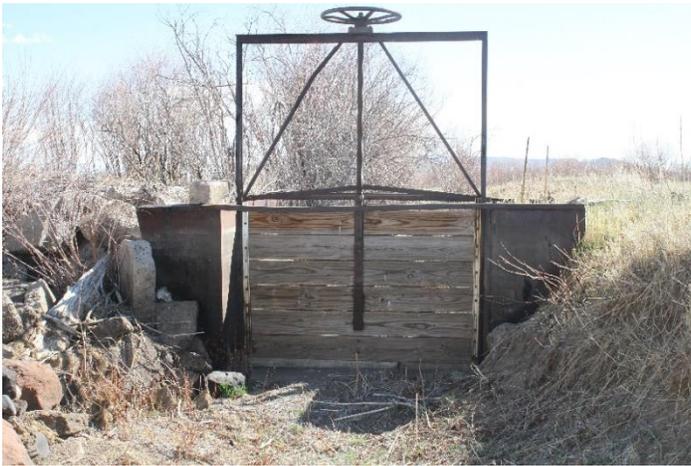
Structure Description: A stacked rock diversion directs water from the North Branch to the headgate, which is located on the east bank of the river. Recent headgate repairs were completed, however it still leaks. The river channel was also recently improved in this area.

Headgate looking downstream

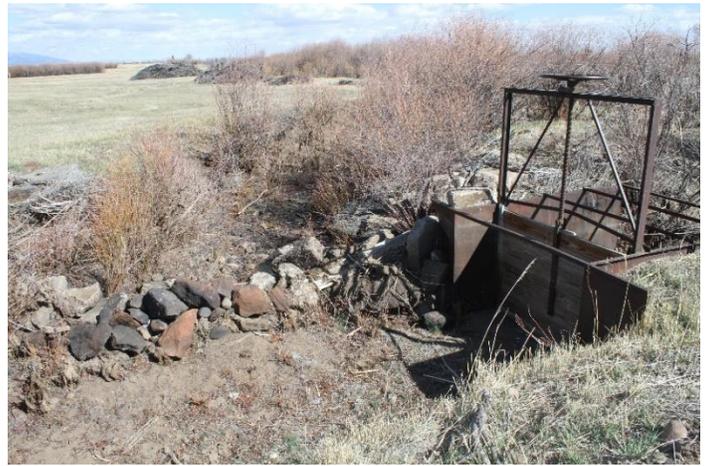
Headgate and diversion dam

Repair(s) or Improvement(s) Currently Needed: The SMP Technical Advisory Team (TAT) recommends regular debris clearing to ensure the diversion dam is functioning properly. The TAT also recommends implementing riparian revegetation to reduce erosion and improve river health.

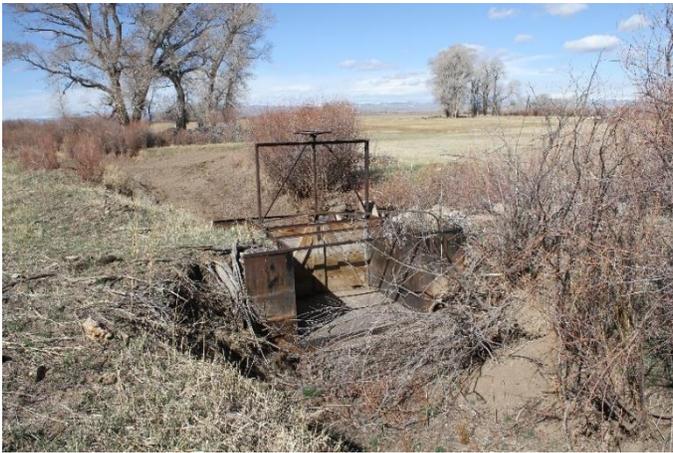
Headgate outlet

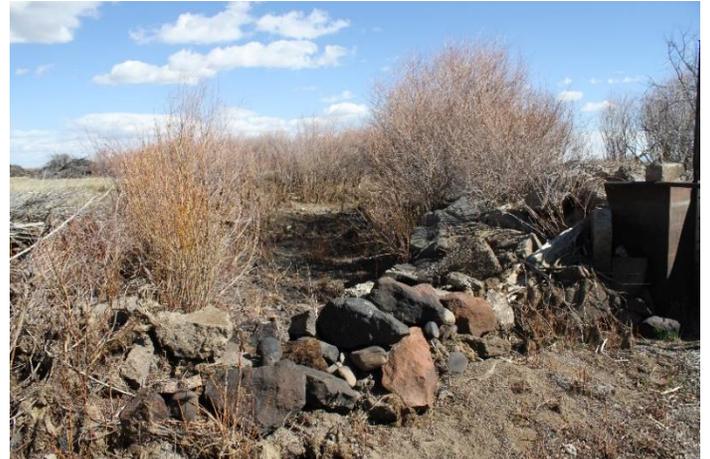
Diversion dam

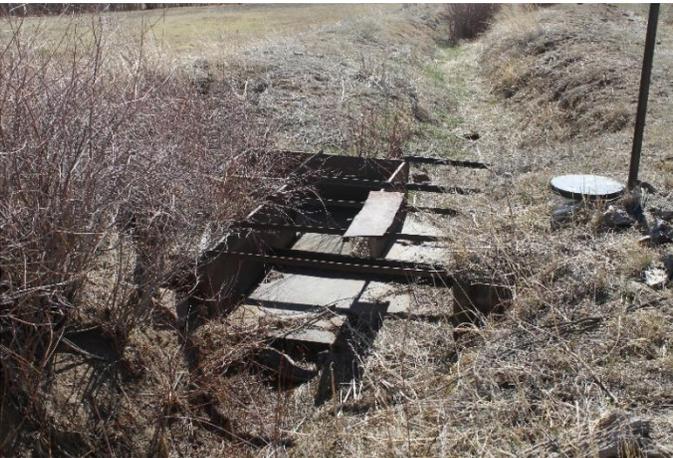
Flume looking downstream

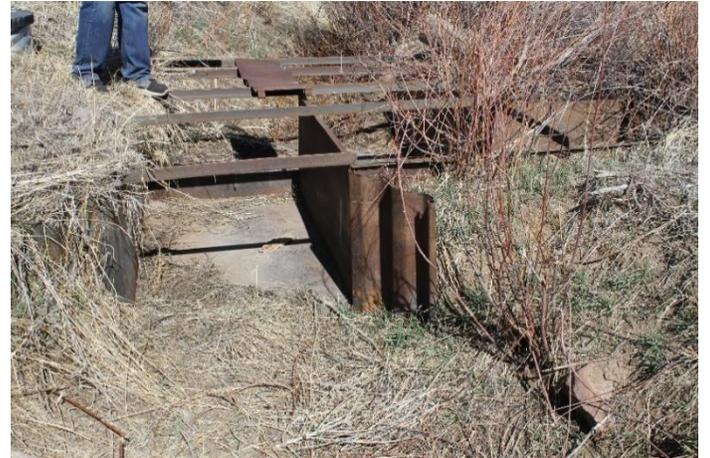
Flume looking upstream
