CONEJOS RIVER

DIVERSION INFRASTRUCTURE INVENTORY

Structure Name: McCARROLL D

Date: April 2, 2019

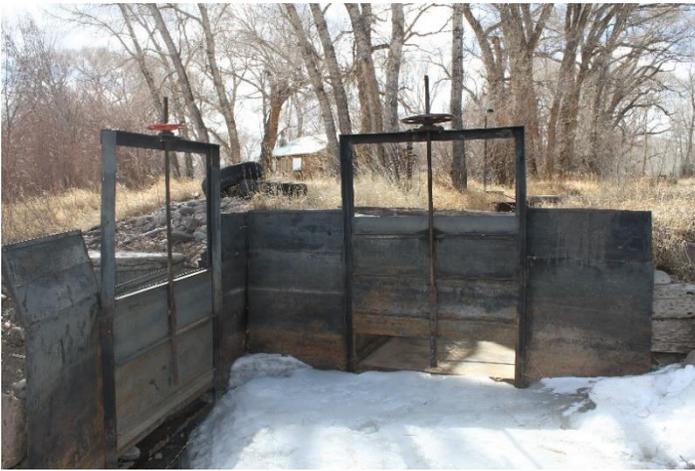
Headgate looking downstream

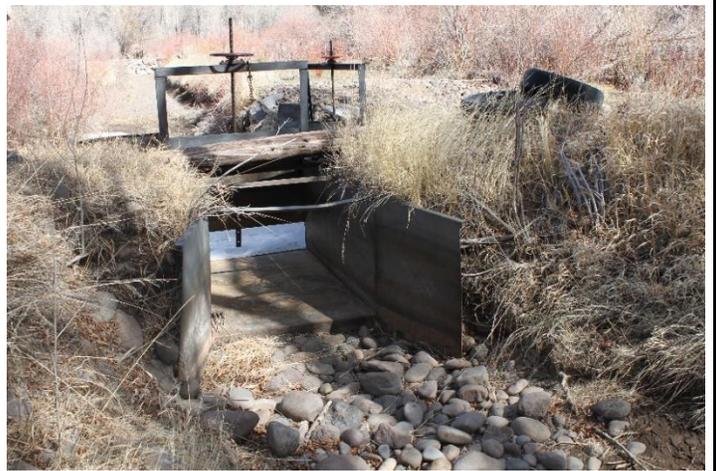
Headgate outlet

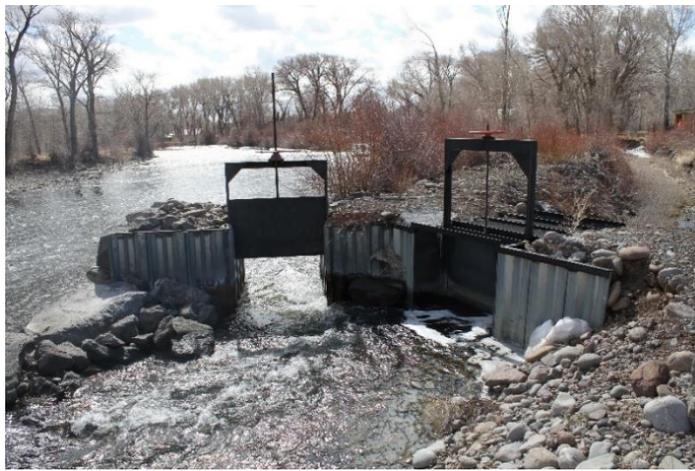
River headgate and overflow gate

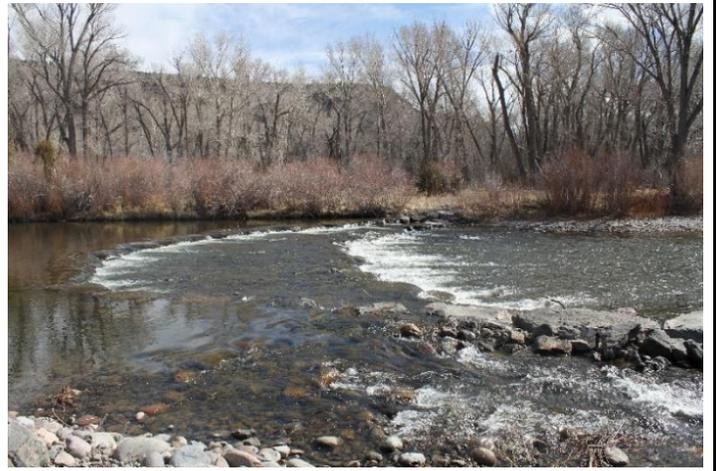
Diversion dam

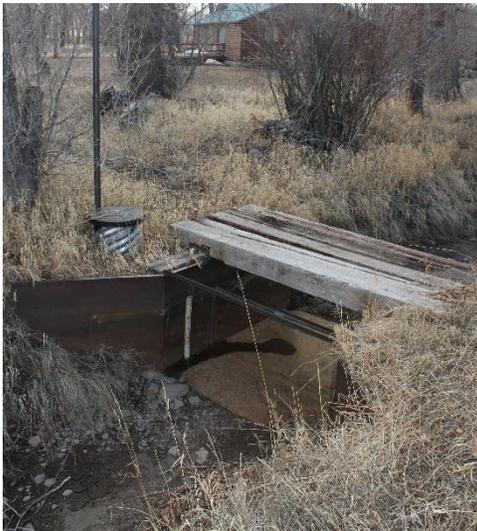
Flume looking downstream

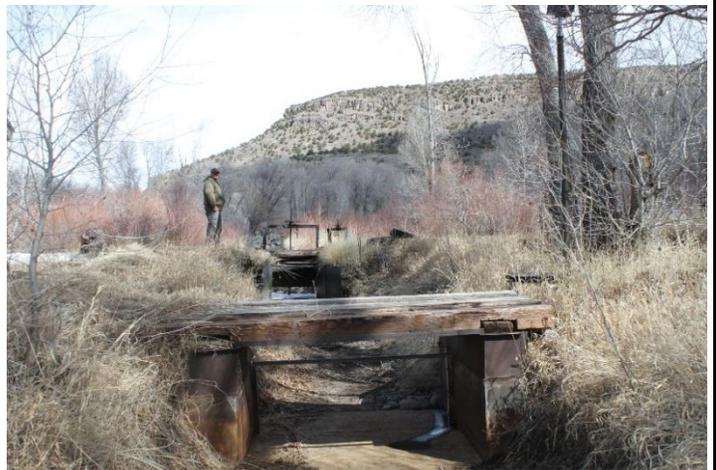
Flume looking upstream

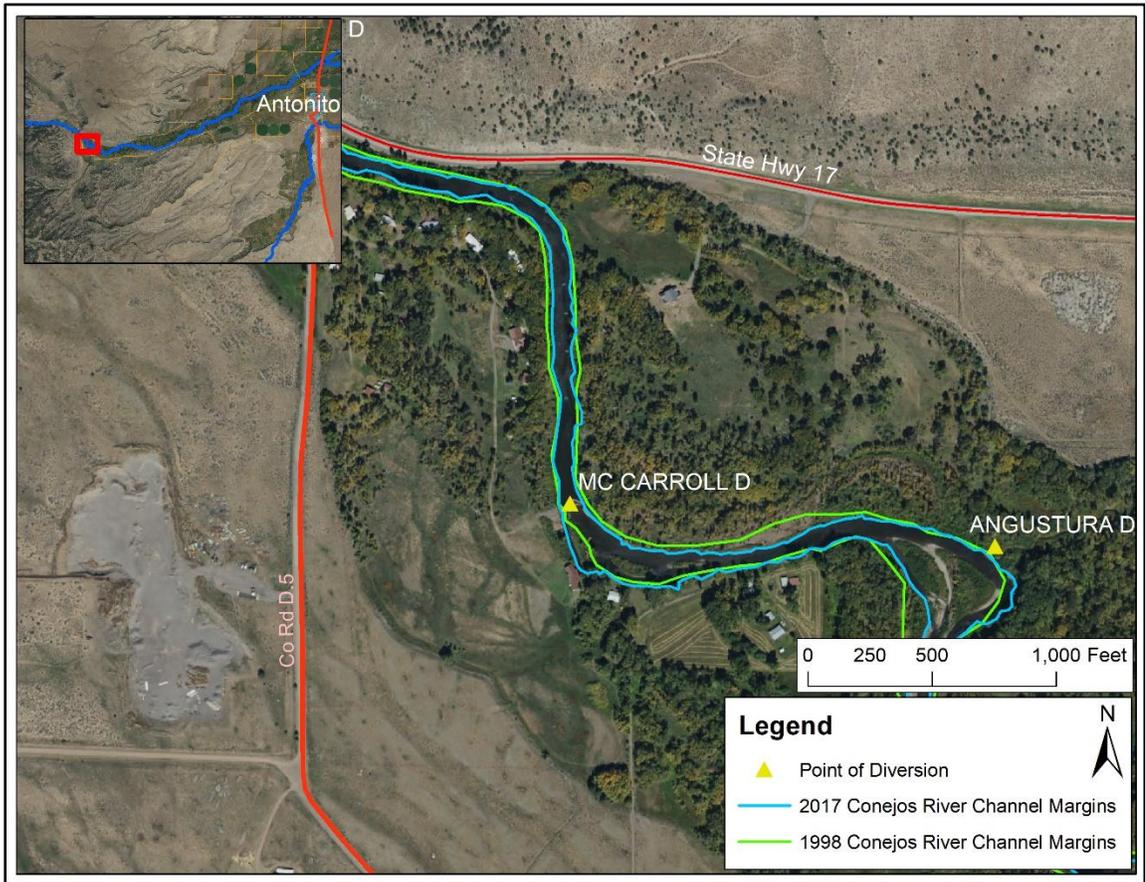
Structure Description: A stacked rock diversion dam directs flow to the river headgate located on the south bank of the mainstem Conejos River. A short feeder channel delivers water from the river to the main headgate. A manually operated 4 ft wide steel slide gate and wood plank weir, at the head of the return flow channel and adjacent to the structure, acts as a diversion and directs water to the headgate. The river is relatively stable both upstream and downstream of the structure, although the river has slowly migrated west since 1998 and a meander was cut off downstream of the diversion sometime between 1975 and 1998. The migration trajectory at this location is not expected to affect this structure.

McCarroll Ditch headgate with 1998 and 2017 channel margins overlaid

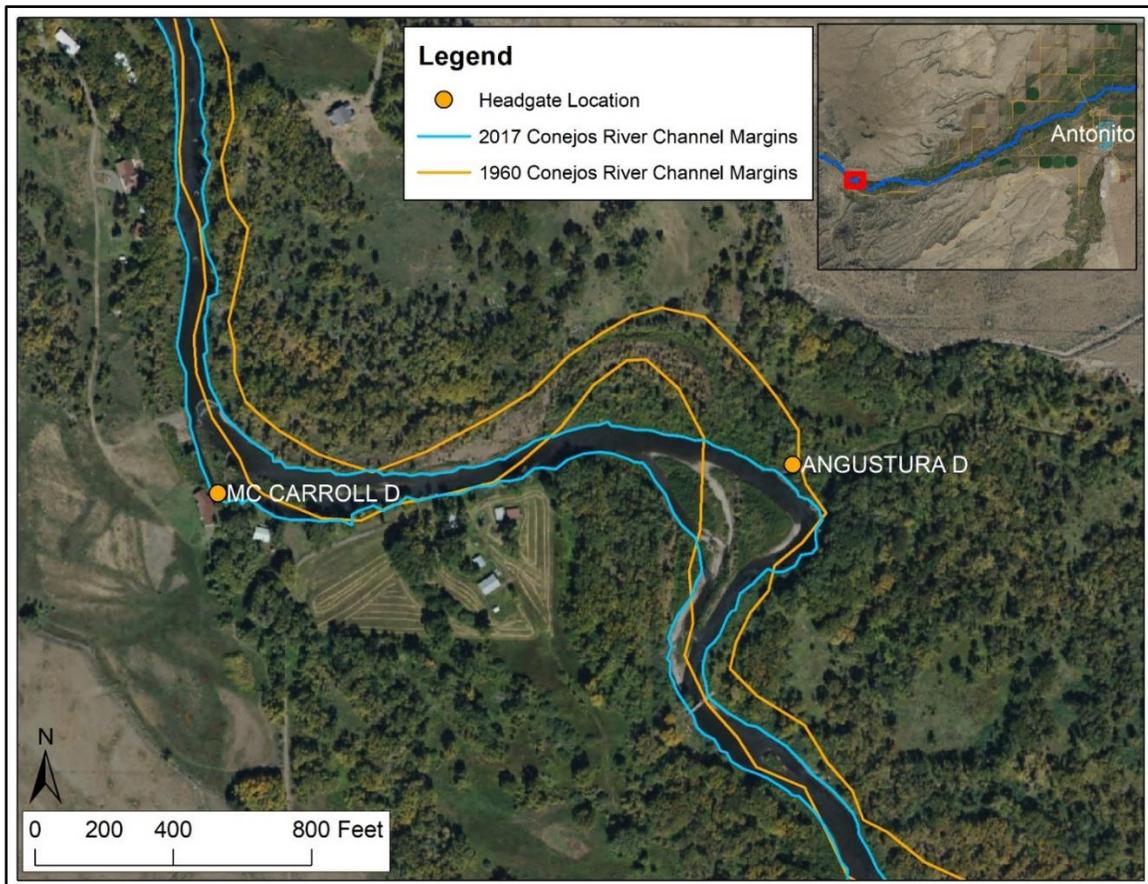
McCarroll Ditch headgate with 1960 and 2017 channel margins overlaid
