CONEJOS RIVER

DIVERSION INFRASTRUCTURE INVENTORY

Structure Name: MECITOS D

Date: April 15, 2019

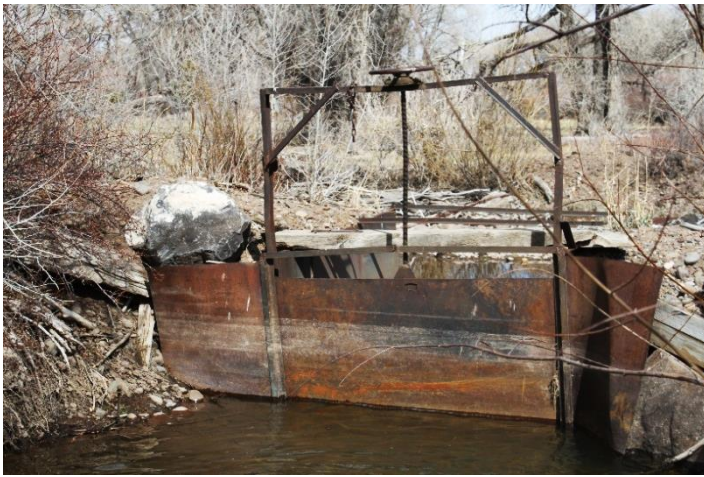
Headgate looking downstream (pre-runoff)

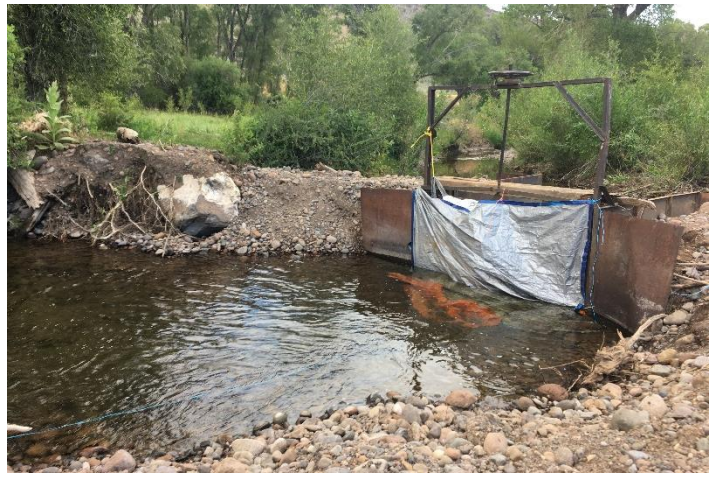
Headgate looking downstream (post-runoff)

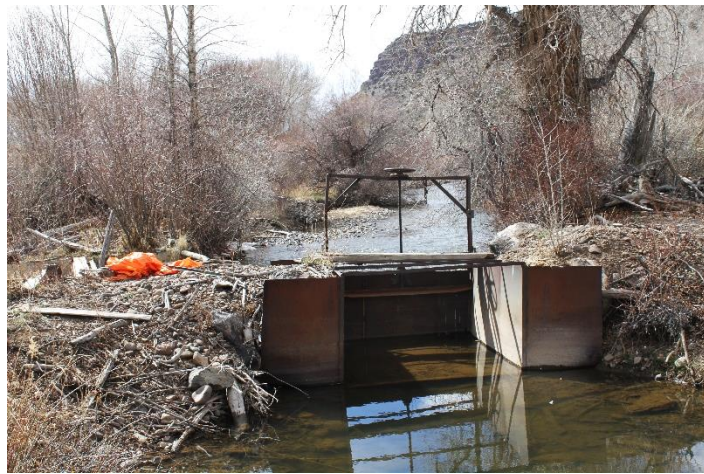
Headgate outlet (pre-2019 runoff)

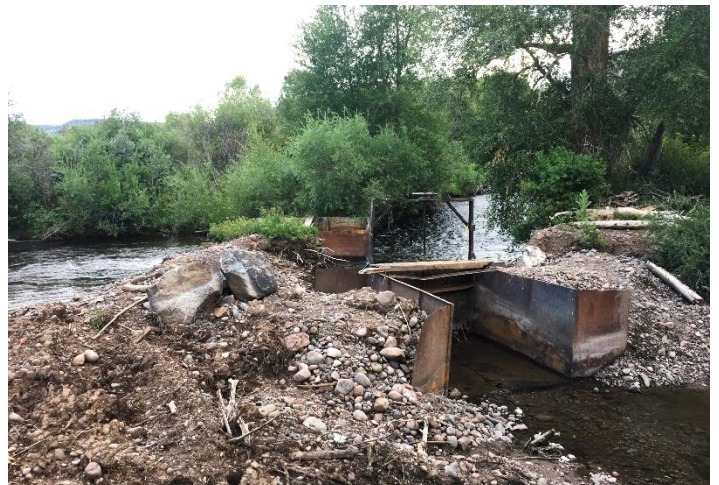
Headgate outlet (post-2019 runoff)

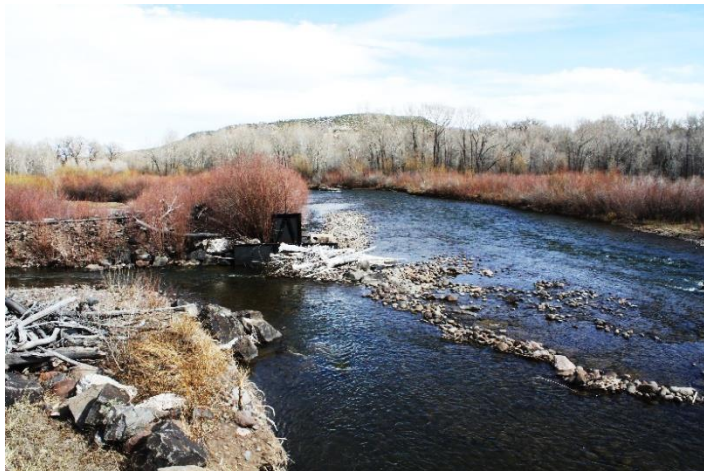
Diversion dam on mainstem Conejos River (pre-runoff)

Repair(s) or Improvement(s) Currently Needed: Given the issues identified at this structure, the SMP Technical Advisory Team (TAT) recommends improving or replacing the diversion dam, stabilizing the banks surrounding the main headgate and diversion dam, adjustment capabilities for the feeder channel, and headgate automation. An improved diversion dam would allow the ditch to access water at all flows and adjustment capabilities for the feeder channel could be improved to better administer the structure's water rights and to minimize the impact of high flow events at the headgate. Bank stabilization would mitigate erosion and reduce sediment accumulation in the feeder channel. Headgate automation would improve efficiency and reduce operating needs. Improved adjustment capabilities may include relocating the point of diversion downstream and/or installing a headgate or other control structure on the feeder channel upstream of the headgate. If the diversion is relocated, the current river channel trajectory should be considered. If it is not relocated, the TAT recommends improving it with a stacked rock or similar structure. The TAT also recommends maintaining fish passage to preserve aquatic habitat connectivity in this reach.

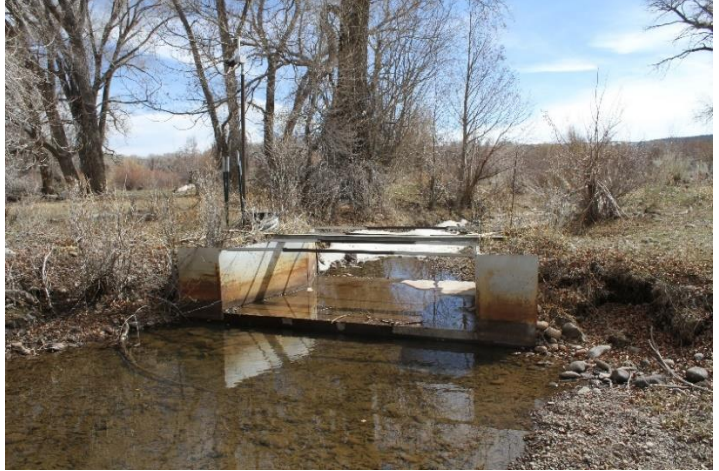
Cutthroat flume looking upstream

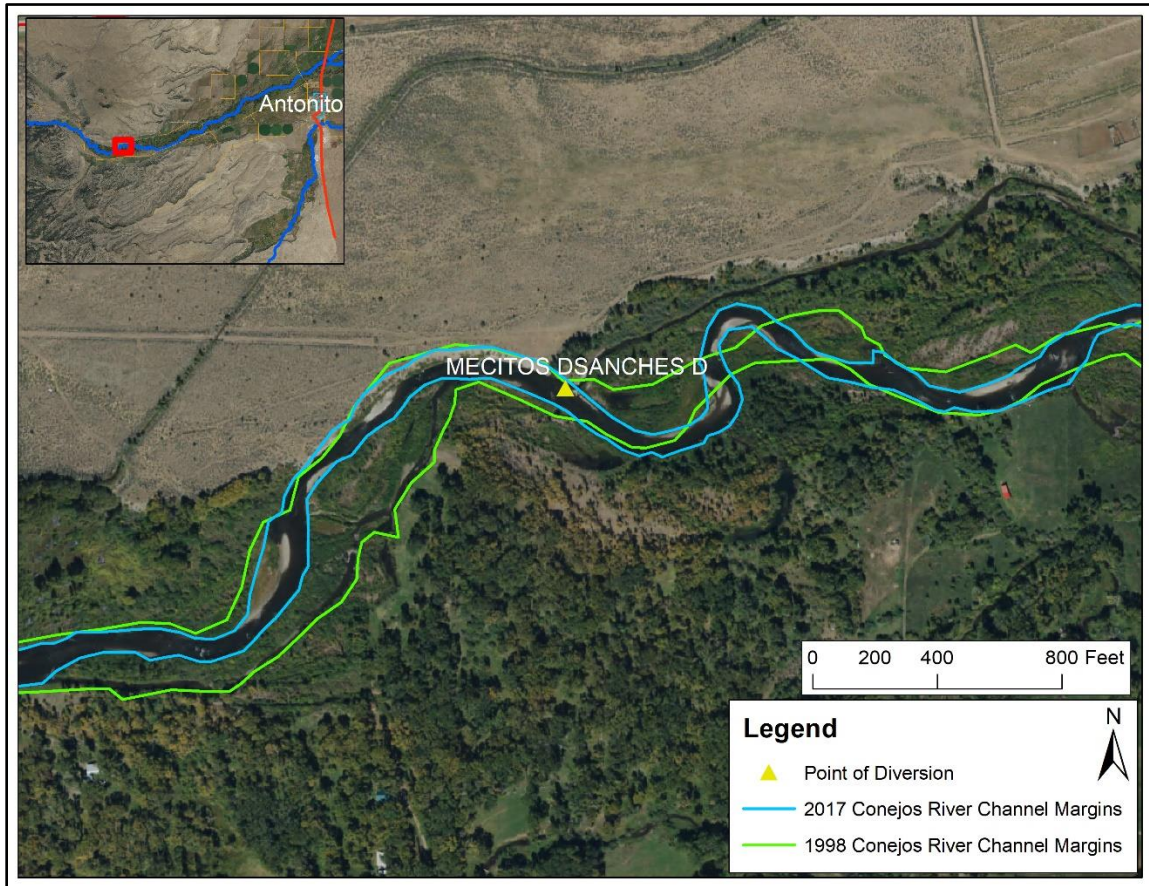
Headgate location with river channel margins from 1998 and 2017 overlaid

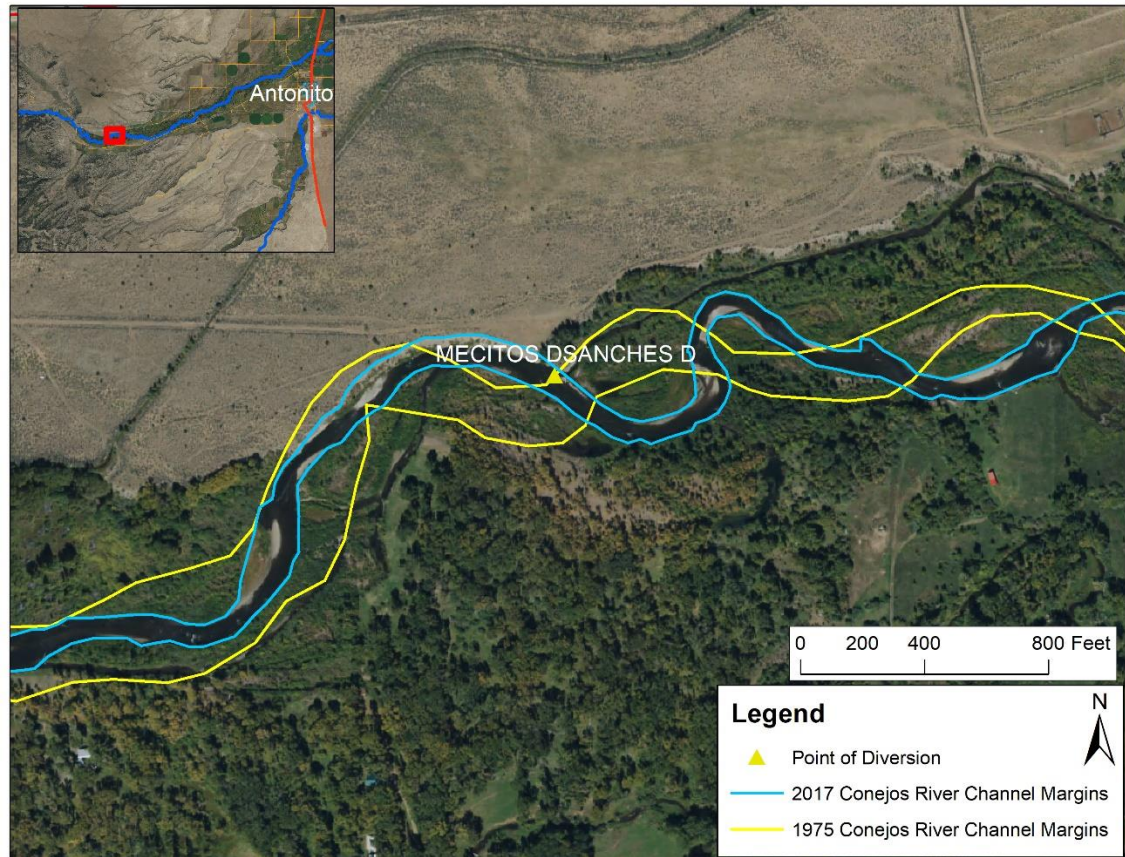
Headgate location with river channel margins from 1975 and 2017 overlaid

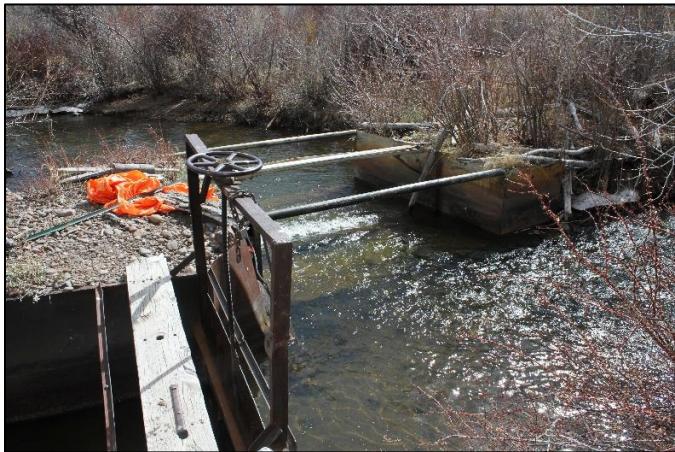
Structure Description: The river channel has undergone significant migration, including meander cutoffs, at the point of diversion and especially downstream of the diversion. A U-shaped rock weir diversion dam directs flow to the feeder channel, located on the north bank of the Conejos River. The feeder channel is approximately 820 meters long and delivers water to the Mecitos Ditch headgate. Adjacent to the headgate, a return flow structure with check boards directs unused water back to the river. This ditch has difficulty accessing its full decree during low flow conditions. During 2019 spring runoff, flood flows caused the banks adjacent to the headgate and return flow structure to fail, resulting in flows bypassing the structure completely (see photos below).

Headgate and overflow structure pre-runoff 2019 (looking downstream)

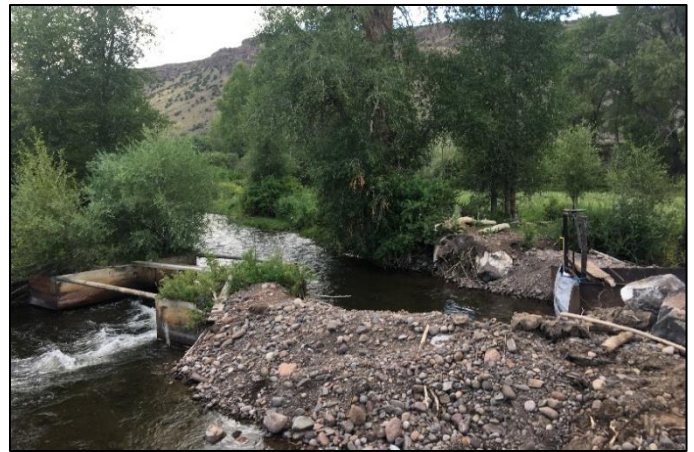
Headgate and overflow structure post-runoff 2019 (looking upstream)

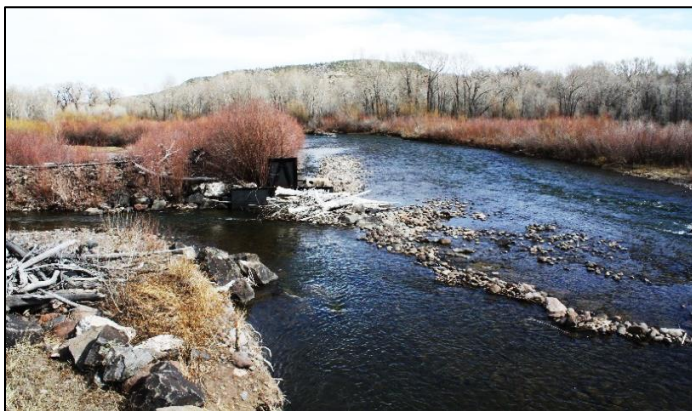
Diversion dam on Conejos River (pre-runoff)

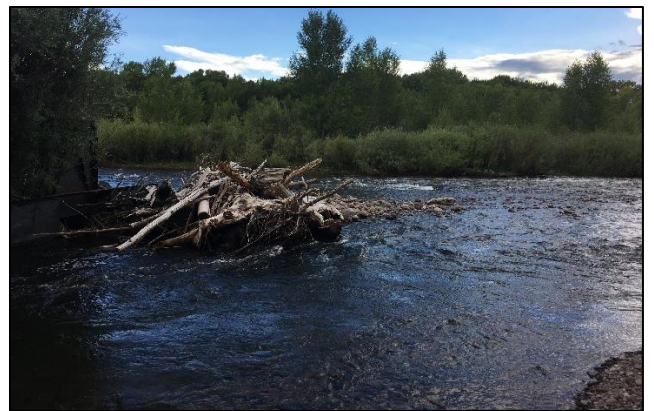
Diversion dam on Conejos River (post-runoff)
