CONEJOS RIVER DIVERSION INFRASTRUCTURE INVENTORY

Structure Name: MILL D

Date: April 15, 2019

Conejos River Stream Management Plan

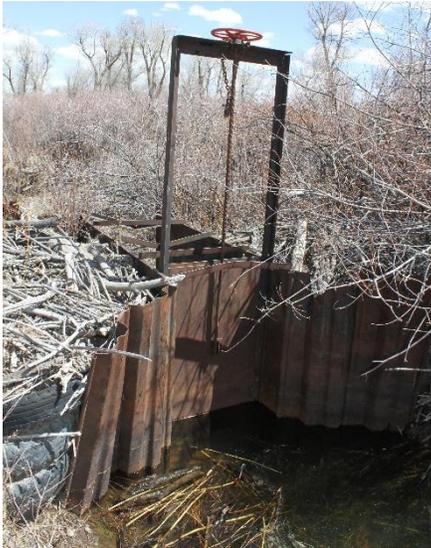
Headgate looking downstream

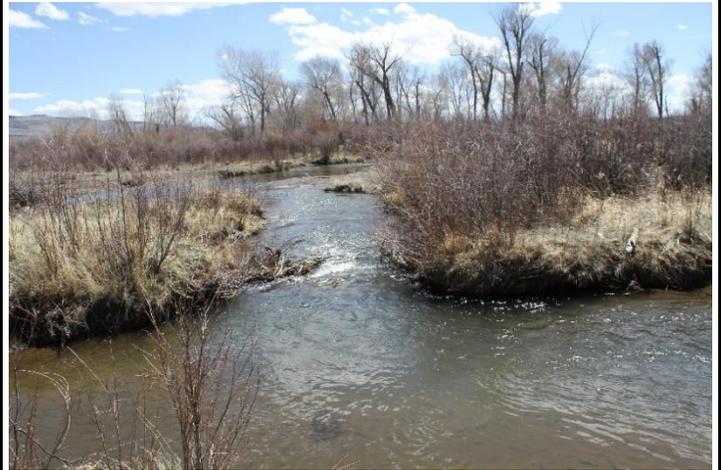
Return flow ditch just upstream of headgate

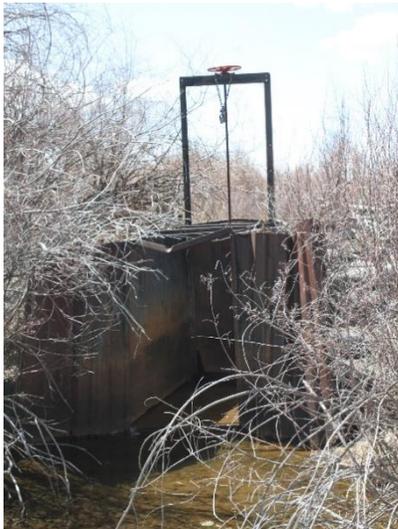
Headgate outlet

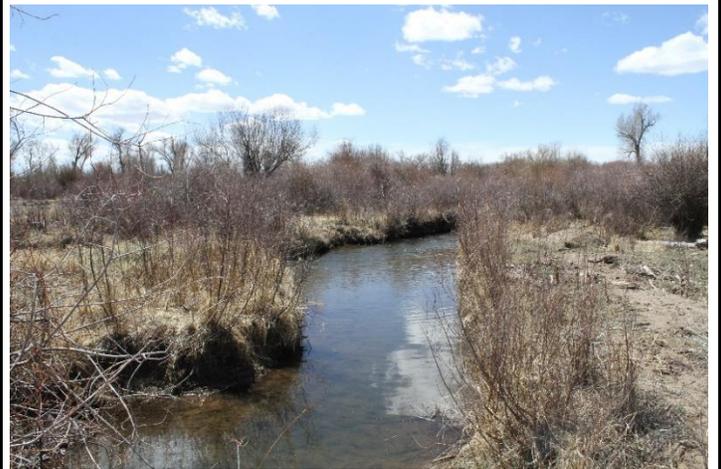
Structure Description: This structure has a minimal stacked rock diversion dam which directs water into an approximately 620 ft long feeder channel which ends at the headgate. The feeder channel's capacity is limited due to sediment accumulation. The channel is migrating south at the point of diversion, and the main channel has captured an old oxbow, leaving the north channel dry at low flows. The diversion dam is not easily controlled and the ditch has difficulty accessing its full decree at low flows. A sluice gate and overflow channel at the headgate returns unused water to the river. The sluice gate functions poorly and the overflow channel's capacity is limited due to sediment accumulation. The Parshall flume is located approximately 1 mile down the ditch, just downstream of County Rd 19.

Feeder ditch looking upstream

Repair(s) or Improvement(s) Currently Needed: Given the issues identified at this structure, the SMP Technical Advisory Team (TAT) recommends improving or relocating the point of diversion, installing a new river headgate, and cleaning both the feeder and return channels. A new diversion and headgate would increase ditch efficiency and allow water users to divert water at all water levels. Feeder and return channel cleaning would increase capacity and ditch efficiency. If any modifications are made to the diversion in the future, the TAT also recommends maintaining fish passage to maintain aquatic habitat connectivity in this reach.

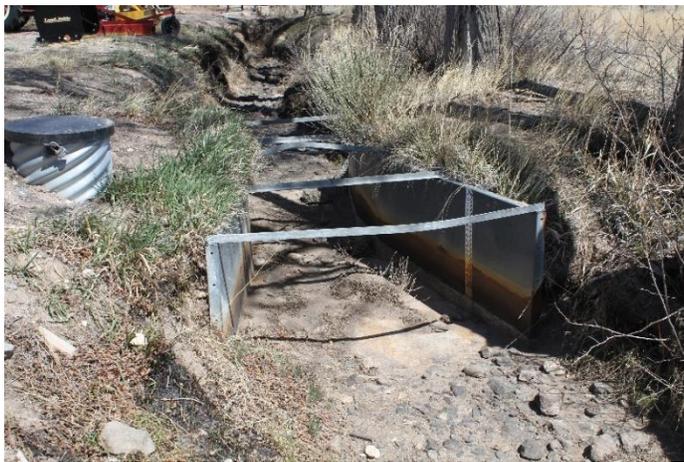
Flume looking downstream

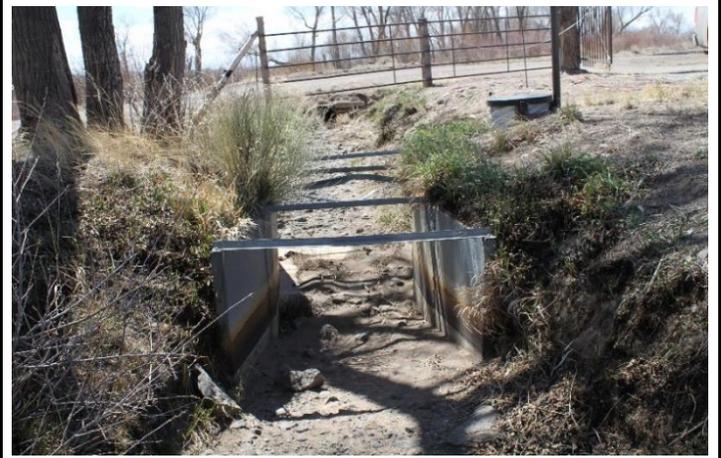
Flume looking upstream

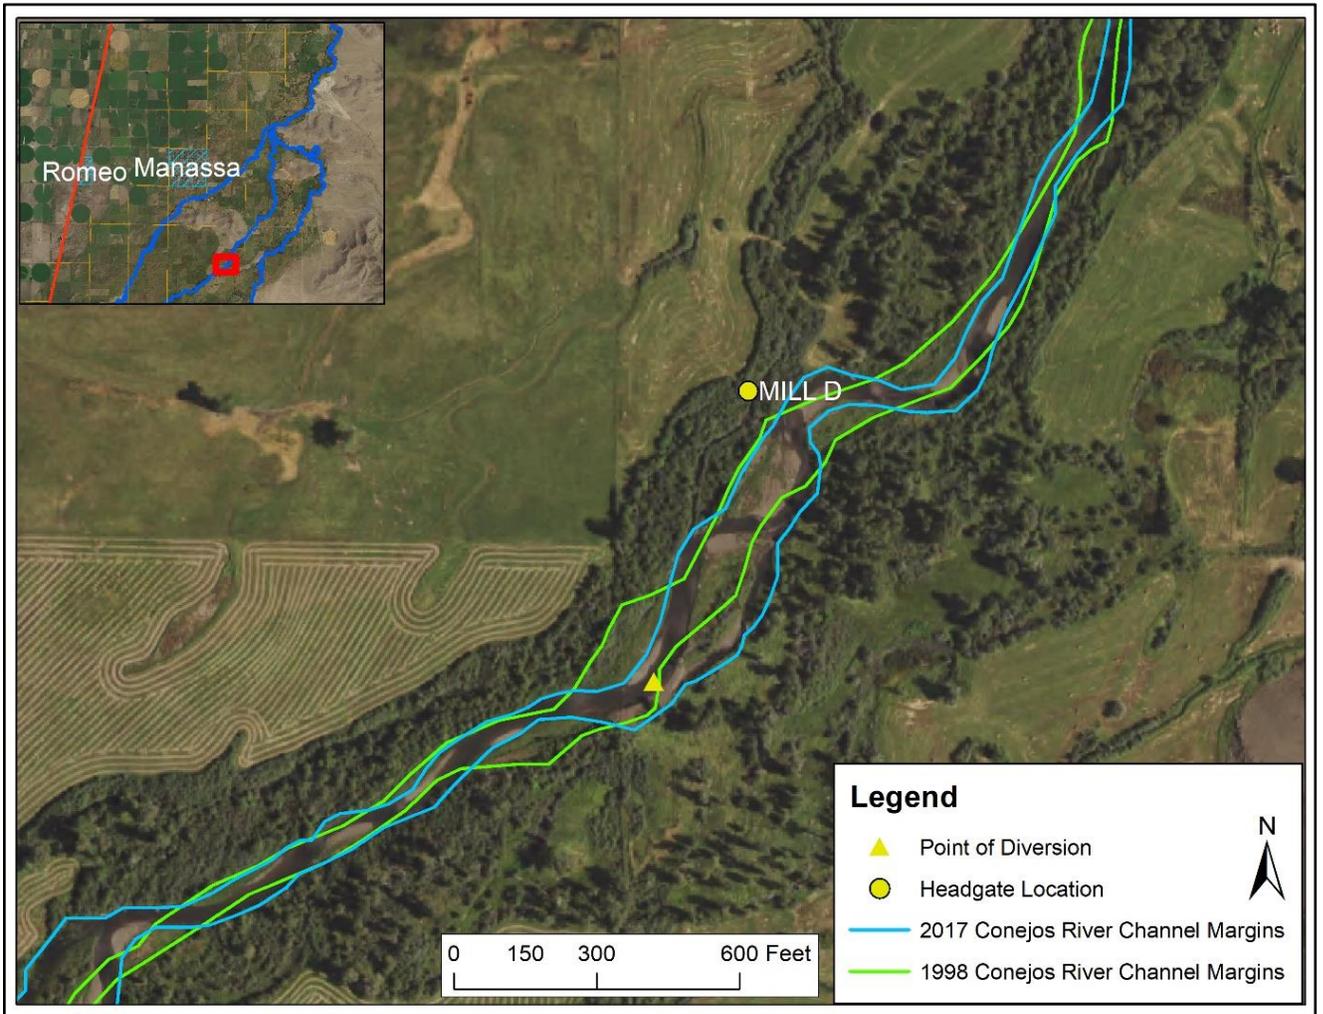
Headgate location with 1998 and 2017 channel margins overlaid
