# CONEJOS RIVER

## DIVERSION INFRASTRUCTURE INVENTORY

**Structure Name:** MOGOTE D

**Date:** April 14, 2019

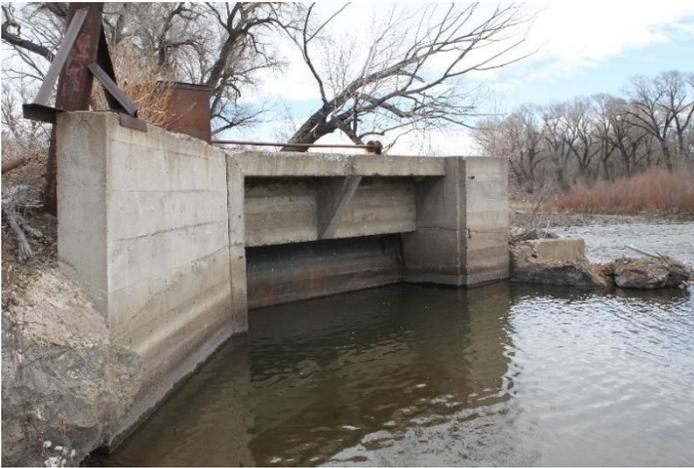
**Structure Description:** The diversion dam is constructed of repurposed molasses tanks and concrete blocks, which direct water to the headgate, located along the north bank of the Conejos River. The headgate does not completely seal when closed and its headwall is spalling. The channel is relatively stable in this reach, although prior to 1998, the channel did experience some migration (see maps in below). A small aggregate berm has been pushed up below the headgate outlet in an attempt to prevent water from flowing down the ditch. The diversion dam can accumulate woody debris and requires maintenance. However, it is not a significant issue for water users. The diversion is currently a barrier to fish passage, especially at low flows.

Headgate looking downstream

**Repair(s) or Improvement(s) Currently Needed:** Given the issues identified at this structure, the SMP Technical Advisory Team (TAT) recommends repairing the headgate and its headwall. A new or repaired headgate would increase efficiency and water control, and reduce maintenance. If any improvements are made to the diversion, the TAT also recommends creating fish passage to increase aquatic habitat connectivity.

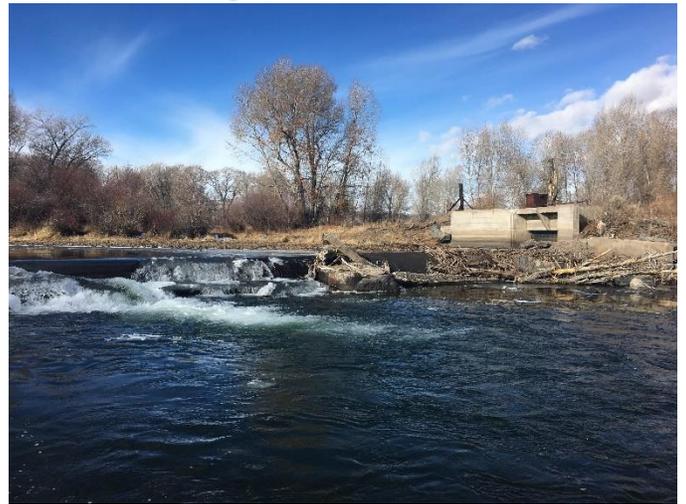
Headgate and diversion dam

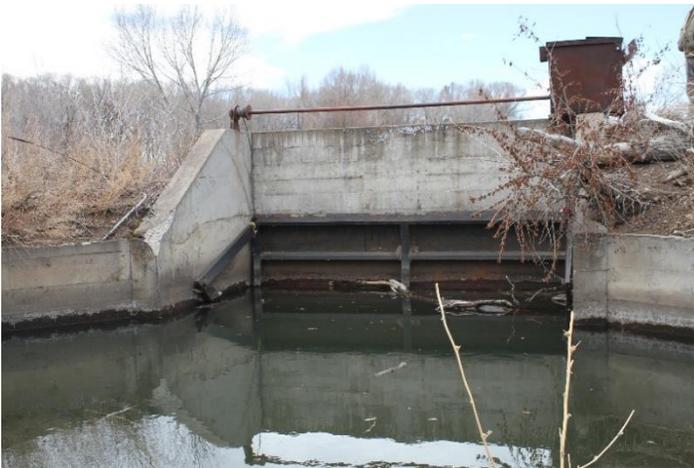
Headgate outlet

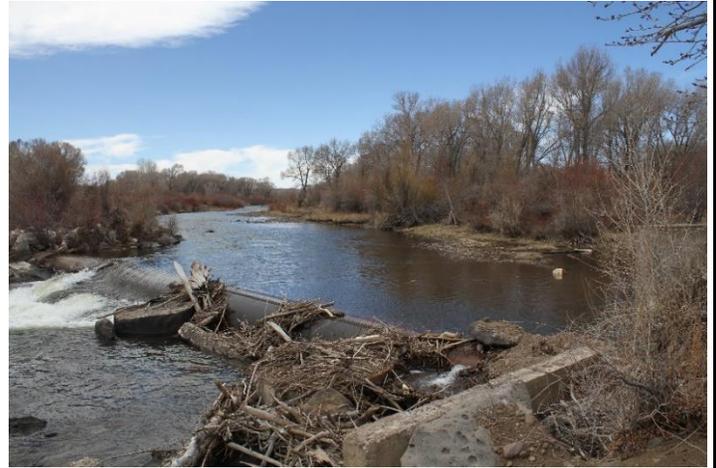
Diversion dam looking upstream

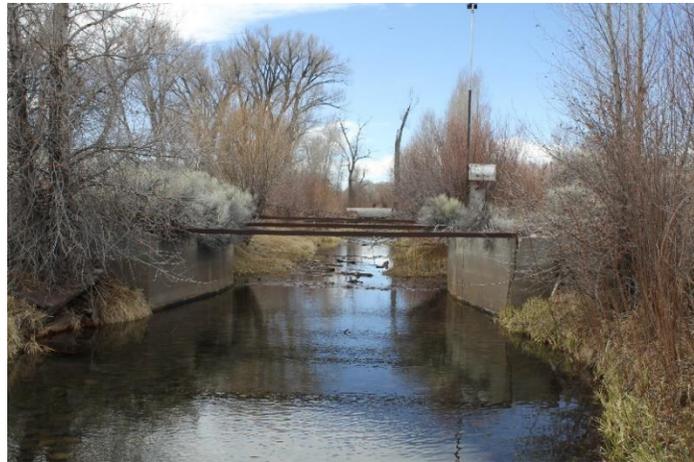
Flume looking downstream

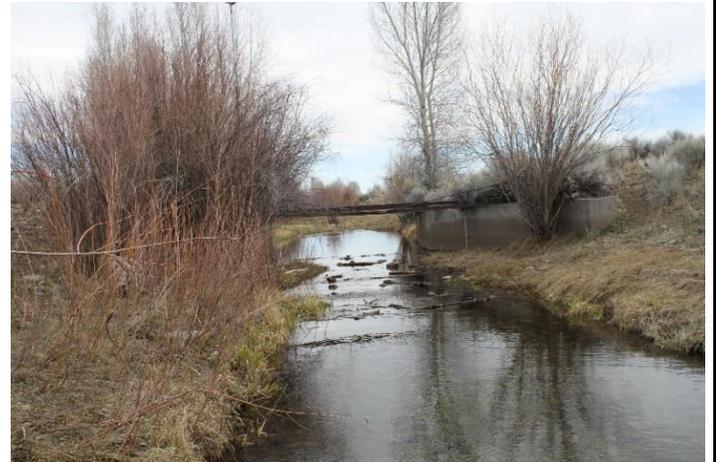
Flume looking upstream
